# *Special Inspection*

*4828 San Miguel Ct*

February 21<sup>st</sup>, 2024

Our office has been requested to provide special inspections of the existing trees and the home located at 4828 San Miguel Ct in northeast Salem.

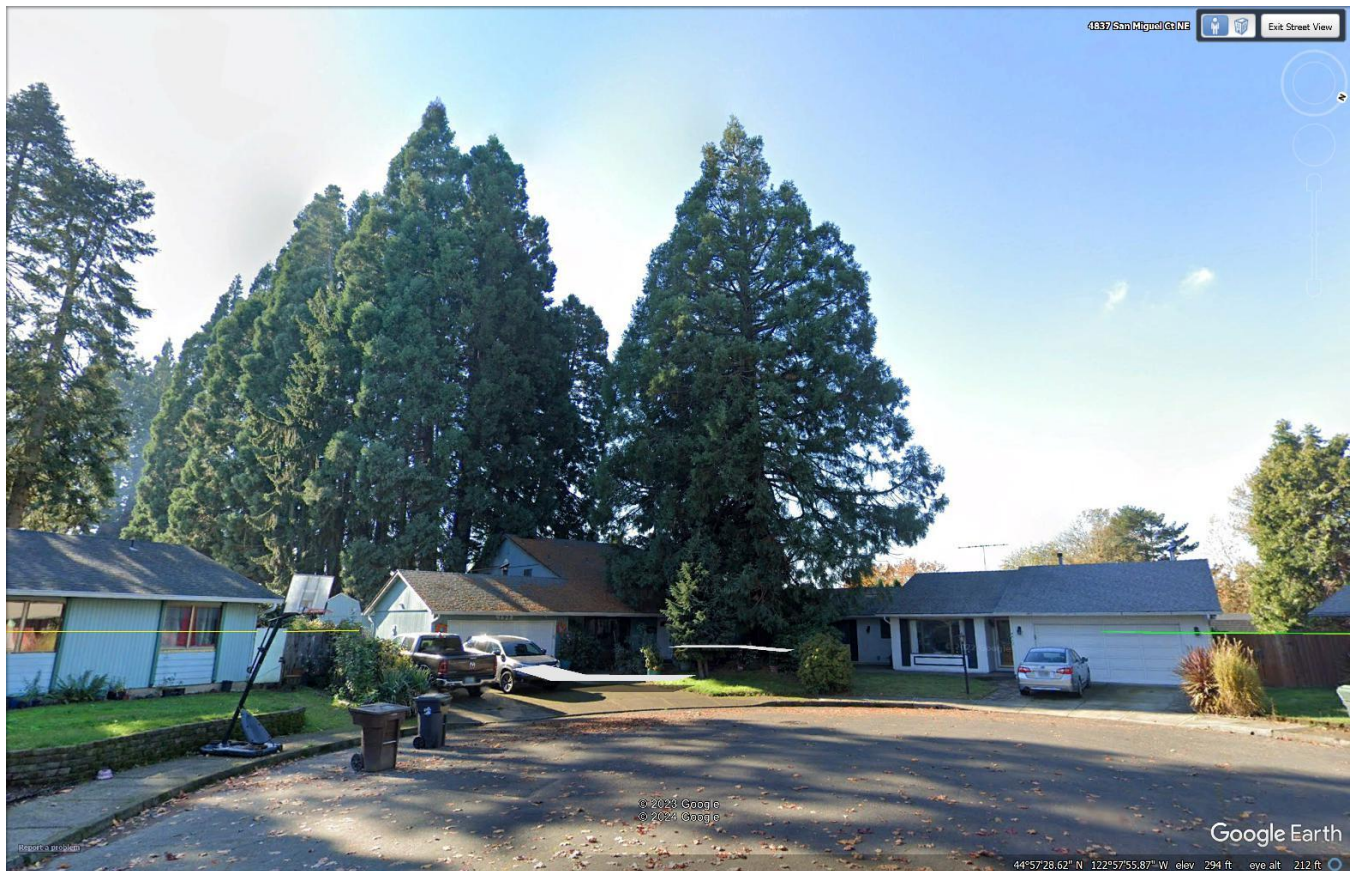
In the area of the southeast corner of the home, a group of 3 sequoia trees, approximately 40 to 48 inches in diameter are starting to lift the house foundation.

It is our recommendation that the group of three trees in the rear of the home next to the house be removed to limit the continued root growth and the lifting of the house foundation corner.

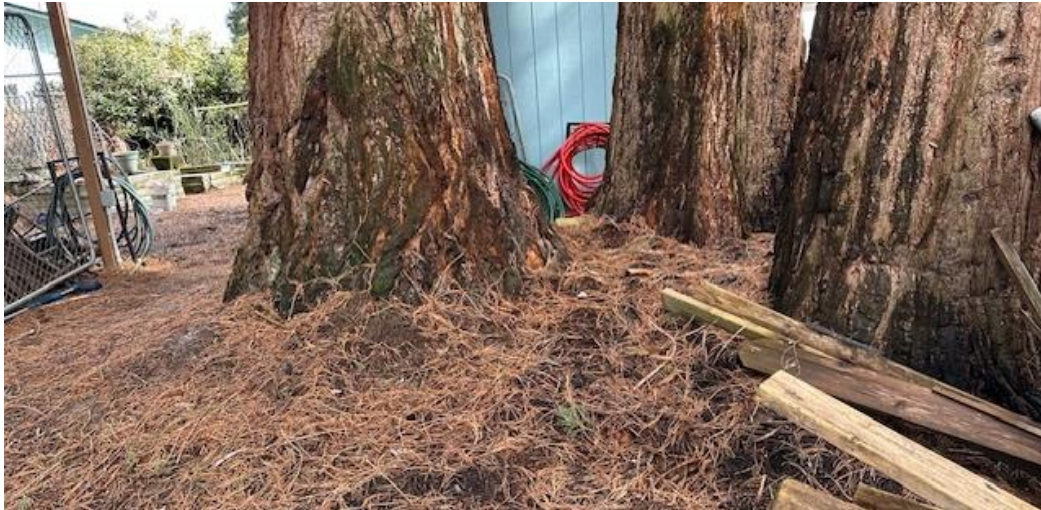
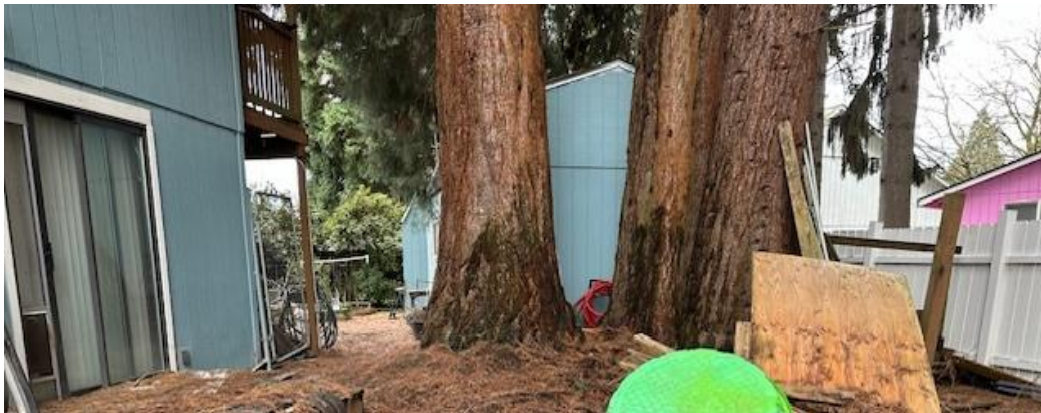
You can see just how much the ground around the trees has been elevated as they grow.

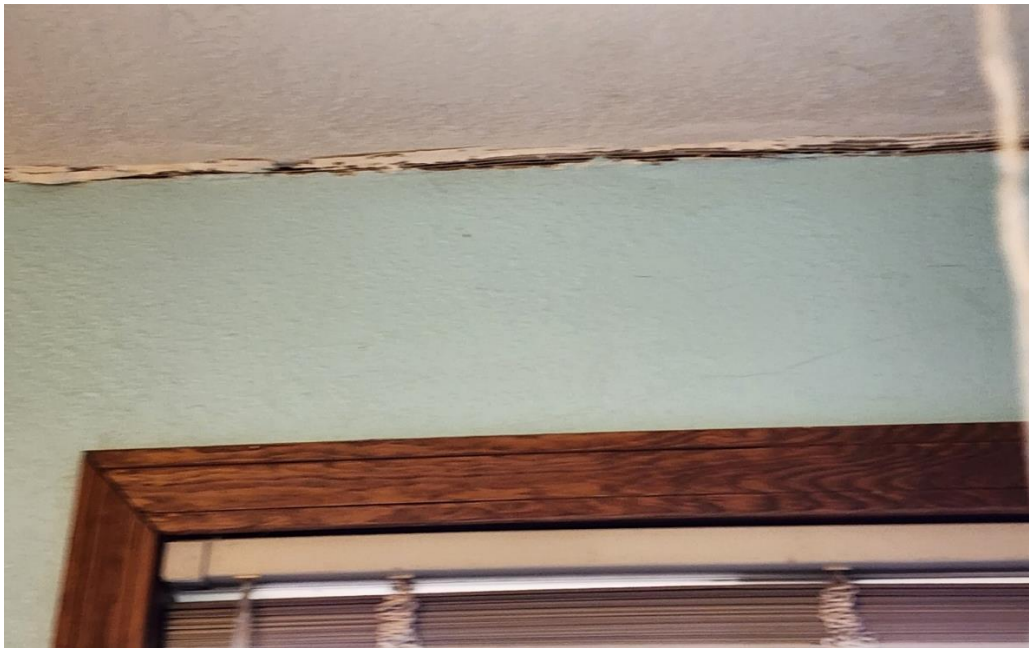
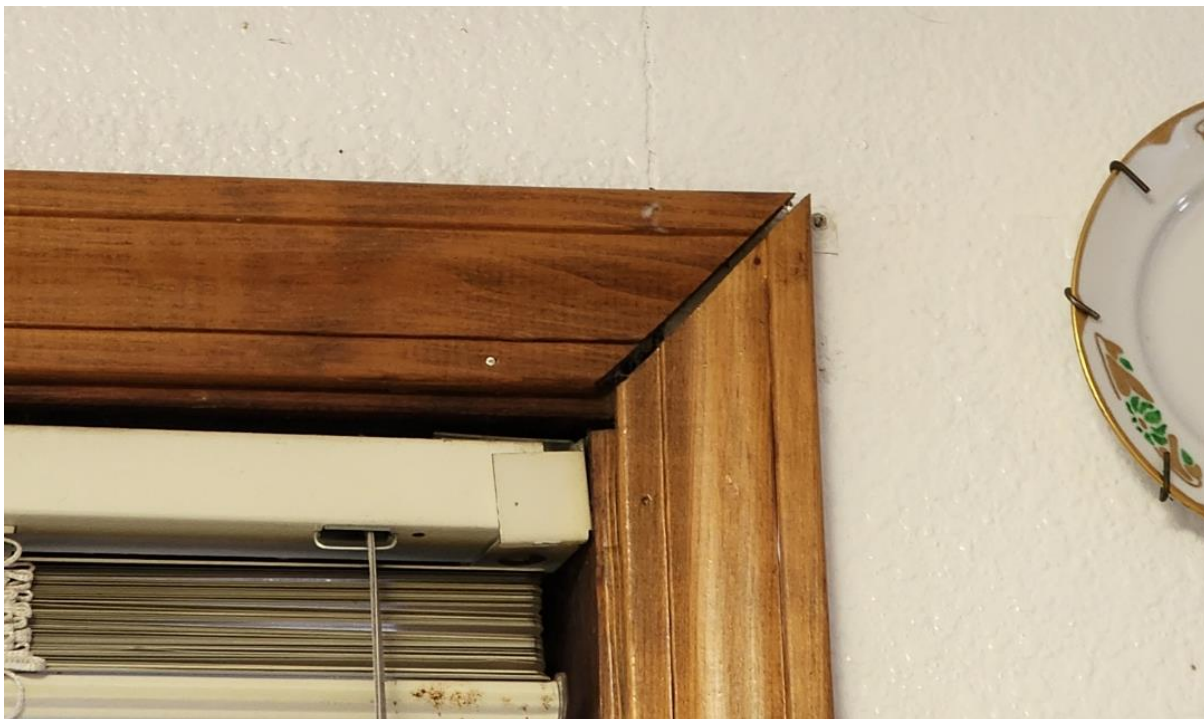
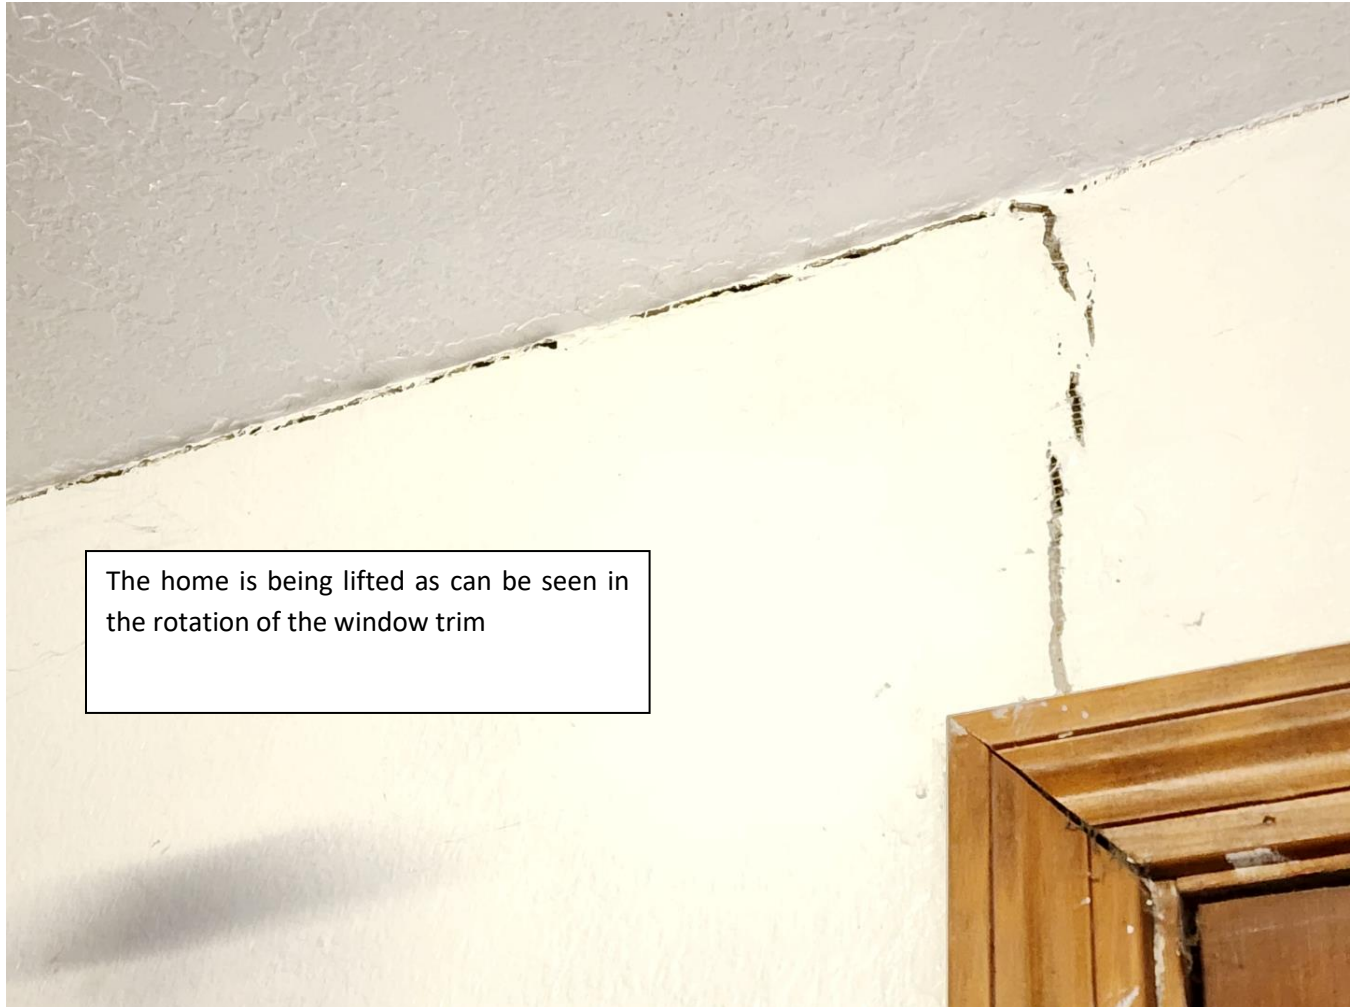
The home has sustained some interior damage already from the tree roots lifting the home.

Failure to take action now will result in more significant damage to the house, which may not be corrected without major efforts and expenses.

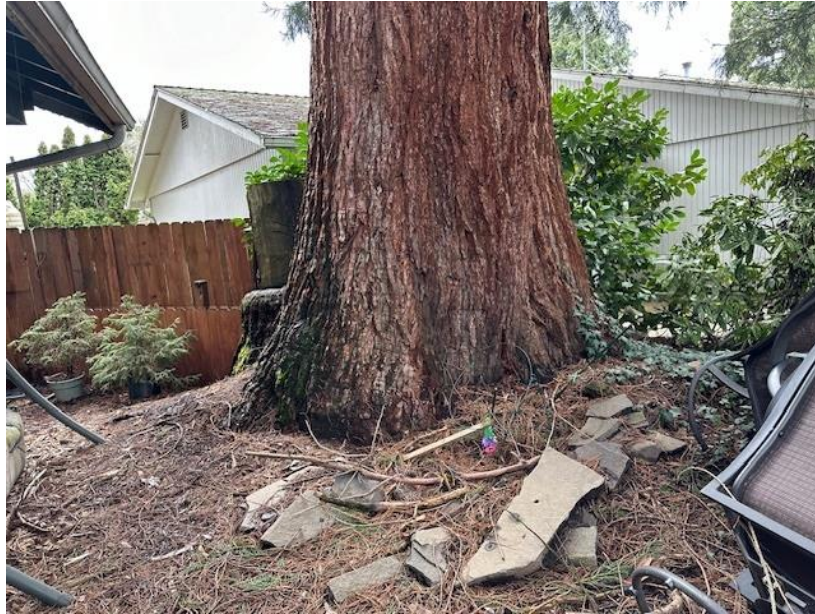
There is also a single tree in the front of the house that will very soon be creating a similar issue.

The tree is approximately 6 feet in diameter and located approximately 6 feet from the home. Again, the mounding of the ground at the tree and toward the home can be seen the root system for this type of tree can be shallow and more horizontal in run than vertical. Such systems can then have a much greater impact on the home foundation than other types of trees.

This tree should also be considered for removal now, before movement and damage begin to occur to the home.

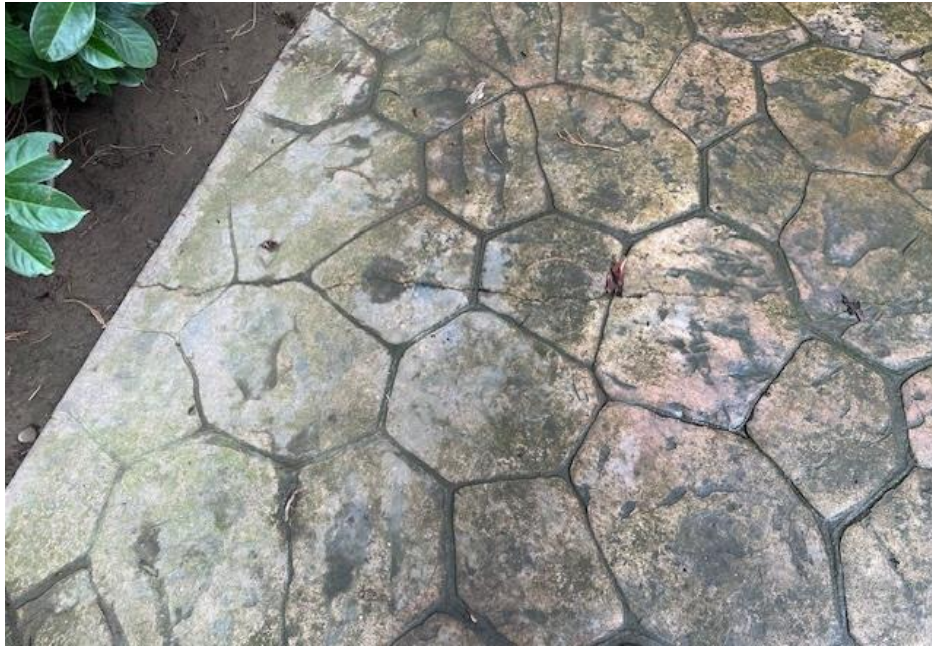
The home to the northwest of this tree on the next lot has a concrete and stone patio area near this tree. Some lifting has begun to show, as there is a linear crack in the flat work.
