Arborist Report

Santiam Tree Service Inc
(541) 905-6674
PO Box 401, Scio OR, 97374

The information in this report has been gathered by means of a visual inspection on March 8th, 2024 at approximately. This report has been written to assess two oak trees for the Coburn Grand View project. Due to the nature of visual inspection, it is important to note that there are limitations to this inspection method. Limitations are evident in assessment of the roots, upper canopy, and heartwood of the tree. These parts of the tree will require more advanced inspection techniques if it is deemed necessary.

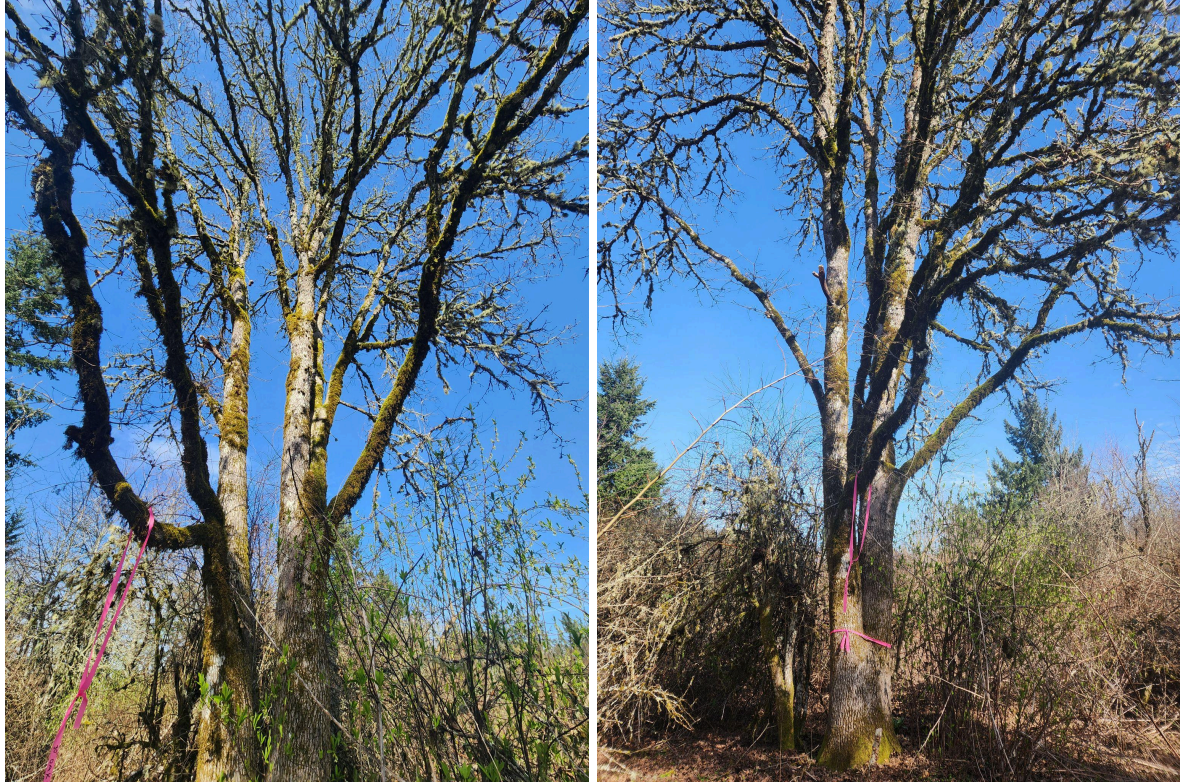
Tree 1:

Arborist Assessment: The tree canopy is full and live. The trunk has a codominant growth structure with included bark present. The root collar/trunk flare is exposed and appears healthy.

Proposed Site Changes: 81 percent of this tree's critical root zone would be impacted during construction from excavation and other site changes. It is unlikely that this tree would survive such drastic changes. If the proposed site plans are to be carried out, this tree should be removed.

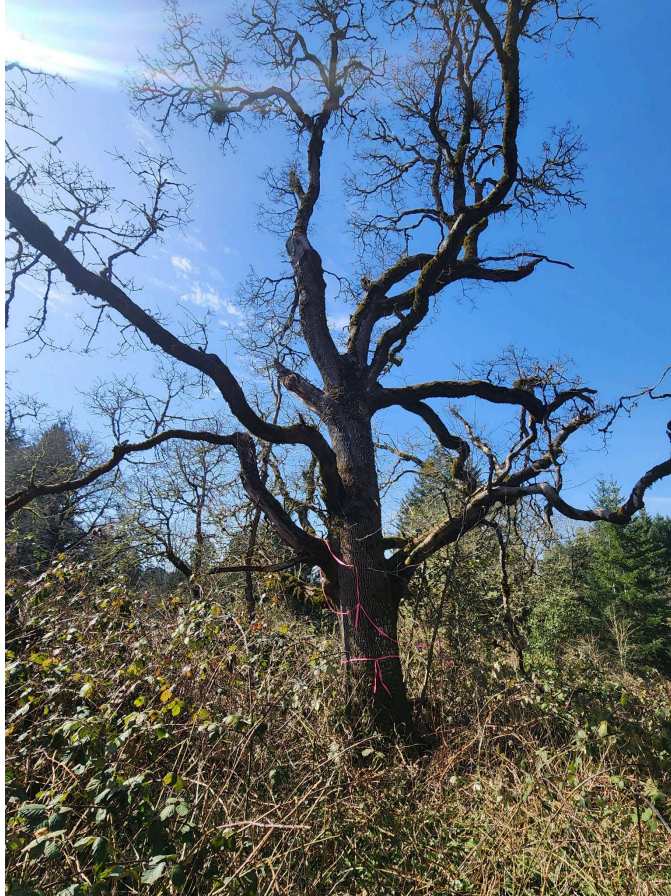
Tree 2:

Arborist Assessment: The tree canopy appears to have been damaged, likely due to a previous storm. There are several large branches that have broken from the canopy, as well as smaller limbs. All of these have left wounds on the tree that are clearly visible. The remaining canopy appears to be healthy and live. The trunk of the tree appears to be healthy. Barbed wire has been wrapped around the tree in the past and is beginning to be grown around by the trunk. The root collar/trunk flare appears to be healthy and exposed.

Proposed Site Changes: 62 percent of this tree's critical root zone would be impacted during construction from excavation and other site changes. It is unlikely that this tree would survive such drastic changes. If the proposed site plans are to be carried out, this tree should be removed.
