# *Special Inspection*

*4828 San Miguel Ct*

June 4<sup>th</sup>, 2024

Our office has been requested to provide special inspections of the existing trees and the home located at 4828 San Miguel Ct in northeast Salem.

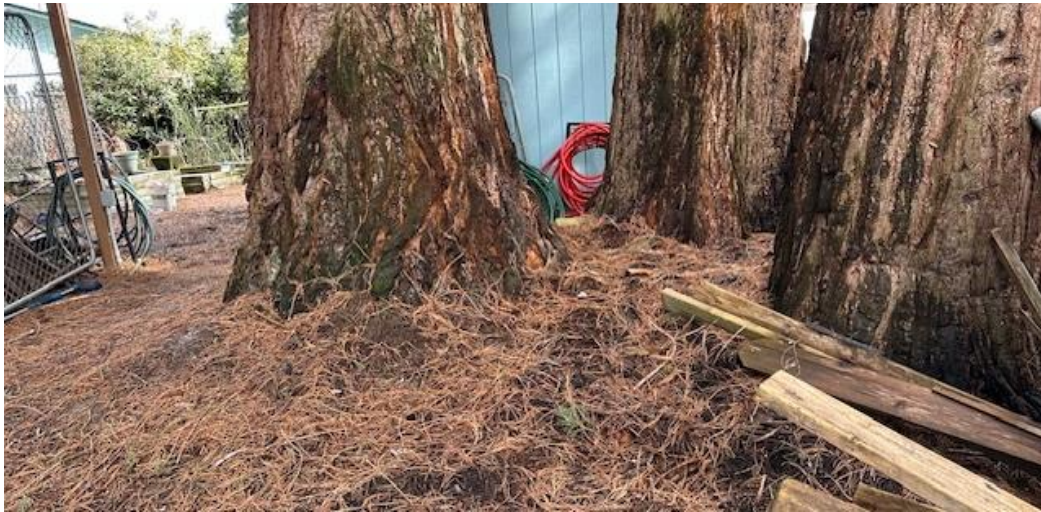
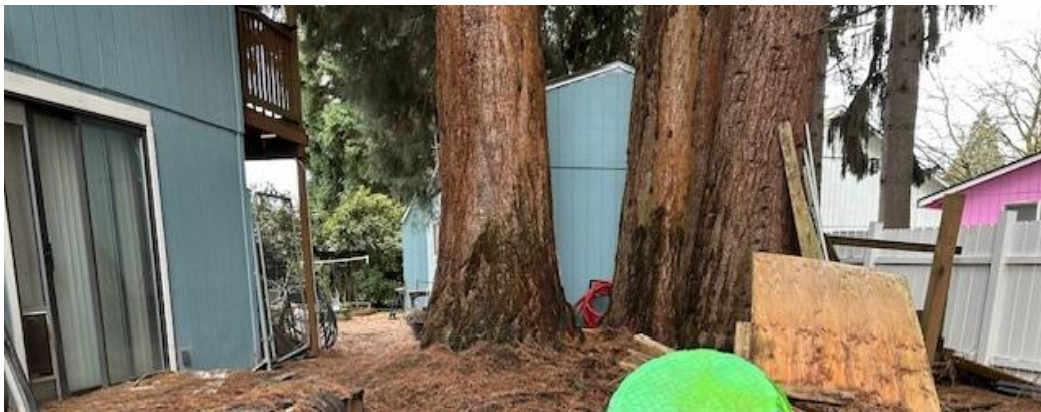
The home has sustained some interior damage already from the tree roots lifting the home.

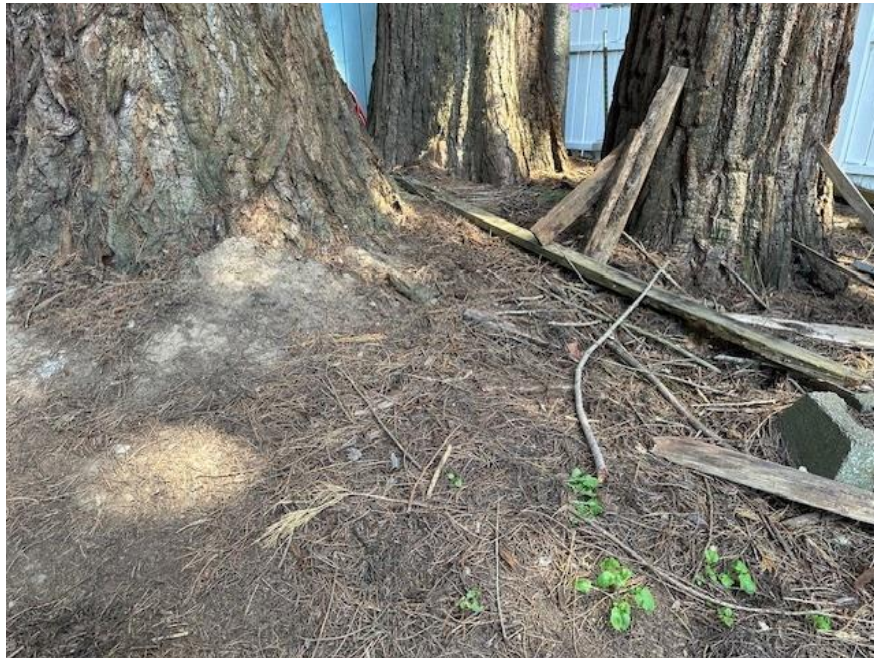
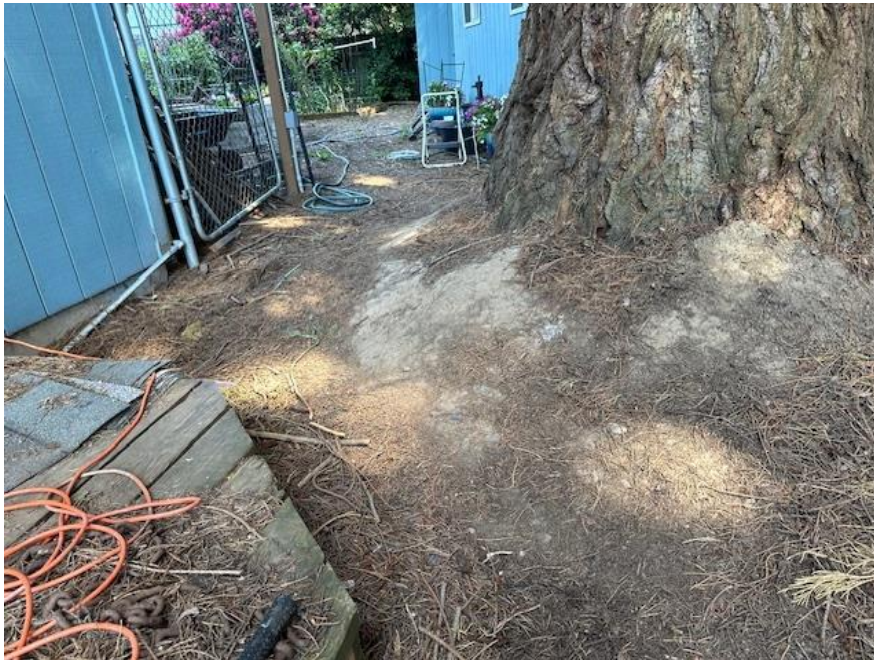
Contrast the above view of the larger tree base, greatly elevated and expanding out away from the tree trunk. These growth-related changes to the area around the trees were likely not considered with the home was constructed.

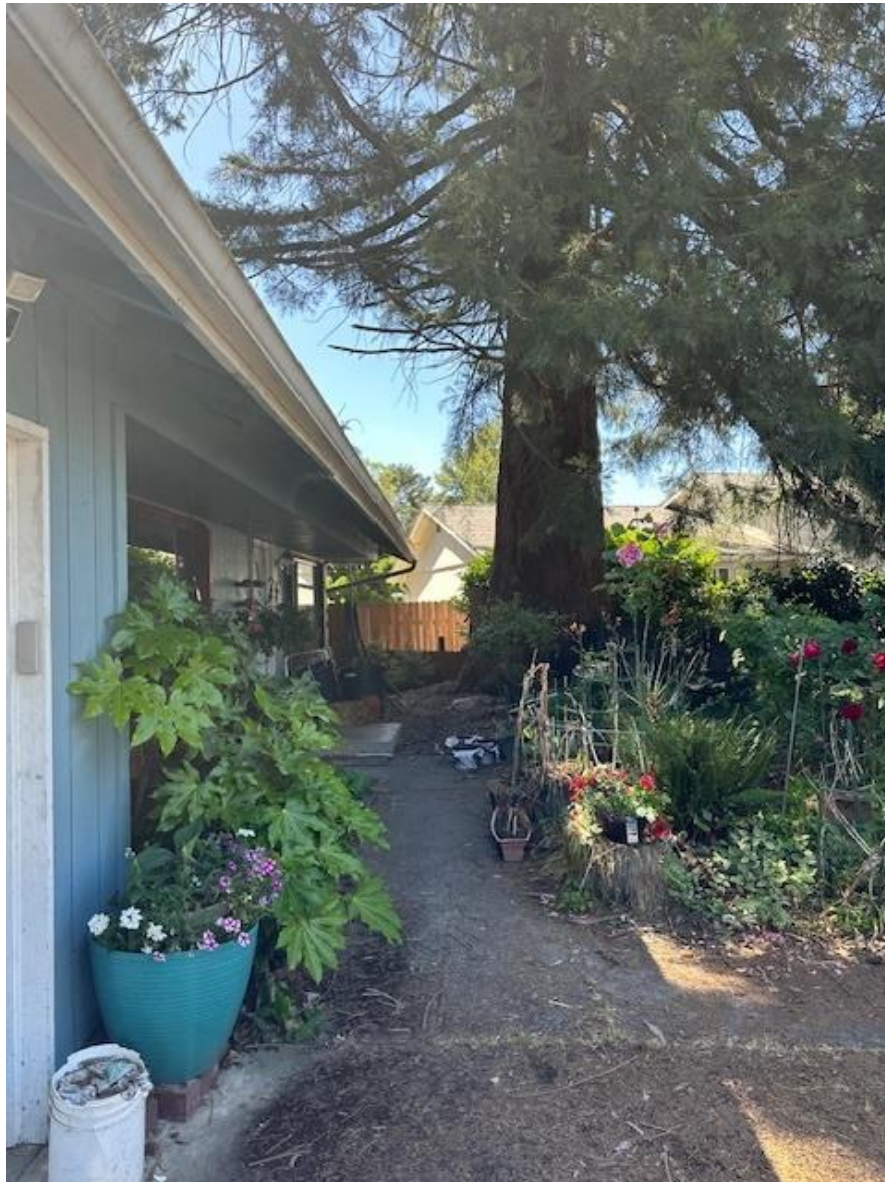
There is also a single tree in the front of the house that will very soon be creating a similar issue. This tree is located next to the northwest corner of the home.

The tree is approximately 6 feet in diameter and located approximately 6 feet from the home. Again, the mounding of the ground at the tree and toward the home can be seen the root system for this type of tree can be shallow and more horizontal in run than vertical. Such shallow root systems can then have a much greater impact on the home foundation than other types of trees.

IT is our professional opinion that the group of three trees near the southeast corner of the home and the single tree near the northwest corner of the home need to be removed. If left in place, they will continue to impact the structure and such impacts will become more significant in nature and create expensive repairs or possible render the home corners in question unreparable leading to the need for extensive reconstruction of the home.

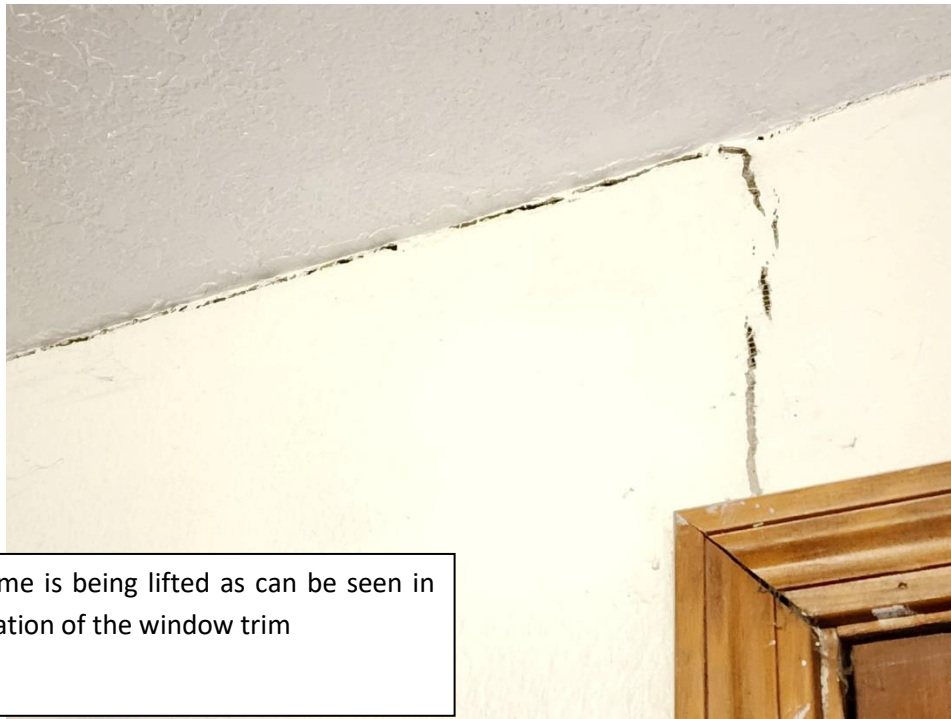
As can be seen in the photo below this tree is also impacting the home foundation pushing up on the corner home footing impacting the interior walls causing separation of the sheet rock at the ceiling.

The home is being lifted as can be seen in the rotation of the window trim

Already the work needed is more than just surface repairs, some structural repairs are needed in both the southeast and northwest corners of the home to correct the present impacts.

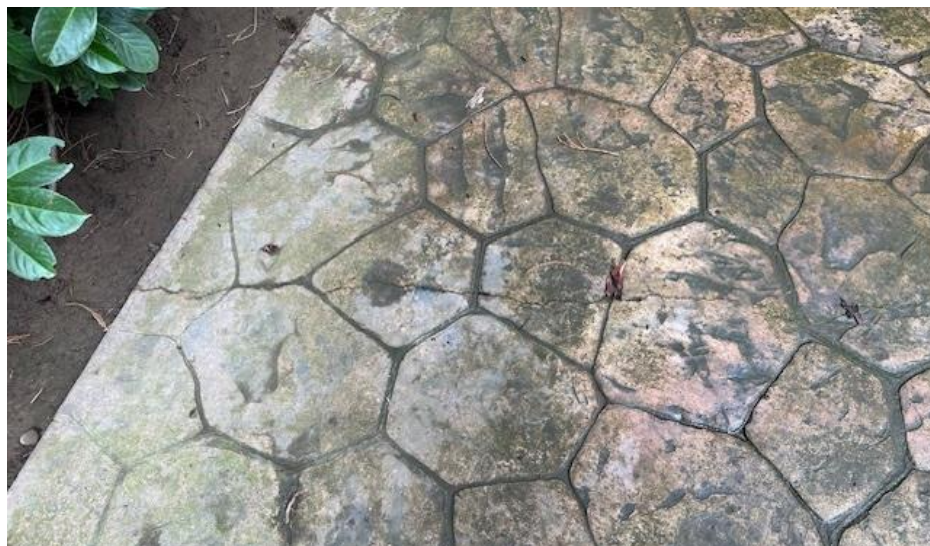
The home to the northwest of this tree on the next lot has a concrete and stone patio area near this tree. Some lifting has begun to show, as there is a linear crack in the flat work.
