# *Special Inspection*

*4828 San Miguel Ct*

June 4<sup>th</sup>, 2024

Our office has been requested to provide special inspections of the existing trees and the home located at 4828 San Miguel Ct in northeast Salem.

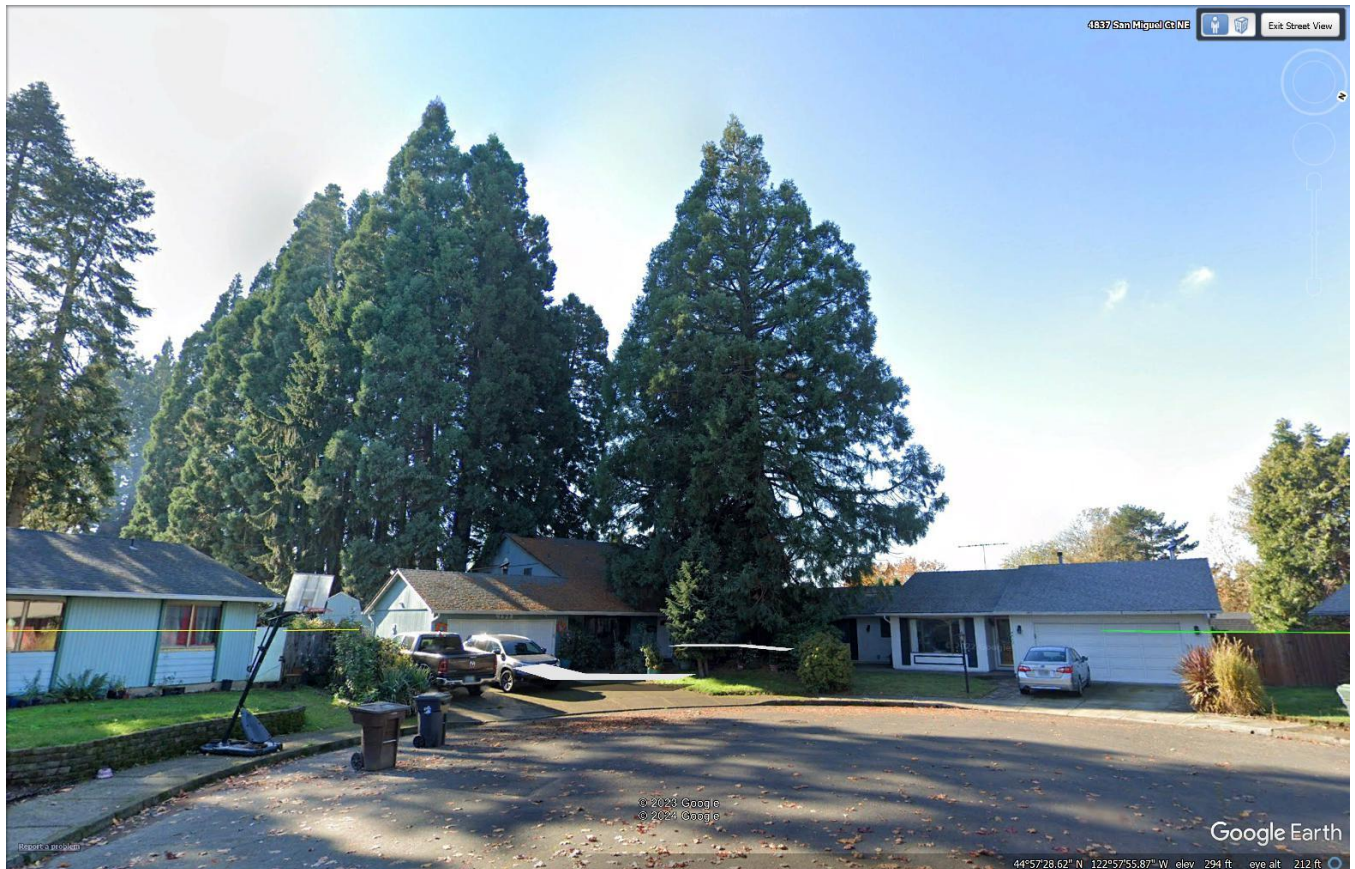
In the area of the southeast corner of the home, a group of 3 sequoia trees, approximately 40 to 48 inches in diameter are starting to lift the southeast corner of the house foundation.

You can see just how much the ground around the trees has been elevated as they grow.

IT is our professional opinion that the group of three trees near the southeast corner of the home and the single tree near the northwest corner of the home need to be removed. If left in place, they will continue to impact the structure and such impacts will become more significant in nature and create expensive repairs or possible render the home corners in question unrepairable leading to the need for extensive reconstruction of the home.

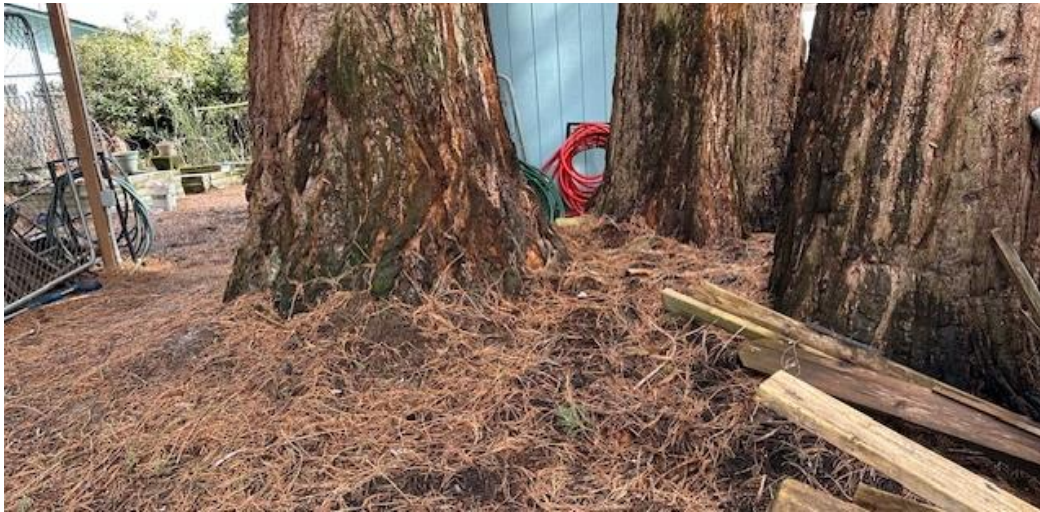
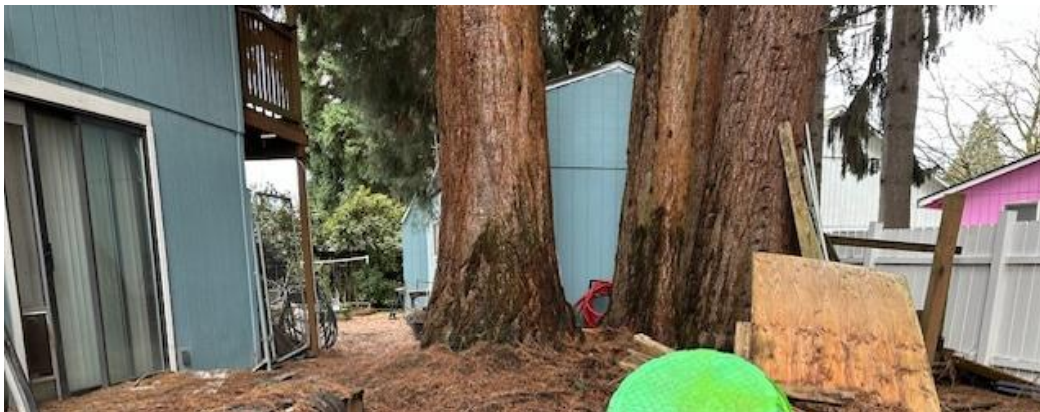
The home has sustained some interior damage already from the tree roots lifting the home.

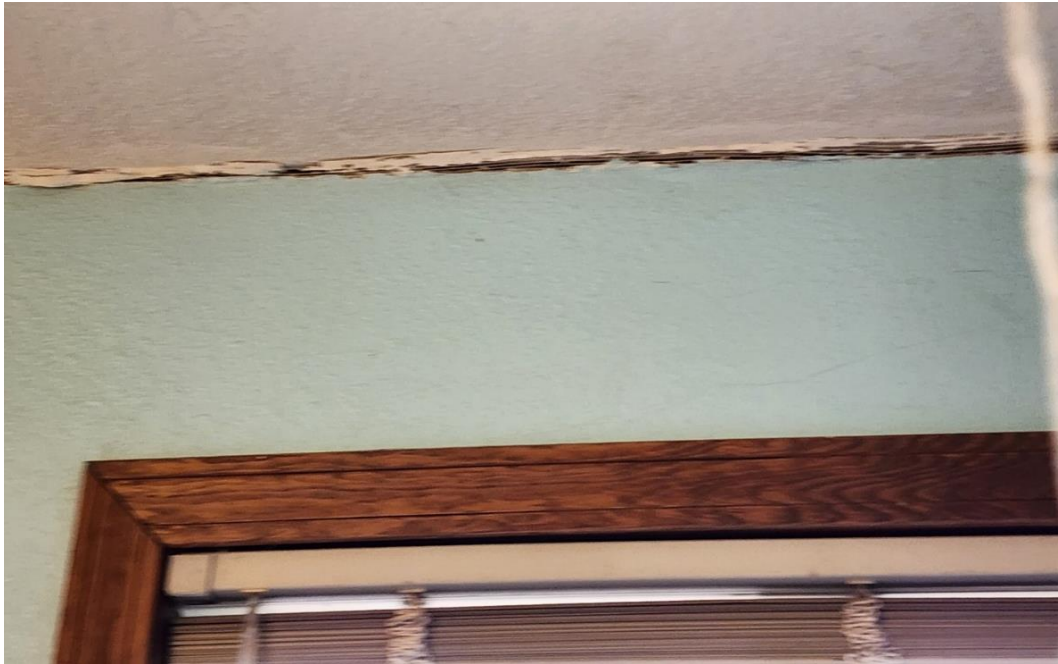
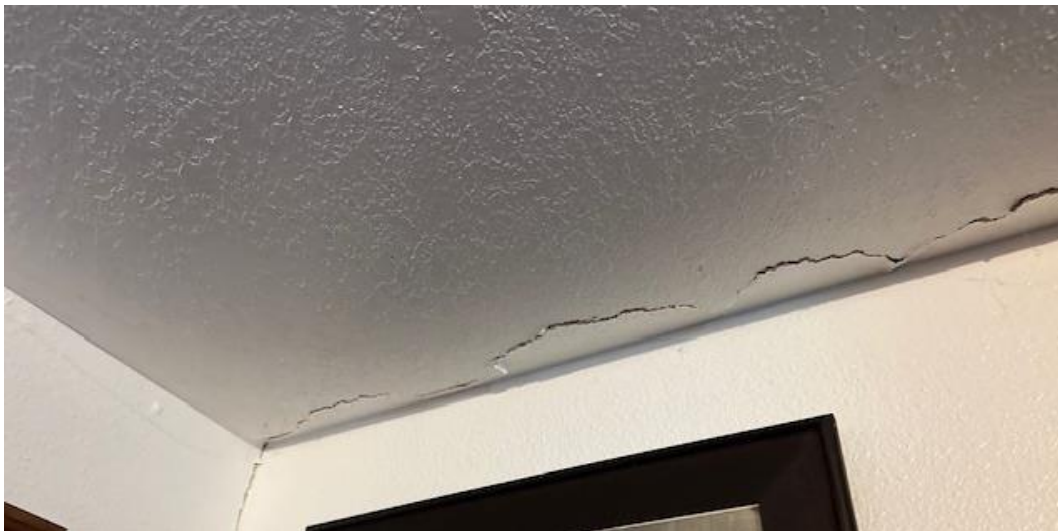
The above photos were taken in the southeast corner of the home. The foundation is being pushed up by the three large trees causing the ceiling to separate from the walls and create excessive damage.

Already the work needed is more than just surface repairs, some structural repairs are needed in both the southeast and northwest corners of the home to correct the present impacts.

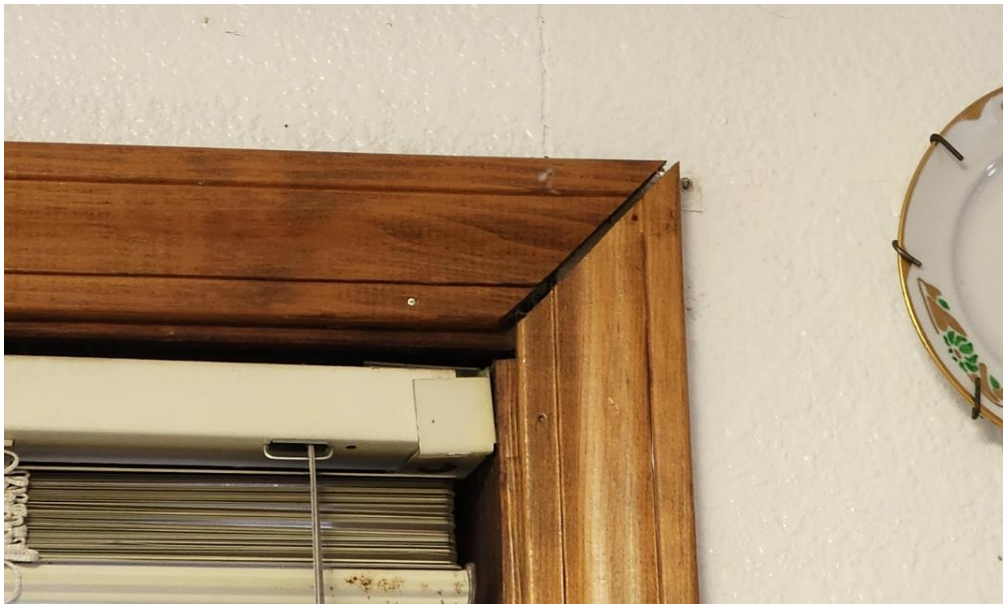
This photo shows the racking of the wall around one of the windows in the south wall.

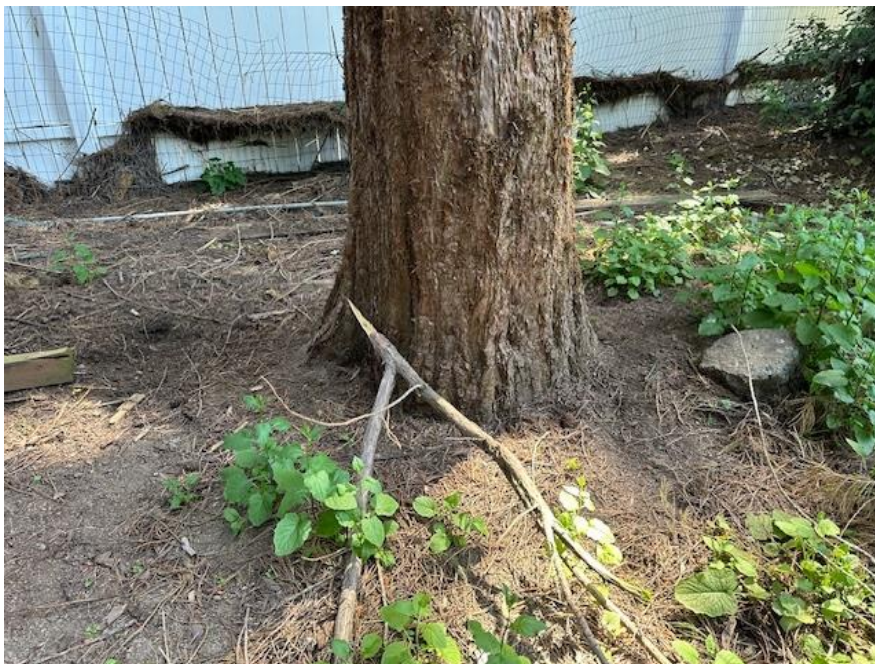
The above photo shows what the base such a tree is like will smaller, most likely what the trees near the house were like then the home was constructed. You note the low profile of the tree base and soil around the tree.

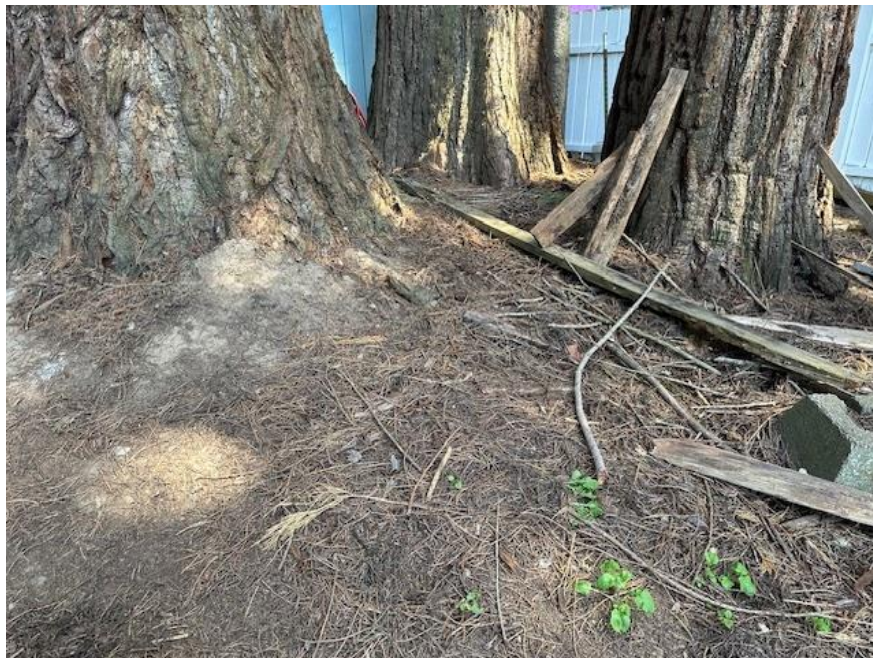
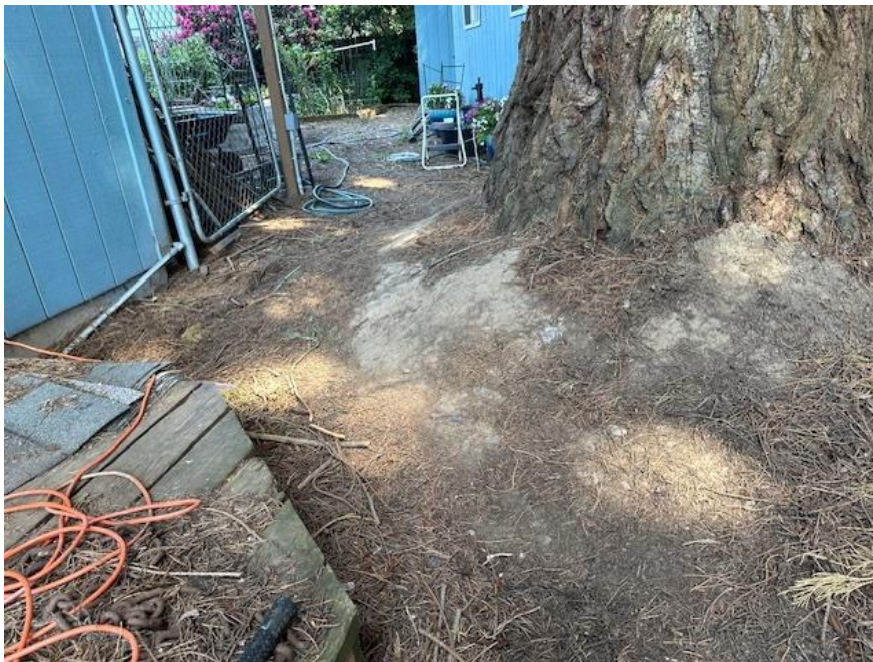
Contrast the above view of the larger tree base, greatly elevated and expanding out away from the tree trunk. These growth-related changes to the area around the trees were likely not considered with the home was constructed.

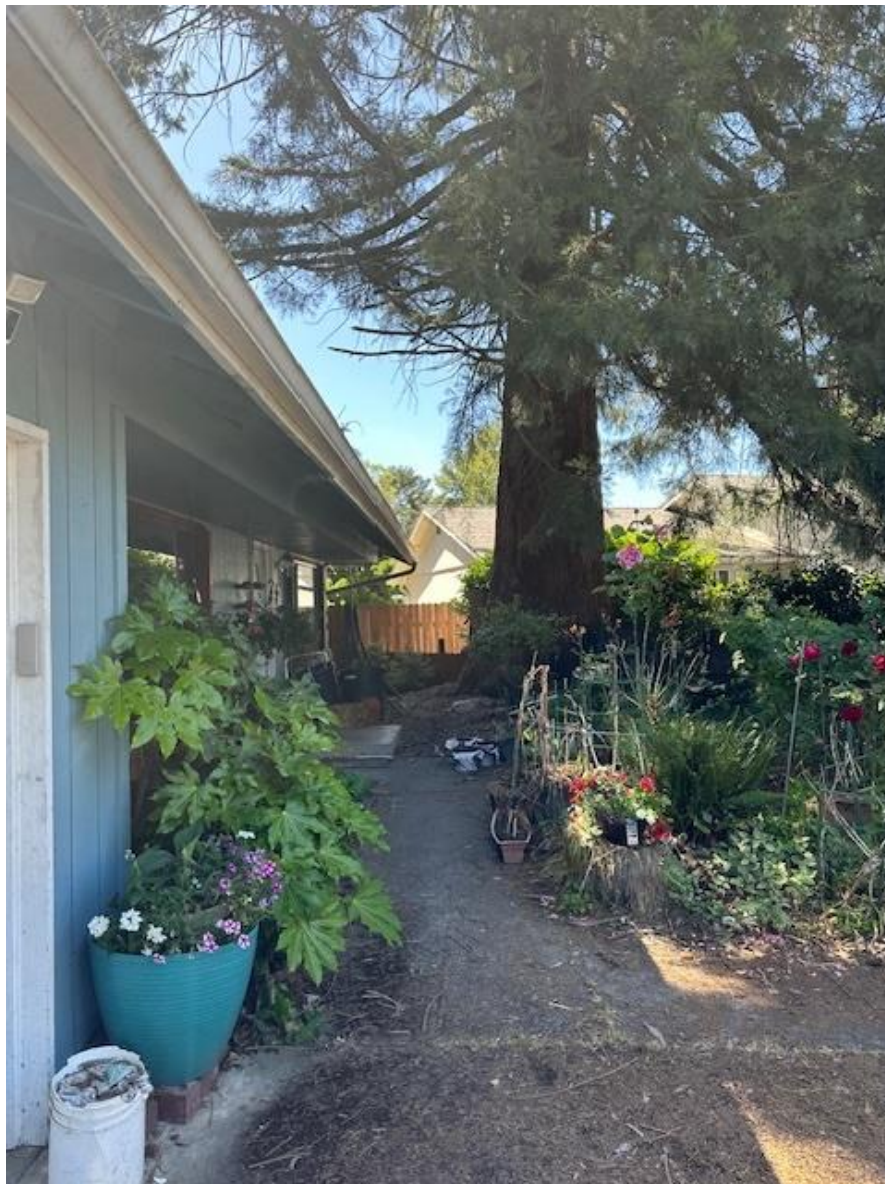
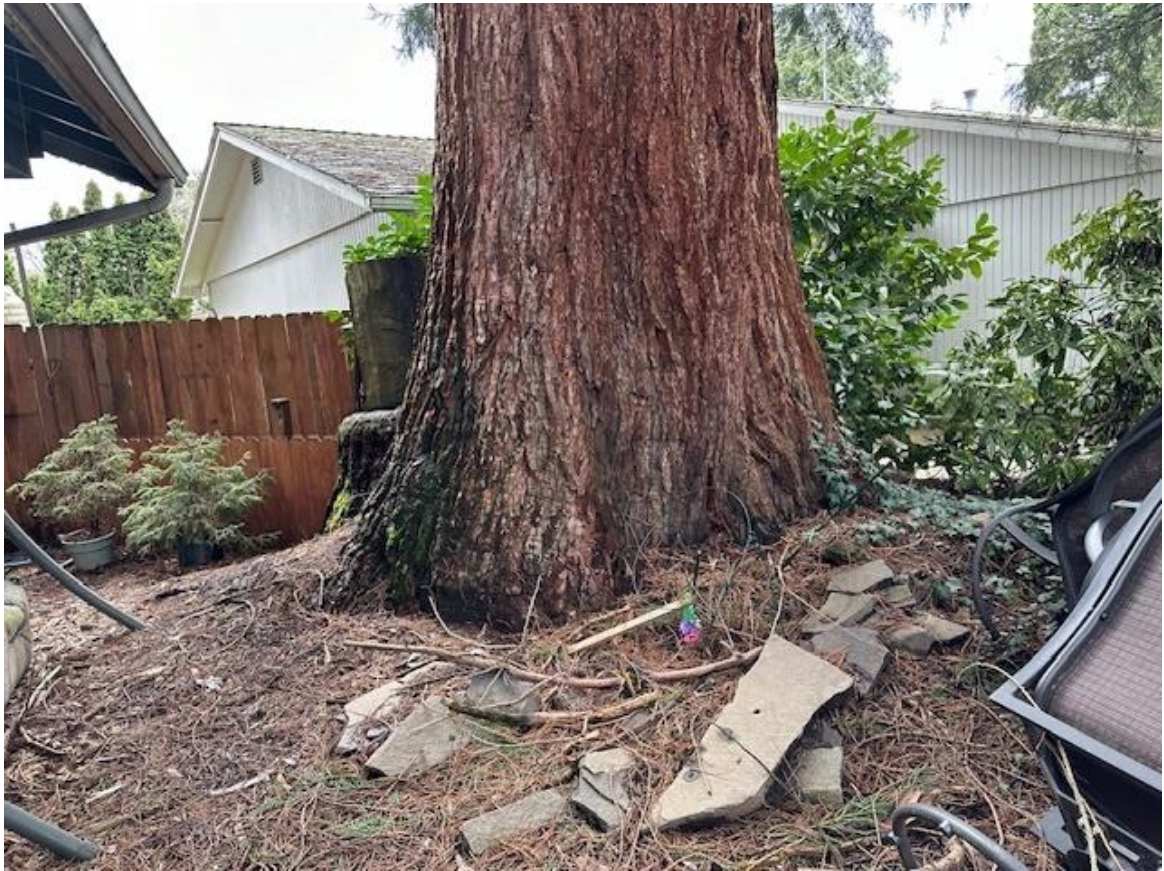
There is also a single tree in the front of the house that will very soon be creating a similar issue. This tree is located next to the northwest corner of the home.

The tree is approximately 6 feet in diameter and located approximately 6 feet from the home. Again, the mounding of the ground at the tree and toward the home can be seen the root system for this type of tree can be shallow and more horizontal in run than vertical. Such shallow root systems can then have a much greater impact on the home foundation than other types of trees. Clearly this tree as are the rear trees discussed above, intruding under the home footing in the northwest corner, lifting that area of the house.

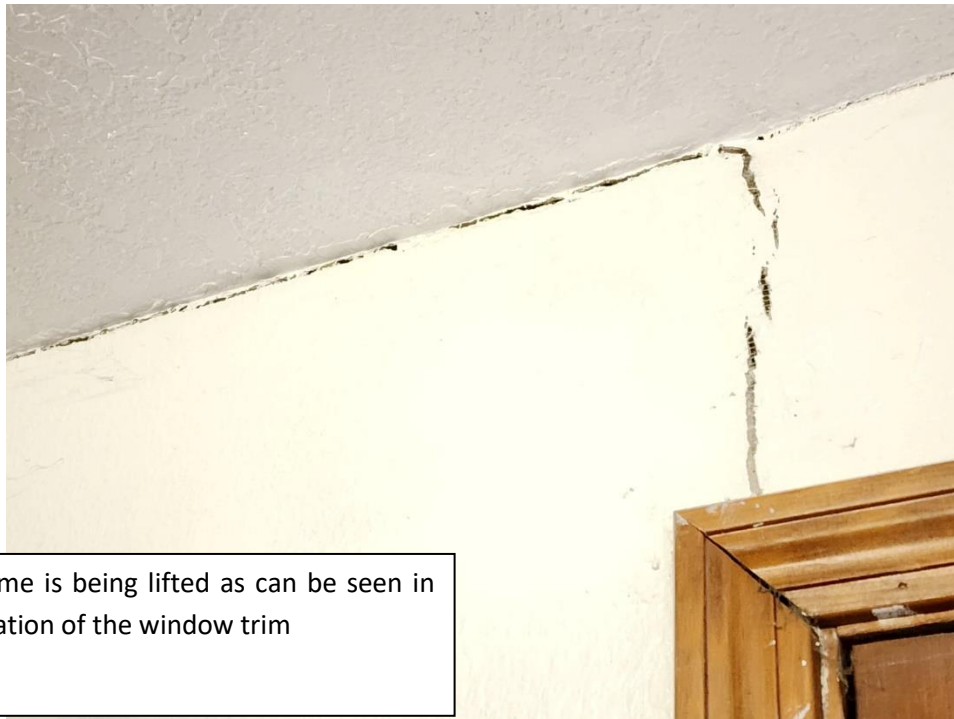
As can be seen in the photo below this tree is also impacting the home foundation pushing up on the corner home footing impacting the interior walls causing separation of the sheet rock at the ceiling.

The home is being lifted as can be seen in the rotation of the window trim

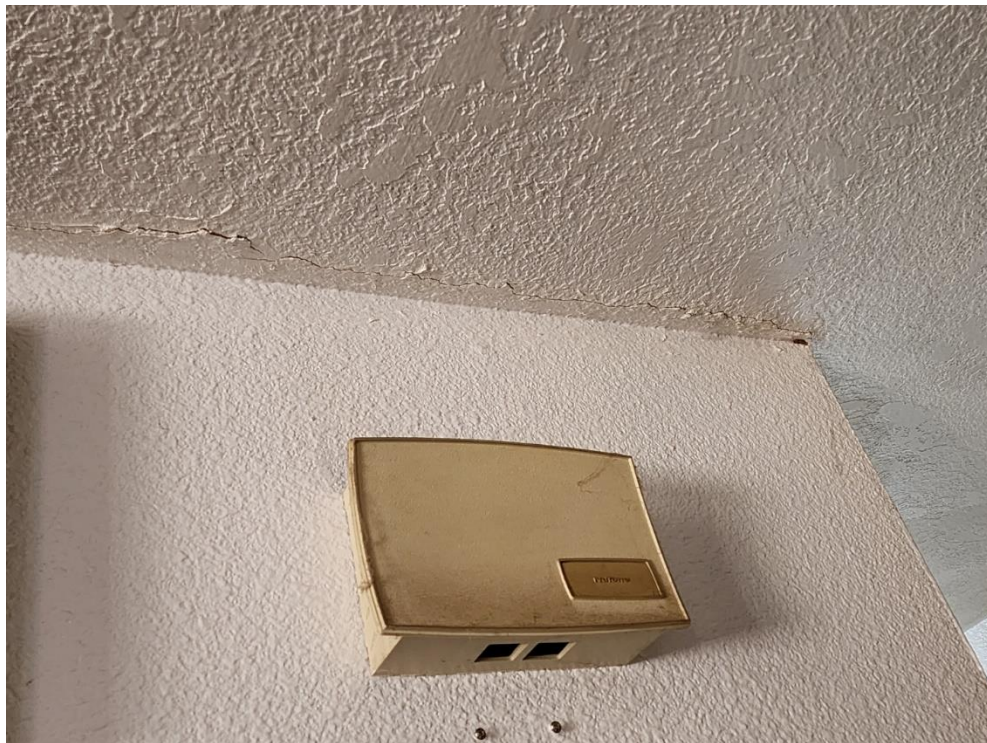
The wall is being lifted and pulling the ceiling sheet rock up, creating a difficult repair.

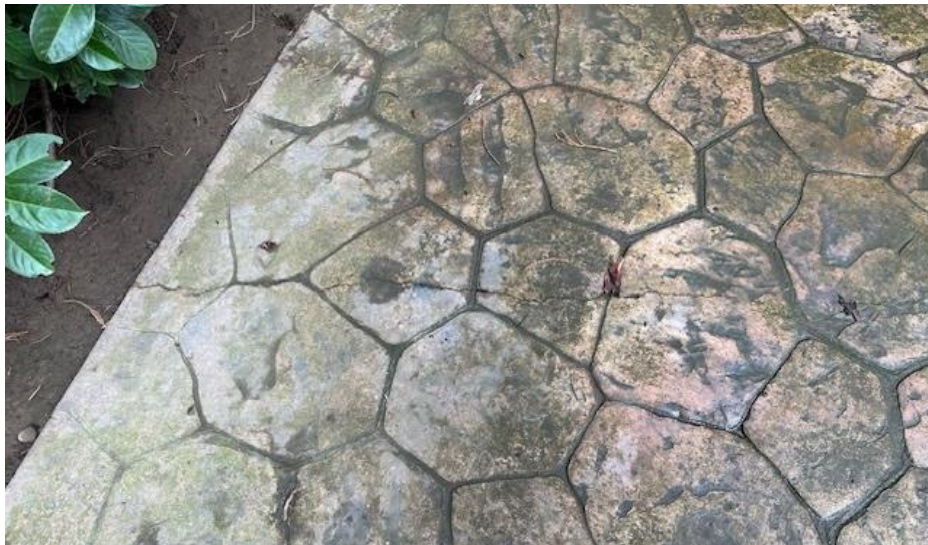
The home to the northwest of this tree on the next lot has a concrete and stone patio area near this tree. Some lifting has begun to show, as there is a linear crack in the flat work.
