ARBORIST REPORT

Tree Evaluation

1221 River Bend Road Northwest

DATE: July 15, 2021

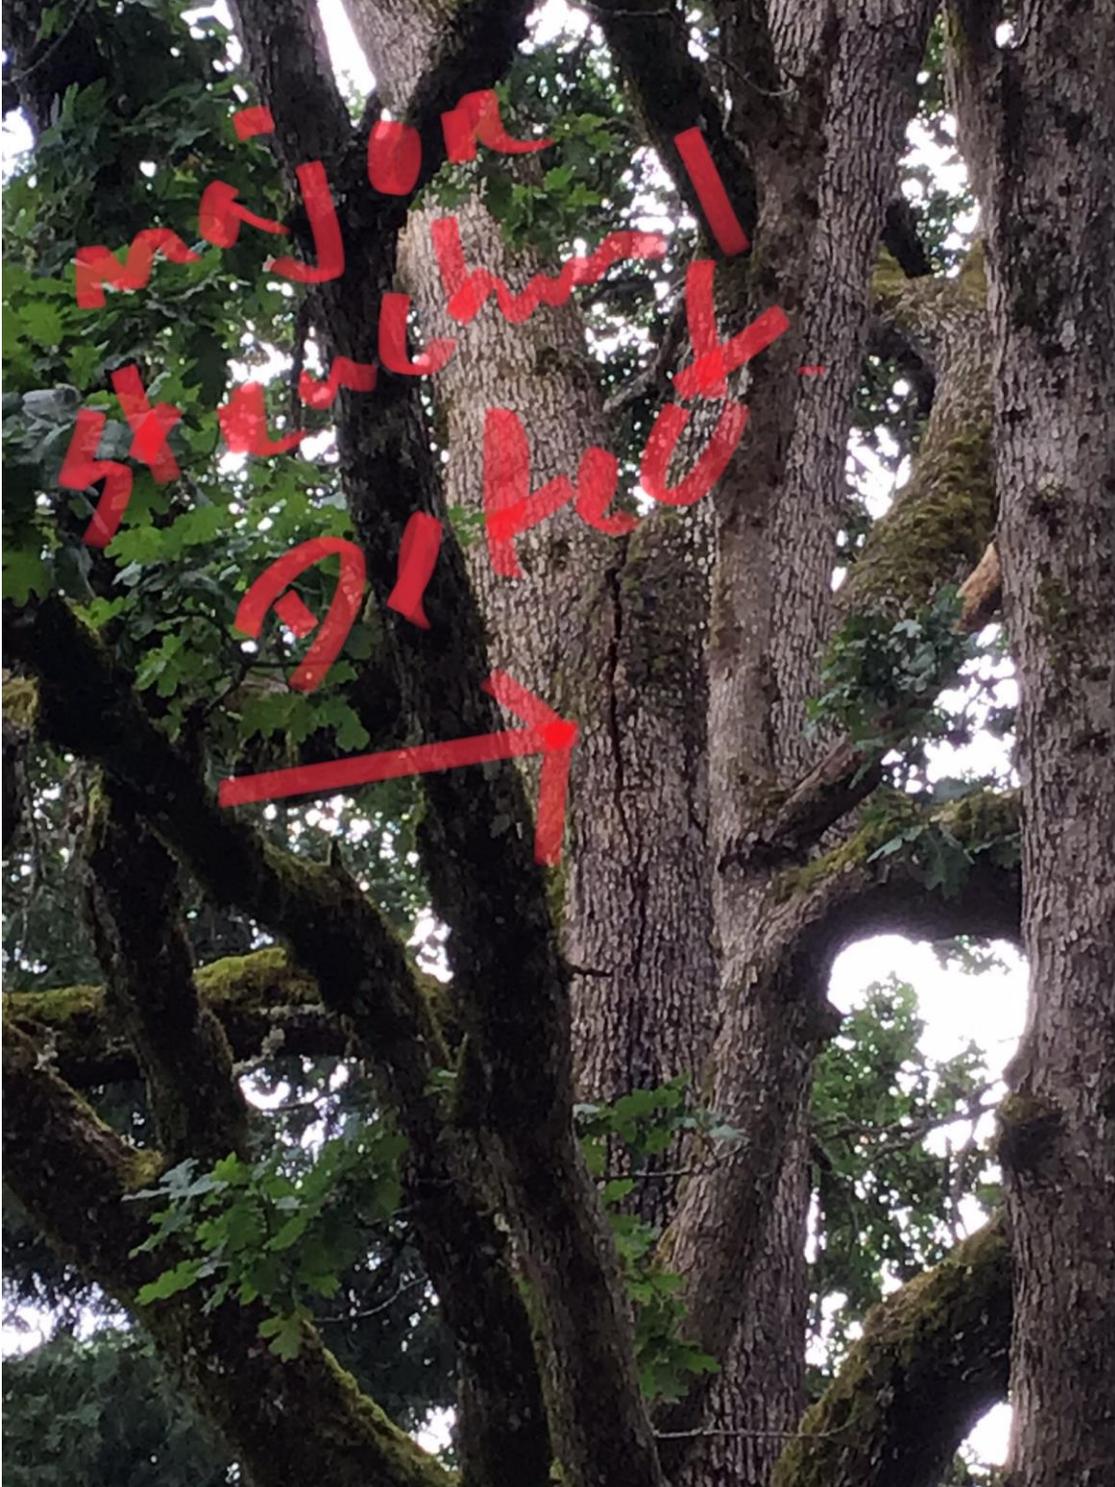
Oak number one has a significant defect in the main crotch and needs immediate mitigation measures. My recommendation is to do significant tip weight reduction to remove large deadwood and install a cabling system to support splitting crotch. This shall only be done by an ISA Certified Arborist. We recommend pruning to repair storm damage, reduce tip weight, and remove large deadwood on the second oak tree.

Oak No. 1 Showing defect

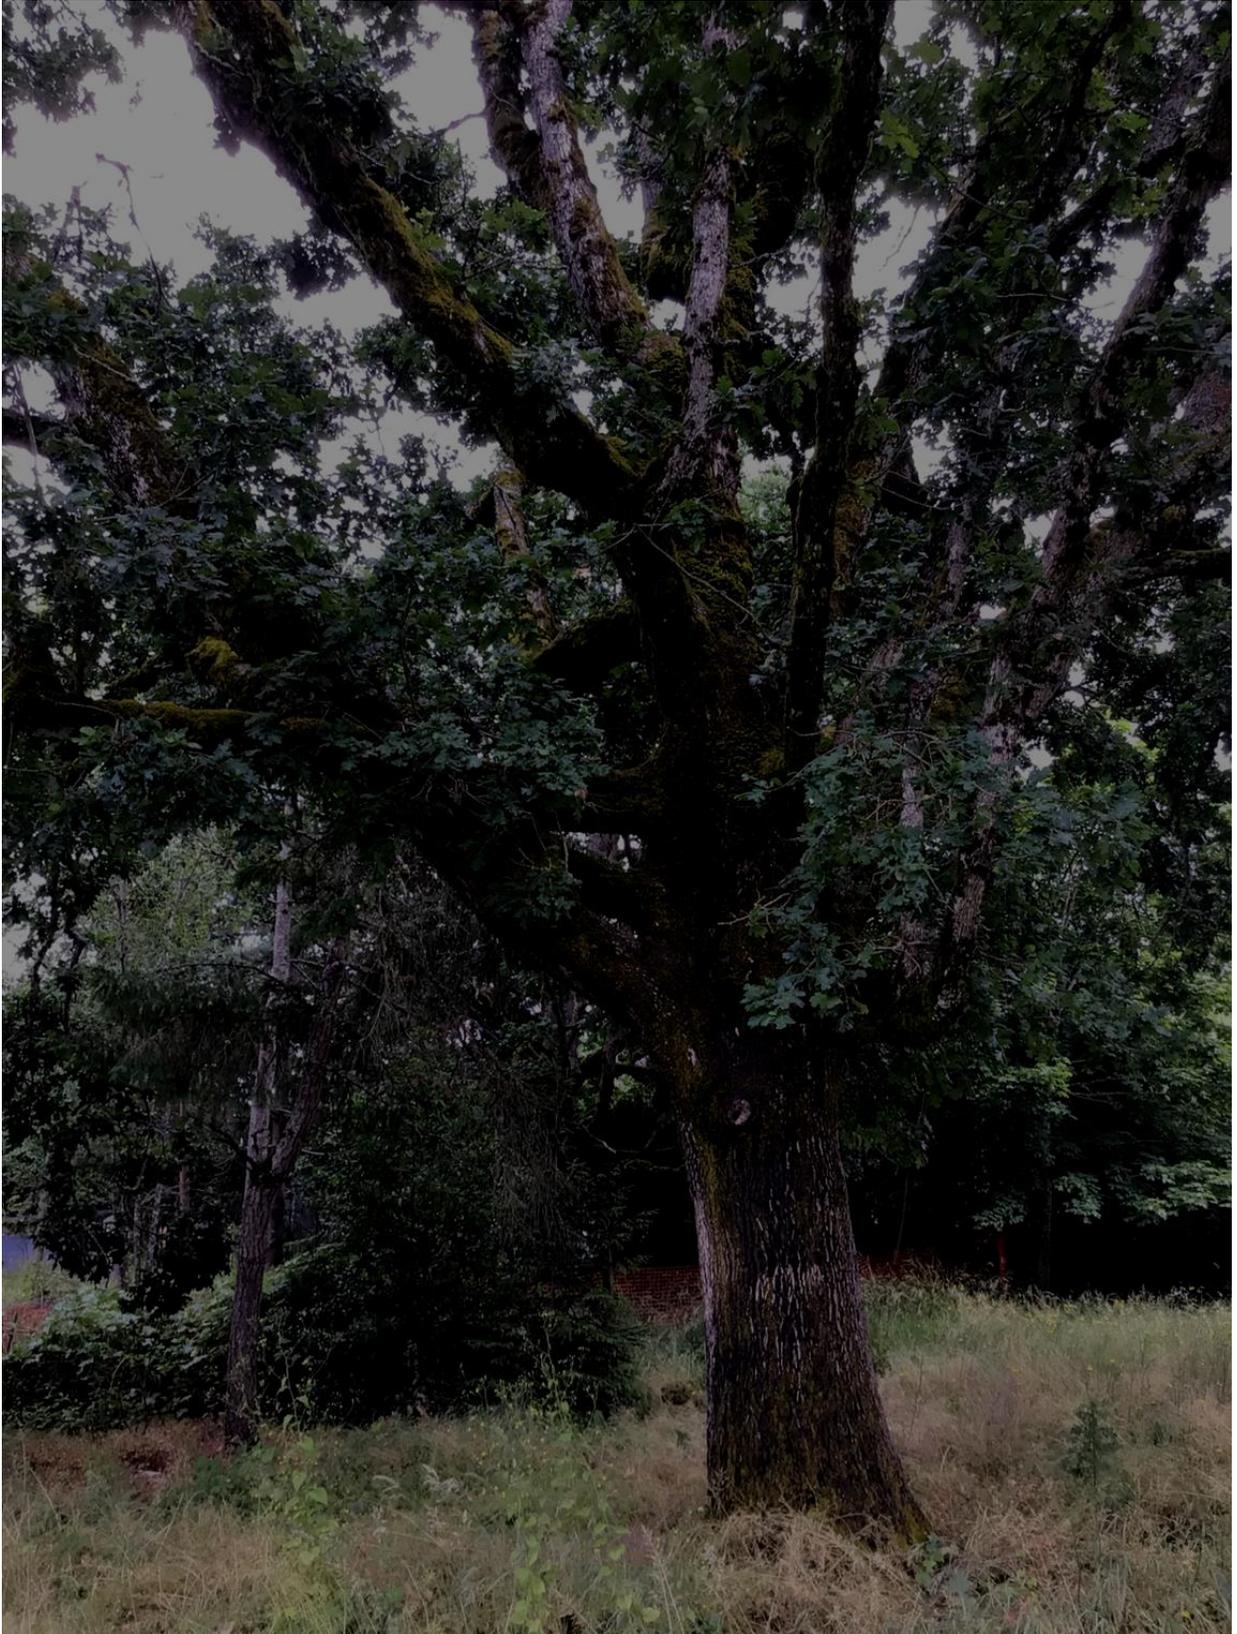
Oak No. 2

Both oak trees appear to be growing at the same health and vigor as the adjacent oak grove. Both oaks have experienced some damage caused by the 2021 winter ice storm.

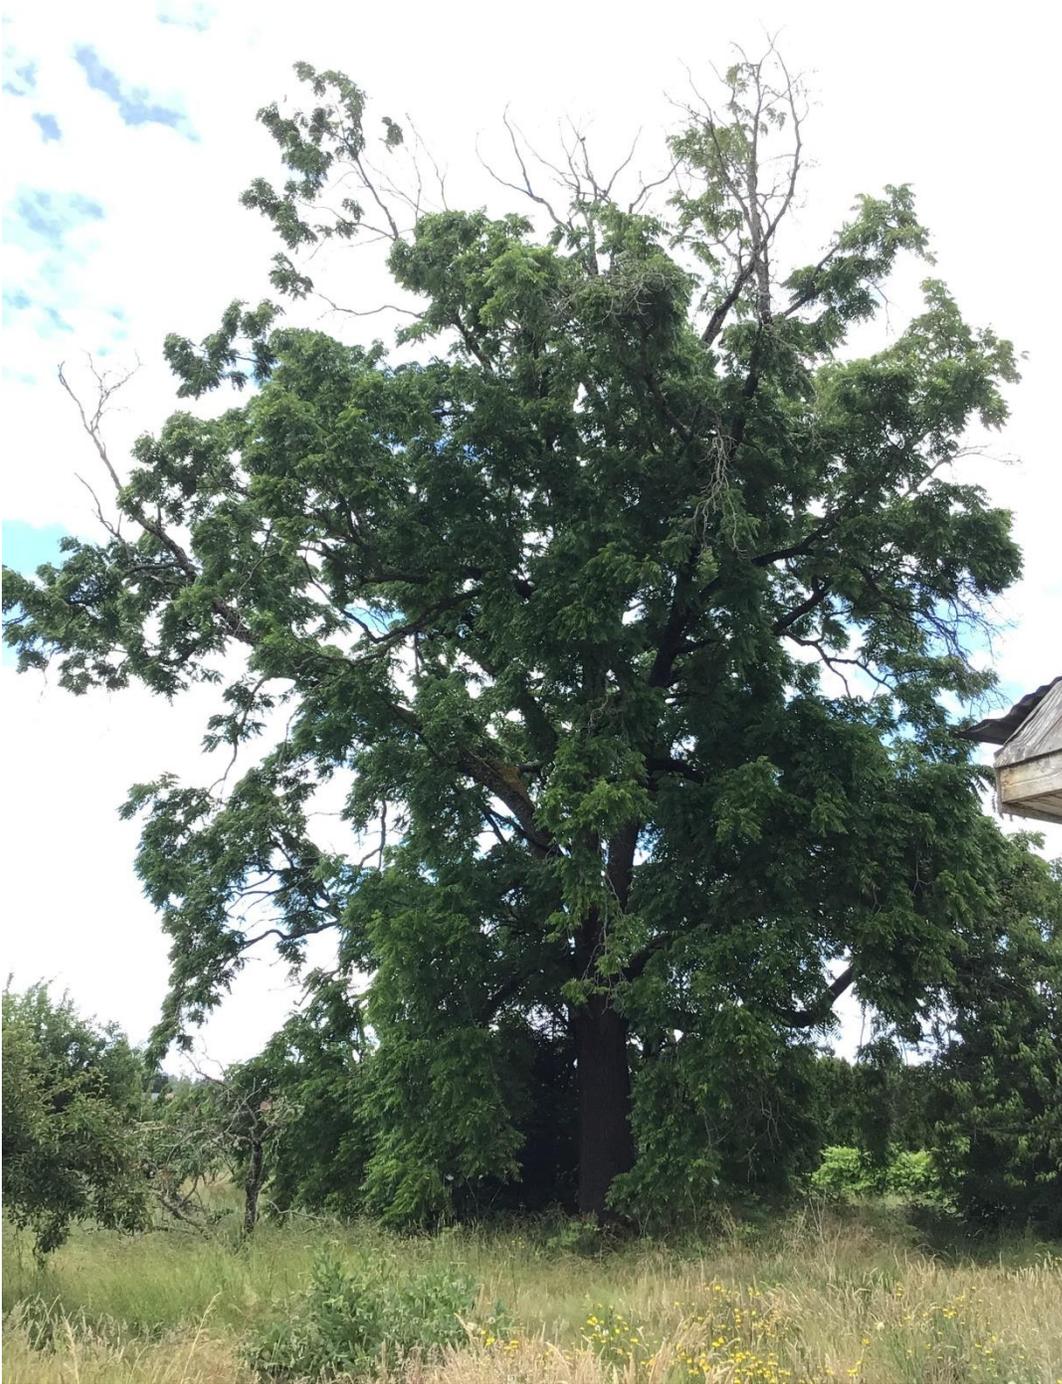
Both oak trees merit preservation. I recommend removal of the walnut. The walnut tree is in significant decline and has multiple structural defects. If the proposed construction occurs the target rating will be high, and removal will be warranted.

Declining Walnut
