ARBORIST REPORT

Located at: 4183 Pullman Ave SE

DESCRIPTION

Re: Chase Residence
Structural Observation Report

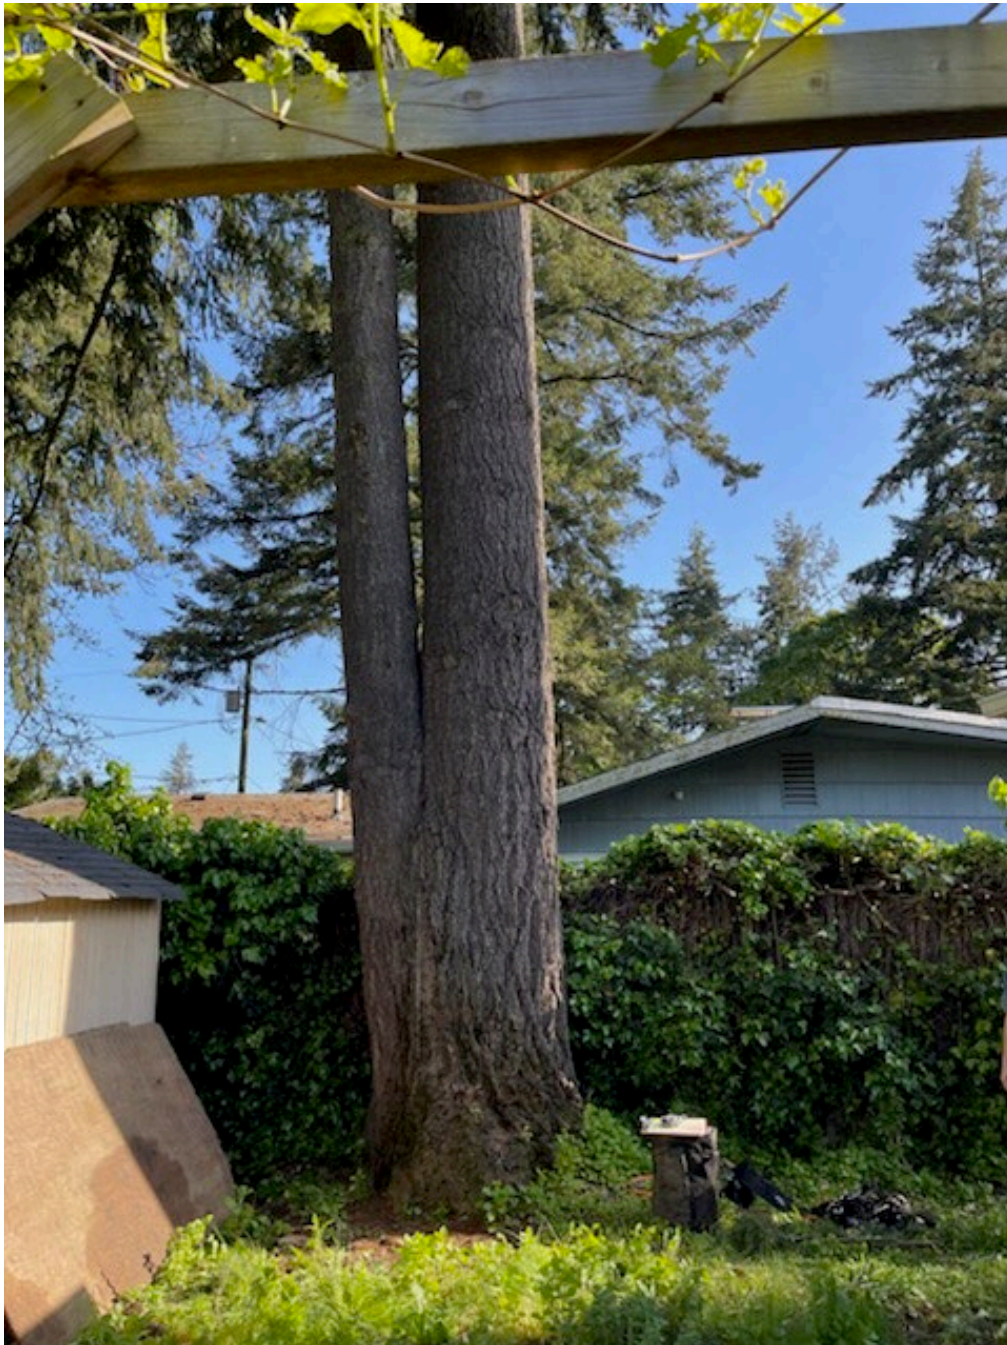
PICTURE 1
Taken 05/17/2022

Our company was contacted by Patrick O'Hara, property owner at 4183 Pullman Ave SE in Salem, regarding concerns the root system from the fir tree in the northwest corner of his backyard, are damaging the foundation and walls of the neighboring home adjacent to the tree at 270 Chase Ave SE. The fir tree is approximately 49" in diameter at breast height (dbh) and requires a permit from the city to remove.

I visited the property on August 10, 2021 and again on May 17, 2022 to assess the health of the tree and take pictures. After visual inspection, the tree appears healthy although it has an extensive root system, which has, in my opinion, caused substantial damage to the foundation and walls to the neighboring home at 270 Chase Ave SE. The owner of the property at 270 Chase Ave SE is actively seeking the tree removal so that he can continue with repairs and rental of his property.

In my opinion, the tree removal is necessary to allow repair of the neighboring property and cannot reasonably be alleviated by treatment or pruning. The footprint of the repair will not be enlarged. Recommend removal for repairs.
