Special Inspection Report

1724 Chemeketa St NE

Salem, OR

August 21st, 2020

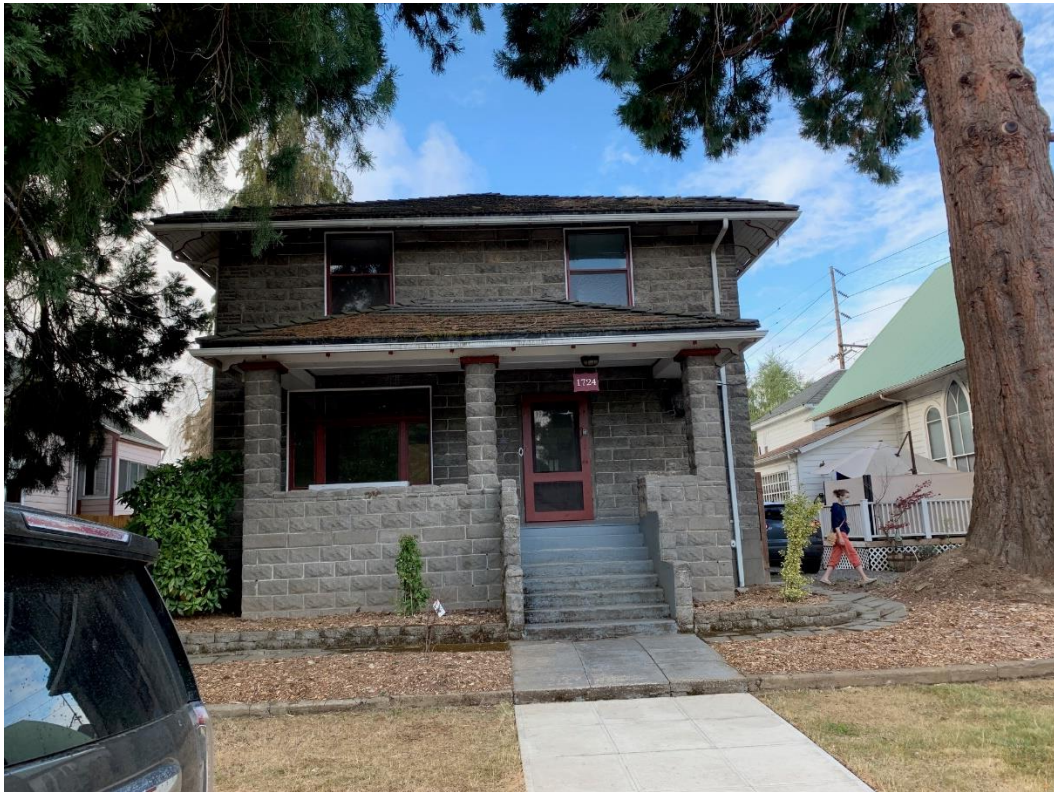
The house is framed by two very large trees in the front of the home. A note on this matter, we did not note any current impact to the house from the oversized trees, however, it is possible that in the future, some damage to the foundation system could occur do to there close proximity to the home. The stone walkway along the west side of the house has been elevated irregularly as a result of the tree in that area, next to the house.

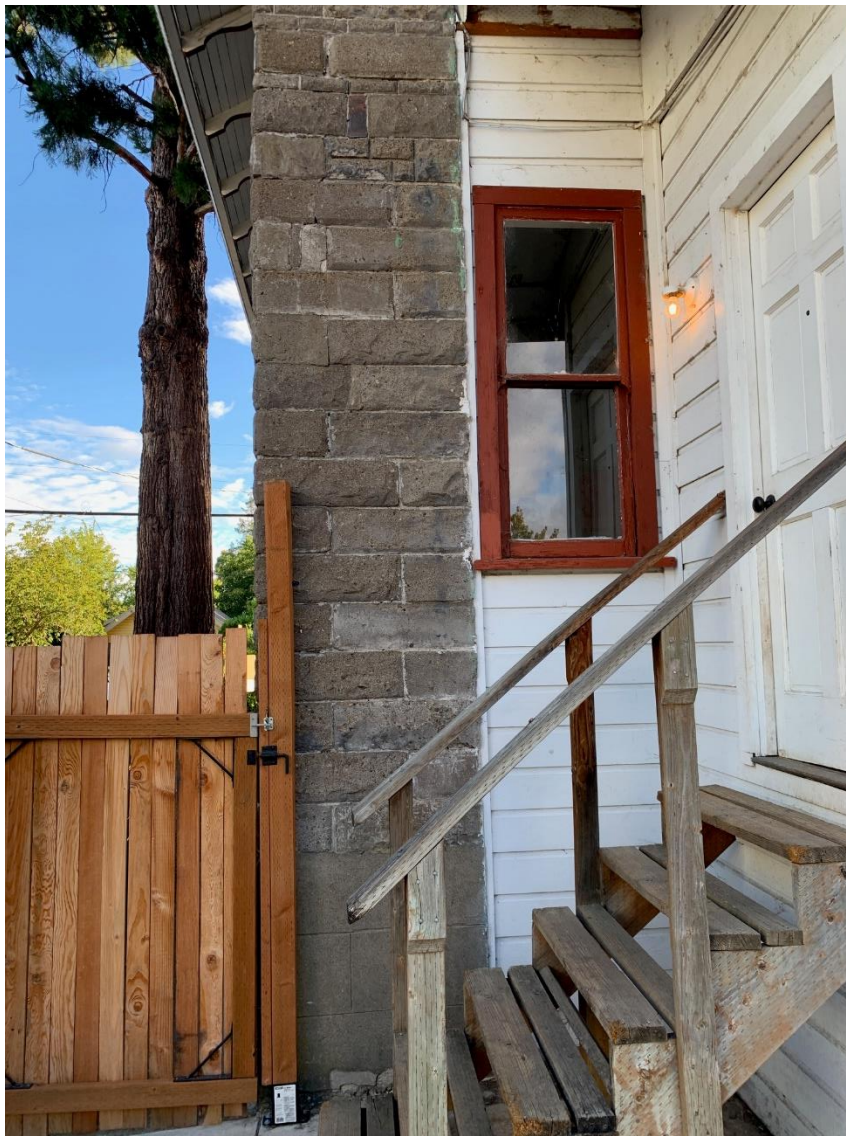
The exterior of the house did not show any signs of settlement or movement.

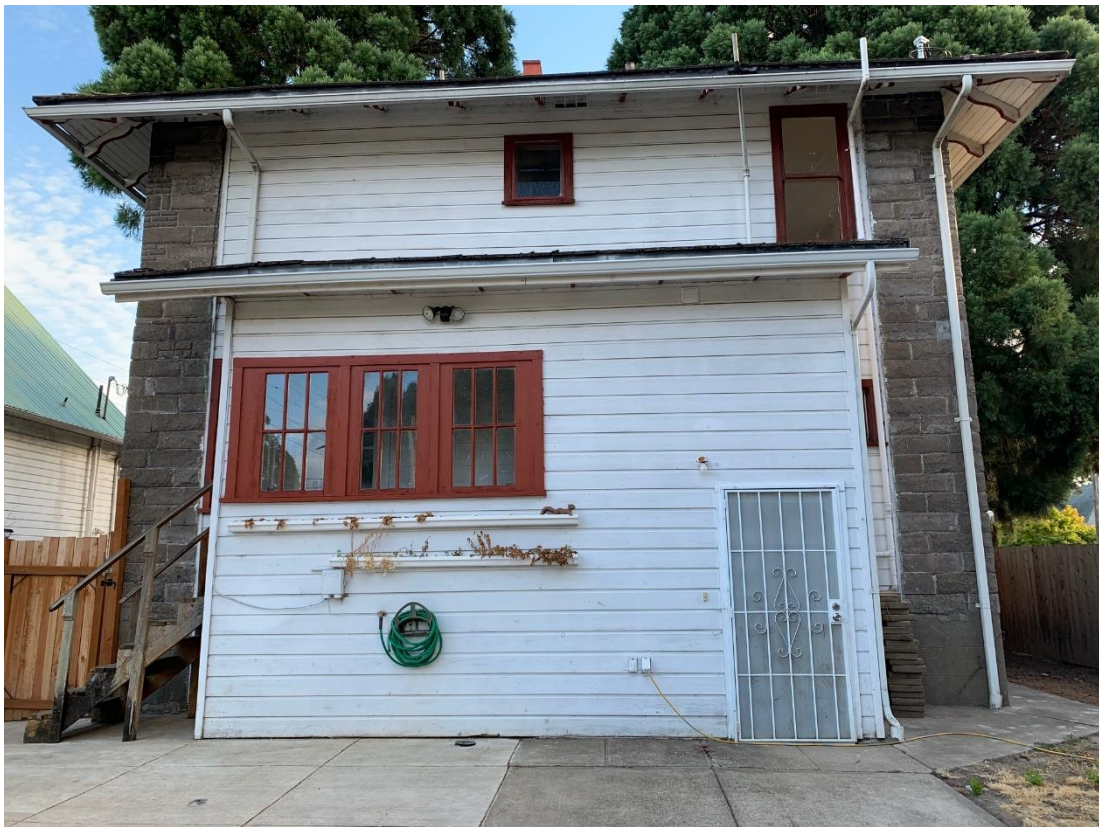
The exterior wood surfaces showed not indications of adjustments other than those expected with time.

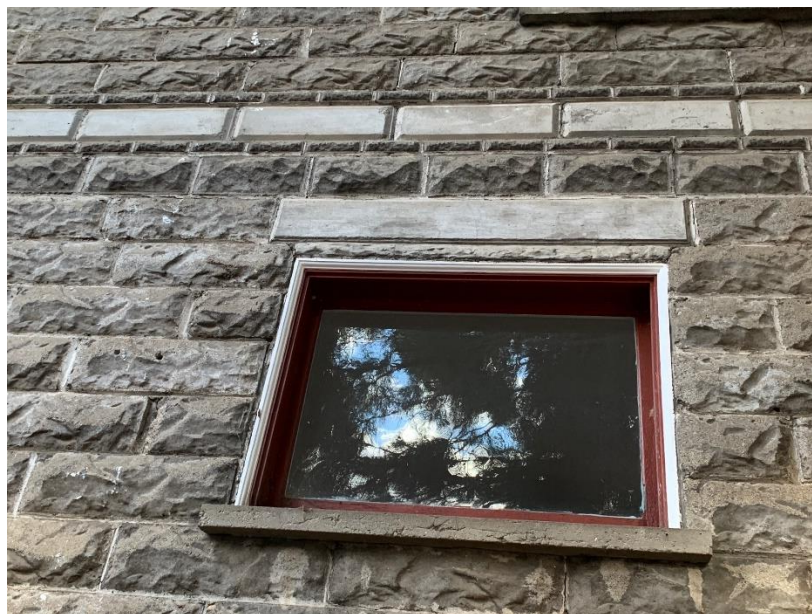
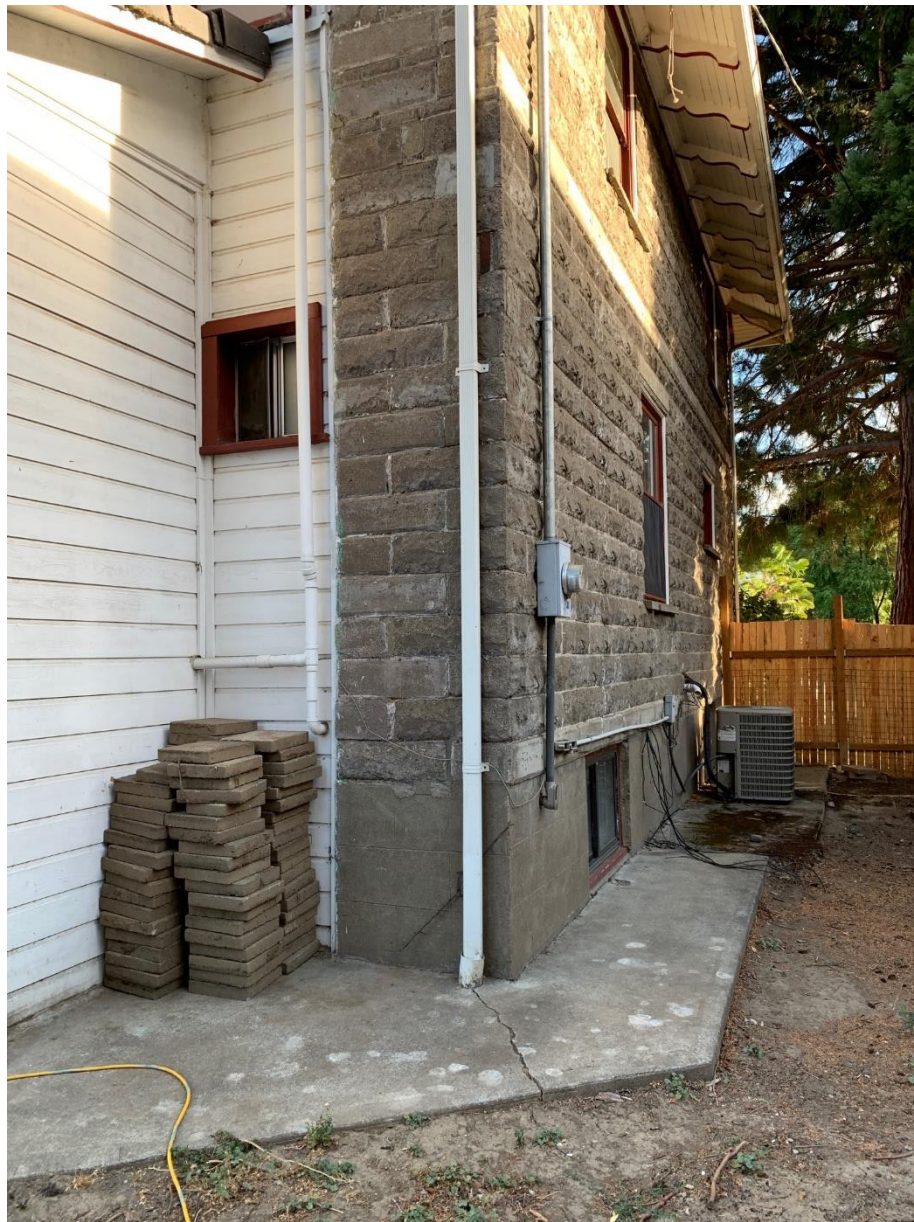
The exterior stonework had only minor joint cracks, no signs of shifting.

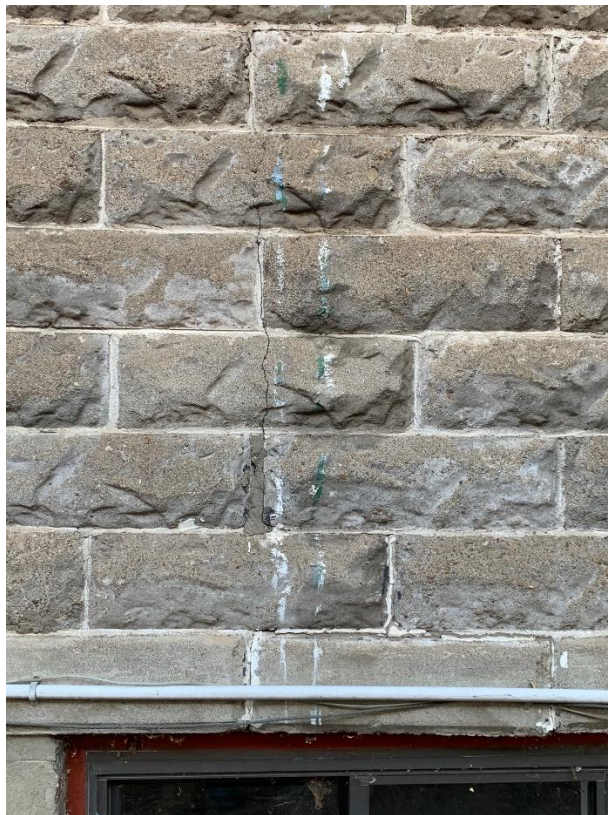
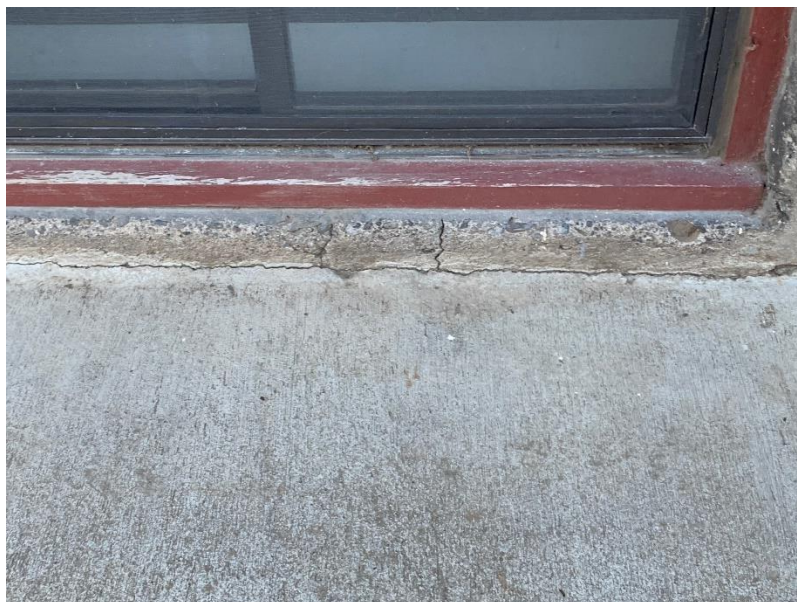
We noted some cracks in the exterior flat work, which is expected over time.

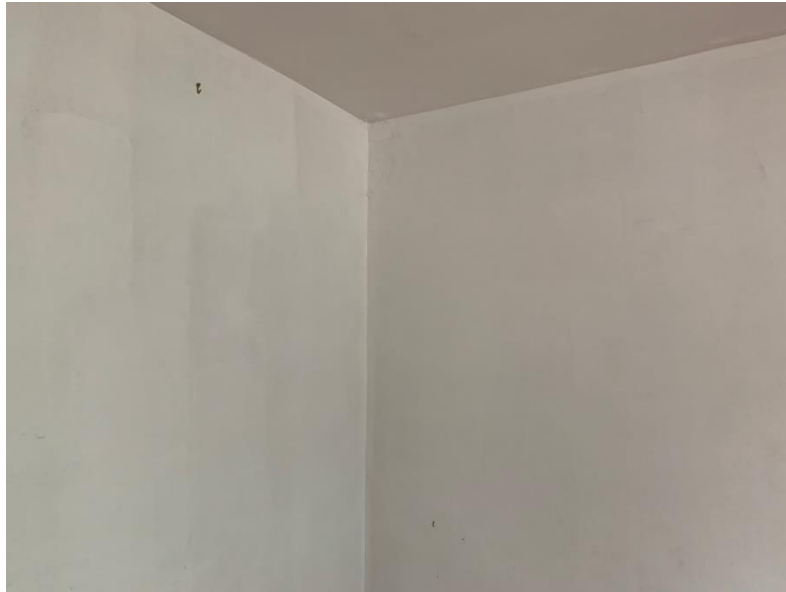
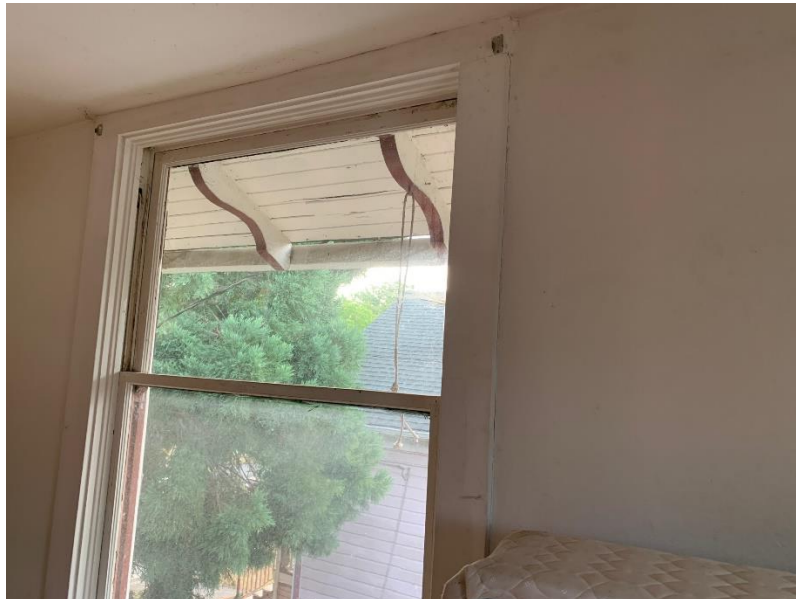
The interior of the structure did not show any cracks or other signs of movement with time.

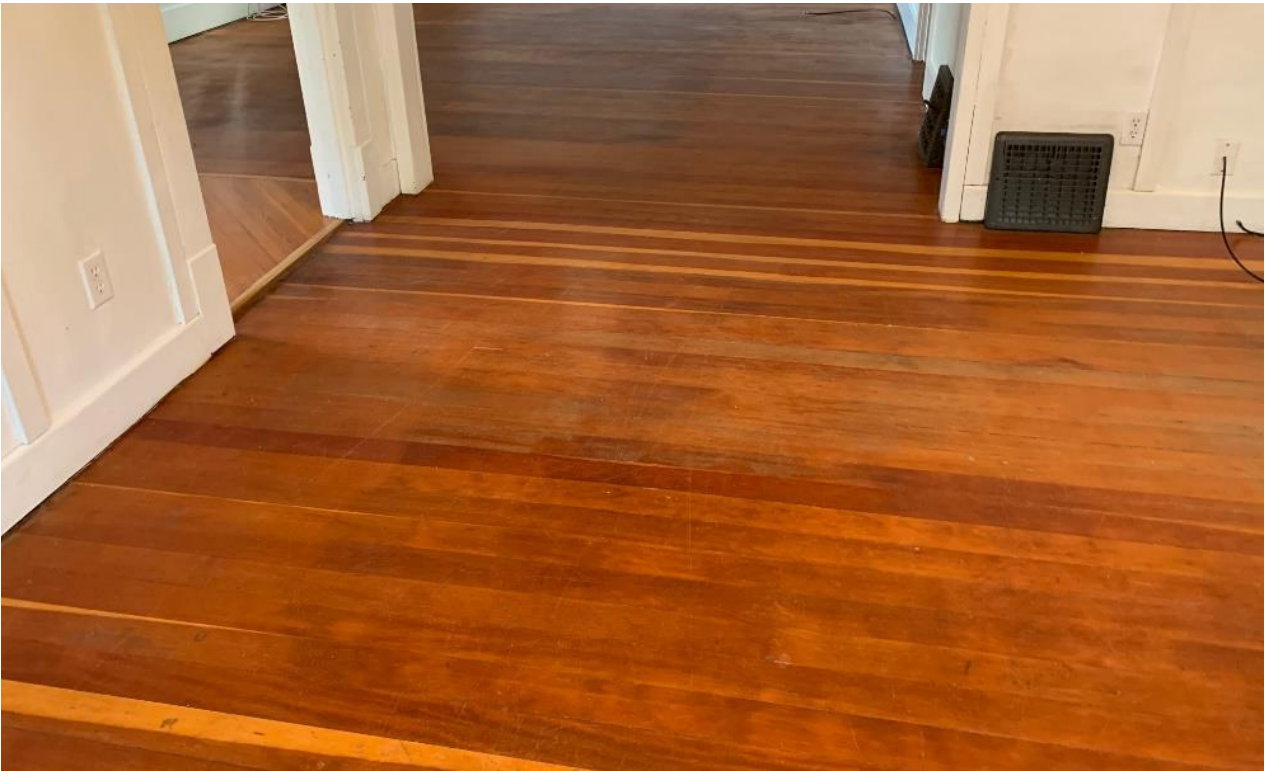
The floors within the house appear and feel to be level within the limits expected for this vintage of a home.

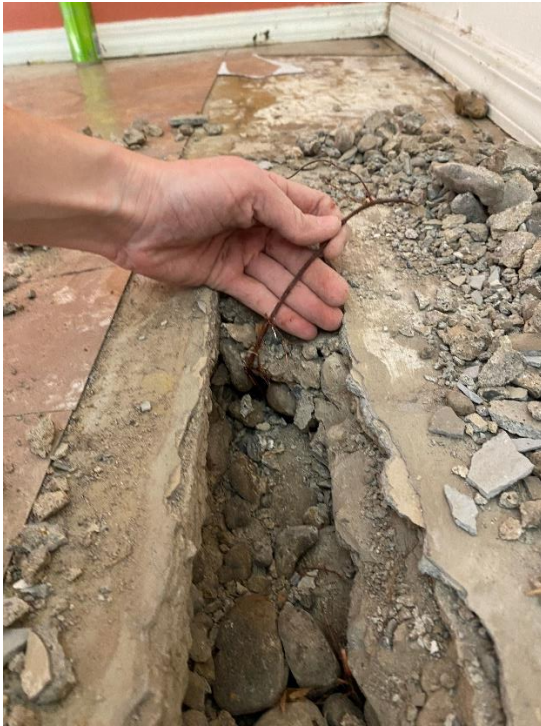
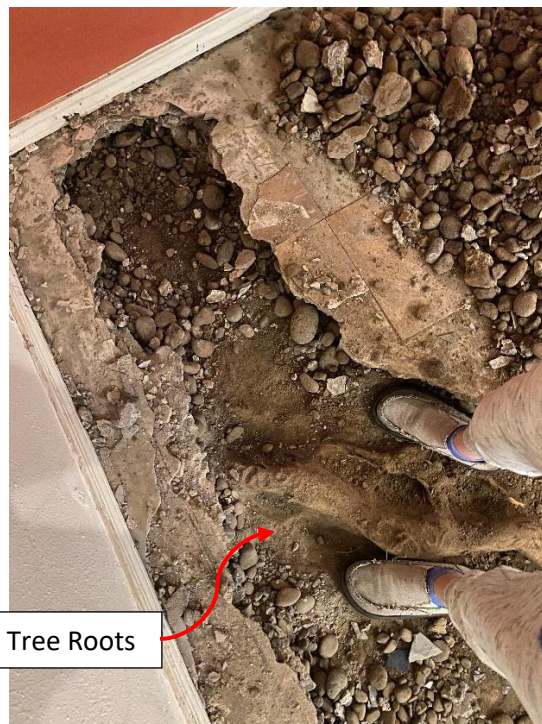
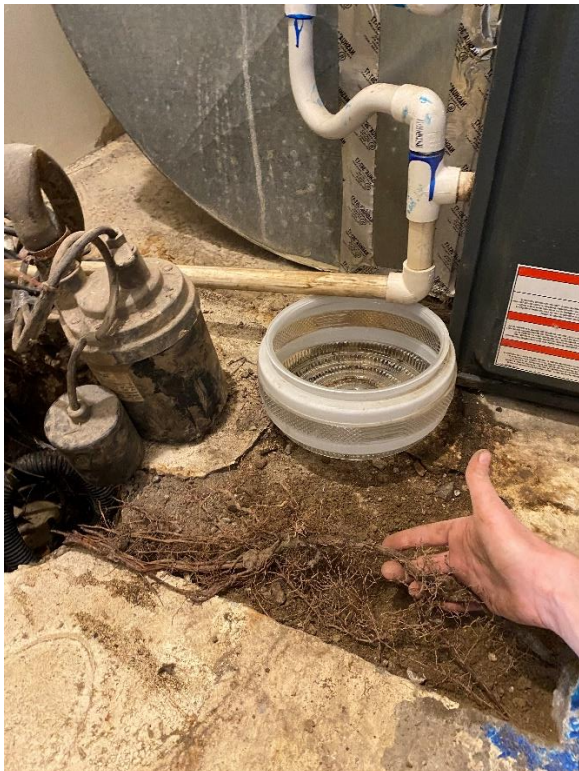
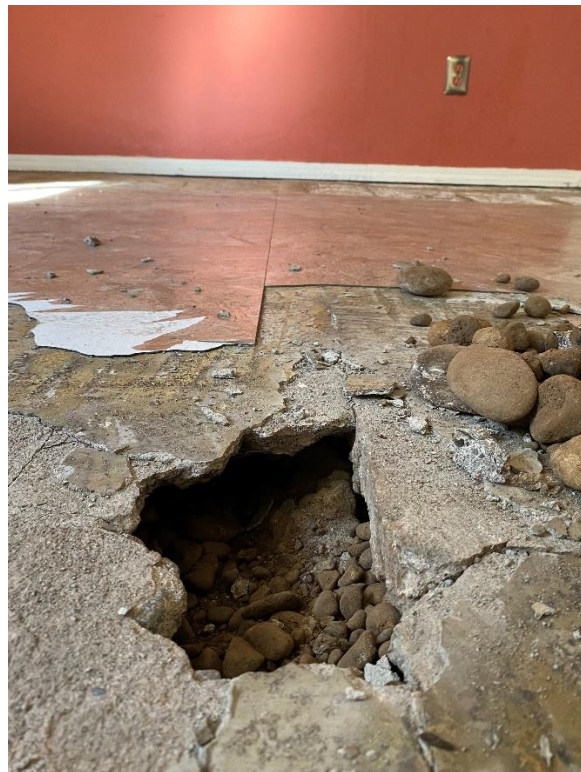
The basement floor is not even and has some irregular surface slopes, they appear to be the results of the very large Red Wood Trees located adjacent to the house as noted earlier in the report.

The owner has done some exploratory work in the basement and has noted the presents of tree roots just under the floor slab that appear to be causing significant impacts to the basement floor and if left unchecked may also impact the exterior concrete perimeter walls.

Based on our inspection and review of documents, it is our professional opinion that the structure is sound and stable and free of any significant structural defects. However, we believe that the large trees are currently creating issues with the basement as can be seen in the photos above and that they do pose a potential threat to the long-term integrity of the home. We recommend that they be removed now to facilitate the basement restoration and to maintain the homes present state.
