ARBORIST REPORT

Located at: 490 Leffelle St S, Salem

Prepared for: Todd Hixson

Evaluation performed: August 8, 2022

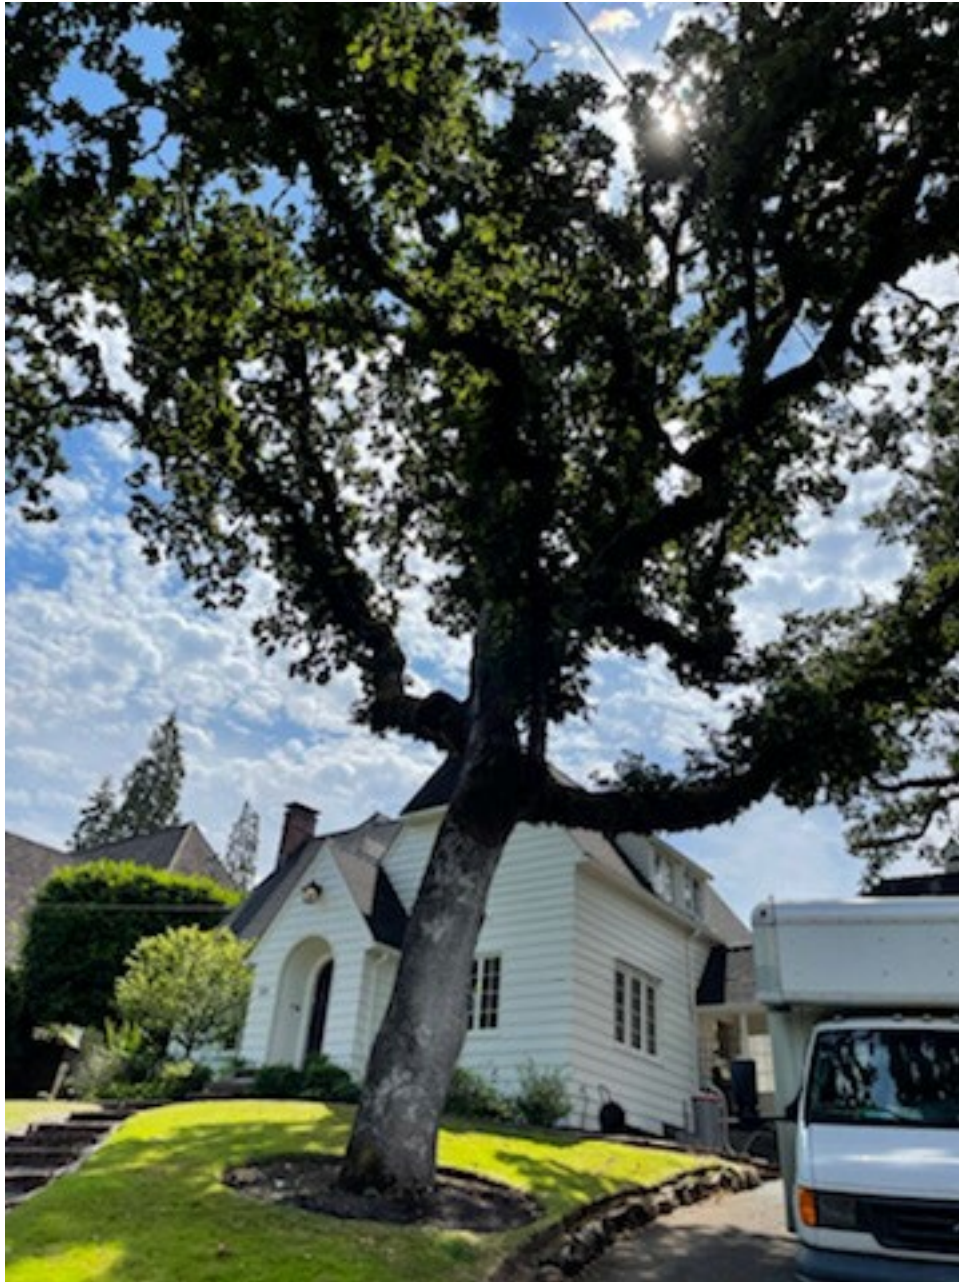
PICTURE 1
Taken 08/09/2022

I visited the property on August 8, 2022 to assess the health of the oak tree. During visual inspection of the tree, I noted fungal conk at the base of the trunk. The homeowner pointed out the tree has been shifting. I noted a large cavity in the base of the tree and using a rod, inserted into the cavity. As you can see by the attached pictures #2 & 3, I measured the cavity at approximately 46" deep.

The combination of conk at the trunk, a deep cavity and shifting indicate the tree is hazardous and should be removed as soon as possible.

In my opinion, the tree removal is necessary because the condition and location of the tree presents both a hazard and danger to persons and property. These hazards cannot be alleviated by treatment or pruning.
