NORTHWEST GEOLOGICAL SERVICES, INC. *Consulting Geologists and Hydrogeologists* 2505 N.E. 42nd Avenue, Portland, Oregon 97213-1201

27 September 2022

Geologic Hazard Assessment 2828 Doaks Ferry Rd 7S/3W-8DA TL 7000 Salem, Oregon

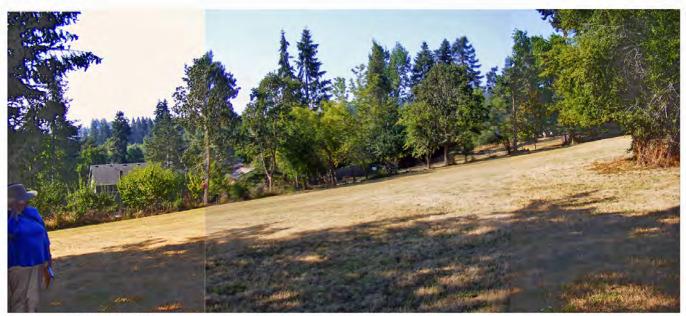
282	8 Doaks Ferry Rd	NW
	Salem, OR	
La	ndslide Hazard Stu	udy
	Site Photographs	
NGS, Inc.	September 2022	Figure 7

Our reconnaissance and review of maps and aerial photos indicate that the current and man-made site slopes have been in their present configuration since the mid-1950s, over 60 years. We found no evidence of slope failure on the site. Tall straight mature fir trees indicate very slow – if any -soil creep (Figure 7, top).

ABOVE - Panorama looking S to SW across east end of site. Note the smooth 15% slope of the Missoula Flood deposits and that the mature conifers are straight and erect.
