**Geotechnical Investigation and Geologic Hazard Assessment
Proposed Doakes Ferry Subdivision/Titan Hill Development Site**

Tax Lot No. 400

Salem (Polk County), Oregon

**Project No. 1004.033.G
November 4, 2022**

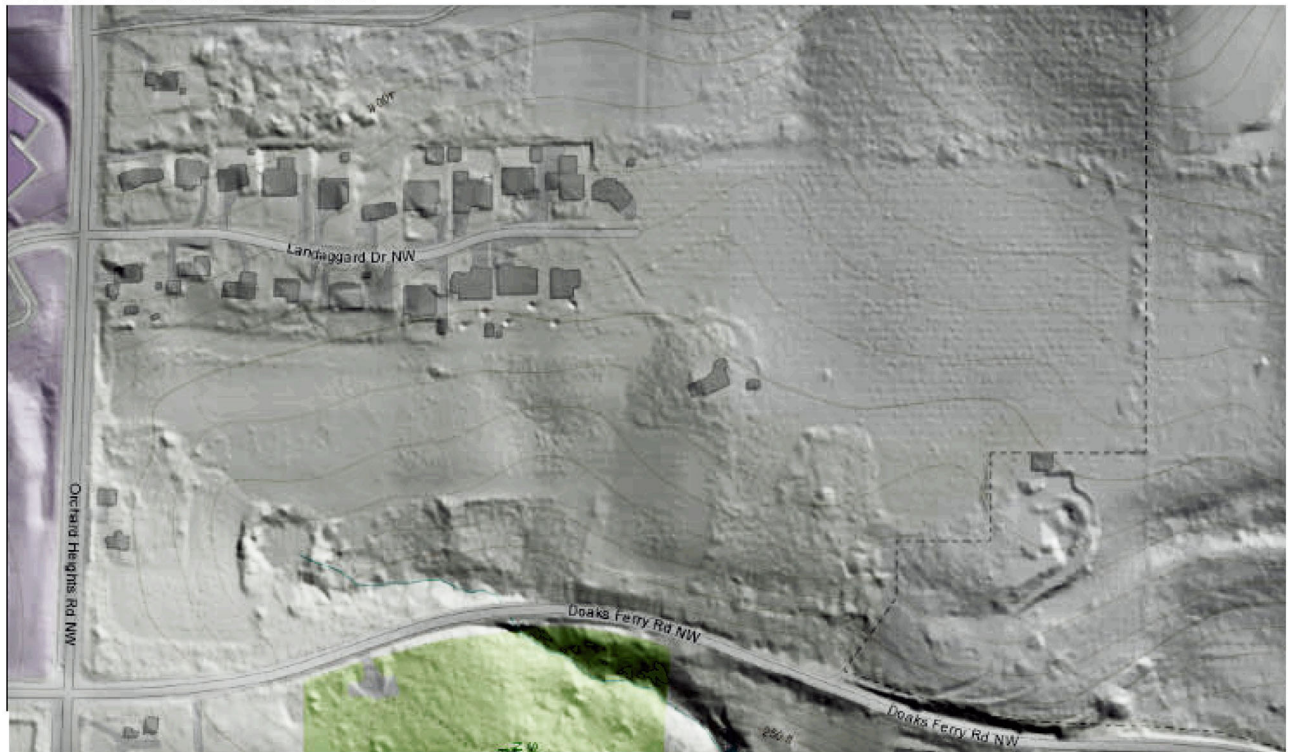
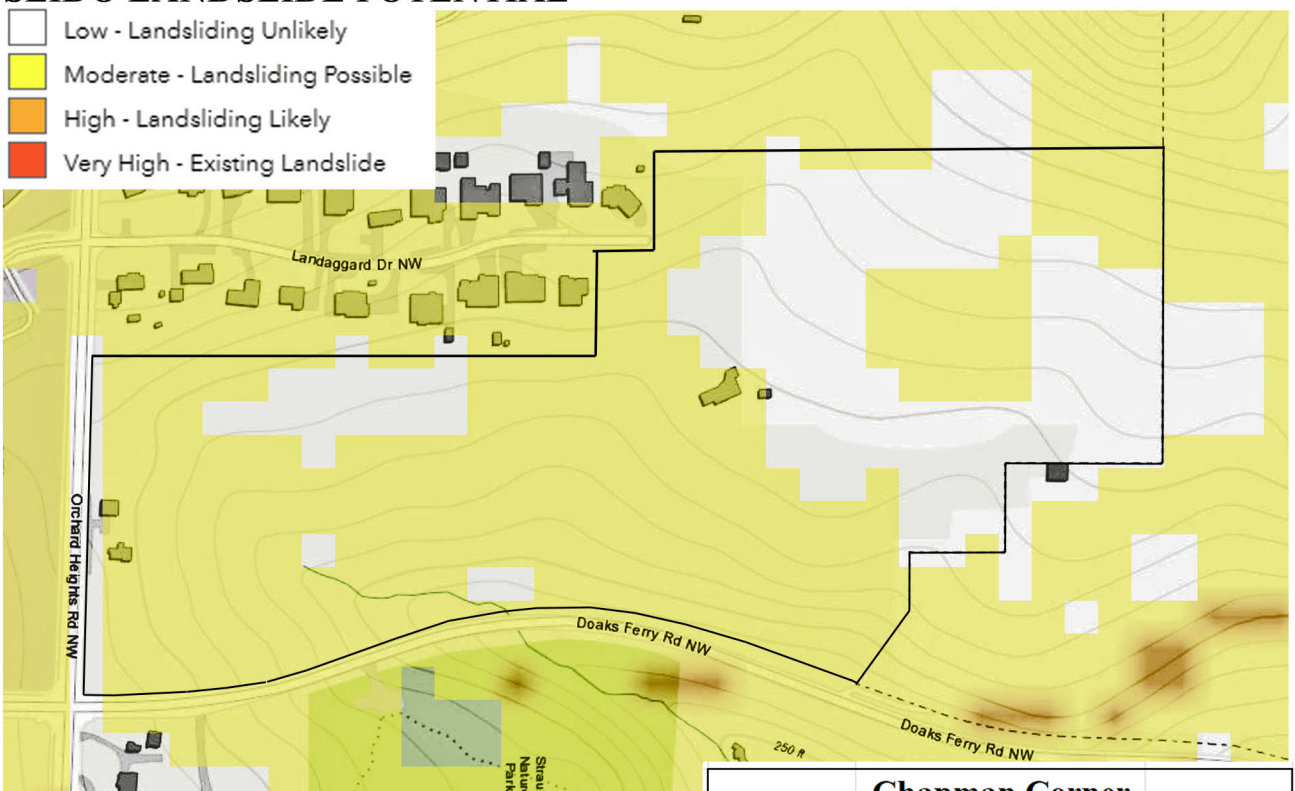
Chapman Corner		
7S/3W-17b TL 400, 900 & 1100		
Landslide Hazard Study		
State Landslide Hazard Map		
NGS, Inc.	November 2022	Figure 3

No ancient and/or active landslides were observed or are known to be present on the subject site. Additionally, development of the subject site into the planned residential homes sites and/or commercial structures does not appear to present a potential geologic and/or landslide hazard provided that the site grading and development activities conform with the recommendations presented within this report. A more detailed assessment of the potential landslide hazard of the subject site is presented in the Geologic Hazard Study in Appendix B.

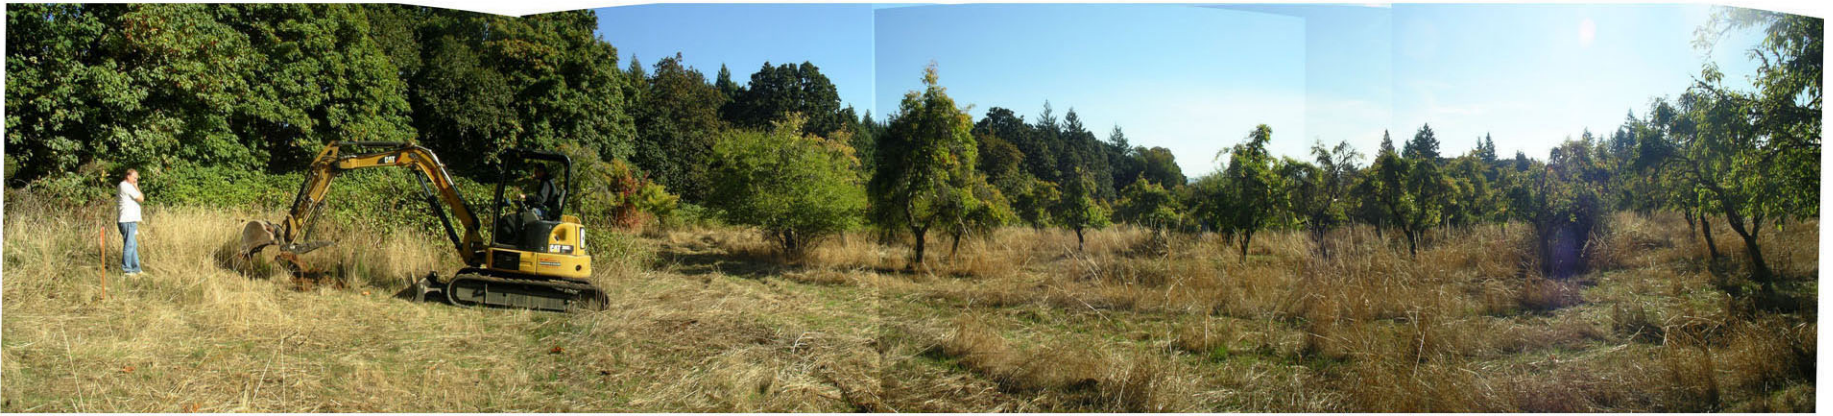
ABOVE: Panorama from north towards TP-1 through the Italian Prune orchard to the east towards Doaks Ferry Rd NW (behind trees on right).
 BELOW: View SE from driveway to TL 1100 across the ploughed field and around to the south. Note smooth gentle slopes.

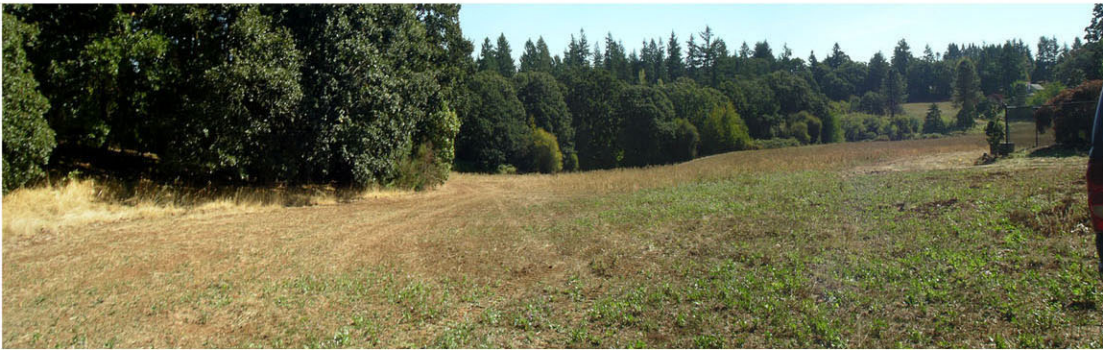
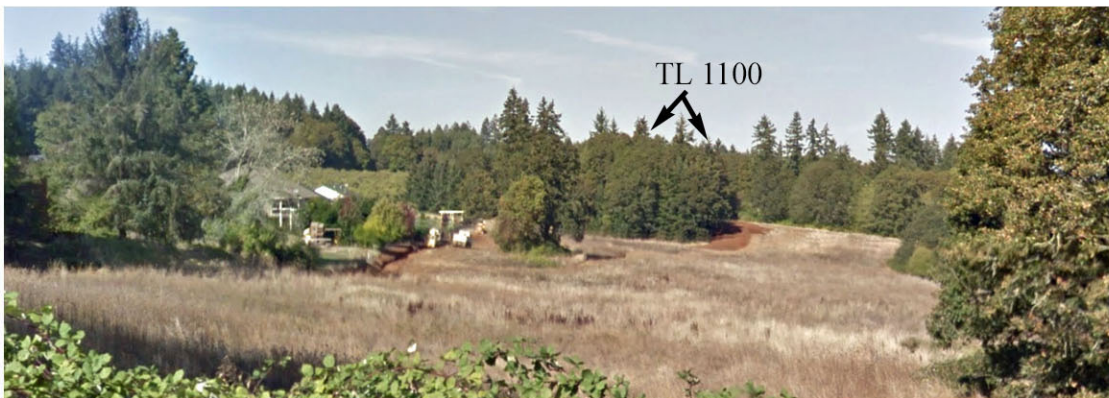
BELOW: View of south half of TL 400 from Orchard Heights Rd NW

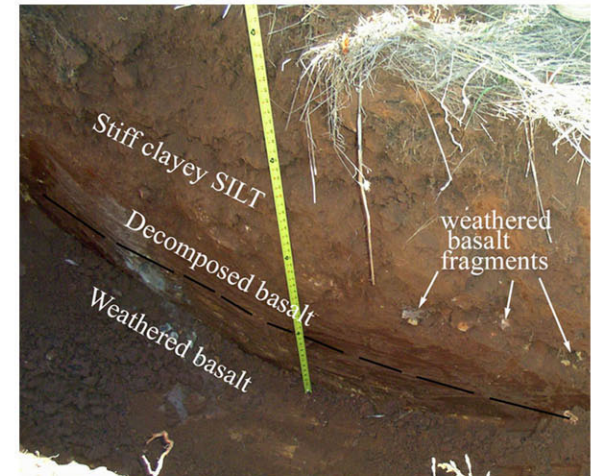
Above: View down into TP-2, showing gradation from clayey SILT to weathered basalt.
