Basic Tree Risk Assessment Form

Client Michael & LeAnne Goodenberger Date 1-9-24 Time 10:26am
 Address/Tree location 550 Leffelle St S. Tree no. _____ Sheet 1 of 1
 Tree species Oregon white Oak dbh 23"/22"/20" Height 85-90ft Crown spread dia. 50-60ft
 Assessor(s) Elwoods Tree Service Tools used probe - shovel Time frame _____

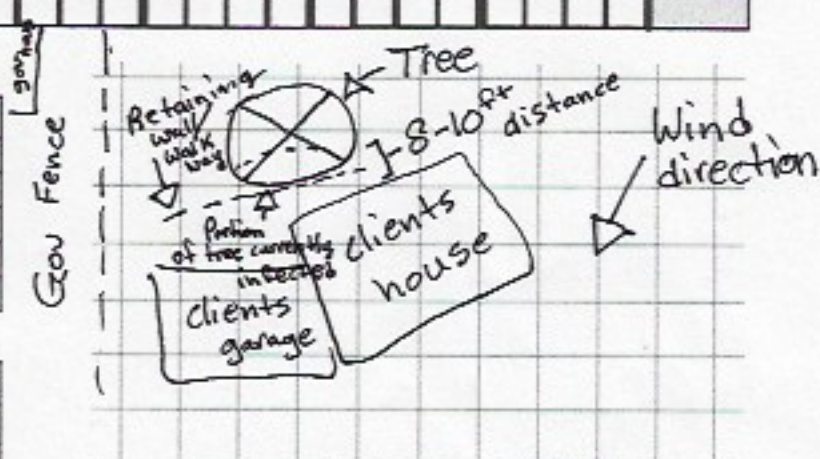
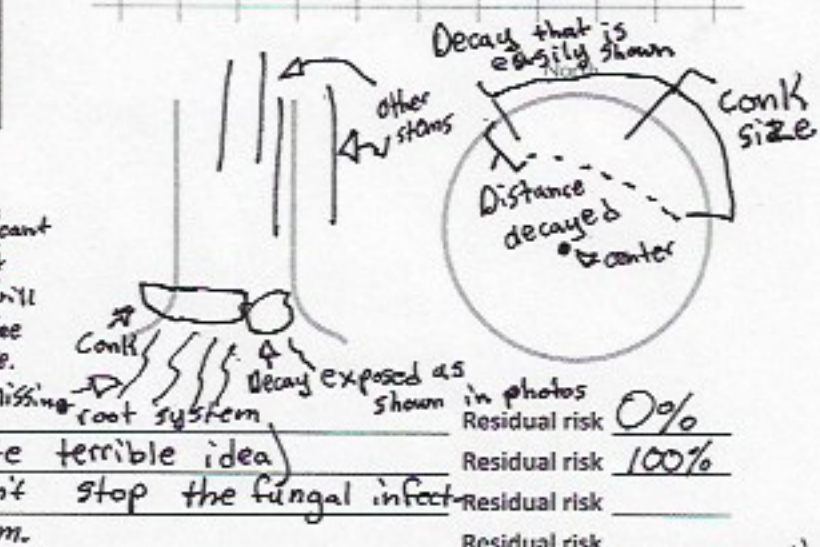
The trunk that has the exposed conk is the northern trunk of the tree that has significant trunk and root decay. These 3 trunks share one root system. Therefore 33-95% of the root system will be missing once this stem is gone and with a tree of this size that is unacceptable.

Inspection limitations ☒ None ☐ Visibility ☒ ~~Access~~ ☐ Vines ☐ Root collar buried Describe has already been dug and exposed
photos taken.

Collar buried/Not visible ☒ Depth 6-8" Stem girdling ☐
 Dead ☐ Decay ☒ Conks/Mushrooms ☒
 Ooze ☐ Cavity 35 % circ.
 Cracks ☐ Cut/Damaged roots ☐ Distance from trunk _____
 Root plate lifting ☐ Soil weakness ☐
 Response growth NONE
 Condition(s) of concern Fungus Ganoderma
 Part Size whole tree Fall Distance 85 ft
 Load on defect N/A ☐ Minor ☐ Moderate ☐ Significant ☒
 Likelihood of failure Improbable ☐ Possible ☐ Probable ☒ Imminent ☐

| | Remove the tree | Missing root system | shown in photos | Residual risk |
| 1. | Remove the tree | | | 0% |
