Todd Prager & Associates LLC

MEMORANDUM

RE: Salem Apartments Tree Protection and Removal Plan

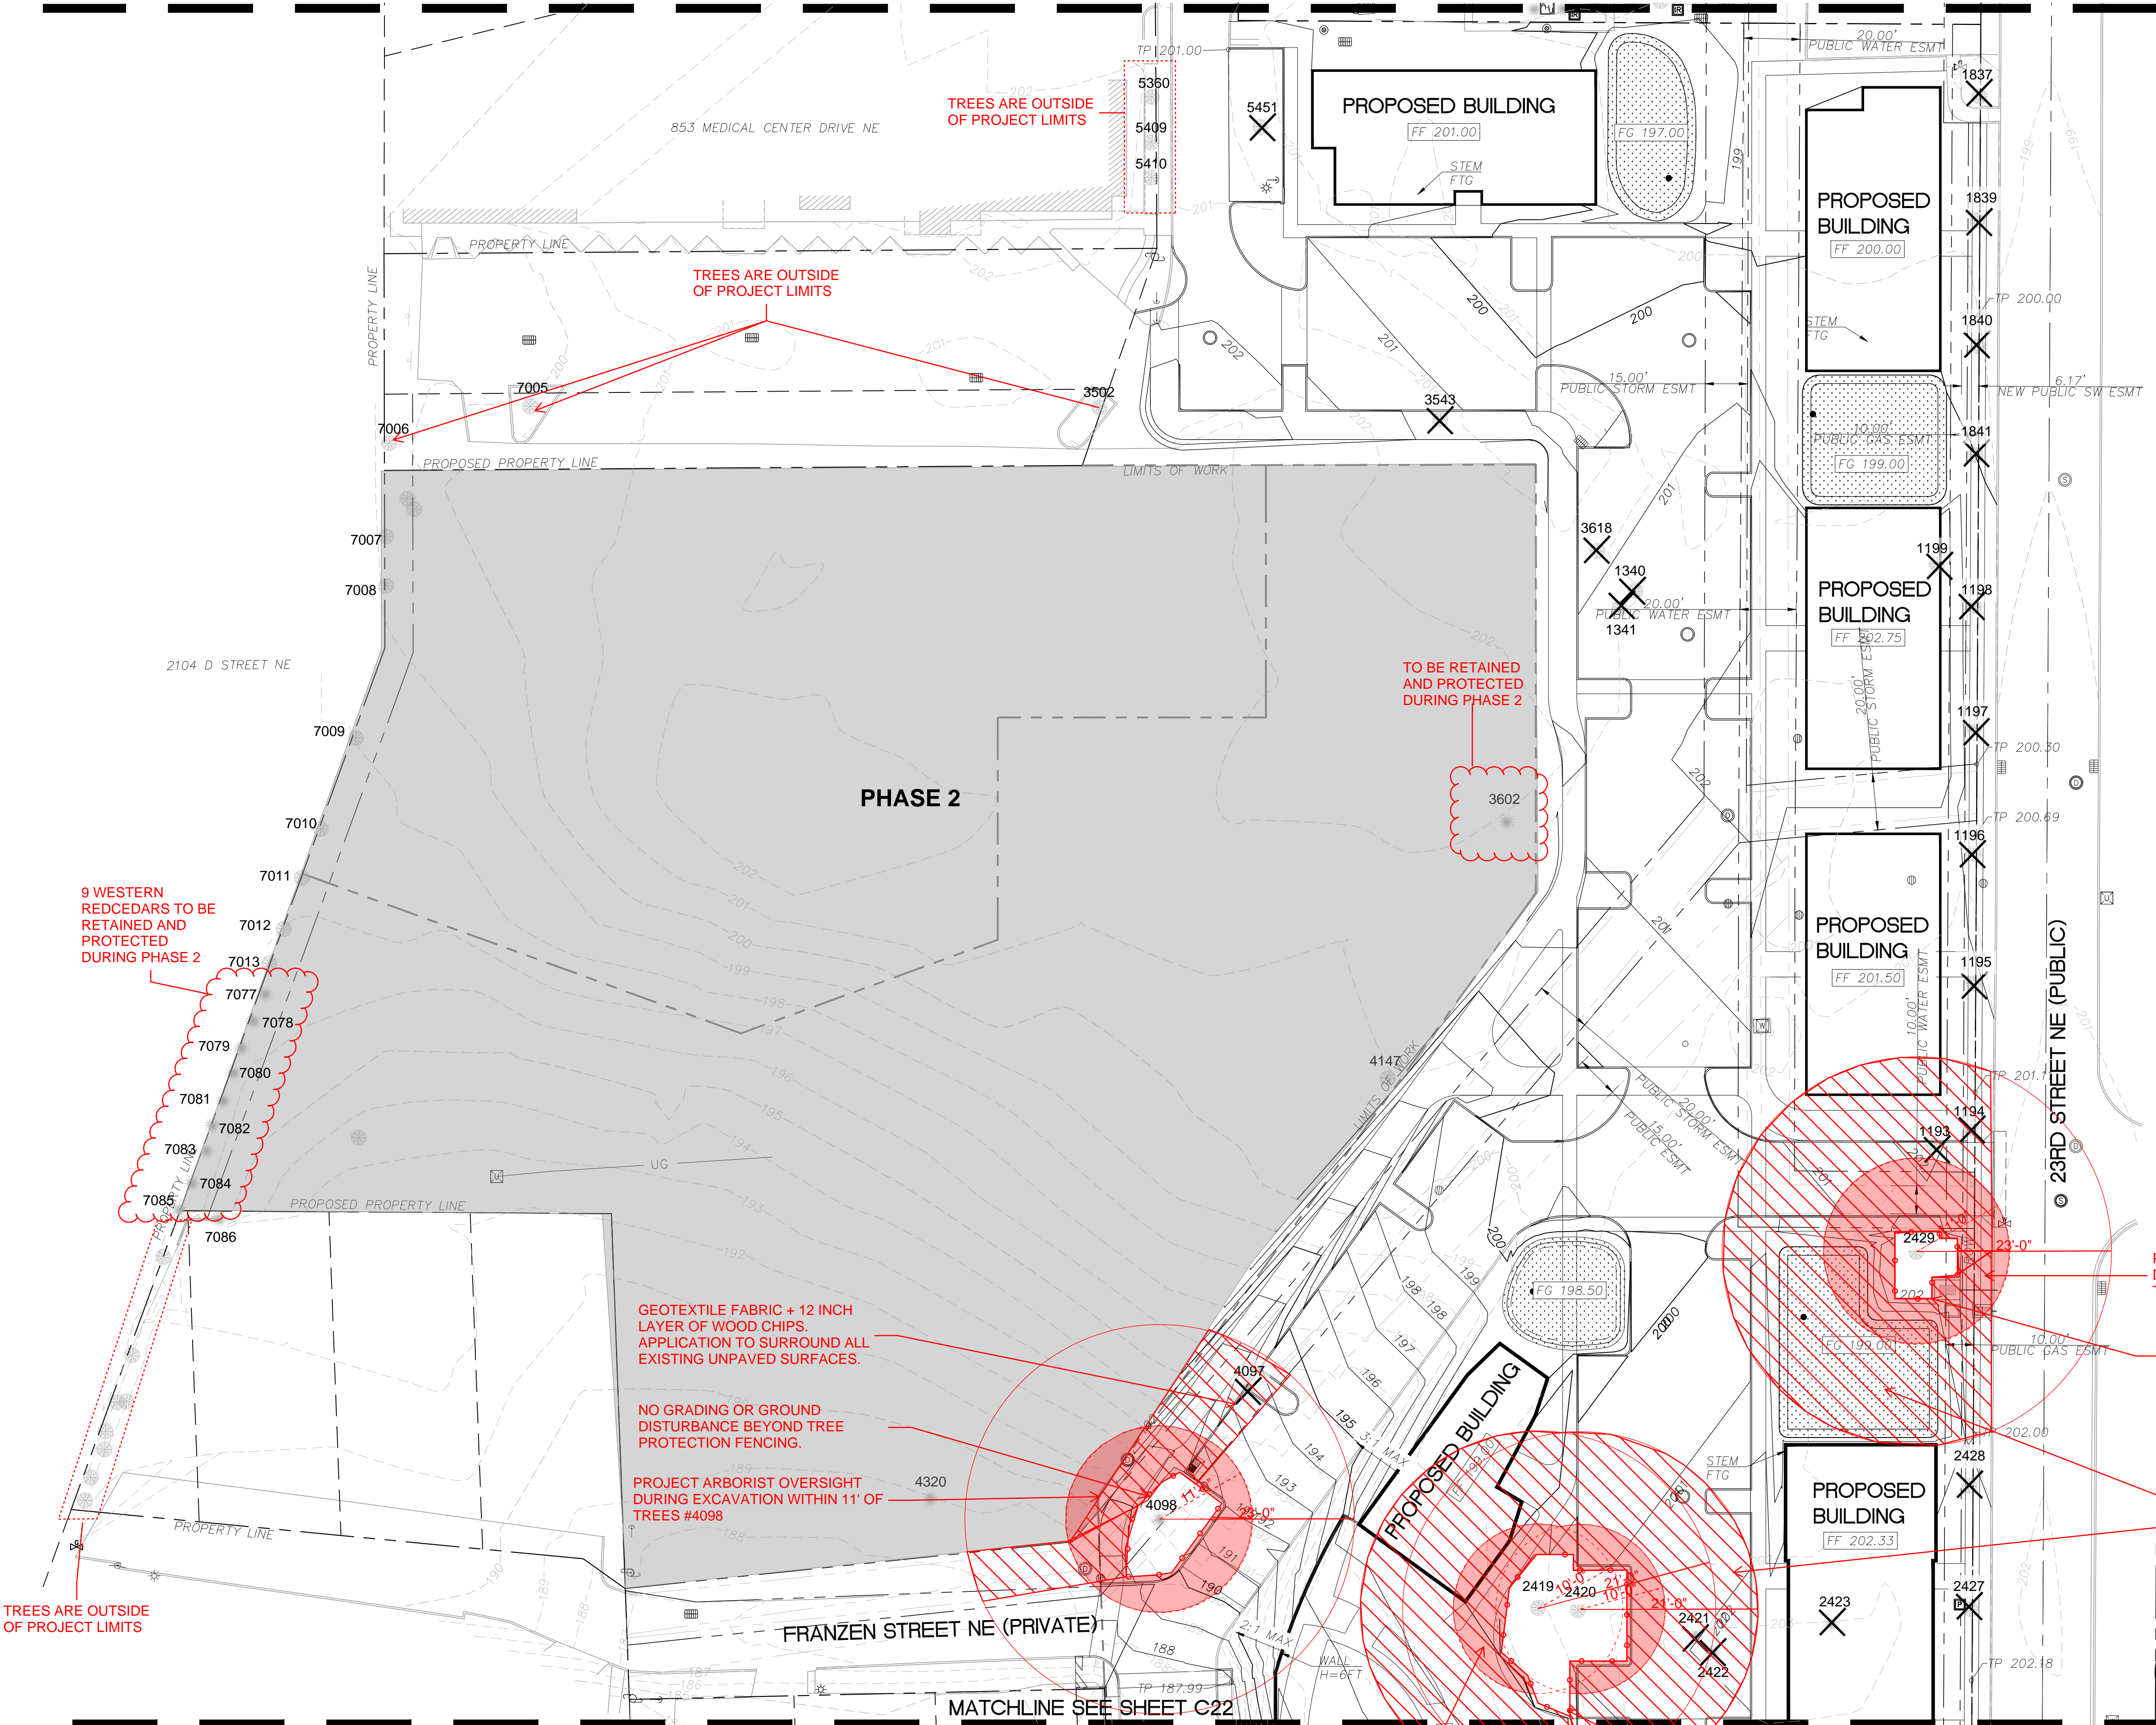
GRADING PLAN
ATTACHMENT 2 -
TREE PROTECTION PLAN
PHASE 1

PROJECT ARBORIST OVERSIGHT
DURING EXCAVATION WITHIN 10' OF
TREES #2419 AND #2420

NO GRADING OR GROUND
DISTURBANCE BEYOND TREE
PROTECTION FENCING.
