MEMORANDUM

DATE: April 15, 2024 (Revised from 3/8/2024 report)

FROM: Christine Johnson, ASCA Registered Consulting Arborist® #823

RE: Salem Apartments Tree Protection and Removal Plan for Phase 1/Parcel 1

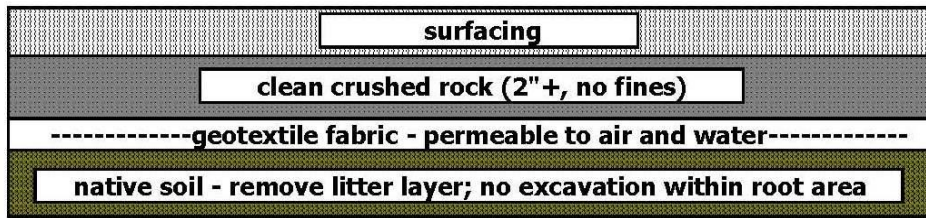
Figure 1 Sample profile for area within fenced tree protection zone. Depth of rock is dependent on grading.

- Paving - Use of a modified pavement profile as shown in Figure 1.

- Methods to minimize the depth of the modified pavement profile, such as the use of reinforced pavement, should be implemented. Also, methods to improve air and water exchange through the pavement such as the use of permeable paving materials or 4-inch diameter aeration holes at 10 feet on center should be used. Curbs constructed adjacent to the trees may need to be roll curbs or extruded curbs to minimize excavation where there are structural roots.

- 8. Paving within Critical Root Zones-** Suspend pavement over the root zone or use a modified pavement profile as shown in Figure 1. Methods to minimize the depth of the modified pavement profile such as the use of concrete, reinforced pavement should be implemented. Also, methods to improve air and water exchange through the pavement such as the use of permeable paving materials or 4-inch diameter aeration holes at 10 feet on center should be used. Curbs constructed adjacent to the trees may need to be roll curbs or extruded curbs to minimize excavation where there are structural roots.

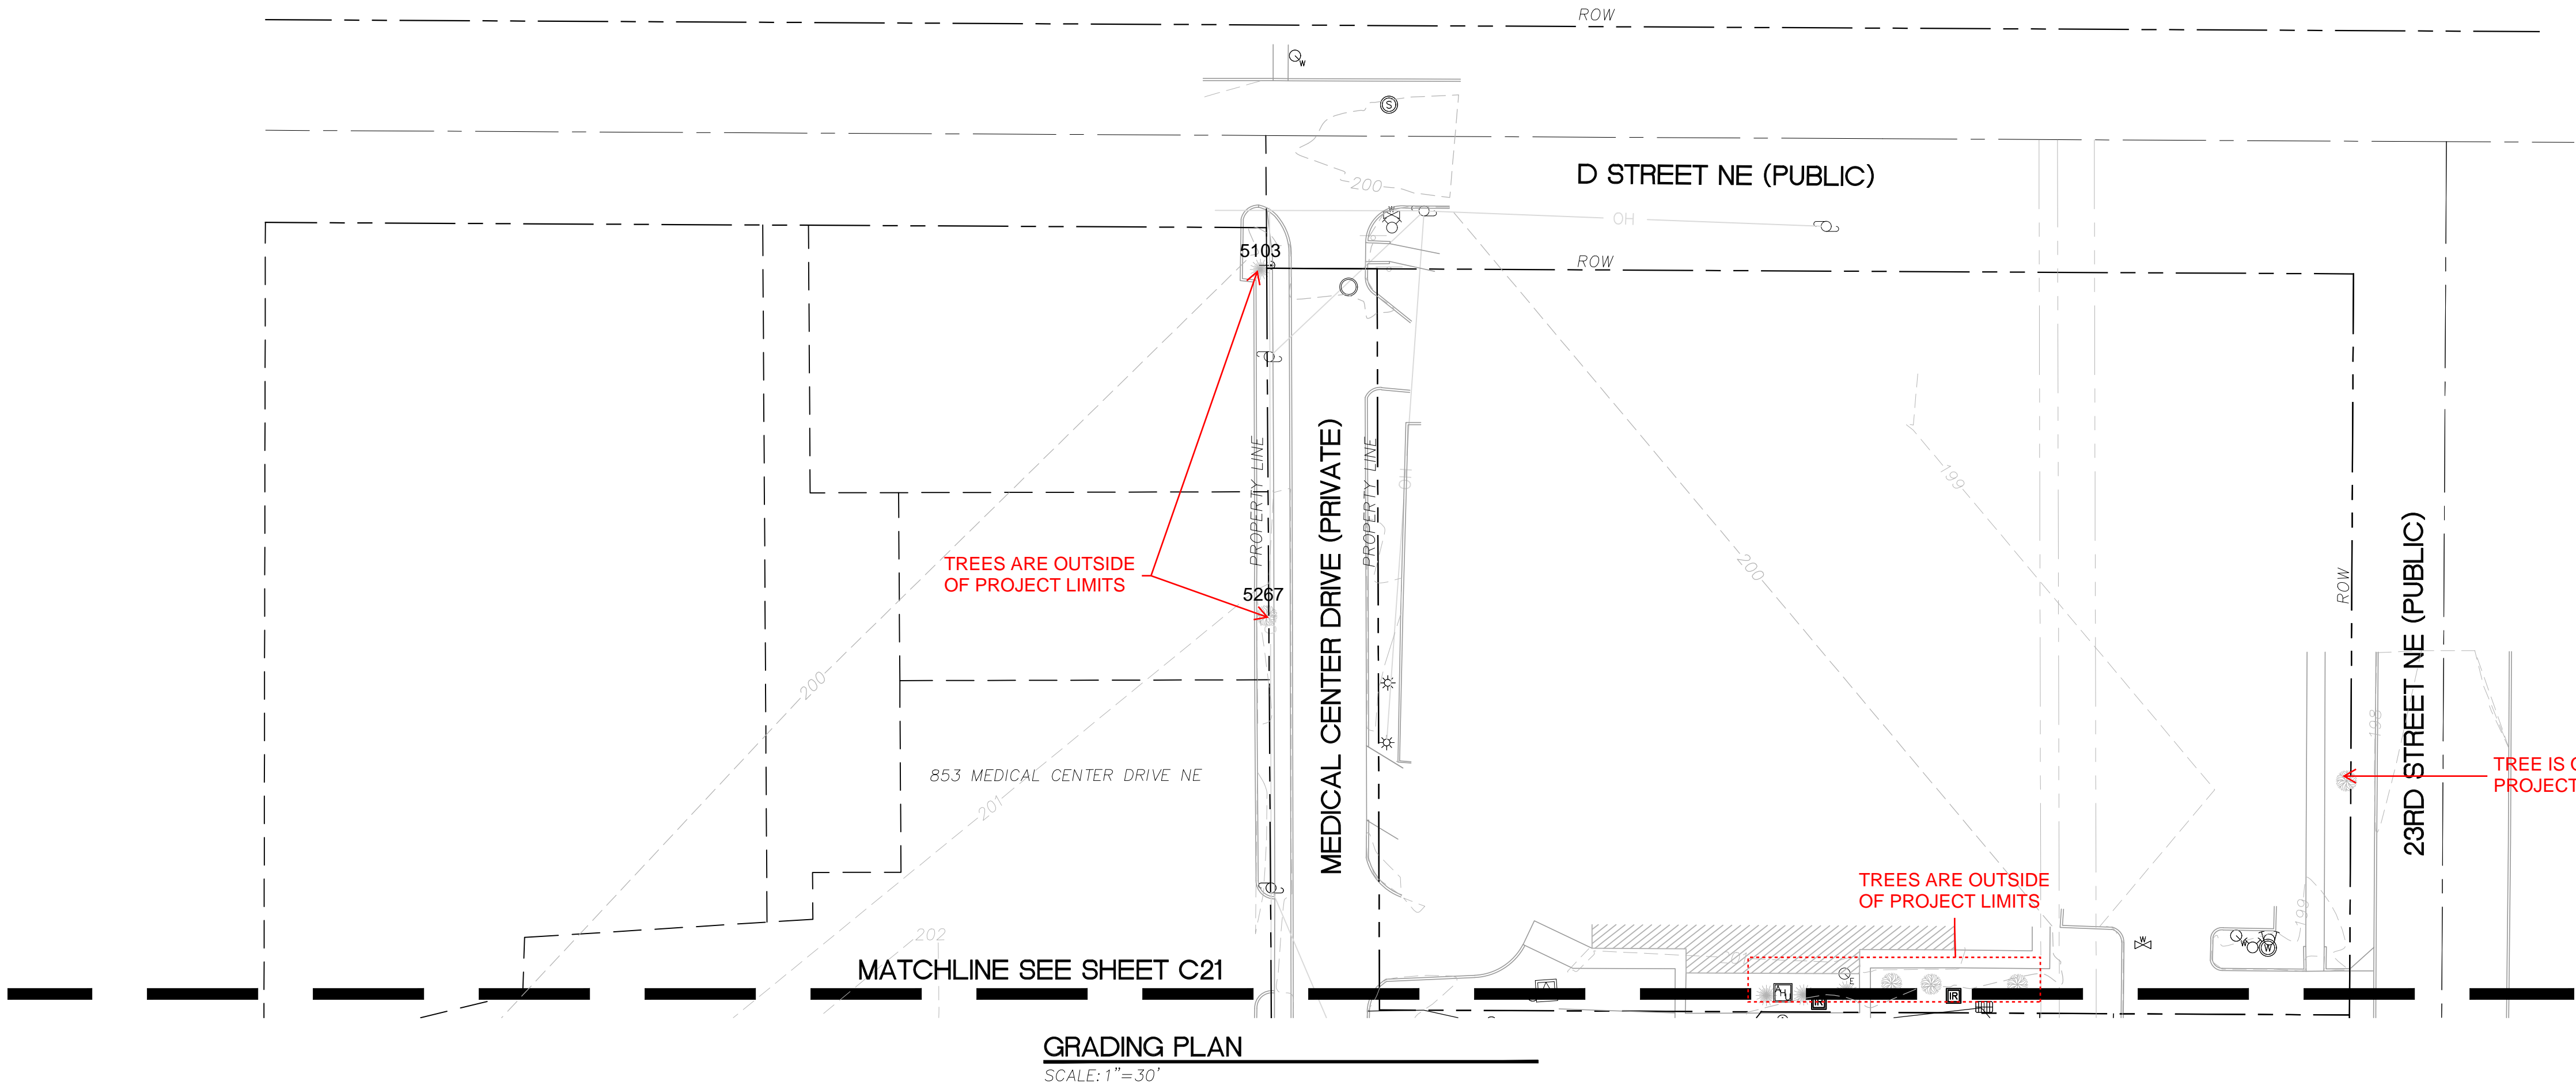
GRADING PLAN
ATTACHMENT 2 -
TREE PROTECTION PLAN
PHASE 1
C20
ORIGINAL SHEET SIZE : 22"x34"

The tree protection plan is in Attachment 2. There are 16 non-exempt trees greater than 10-inches in diameter proposed for preservation over Phase 1 and Phase 2 of the project. There are an additional two (2) trees less than 10-inches in diameter being preserved. All eight (8) significant trees are proposed for preservation.

The critical root zones² for preserved trees in the Phase 1 area of the project are shown on the tree protection plan. This section of the report provides an overview of the trees proposed for preservation in Phase 1.

- a. *For trees on private property:*
 - i. *Height:* Provide a minimum 6-foot-high metal fence (chain-link or chain-link panels).
 - ii. *Posts & Spacing:* Place concrete footers, steel footers, or metal t-posts no more than 10-feet apart.
 - iii. *Existing Grade:* Install fencing flush with the initial undisturbed grade of the protection zone.
 - iv. *Locations:* Install fencing as shown in Attachment 2.
