## MEMORANDUM

**DATE:** June 27, 2024 (Revised from 4/15/2024 report)

**RE:** Salem Apartments Tree Protection and Removal Plan for Phase 1/Parcel 1

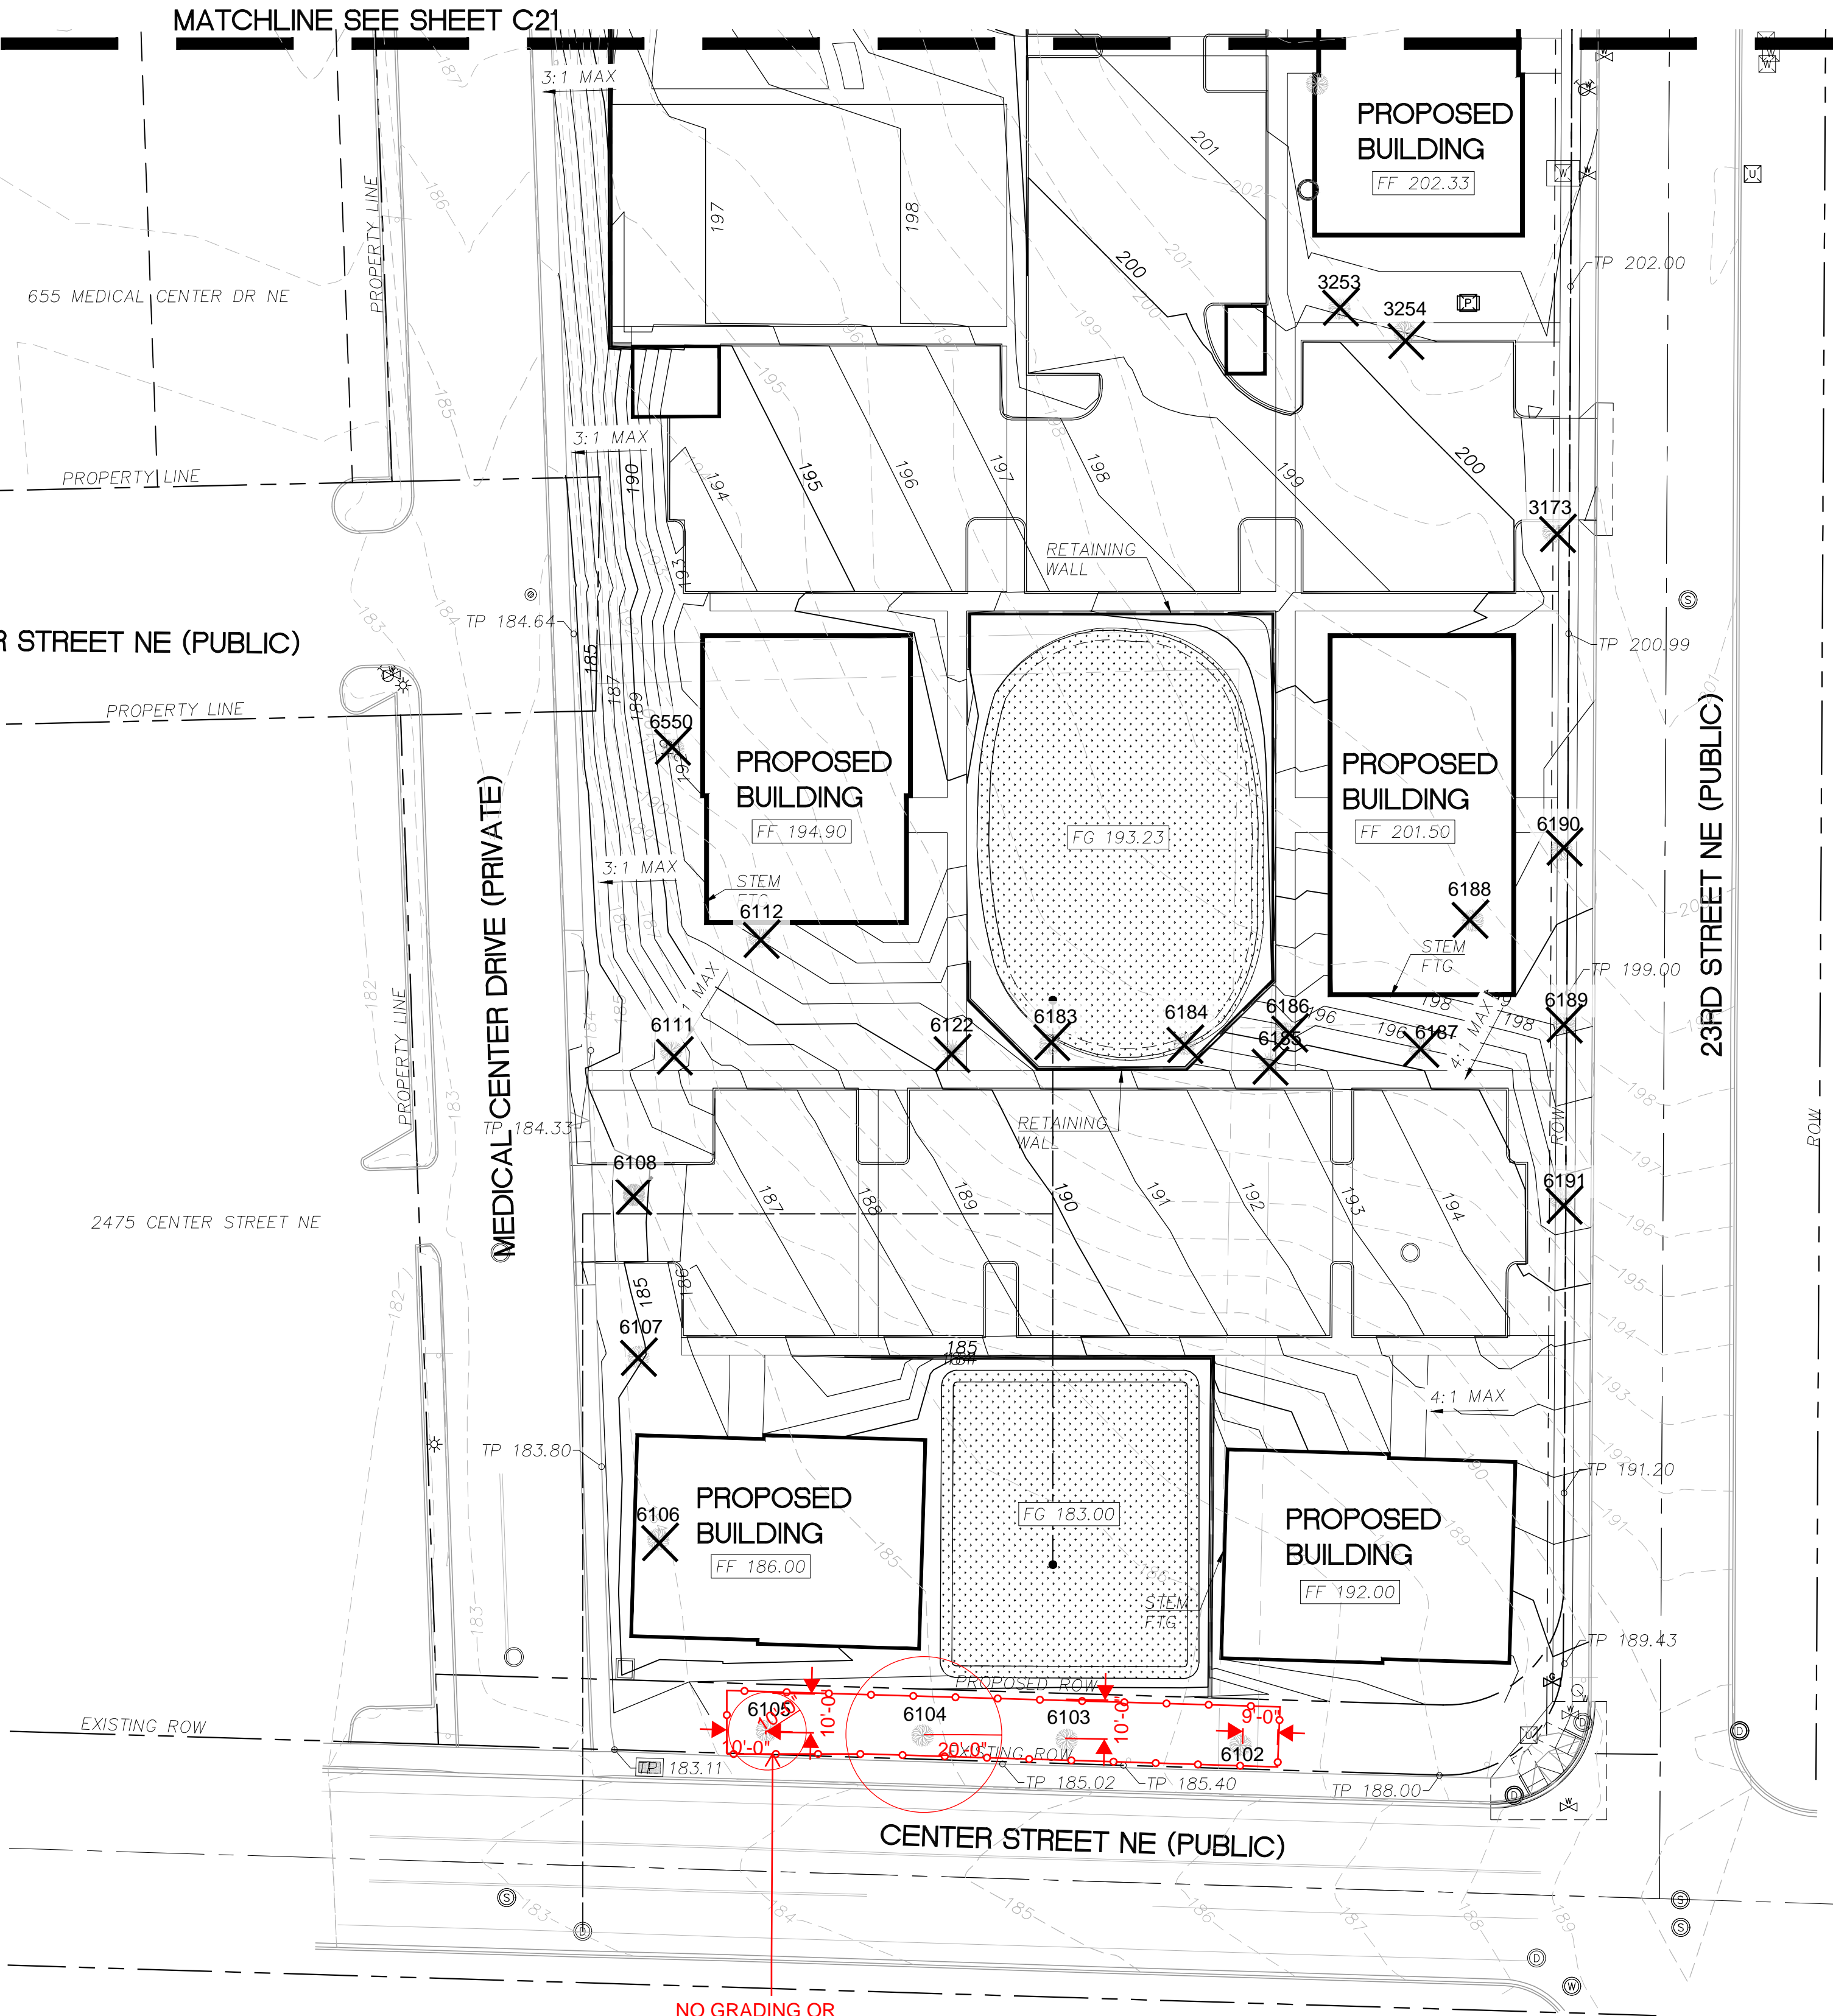
GRADING PLAN  
SCALE: 1" = 30'

30% MAX ENCROACHMENT : 6,032

NO GRADING OR  
GROUND  
DISTURBANCE  
BEYOND TREE  
PROTECTION  
FENCING.
