DECISION OF THE PLANNING ADMINISTRATOR

TREE REMOVAL PERMIT: TRP24-34

August, 15th 2024

RE: 4824 San Antonio Ct. NE Salem, OR 97305

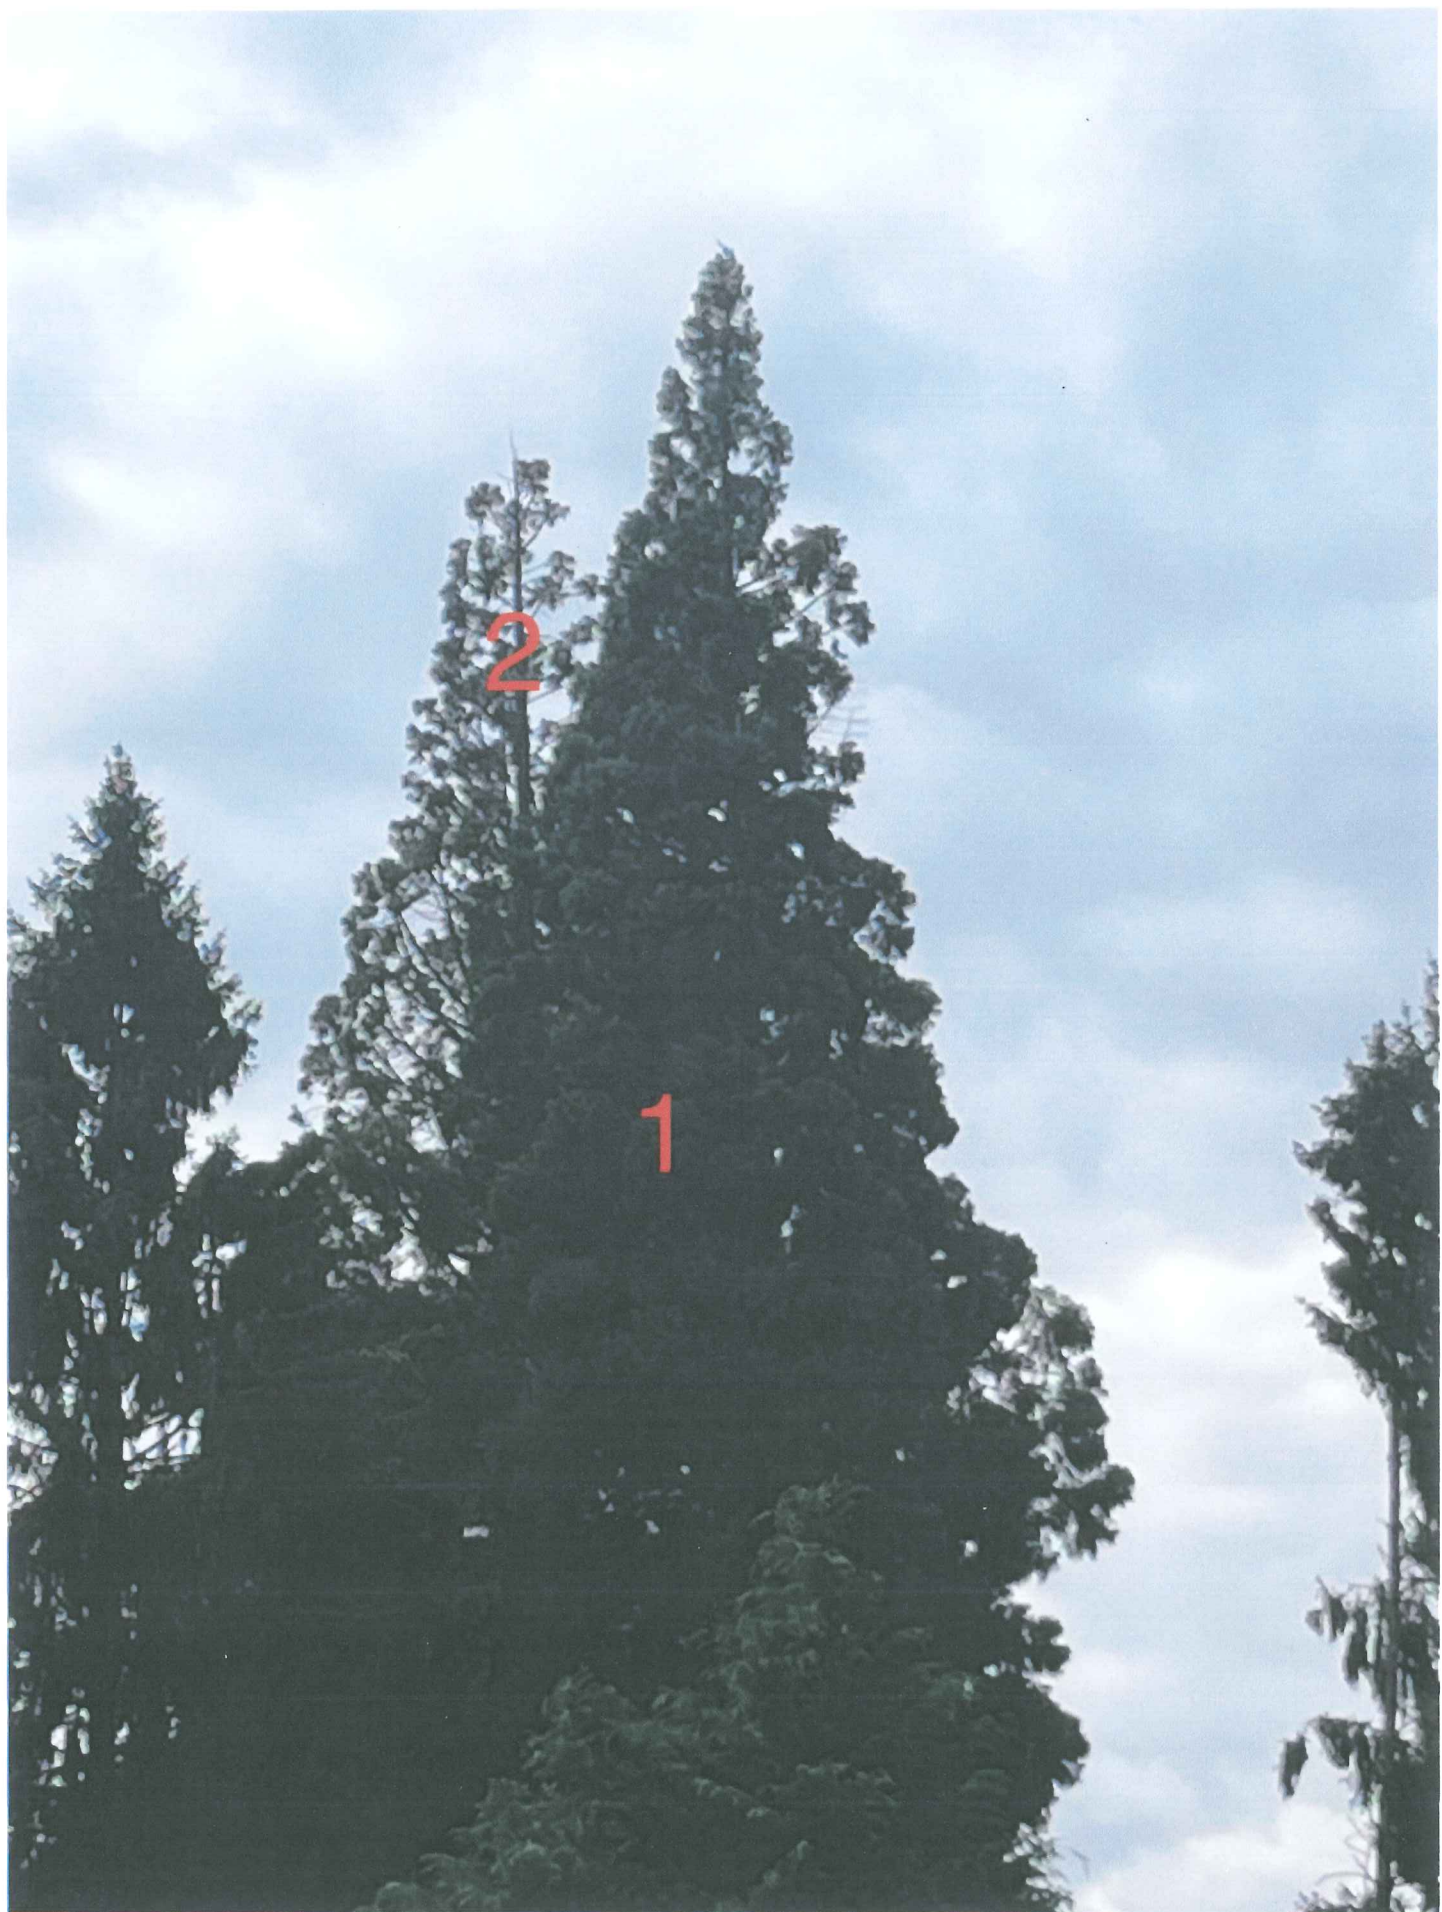
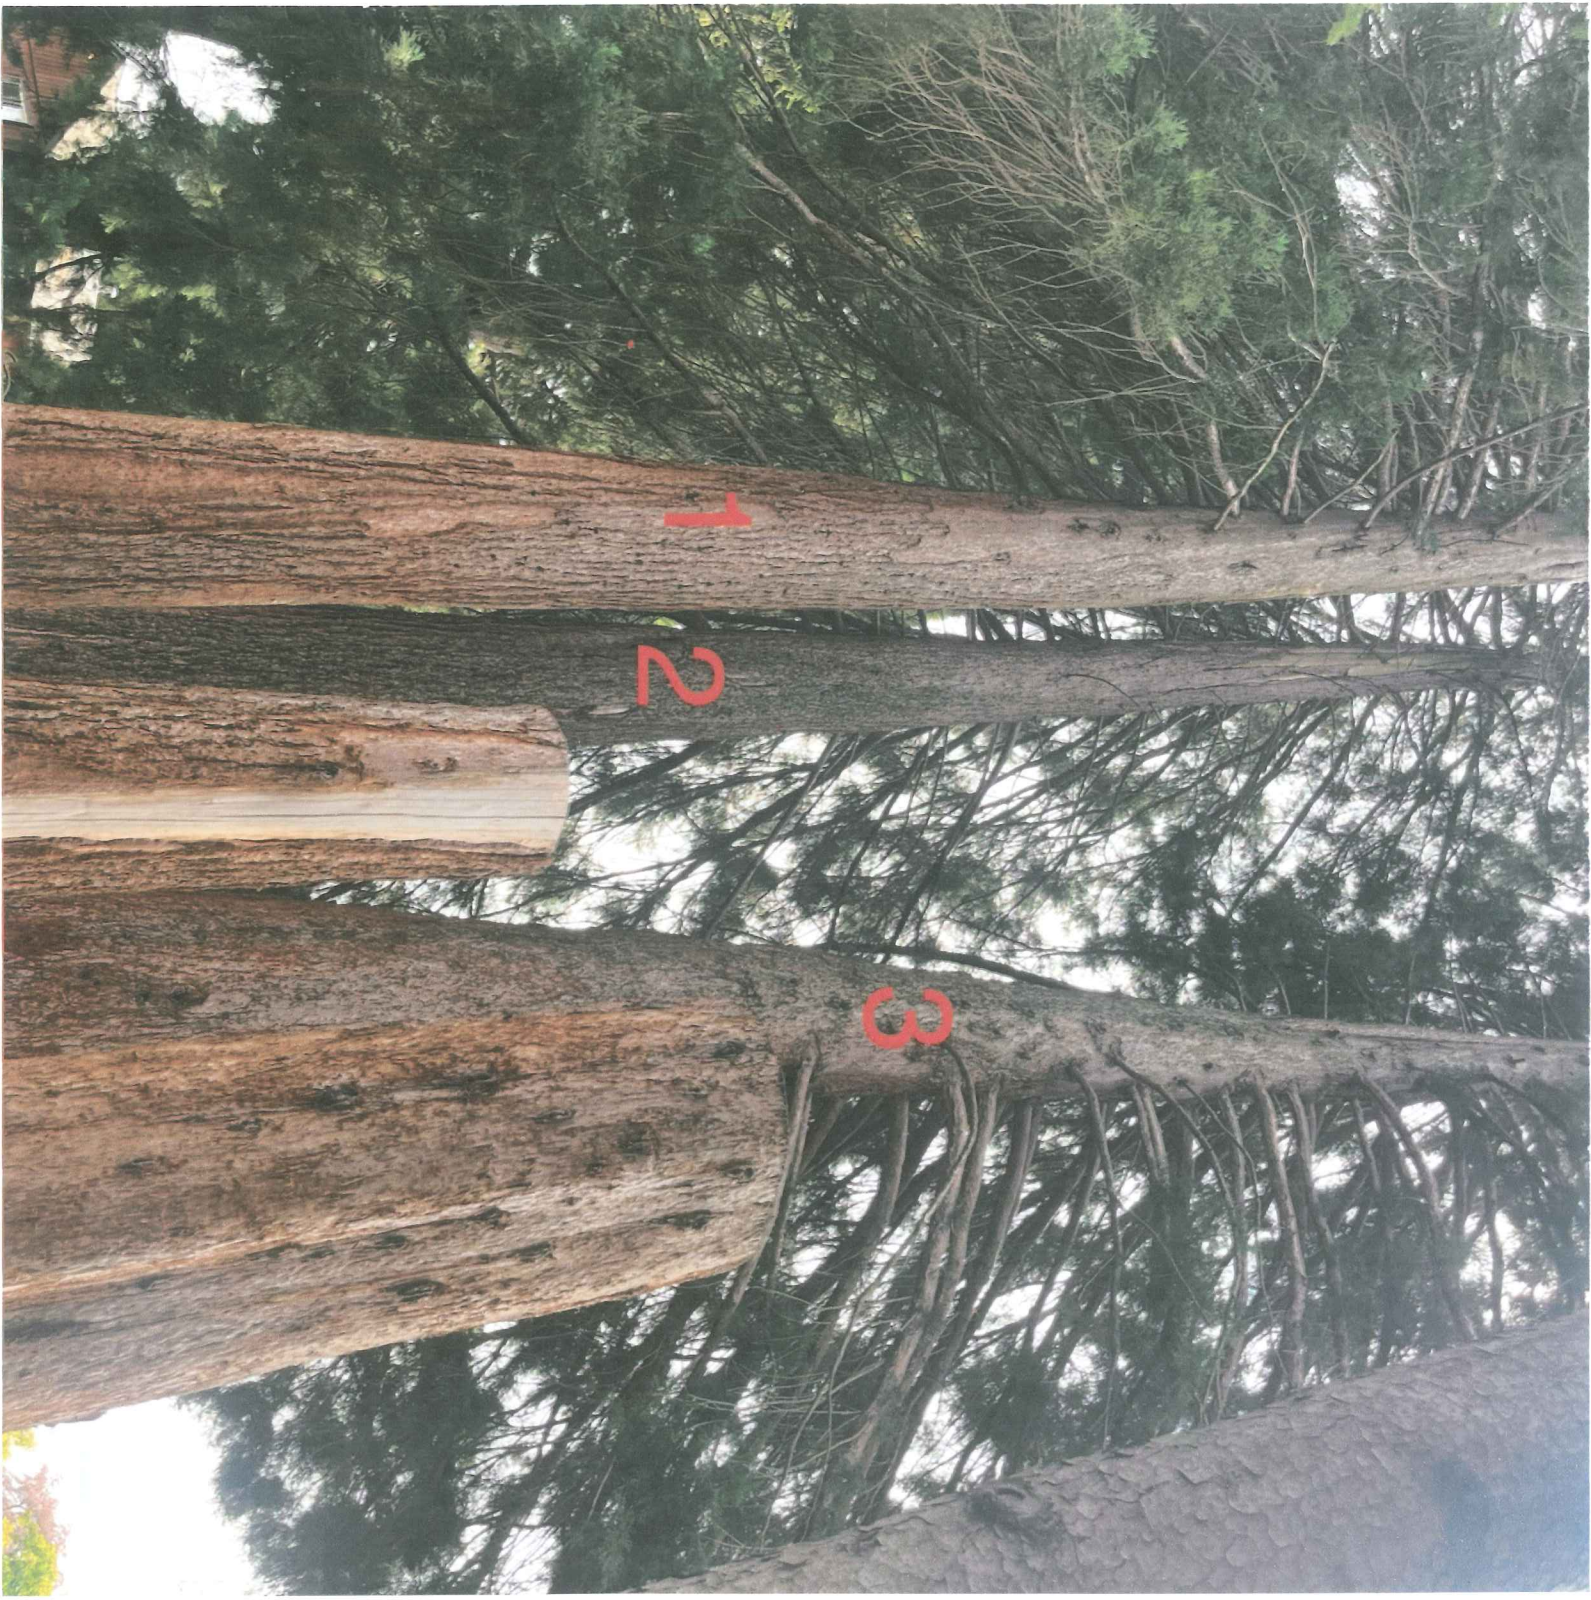
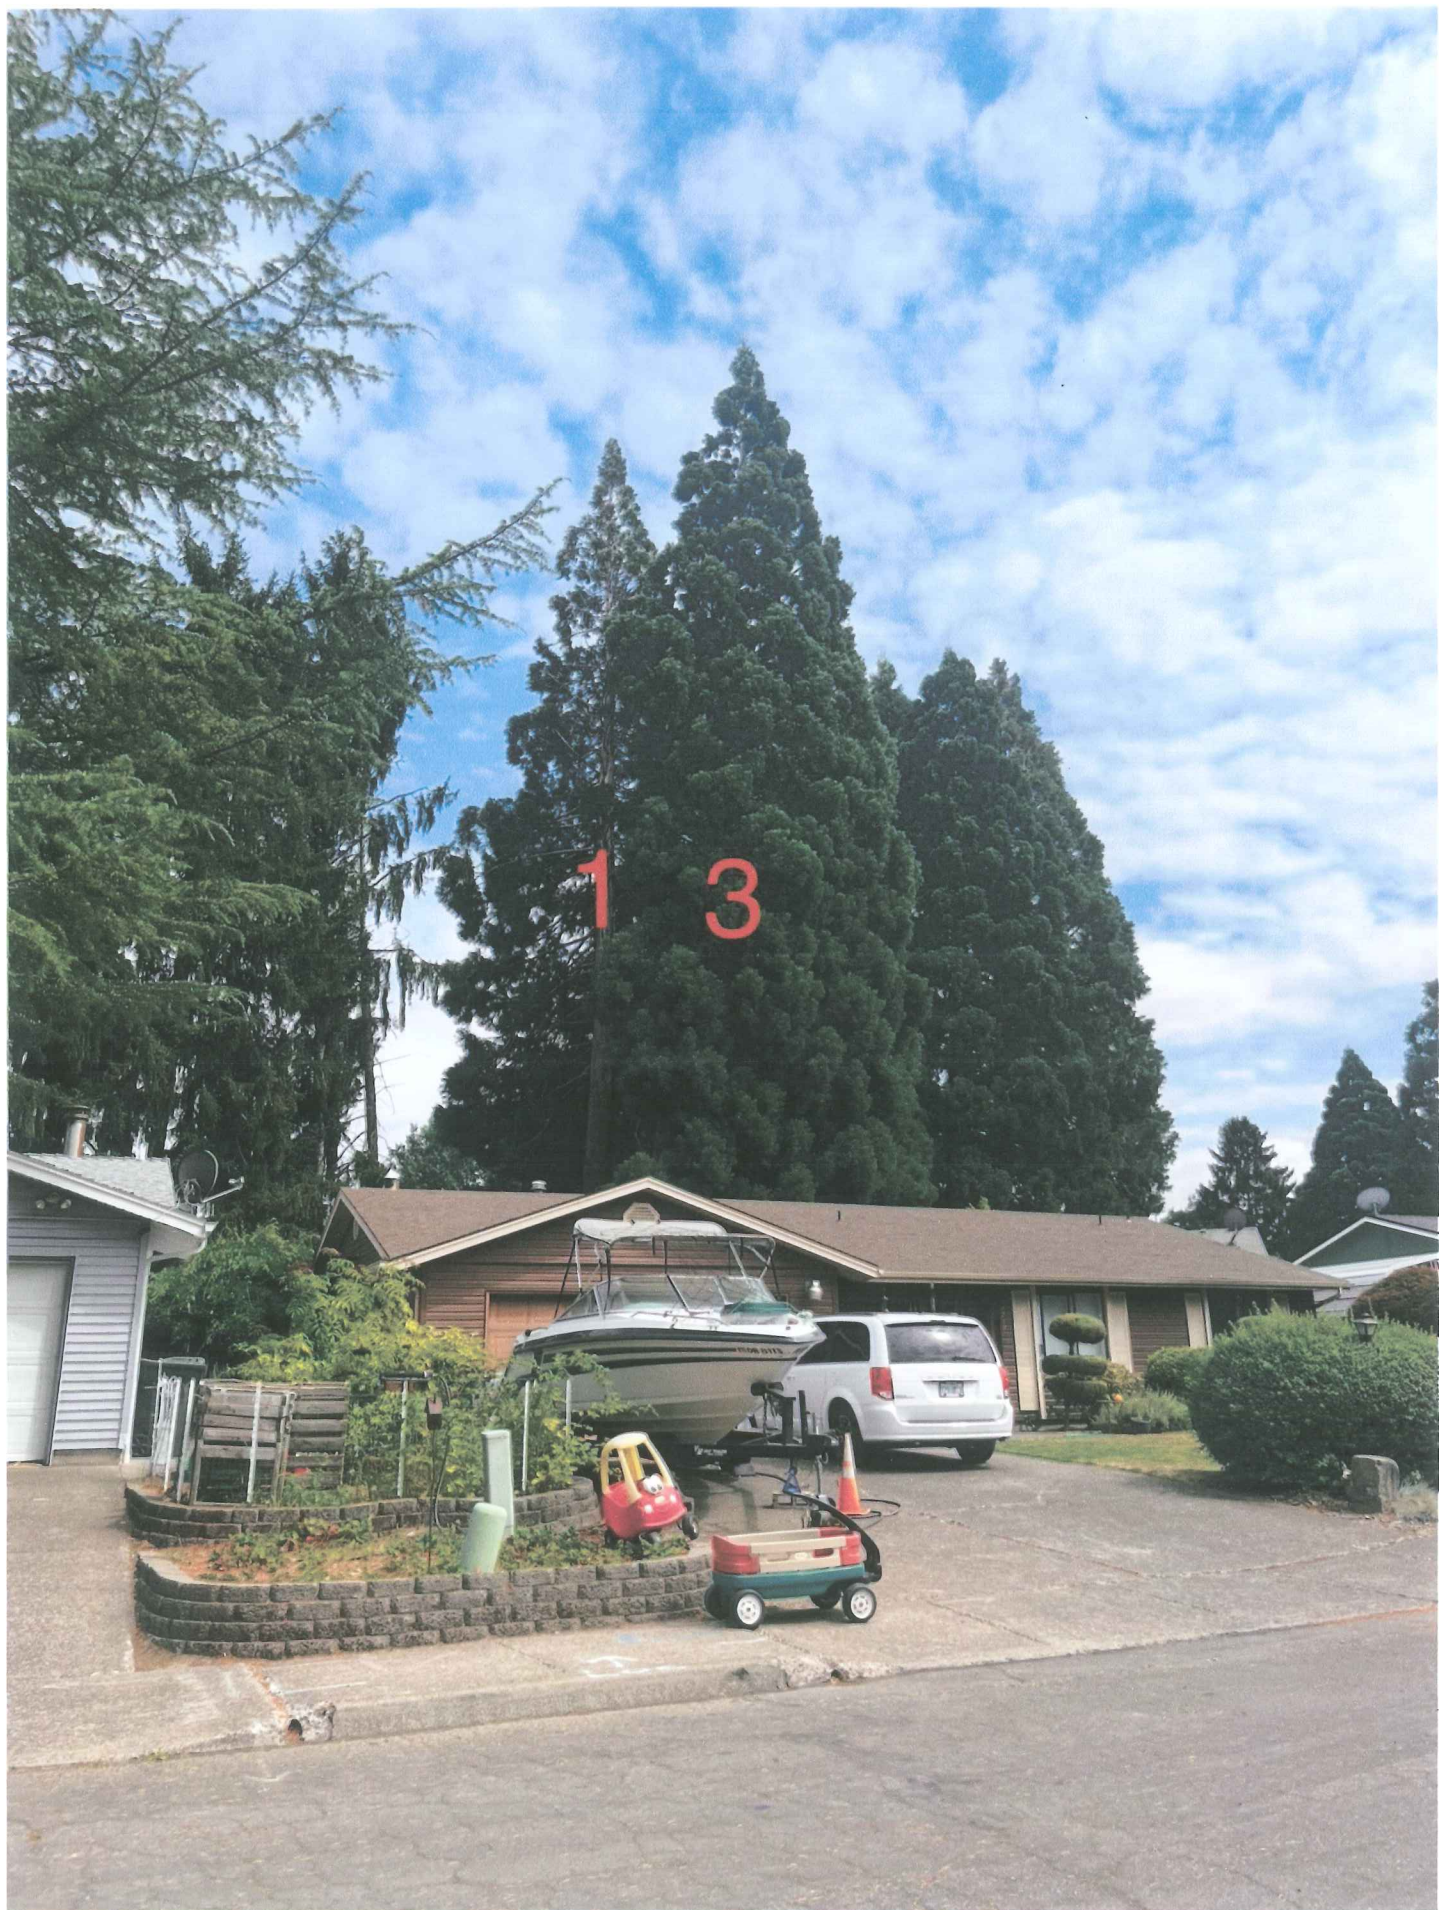
I have been contracted by property owners Dennis and Debbie Engelhard to evaluate three (3) Giant Sequoia (*Sequoia sempervirens*) trees bordering their property's west property line. In addition to providing a basic Tree Risk Assessment using standardized tree risk assessment criteria established by the International Society of Arboriculture (ISA) I have also provided recommendations to mitigate any risk associated with these trees. The trees are identified as *Tree 1* (59" DBH), *Tree 2* (60" DBH) and *Tree 3* (39" DBH). Photos of the evaluated trees are attached to this report.

In evaluating these trees, it was determined that this was originally a grove of five (5) closely spaced Giant Sequoia trees that grew up together and are approximately 50-60 years old at present day. The two northernmost trees of the grove have already been removed as they were badly damaged by a lightning storm approximately ten (10) years ago. Additionally, the top, or apical meristem of *Tree 1* experience a complete failure in the ice storm of 2021 with the top of the tree landing on the property owner's roof. The remaining three trees have significant lightning damage. The lightning damage to *Tree 1* and *Tree 2* has exceeded the tree's ability to compartmentalize the damage and has led to noticeable decline. An almost certain impending death of *Tree 2* can be seen by the presence of a dead top, or apical meristem.

While the lightning damage to these trees is significant and appears to be leading to the trees decline, a far more significant risk is total tree failure. It should be noted that *Tree 1* is leaning (10%) towards Dennis and Debbie Engelhard's property, *Tree 2* is leaning (10%) towards the neighbor's home to the South and *Tree 3* leans (15%) west towards another neighboring house. Because the trees grew up together in a tight grove, their canopies are unbalanced, with the majority of the canopy weight compounding the lean of the trees. Moreover, in discussing the history and future plans for the property, the root zones on all four sides of the grove have been compromised: On the North side of the grove's critical root zone, two Giant Sequoia trees have already been removed. As the roots from these two trees decay, the intertwining roots from the remaining three

trees will lose stability. Additionally, when the homeowners proceed with stump grinding and replanting of the two trees removed, the existing trees will be unavoidably damaged and further destabilized. On the West side of the critical root zone, a fence and raised garden bed have been built on the neighbor's property altering the natural grade of the soil. On the east side of the critical root zone, the property owners have brought in fill dirt in an attempt to better grow a lawn in the backyard. They reported extensive soil compaction and existing root damage during this process. The entire root plate from these trees is significantly uplifted approximately two (2) feet from the natural grade. The property owners have noticed additional root plate uplifting in recent years and recently had to replace a leaking automatic sprinkler line that broke (likely due to root plate uplift) on the south side of the grove's critical root zone. It is unknown how long this line had been broken and fully saturating the tree's critical root zone.

Because Giant Sequoia trees are a very long lived species I chose a ten year time frame over a typical five year time span used for these reports. Given the significant lean of all three trees towards high risk targets, and the lean compounded by an imbalance canopy and deteriorating root zone, I found total tree failure within ten years to be probable with a high likelihood of impacting targets. Given the severe consequences of total tree failure, all three trees are determined to be high risk trees and are recommended to be removed.
