**Geologic Assessment Report  
Keubler Lot Partitions  
2592 Kuebler Road South  
Salem, Oregon**

**CGT Project Number G2406322**

March 5, 2025

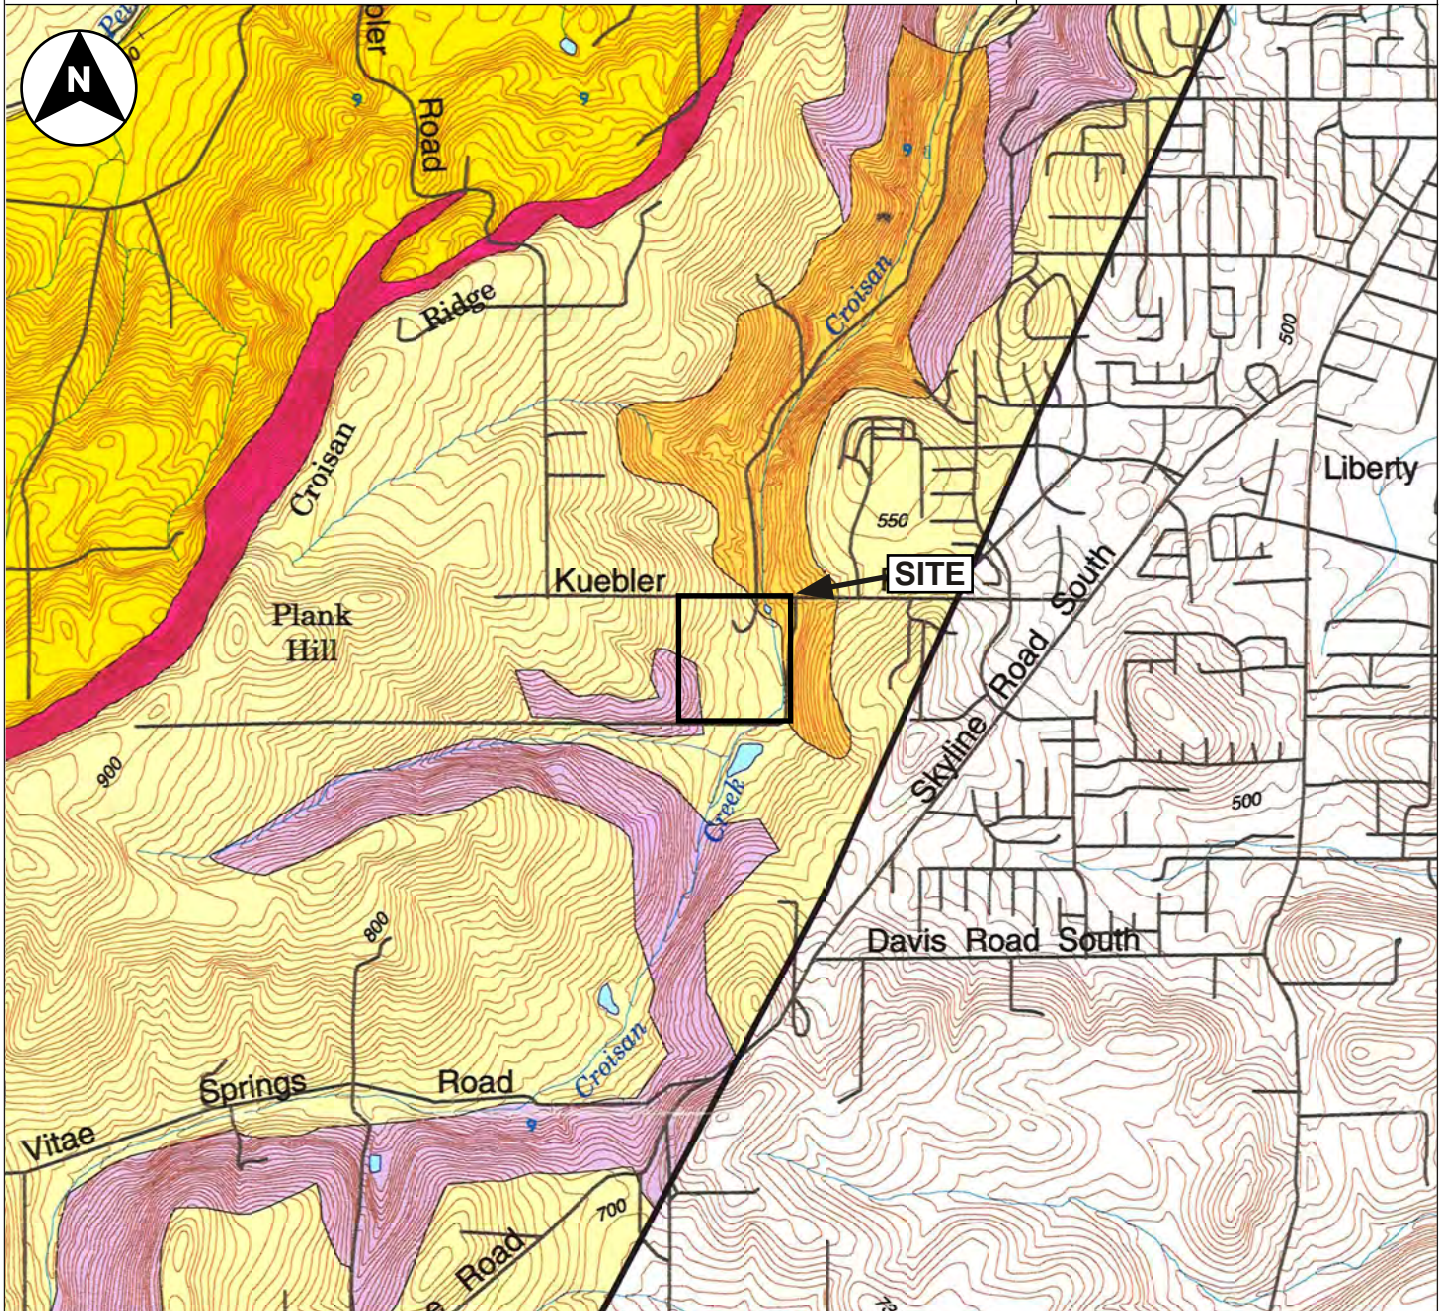
**Figure 8**  
**Water-Induced Landslide Hazard**

The site is located within the study area for IMS-6: Water Induced Landslide Hazards, Western Portion of the Salem Hills as shown on Figure 8. The majority of the site is mapped as having a low potential (1) for water-induced slope instability, with two exceptions. The southwestern corner of the site is categorized as having a high (4) potential for slope instability, and the northeastern corner is mapped as having a moderate (2) potential for slope instability.

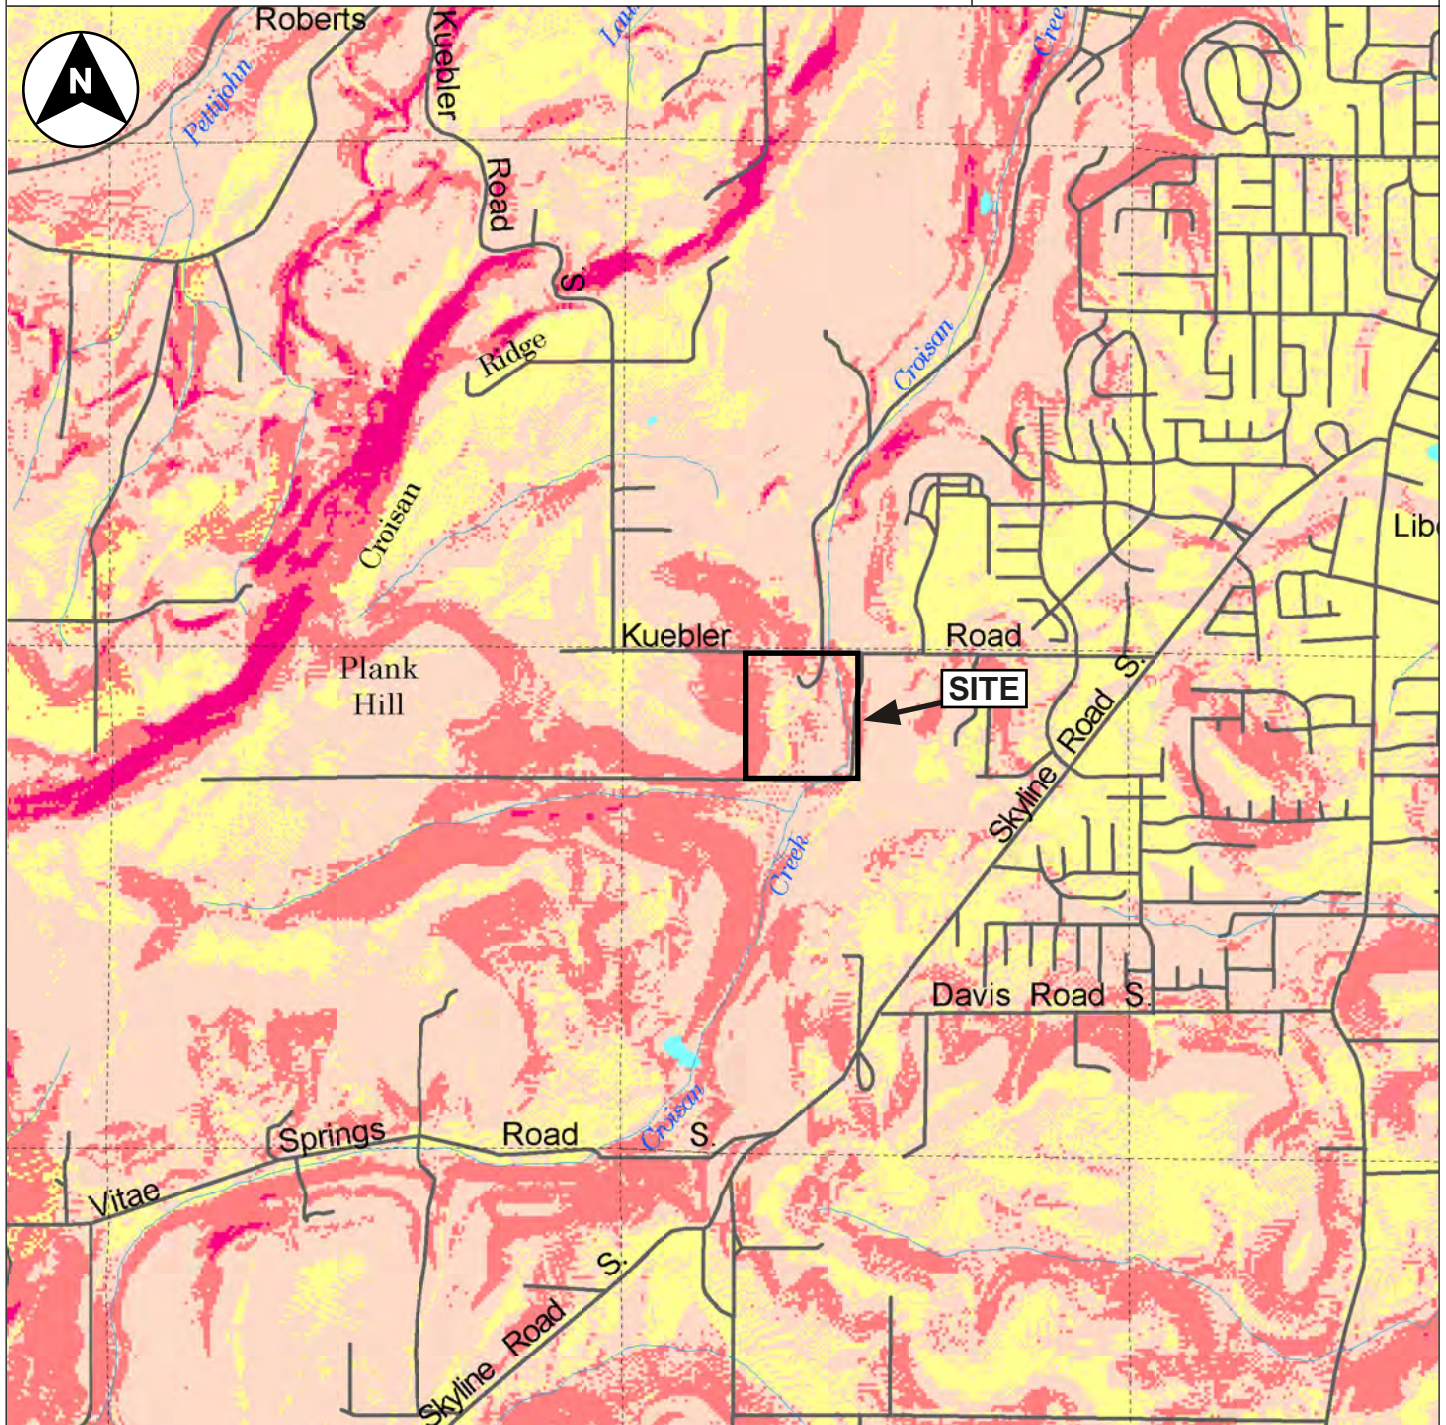
The site is located within the study area for IMS-17: Earthquake-Induced Slope Instability: Relative Hazard Map, a portion of which is attached as Figure 9. The site is mapped as having a low to moderate potential for earthquake-induced slope instability. The mapped level of hazard varies across the site with slope gradient.

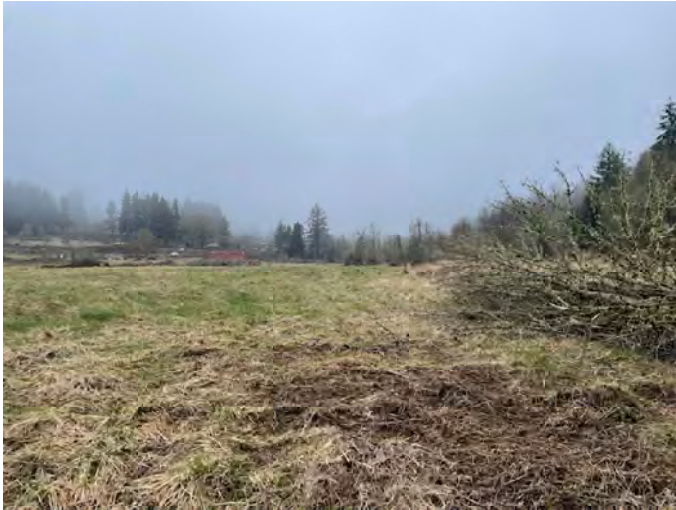
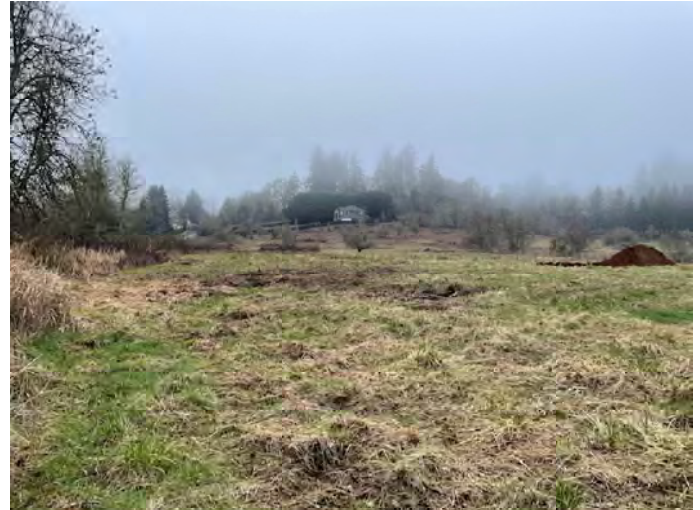
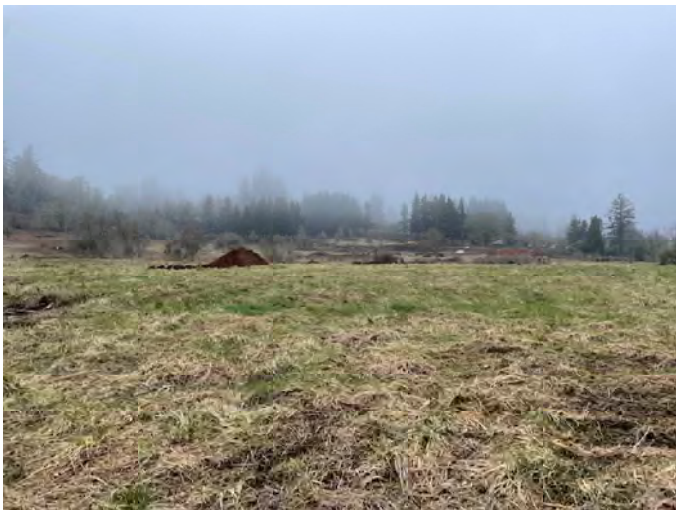
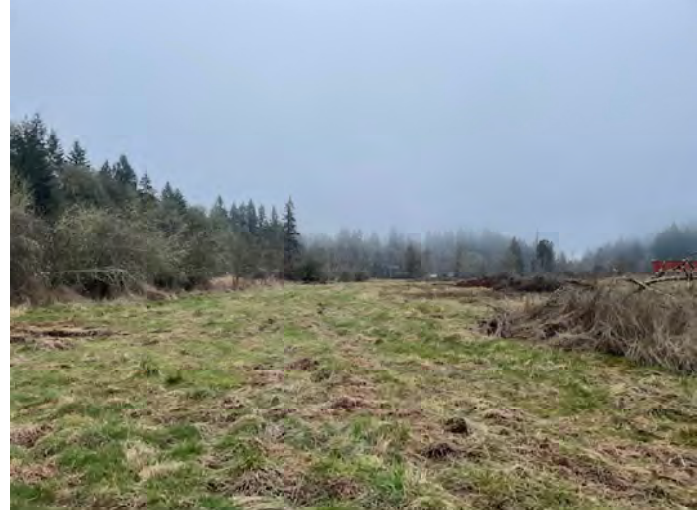
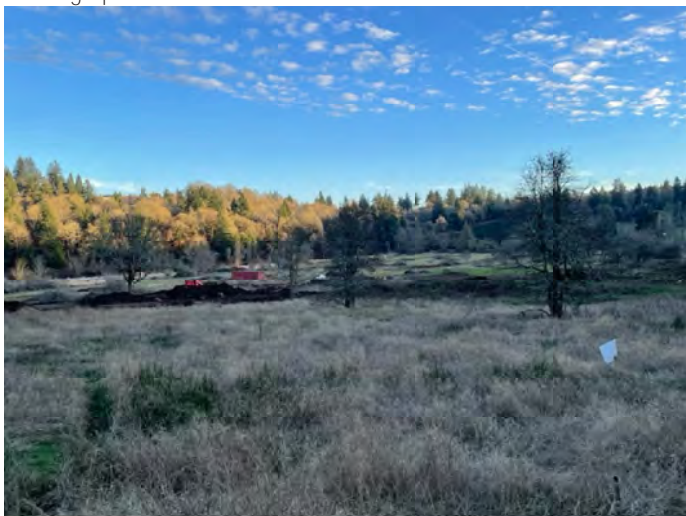
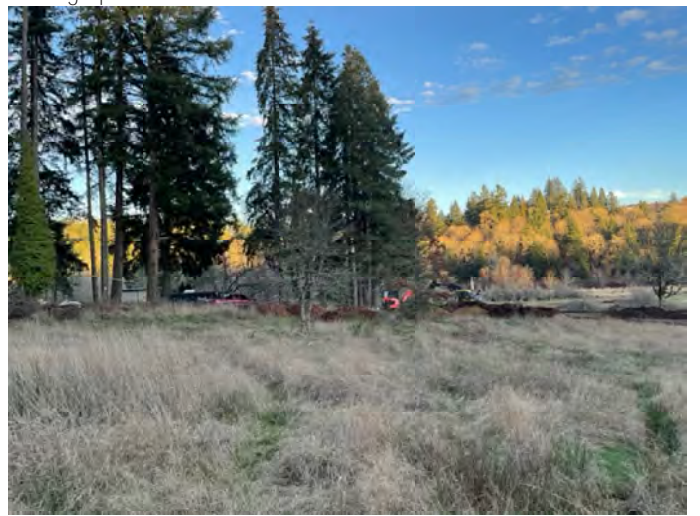
The site conditions at the time of our field work are shown on the attached Site Photographs (Figure 10).

No indicators of recent or ongoing slope instability were observed on the site during the reconnaissance.
