NOTICE OF DECISION

TREE REMOVAL PERMIT: TRP25-10

REQUEST: A Tree Removal Permit to remove one significant cedar tree, approximately 43-inches in diameter at breast height (dbh), on the basis that it is a hazard to persons and property, for property zoned RS (Single-Family Residential) and located at 954 Huron Court SE (Marion County Assessor's Map and Tax Lot Number: 083W03DD / 6000).

ARBORIST REPORT

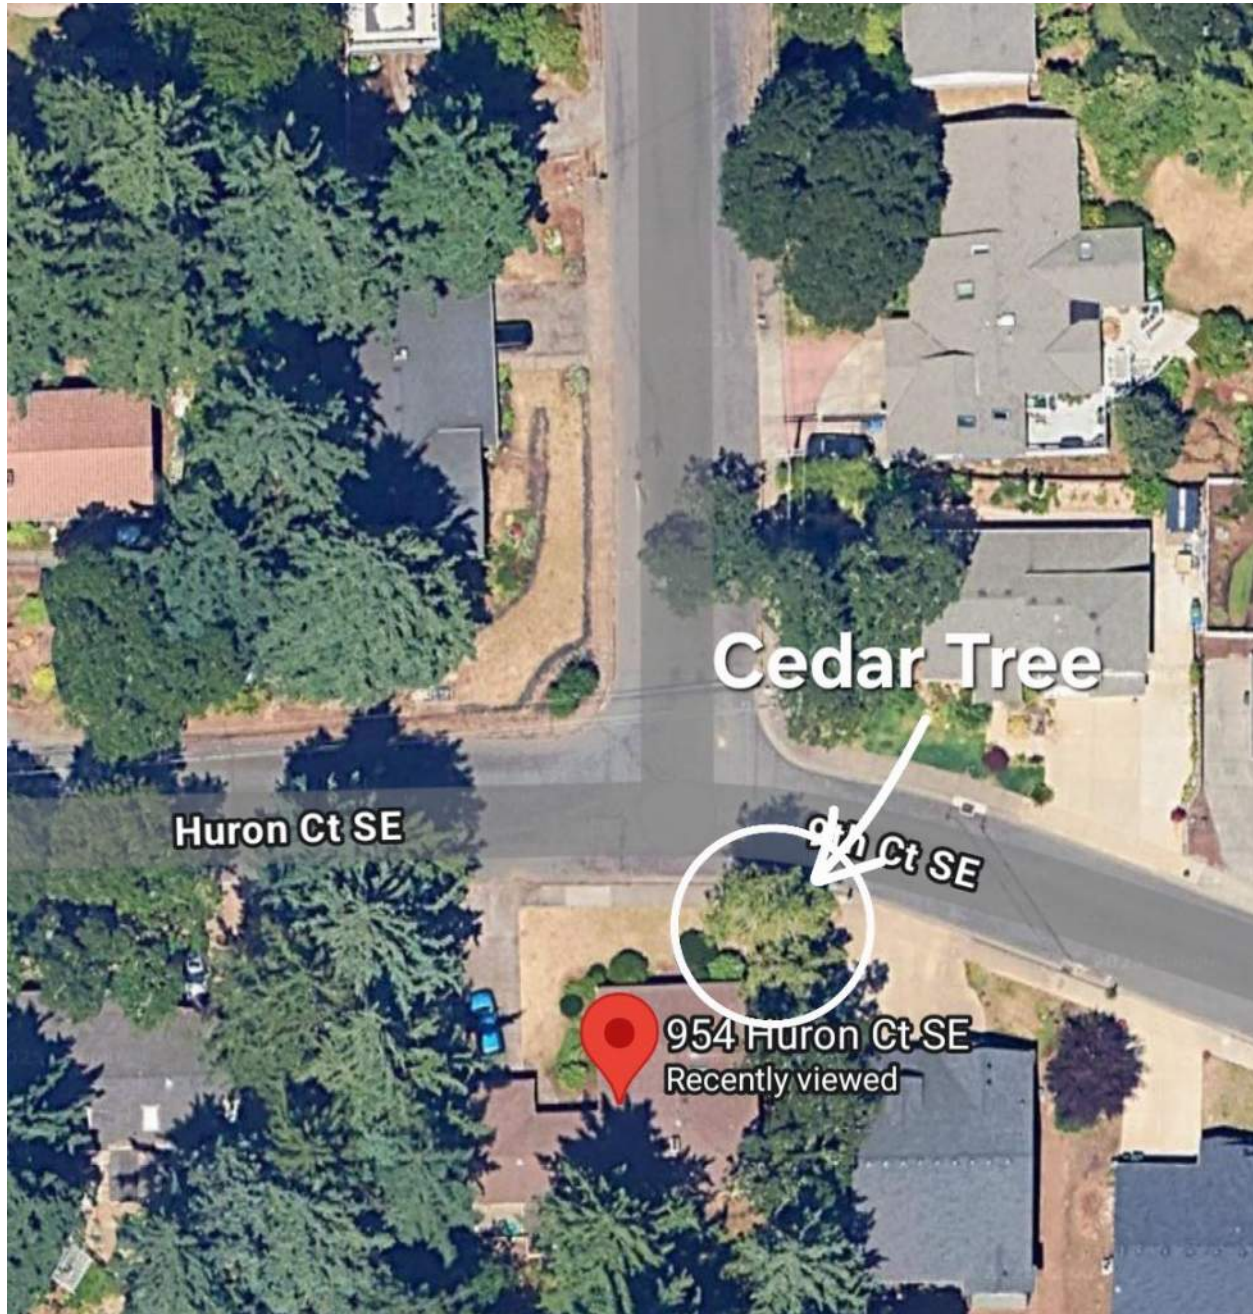
LOCATION - Overview

Our company was contacted by Chris Forns & Jennifer Glass, property owners of 954 Huron Ct SE in Salem, regarding the hazardous condition of a dead cedar tree. The cedar tree is located in the left front corner of the home as facing from the street. *(Tree location is circled in red on following page)*

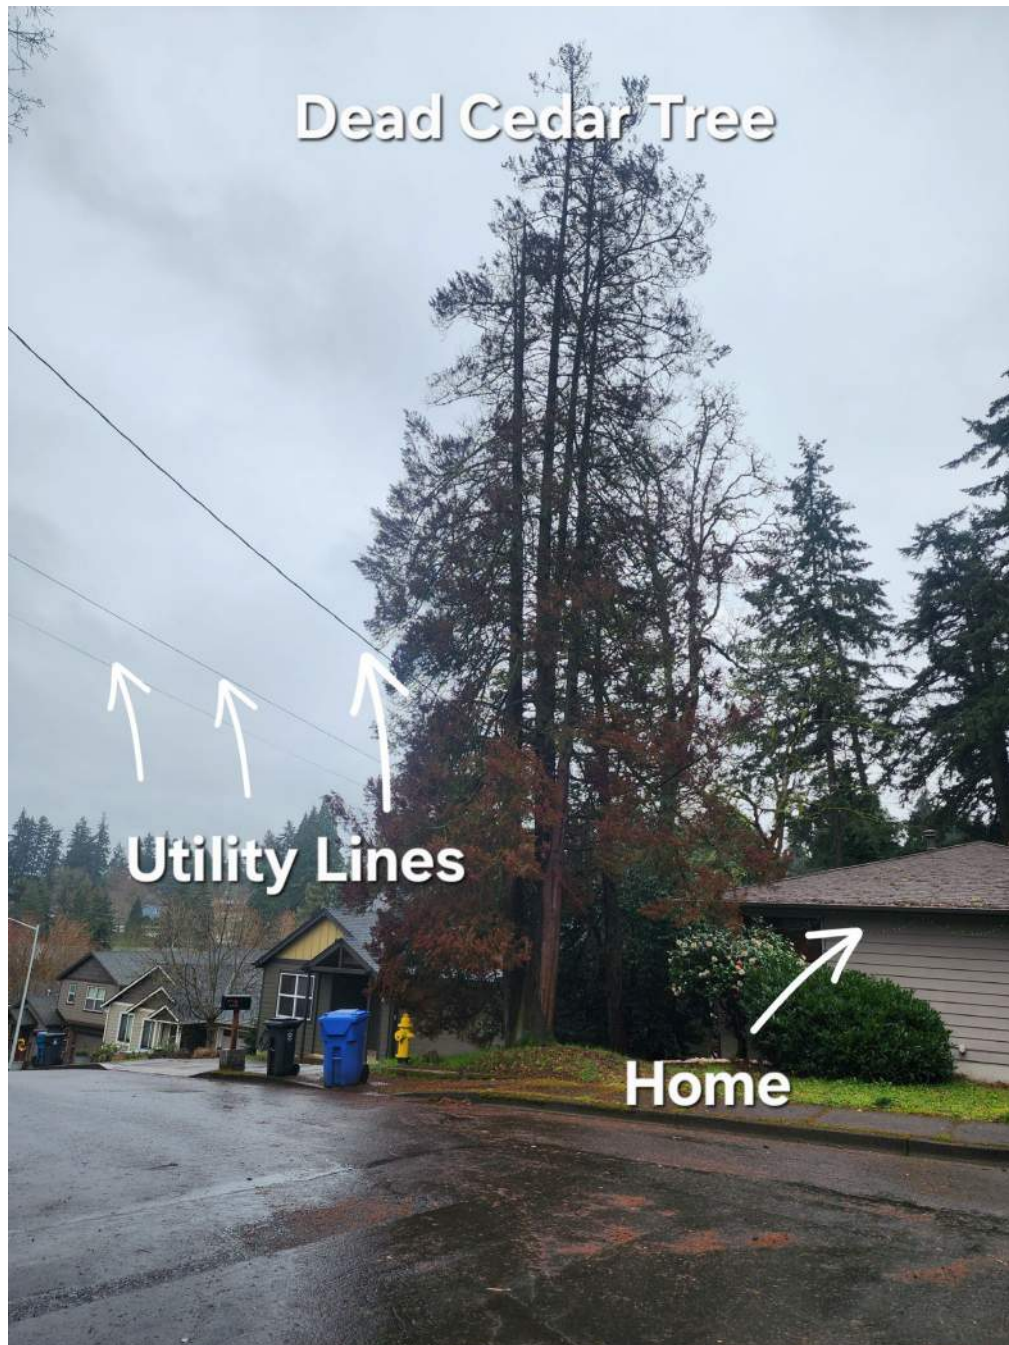
PICTURE
Taken 3/27/2025

The 43-inch dbh cedar tree is located in the front yard of the subject property adjacent to Huron Court SE and the eastern interior side property line. Per the Arborist Statement and ISA Risk Assessment, the tree is dead and showing signs of "root rot" and limb loss, with the arborist noting that total failure of the tree is possible.

The tree is dead.

In my opinion, the removal is necessary for safety of the nearby homes, utility lines, property and people and these hazards cannot be alleviated by treatment or pruning.
