TREE REMOVAL PERMIT: TRP25-12

APPLICATION NO.: 25- 107363-PLN

ARBORIST REPORT

Located at: 1205 Hillendale Dr SE, Salem

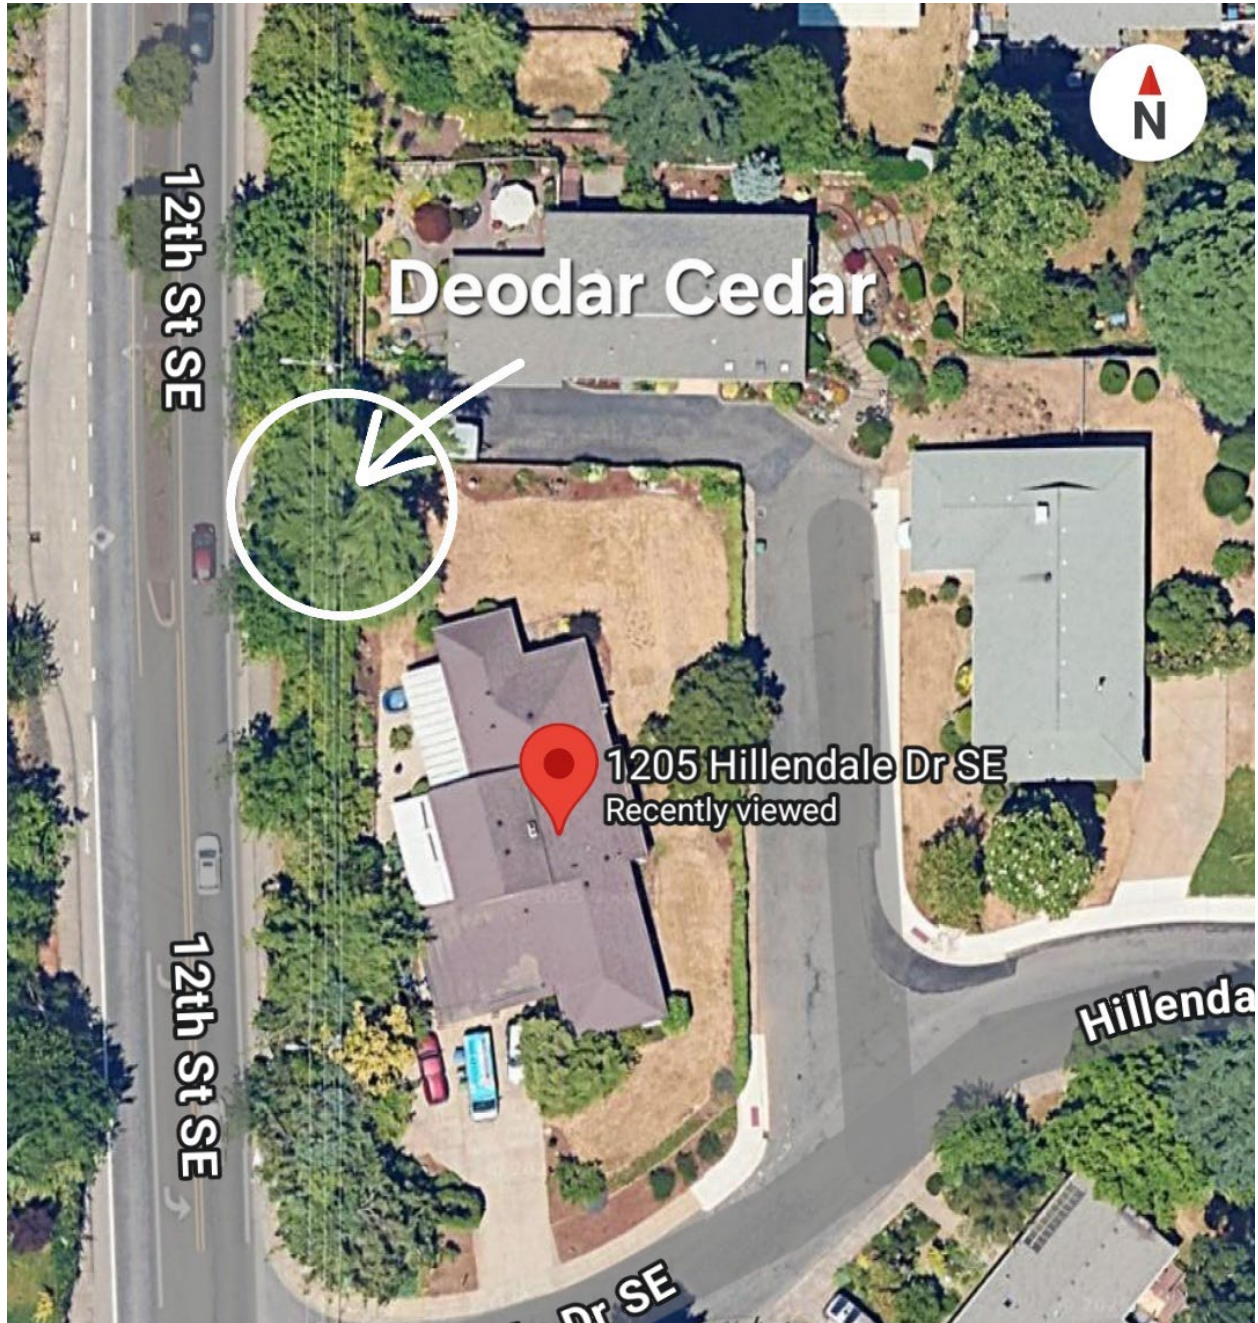
LOCATION – Overview

Our company was contacted by Gordon Jackson, homeowner at 1205 Hillendale Dr SE in Salem, regarding the hazardous condition of a cedar tree located in the left rear corner (NW) of his backyard. *(Tree location is circled in white on following page)*

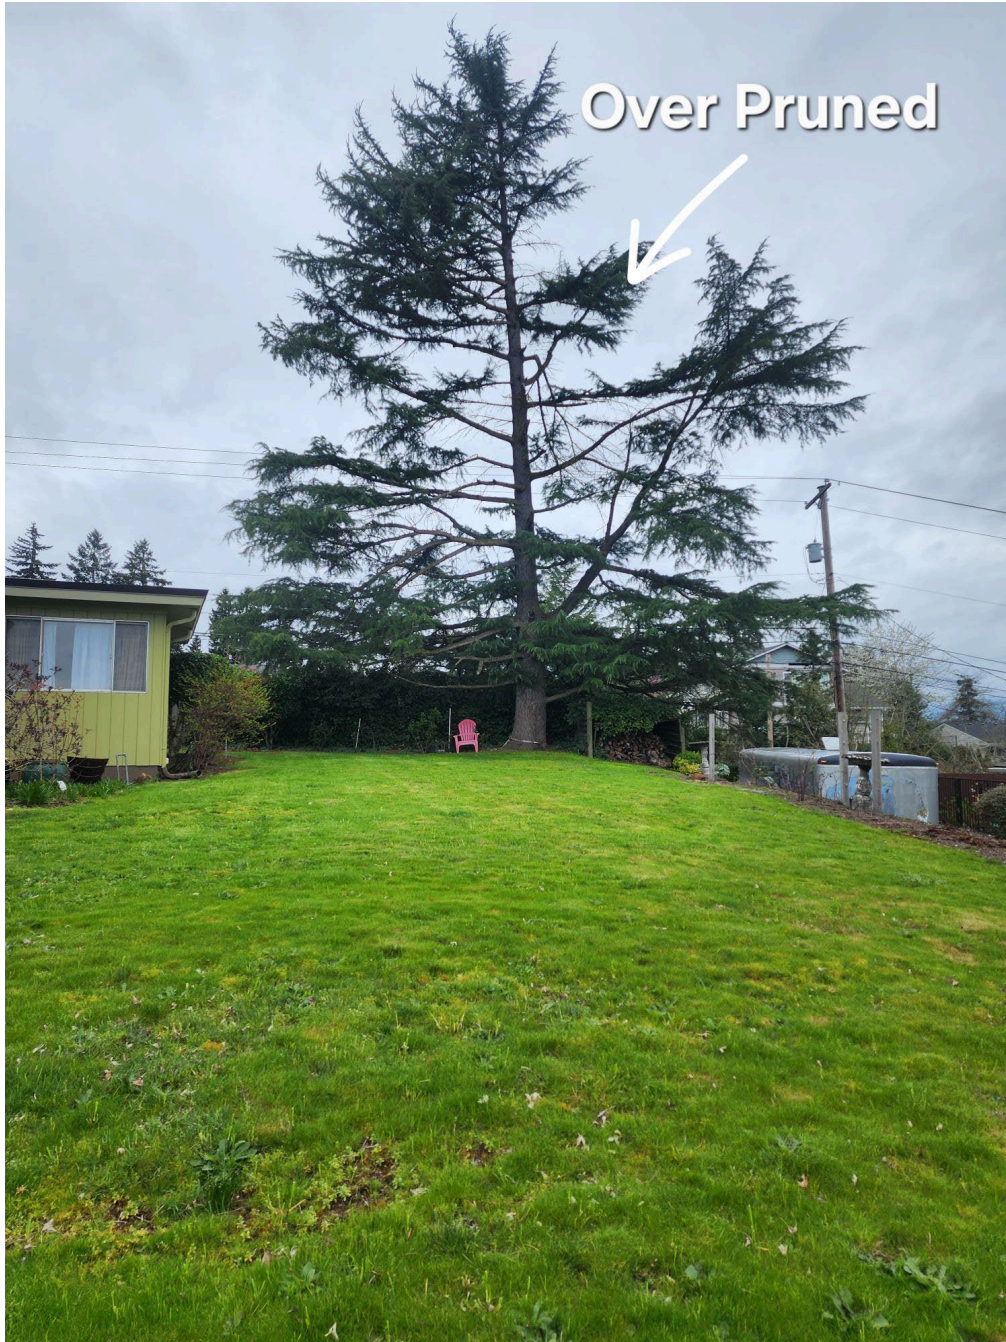
PICTURE 1
Taken 03/27/2025

On March 27, 2025 I inspected the cedar tree. The tree poses significant safety issues for both the city and public due to the close proximity to multiple utility wires. The cedar has been severely over pruned by the utility company, removing more than 50% of the live canopy. The tree was also "lion-tailed". Lion tailing removes a large number of inner branches, leaving the tree with long bare limbs and foliage left at the tips, leaving the tree vulnerable to wind damage, increases the risk of breakage and dampening wind movement. The lower canopy is in direct contact with the utility communication lines on the west side of the tree. It appears the limbs are rubbing against the lines, causing excessive wear that can lead to fire/damages and/or outages to communication and power in the area. Consistent over pruning by the utility company has weakened the integrity of the limbs, making the tree more prone to breakage. In addition, the tree type and size are inappropriate for the planting area below these overhead power lines.

In my opinion the tree should be removed for safety and to prevent the loss of communication and power. I believe the removal is necessary due to the hazardous condition and location of the tree, which present both a hazard and danger to persons and property. These hazards cannot be alleviated by treatment or pruning.
