PROJECT NO. 1001.052.G

DEVON AVENUE SUBDIVISION

**Geologic Hazard Assessment**

**Geological Assessment  
8S/3W-22C Tax Lot 300  
Salem, Marion County, Oregon**

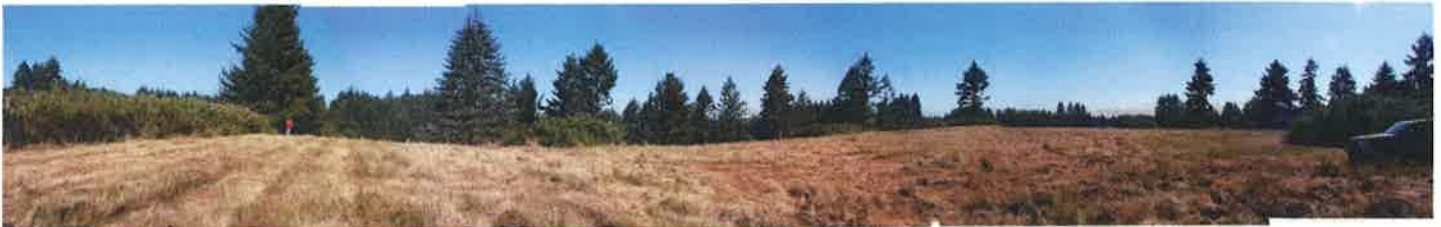
Panorama of central part of site looking N (on left) and around to SSE (on right). Note brush mound at far right behind vehicle.

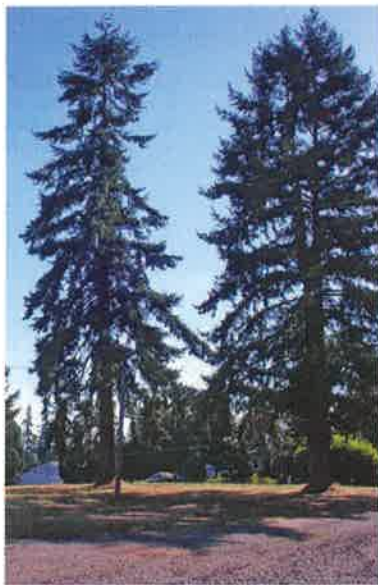
Even though the site soils have not failed, they do creep, and similar soils have failed locally in overly-steep excavations (NGS, 2008). Consequently, we recommend that foundations be placed on competent material. Foundations and retaining walls should be designed by a qualified professional to withstand forces from soil creep and lateral loads from earthquakes. Given the thin soils and shallow depth to weathered bedrock, this requirement should not be onerous.

Mature Douglas Firs at the East end of the site show slight curvature from moderate creep in the thin site soil.

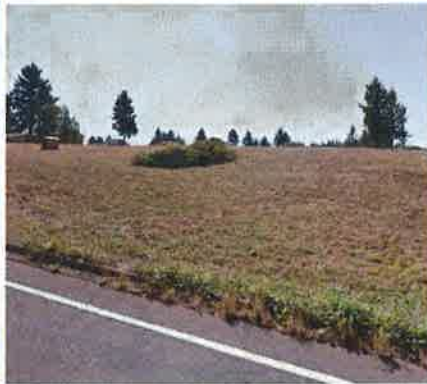
Smooth topography in NE part of site is typical of the entire site with exception of brush-covered piles of soil and woody debris left from clearing old orchard.

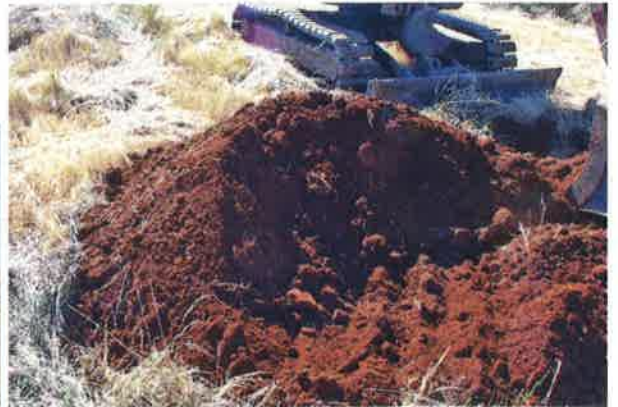
Four test pits were excavated on 11 July 2017 to assess site soils (Figure 7). TP-1, -2 and -4 found severely weathered Sentinel Bluffs basalt at 3 ft, 3.5 ft and 2.5 ft, respectively. TP-3 found small boulders of weathered Winter Water basalt at 1 ft. The boulders were in a

Decomposed Sentinel Bluff basalt spoils from test pit TP-1

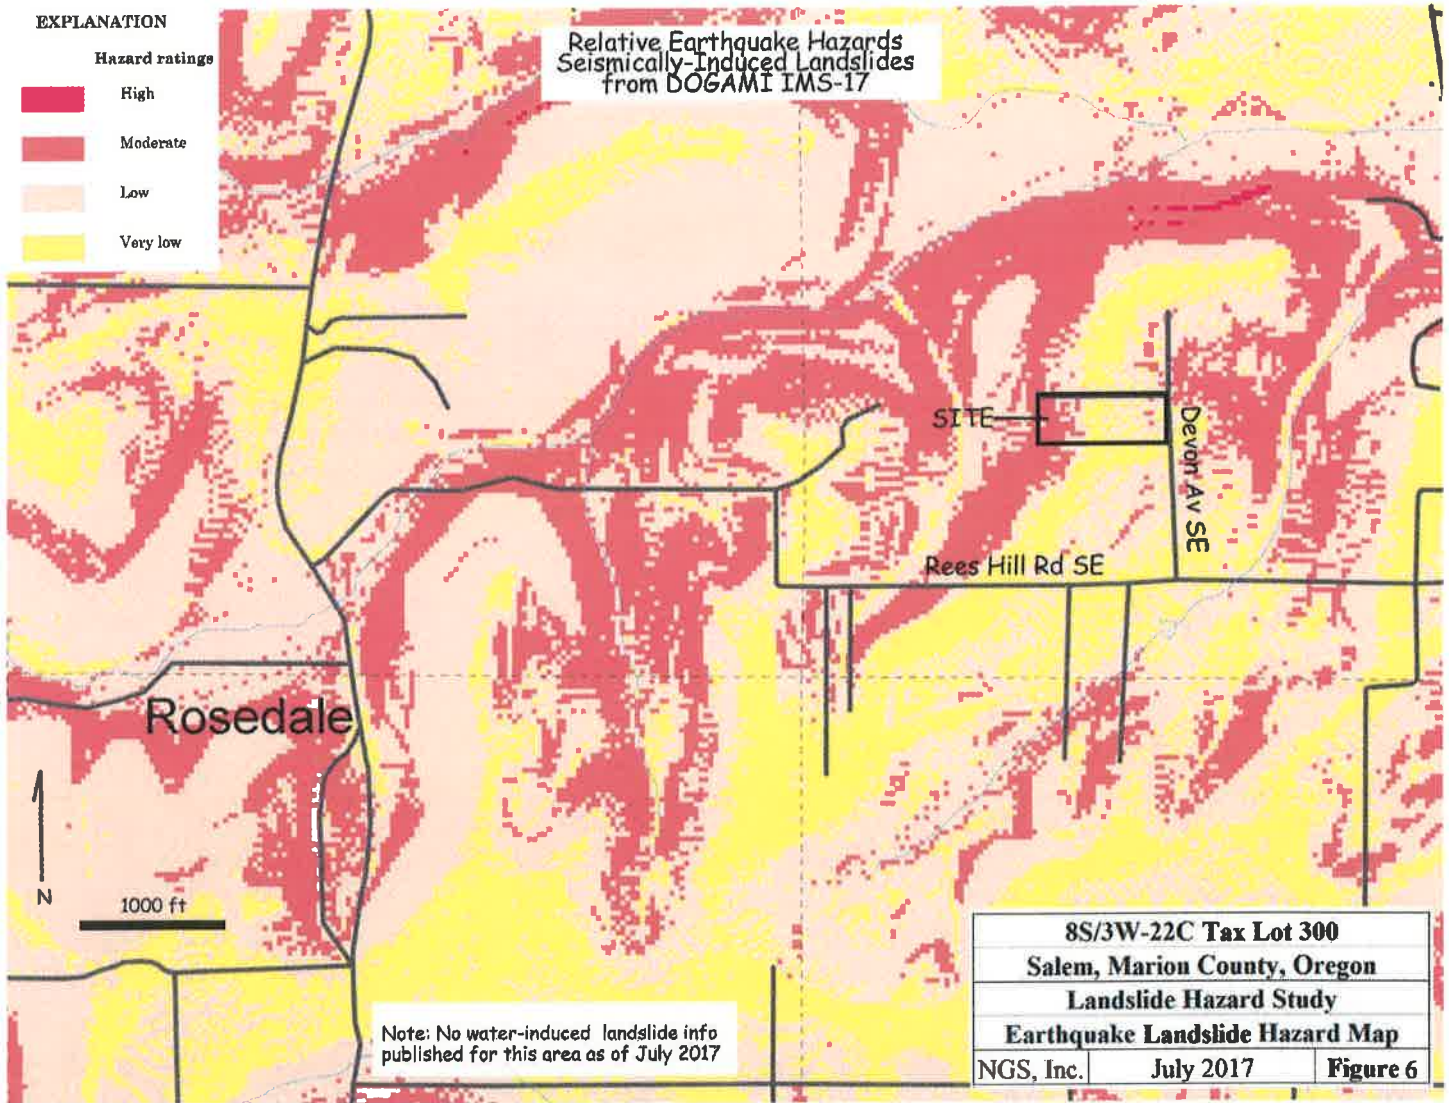
8S/3W-22C Tax Lot 300		
Salem, Marion County, Oregon		
Landslide Hazard Study		
Earthquake Landslide Hazard Map		
NGS, Inc.	July 2017	Figure 6

IMS-6 does not extend east to the site nor is the site in an active or inactive landslide area (e.g., as defined by OFR O-77-4). IMS-17 estimates the site ranges from very low to moderate relative risk of earth-induced landsliding (Figure 6). The latest State estimates are incorporated into SLIDO<sup>5</sup> that shows no nearby active, historic or prehistoric landslides. However, the SLIDO landslide susceptibility map shows no to moderate landslide hazard in agreement with IMS-17 estimates.

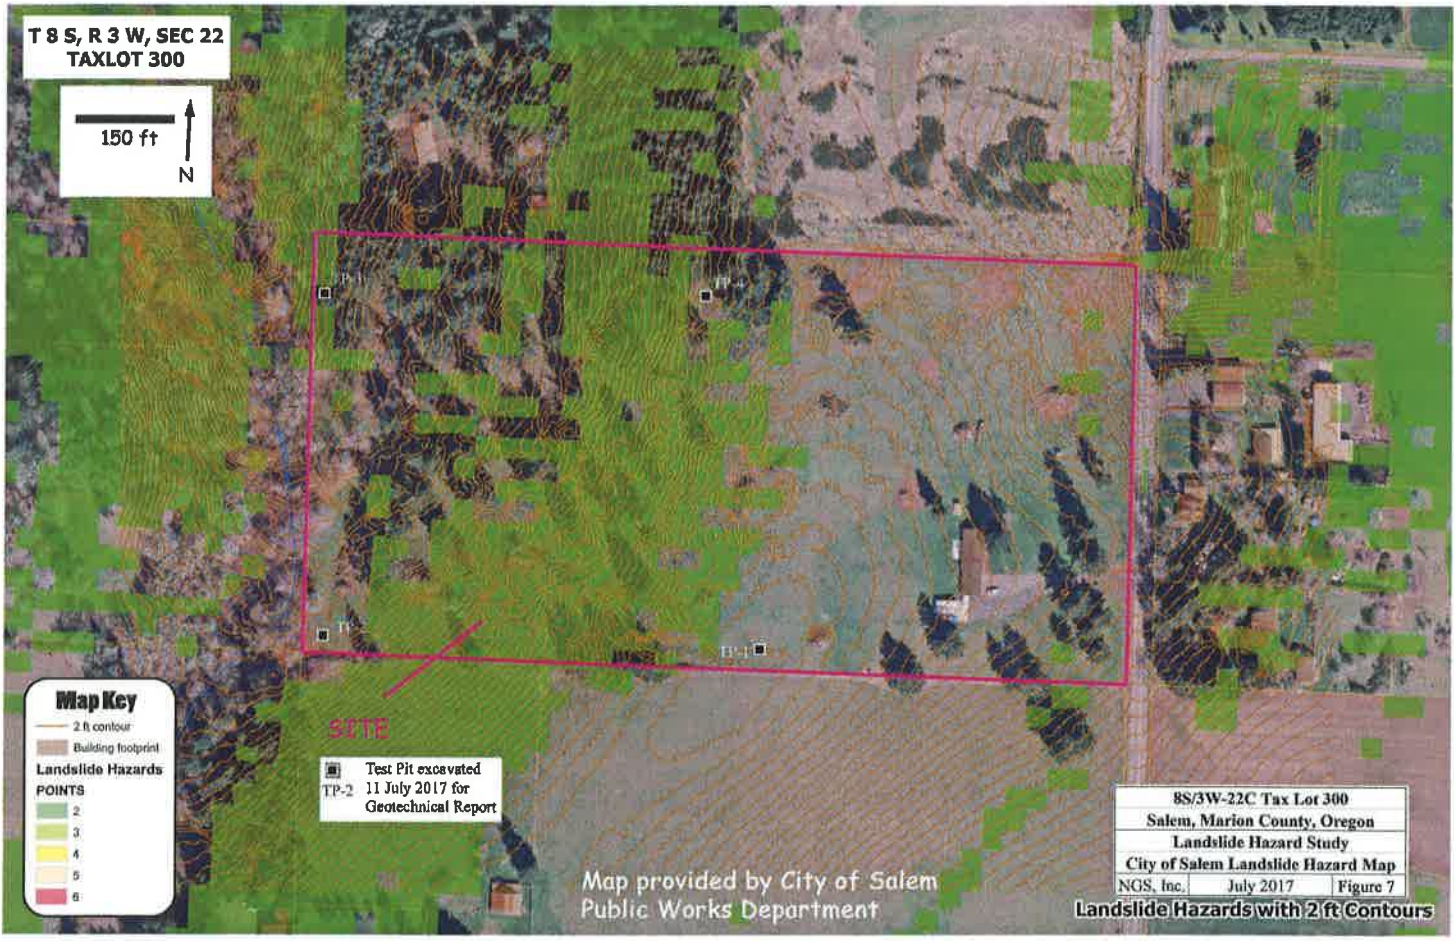
8S/3W-22C Tax Lot 300		
Salem, Marion County, Oregon		
Landslide Hazard Study		
City of Salem Landslide Hazard Map		
NOS, Inc.	July 2017	Figure 7

The City of Salem provides Landslide Hazard Maps based on slope (generally from LIDAR) and available risk assessments from various government sources (Figure 7). Salem's map assigns 2 to 3 landslide hazard points (low to moderate) to the site.
