February 9, 2021

State Street Homes
Salem, Oregon 97306

RE: State Street Homes Arborist Report

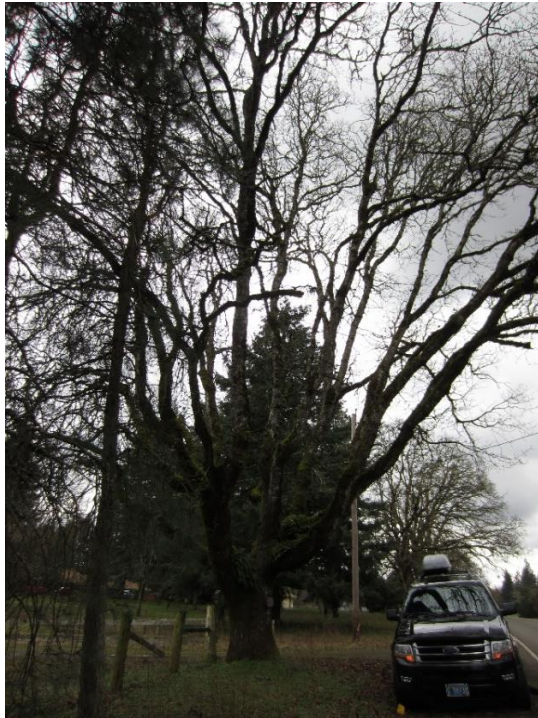
Tree #1 is found adjacent to Battle Creek Rd. SE and the existing paved driveway leading to the single home on the property. The DBH of this tree is 42 inches, with a canopy diameter of 70 feet. Nails have been used to attach an address plaque to the trunk, however no sap drip is evident. Limbs extend over the full width of the driveway and road. Although this is a low branching specimen (major limbs emerge approximately 6 feet from the ground), the limbs ascend sufficiently to allow unimpeded vehicular movement on both Battle Creek Rd. SE and the private driveway. The low and wide branching created a crotch that has collected debris and should be monitored for signs of decay. Moss and Licorice Ferns are abundant on the trunk and limbs, but these pose no concerns for tree health. This tree exhibits a significant number of insect induced galls. In general, this should not harm the tree, however a very heavy occurrence may lead to early leaf drop. A small amount of mistletoe is present (4-5 clusters), but is likely to spread over time as evidenced by other surrounding oaks with heavy infestation. Although mistletoe is a parasitic plant, in smaller quantities the tree should not be in danger. The presence of mistletoe should be monitored over time. If it begins to appear in large quantities, the tree may have health risks and decline in times of stress (drought, disease, damage). Pruning diseased limbs is one way to control mistletoe, however the form and balance of the tree may be compromised. Some watersprouts are present on larger limbs, but not in abundance. There is a small amount of deadwood present which shows signs of decay and bird/insect activity, however this is not uncommon for a tree of this size/age. The tree is somewhat crowded on the north-northwest side by 3 closely planted conifers,

which has somewhat limited limb extension in that direction, but nothing drastic. The smaller limbs on the crowded side intermingle and surround the conifers to some extent. This tree is in good condition.

Tree #1 – location, form

In the case of tree #1, somewhere in the ballpark of 60% of the CRZ will be affected by construction. Impact will predominantly be with fill, however it will come within a few feet of the trunk. In addition, there will be significant compaction throughout the affected zone for construction of roads and sidewalks. Although some efforts could be made to lessen the impact of the fill and compaction of the CRZ, they would come at great expense and would not necessarily assure tree survival.

Unless there are significant changes to the design of the roadways and utilities, or the use of unique construction methods around the CRZ of these trees, it is recommended that both native oak trees be removed.

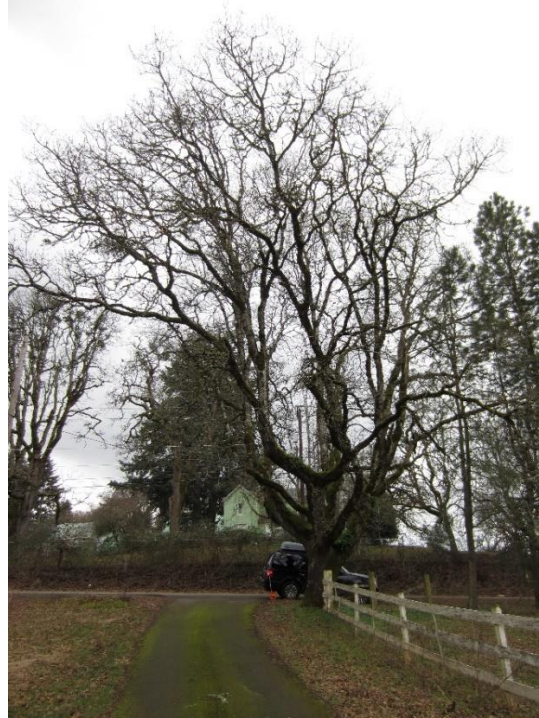
Tree #1 – location, form, powerlines, crowding

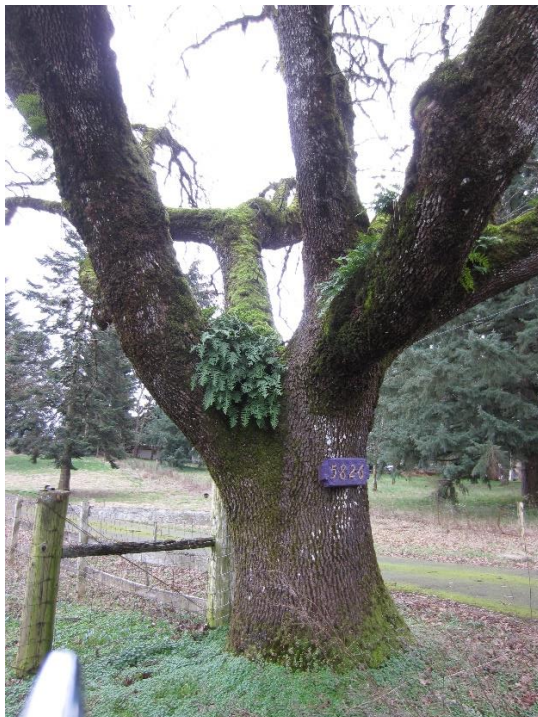
Tree #1 – location, plaque, branching, crotch, epiphytes

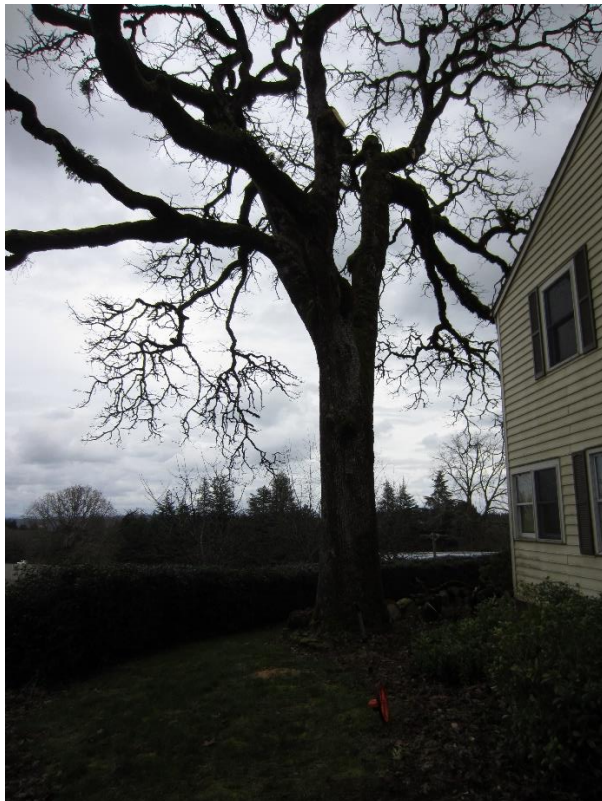
Tree #2 is located on the north side of the existing house in a plant bed, adjacent to large, open fields, lawn and very little paving, however it is within 10 feet of the structure. No surface roots are visible. The DBH of this tree is 43 inches, with a canopy diameter of 77 feet. This is a more upright and high branching specimen, with a high, wide reaching canopy. At least 3 major limb removals have been performed recently on the south side which appear to have been extending over the house. This has altered the form of the tree, making it rather 3-sided in its current state, but offers increase safety and protection of the structure. Moss and Licorice Ferns are present on the trunk and limbs, but these pose no concerns for tree health. This tree exhibits a smaller amount of insect induced galls than tree #1. A large amount of mistletoe is present, thus the tree should be monitored for health risks and decline in times of stress (drought, disease, damage). In this case, the pruning of diseased limbs to control spread is not recommended, as it would decimate the tree's form and structure. Minor fungal decay is present on deadwood/old cuts/old breaks within the canopy. Wood from the removed limbs was stacked nearby which exhibited fungal conks, however it is unknown if these surfaced before or after removal. The edge of the canopy on the west side is intermingling with branches from the adjacent Cedar, however they don't appear to be interfering with one another. Minor bark abrasions are present low on the trunk, but none have fully pierced the bark and caused injury to the living tissues below. This tree is in fair condition, primarily due to the high presence of mistletoe and the balance/form created by limb removal.

Tree #2 – location, form, pruning cuts, proximity

Tree #2 has a large percentage of the CRZ which will be affected by construction: over 50%. However, the disturbance in this instance would be 3 feet of cut on the south side which comes very near to the trunk. This would remove a significant amount of structural and feeder roots which could compromise tree stability and survival. The remaining roots on the north side would be subject to compaction on the new home building lot.

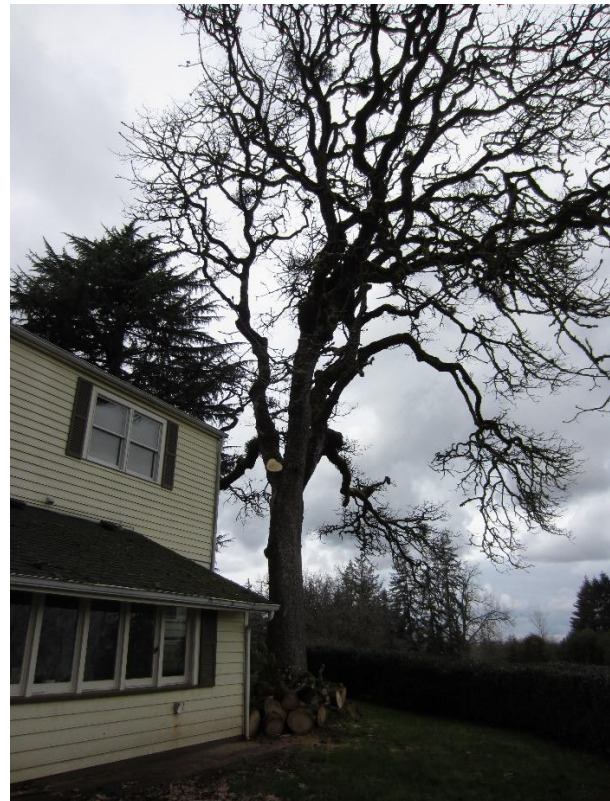
Tree #2 – location, form, pruning cuts, proximity

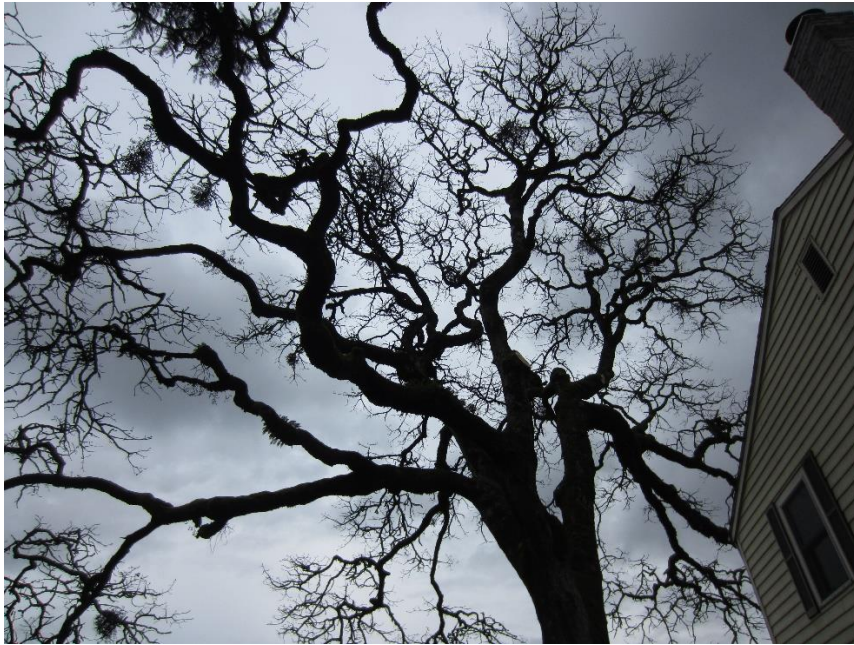
Tree #2 – mistletoe, form
