April 13, 2021

**Subject: Geotechnical Evaluation & Landslide Hazard Study  
Meyer Farm Subdivision  
GCN Project 1556-01**

The approximate 30-acre Meyer Farm site located in the hill area south of the Salem Airport is to be developed with single family homes. The site relative to surrounding features is shown in Figure 1.

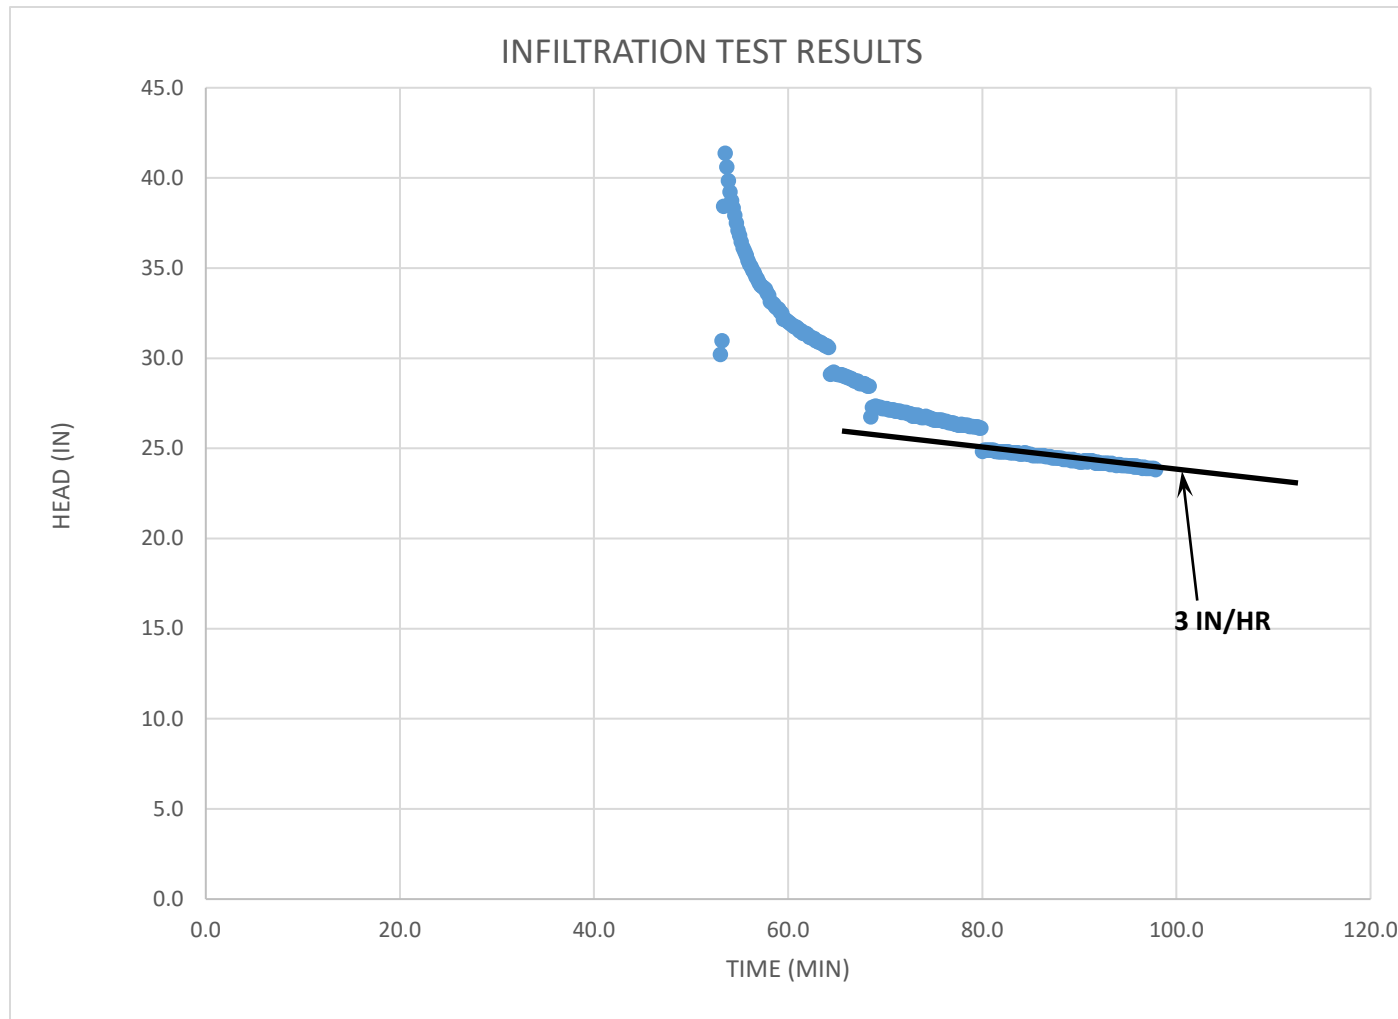
<b>GEO</b> CONSULTANTS NORTHWEST	PROJECT 1556-01	KEHOE MEYER FARM	
	APR 2021	INFILTRATION RATE HA-1	FIGURE 3
	2839 SE Milwaukie Avenue Portland, OR 97202 Drawn By: tac

We conducted a falling head infiltration test in boring HA-1 and HA-2 at the approximate location shown in Figure 2. Infiltration varies with head pressure. Selected infiltration rates at three head levels are provided in Table 3 below. The complete tests are plotted on Figures 3 and 4.

TEST NUMBER	SOIL CONDITION	HEAD (INCHES)	INFILTRATION RATE IN/HR
HA-1	SILTY GRAVEL	40	204
		30	31
		24	3
HA-2	SILTY GRAVEL	10	76
		8	18
		6	12

We do not recommend infiltrating storm water to the subsurface in the planned stormwater facilities which are adjacent to existing downslope homes. The potential to flood the existing properties is high.

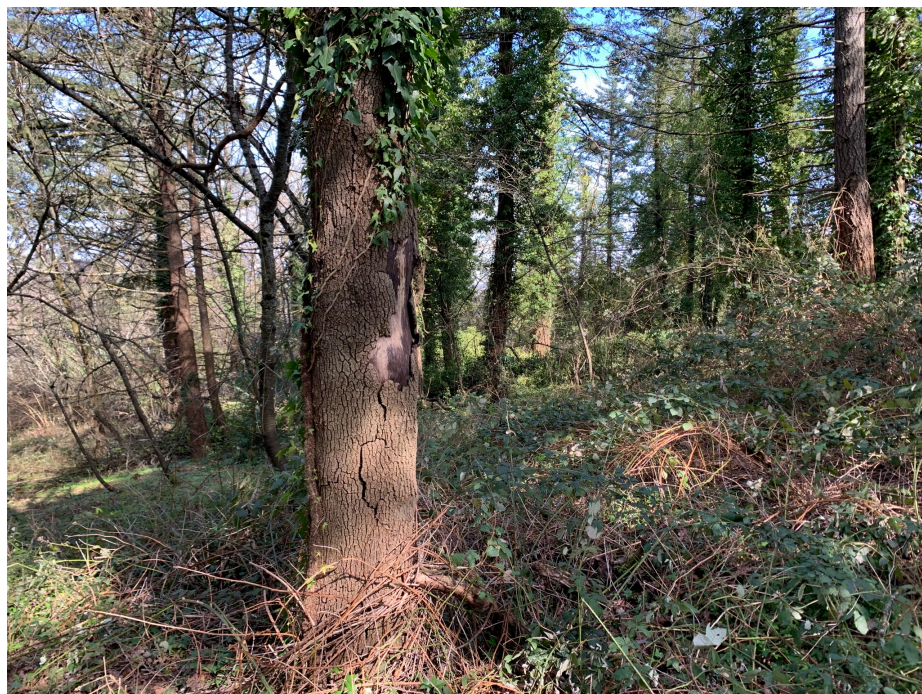
DESCRIPTION:  
Photo 1: Northwest slope  
looking east.

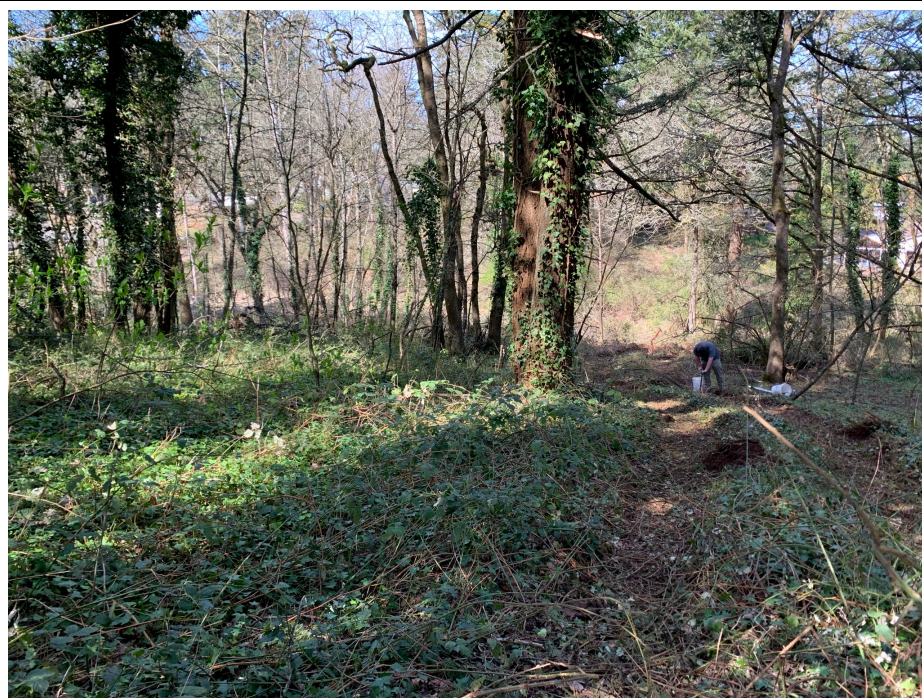
DESCRIPTION:  
Photo 2: Northwest slope  
looking down slope to the  
north-northwest.

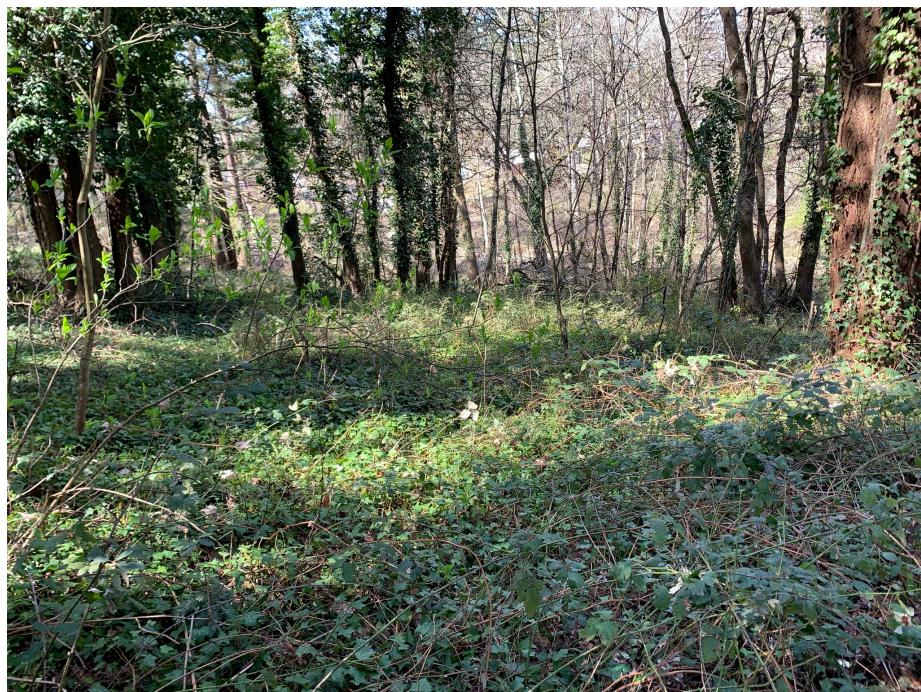
DESCRIPTION:  
Photo 3: Northwest  
slope, looking northwest.

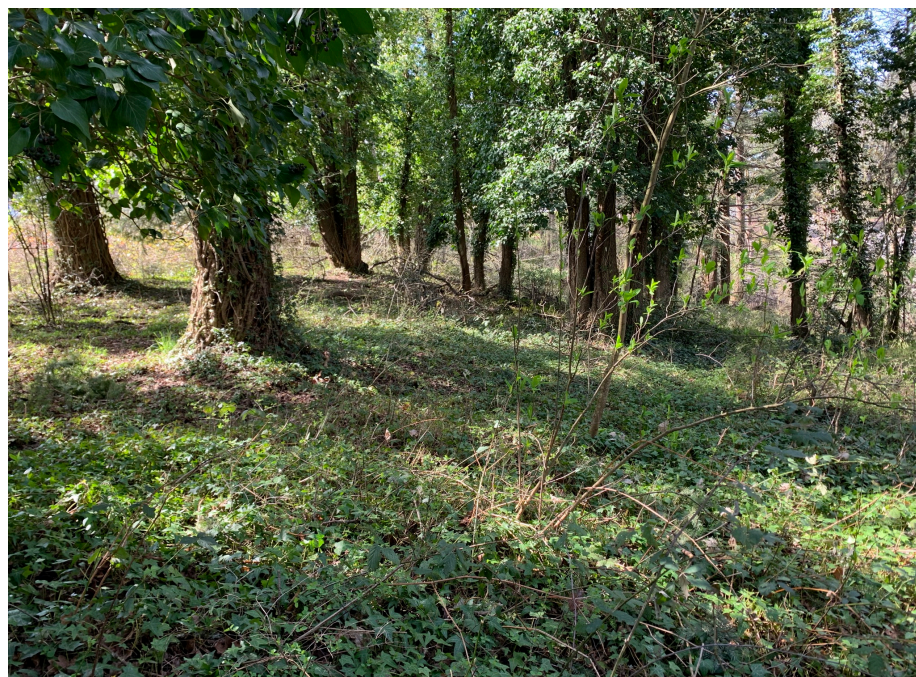
DESCRIPTION:  
Photo 4: Northwest  
slope, looking west.

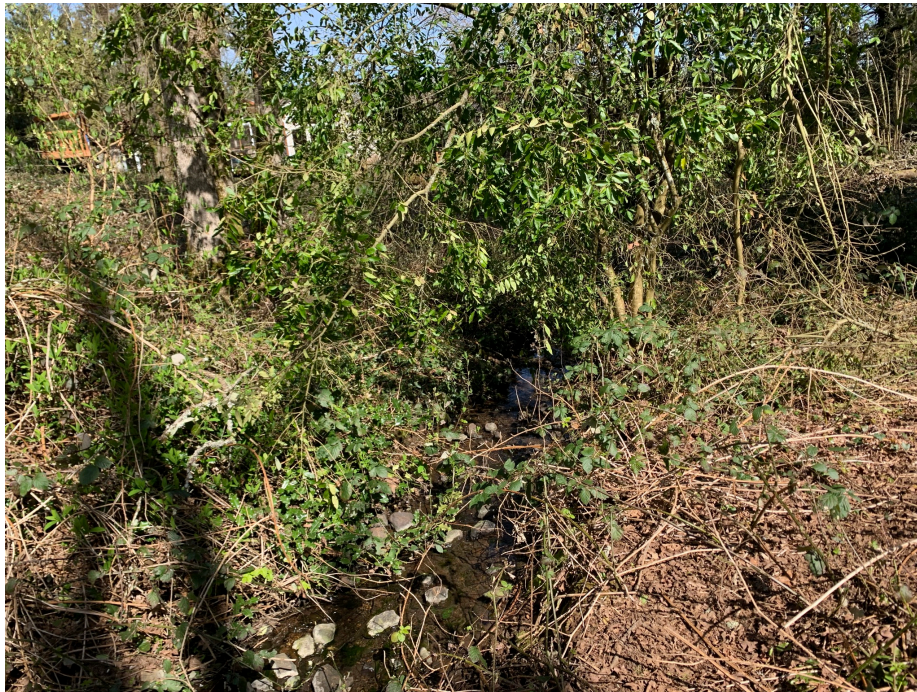
DESCRIPTION:  
Photo 5: Northwest  
slope, looking down  
stream in channel.

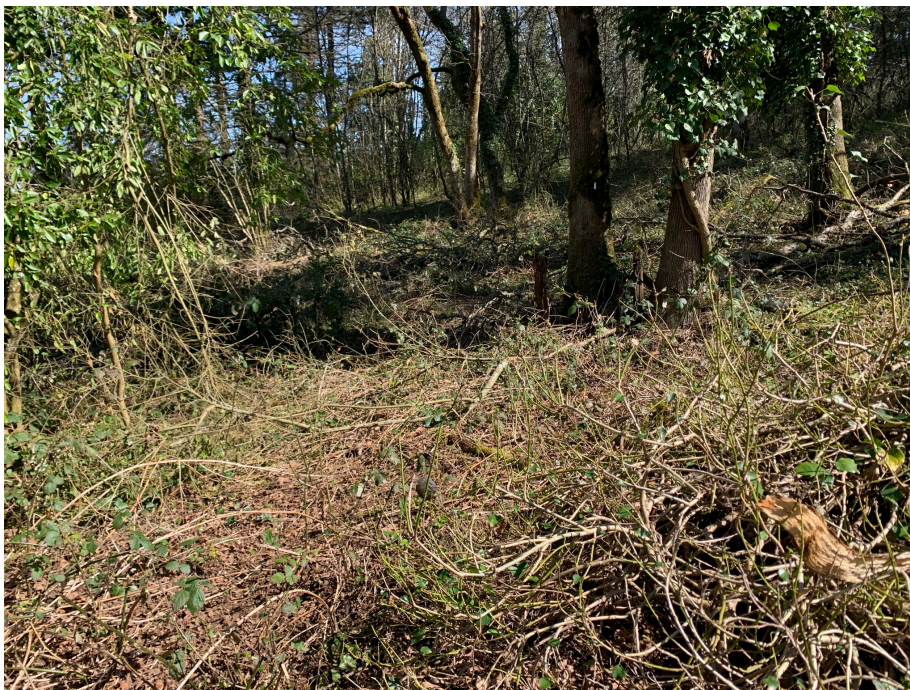
DESCRIPTION:  
Photo 6: Northwest  
slope, east portion  
looking east.

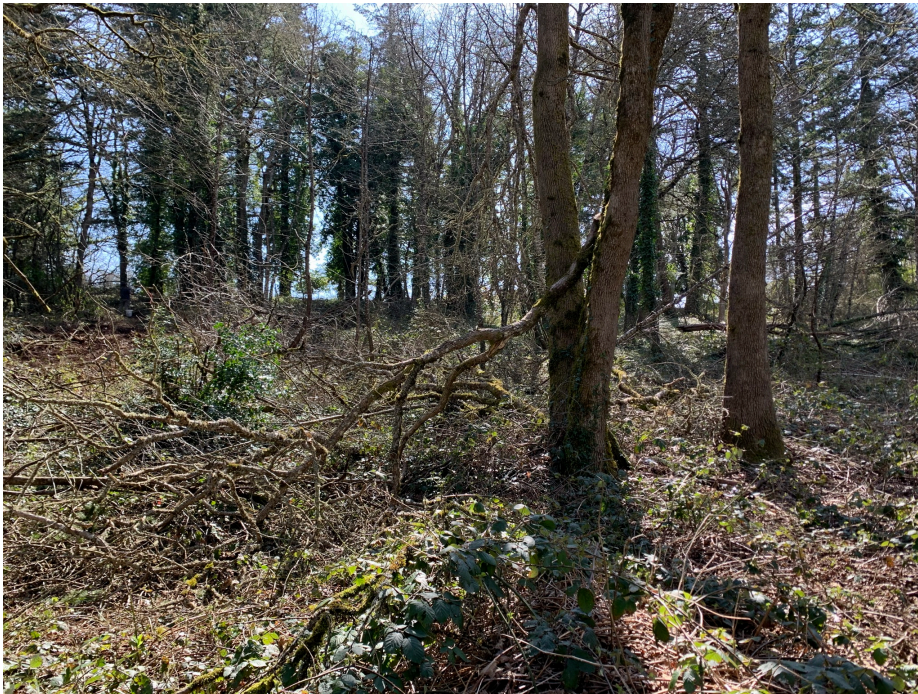
DESCRIPTION:  
Photo 7: Northwest  
slope, east portion,  
looking south upslope.

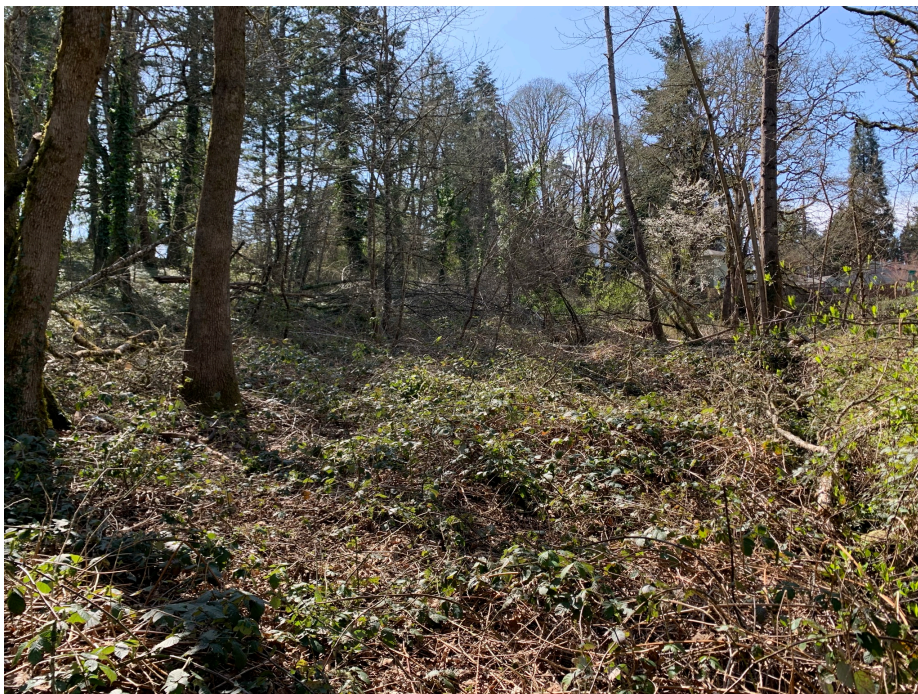
DESCRIPTION:  
Photo 8: Northwest  
slope, east portion,  
looking west.
