# MEMORANDUM

**RE:** Oak Tree Protection and Removal Recommendations for Meyer Farm

This report includes tree protection and removal recommendations for 33 Oregon white oaks over 24-inch DBH at the proposed Meyer Farm Subdivision in Salem.

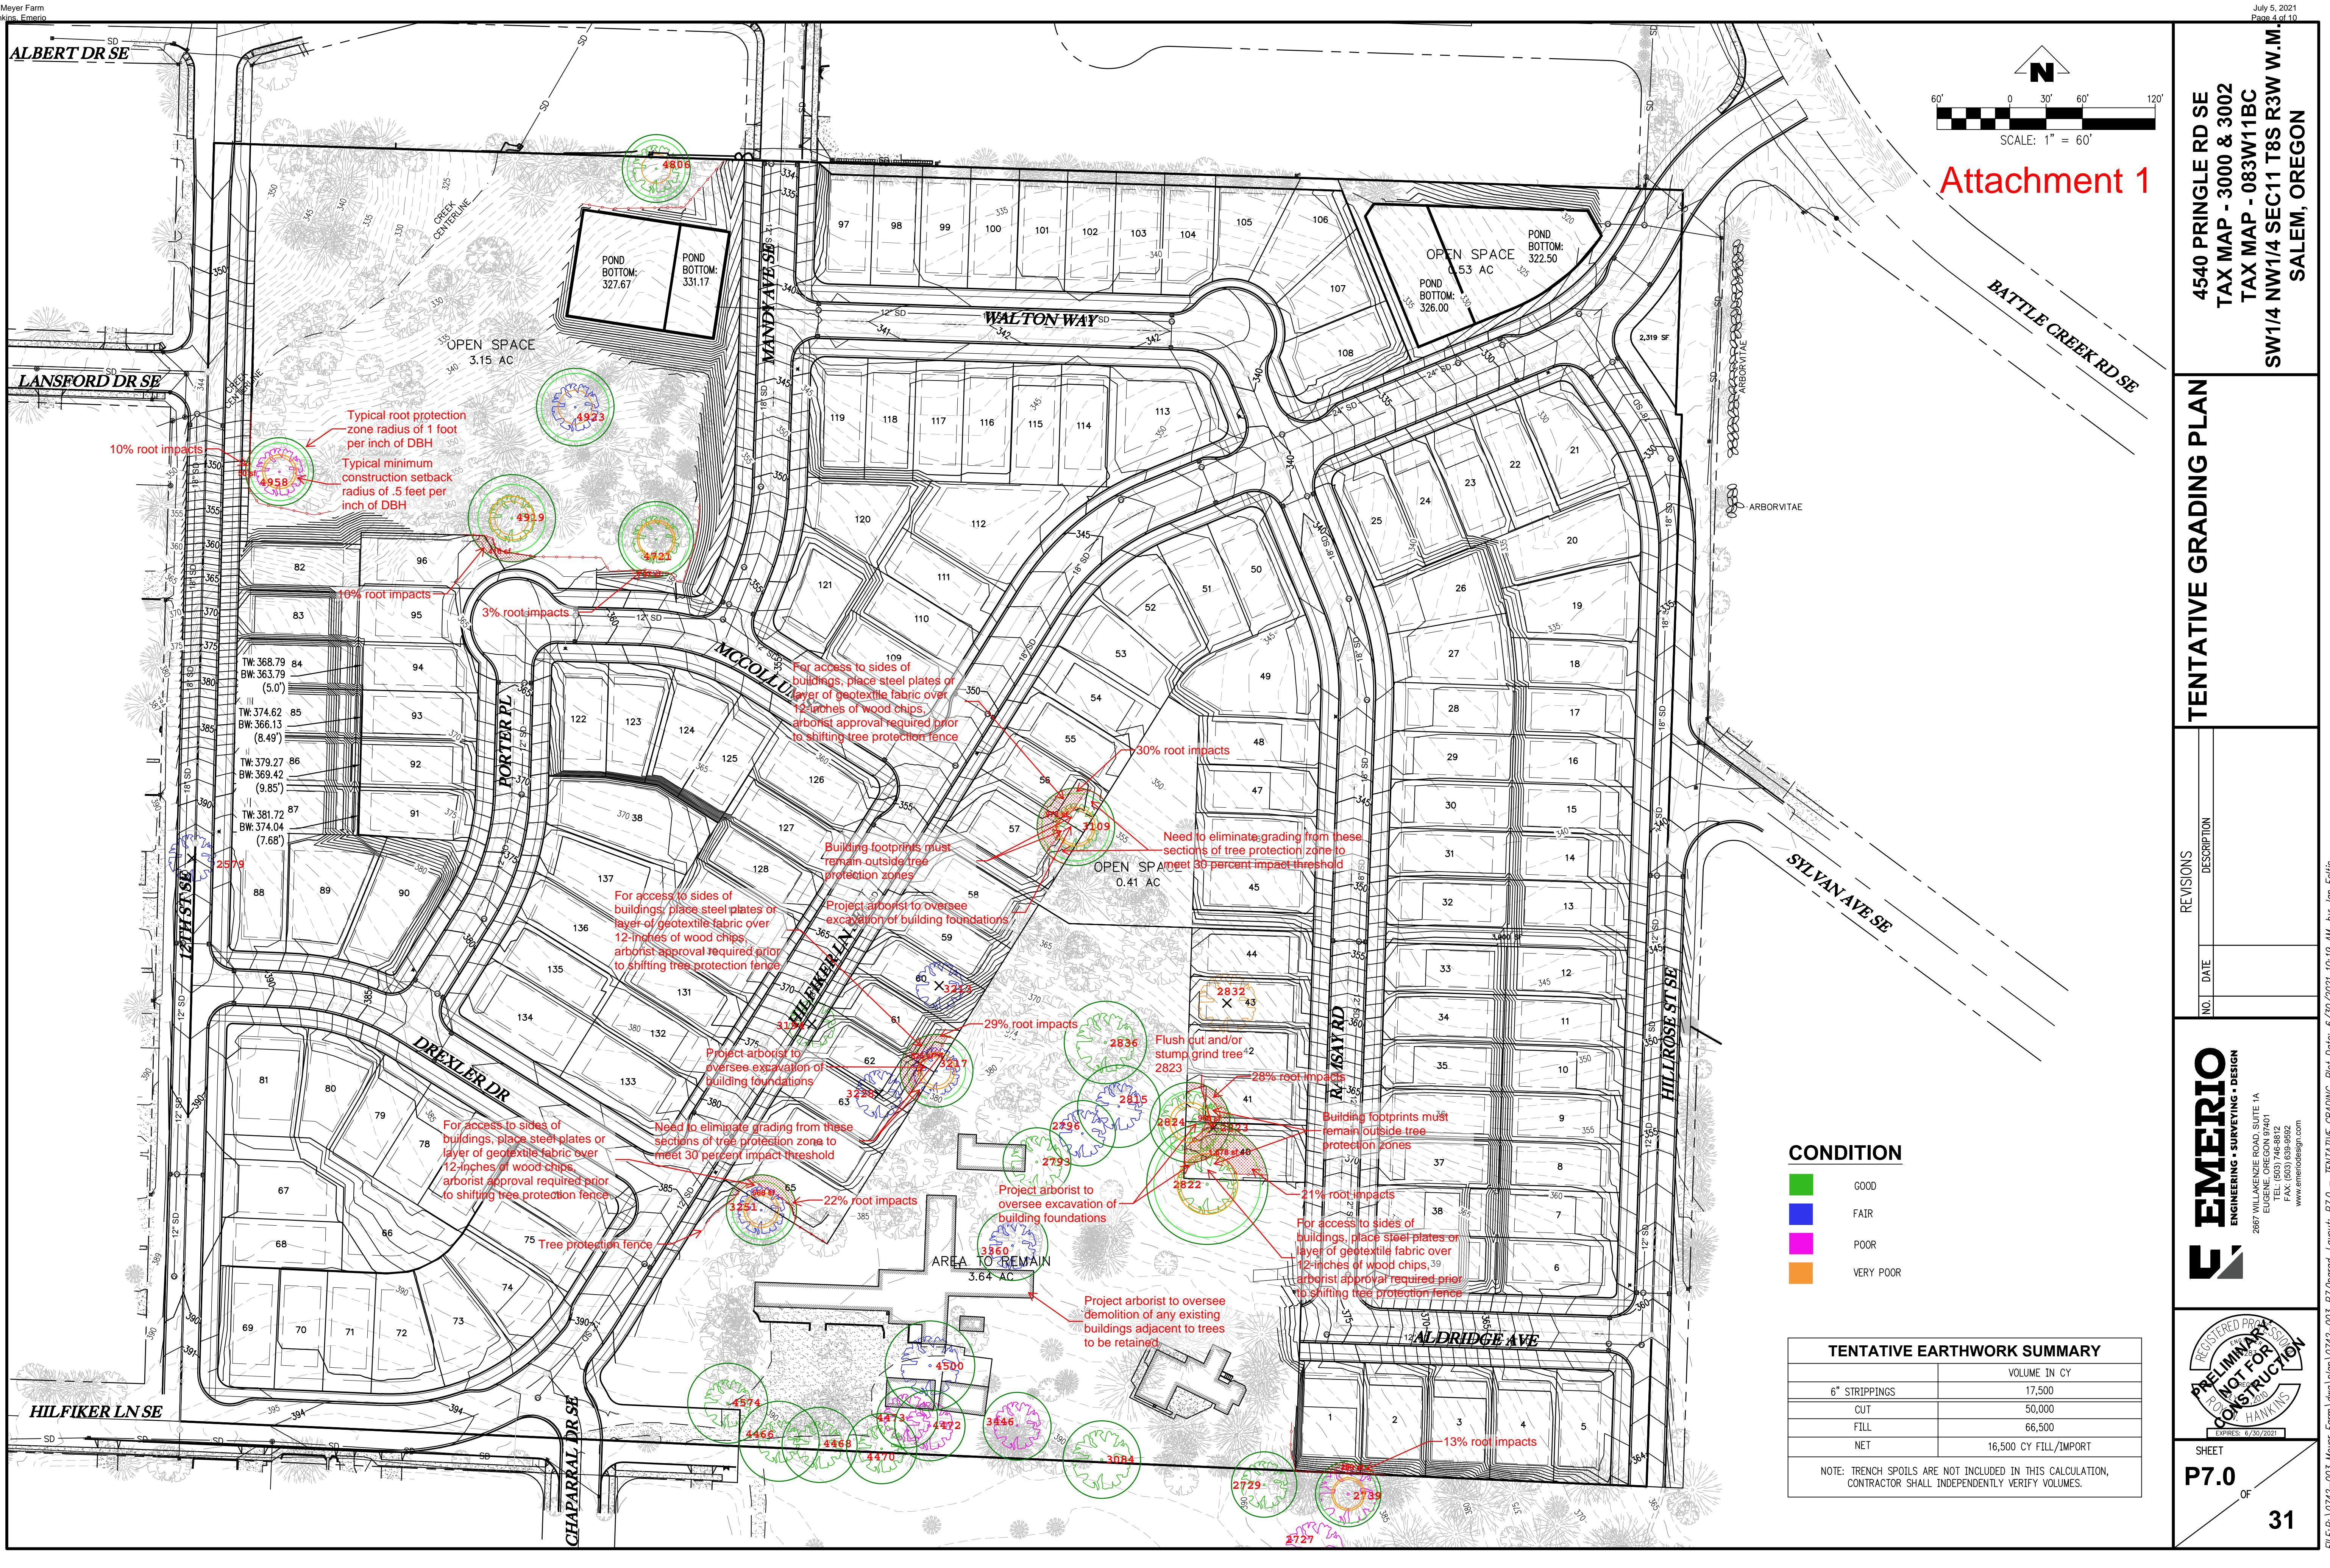
Enclosures: Attachment 1 – Grading Plan with Tree Removal and Protection Attachment 2 – Tree Inventory Attachment 3 – Tree Protection Recommendations Attachment 4 – Assumptions and Limiting Conditions

On May 24, 2021, I inventoried and assessed 33 Oregon white oaks over 24-inch DBH. The assessed trees are number in red on the proposed grading plan in Attachment 1. A spreadsheet with the tree assessment data is provided in Attachment 2. The inventory spreadsheet lists the tree number, species (common and scientific names), DBH, crown radius, tree health condition, tree structural condition, pertinent comments, and treatment (remove or retain). The tree numbers in the inventory in Attachment 2 correspond to the tree numbers on the proposed subdivision grading plan in Attachment 1.

After reviewing the proposed construction and grading plan in Attachment 1, five of the assessed Oregon white oaks (trees 2479, 2823, 2832, 3213, and 3228) will be removed. The remaining 28 assessed Oregon white oaks will be retained.

- *Tree Protection Fencing*: Place tree protection fencing in the locations shown in Attachment 1. The tree protection fencing has been carefully located to ensure no more than 30 percent of the assessed trees' root systems are impacted. It may be necessary to have surveyors locate the tree protection fencing with stakes, flagging, or other markings on site to ensure it is accurately placed. Any work within the tree protection zones shall occur under the onsite supervision of the project arborist.

- *Stump Removal*: The stump of tree 2823 shall be flush cut and retained or carefully stump ground to avoid disturbing the root system of tree 2824.
- **Building Demolition**: If any of the existing buildings in the southern area of the site will be demolished, it shall occur under the onsite supervision of the project arborist. Heavy equipment shall be positioned on the existing driveway or gravel areas, or on steel plates if demolition access is needed on non-paved or graveled areas.

- *Modify Grading*: The proposed grading within the root system of trees 3109 and 3217 needs to be modified so it is outside the tree protection zones and not more than 30 percent of their root systems are impacted by grading.

- **Building Footprint Locations**: The building footprints on lots 40, 41, 56, and 57 will need to be designed so they are outside the tree protection zones of the adjacent trees.

- *Excavation Oversight*: The project arborist shall be onsite to oversee the excavation of the building foundations and proper pruning and protection of roots over 2-inches in diameter adjacent to trees 2822, 2824, 3109, and 3217.
