PRELIMINARY
TREE CONSERVATION
PLAN - ONSITE: WEST

DEVON ESTATES

RE: *TREE CONSERVATION PLAN ADJUSTMENT FOR TCP21-02*

Site/Address: 6719 Devon Ave SE
 Map/Location: Salem, OR 97306
 Owner: public ☐ private ☒ unknown ☐ other ☐
 Date: 8-23-2021 Inspector: Austin Cohn SO-10036A
 Date of last inspection: _____

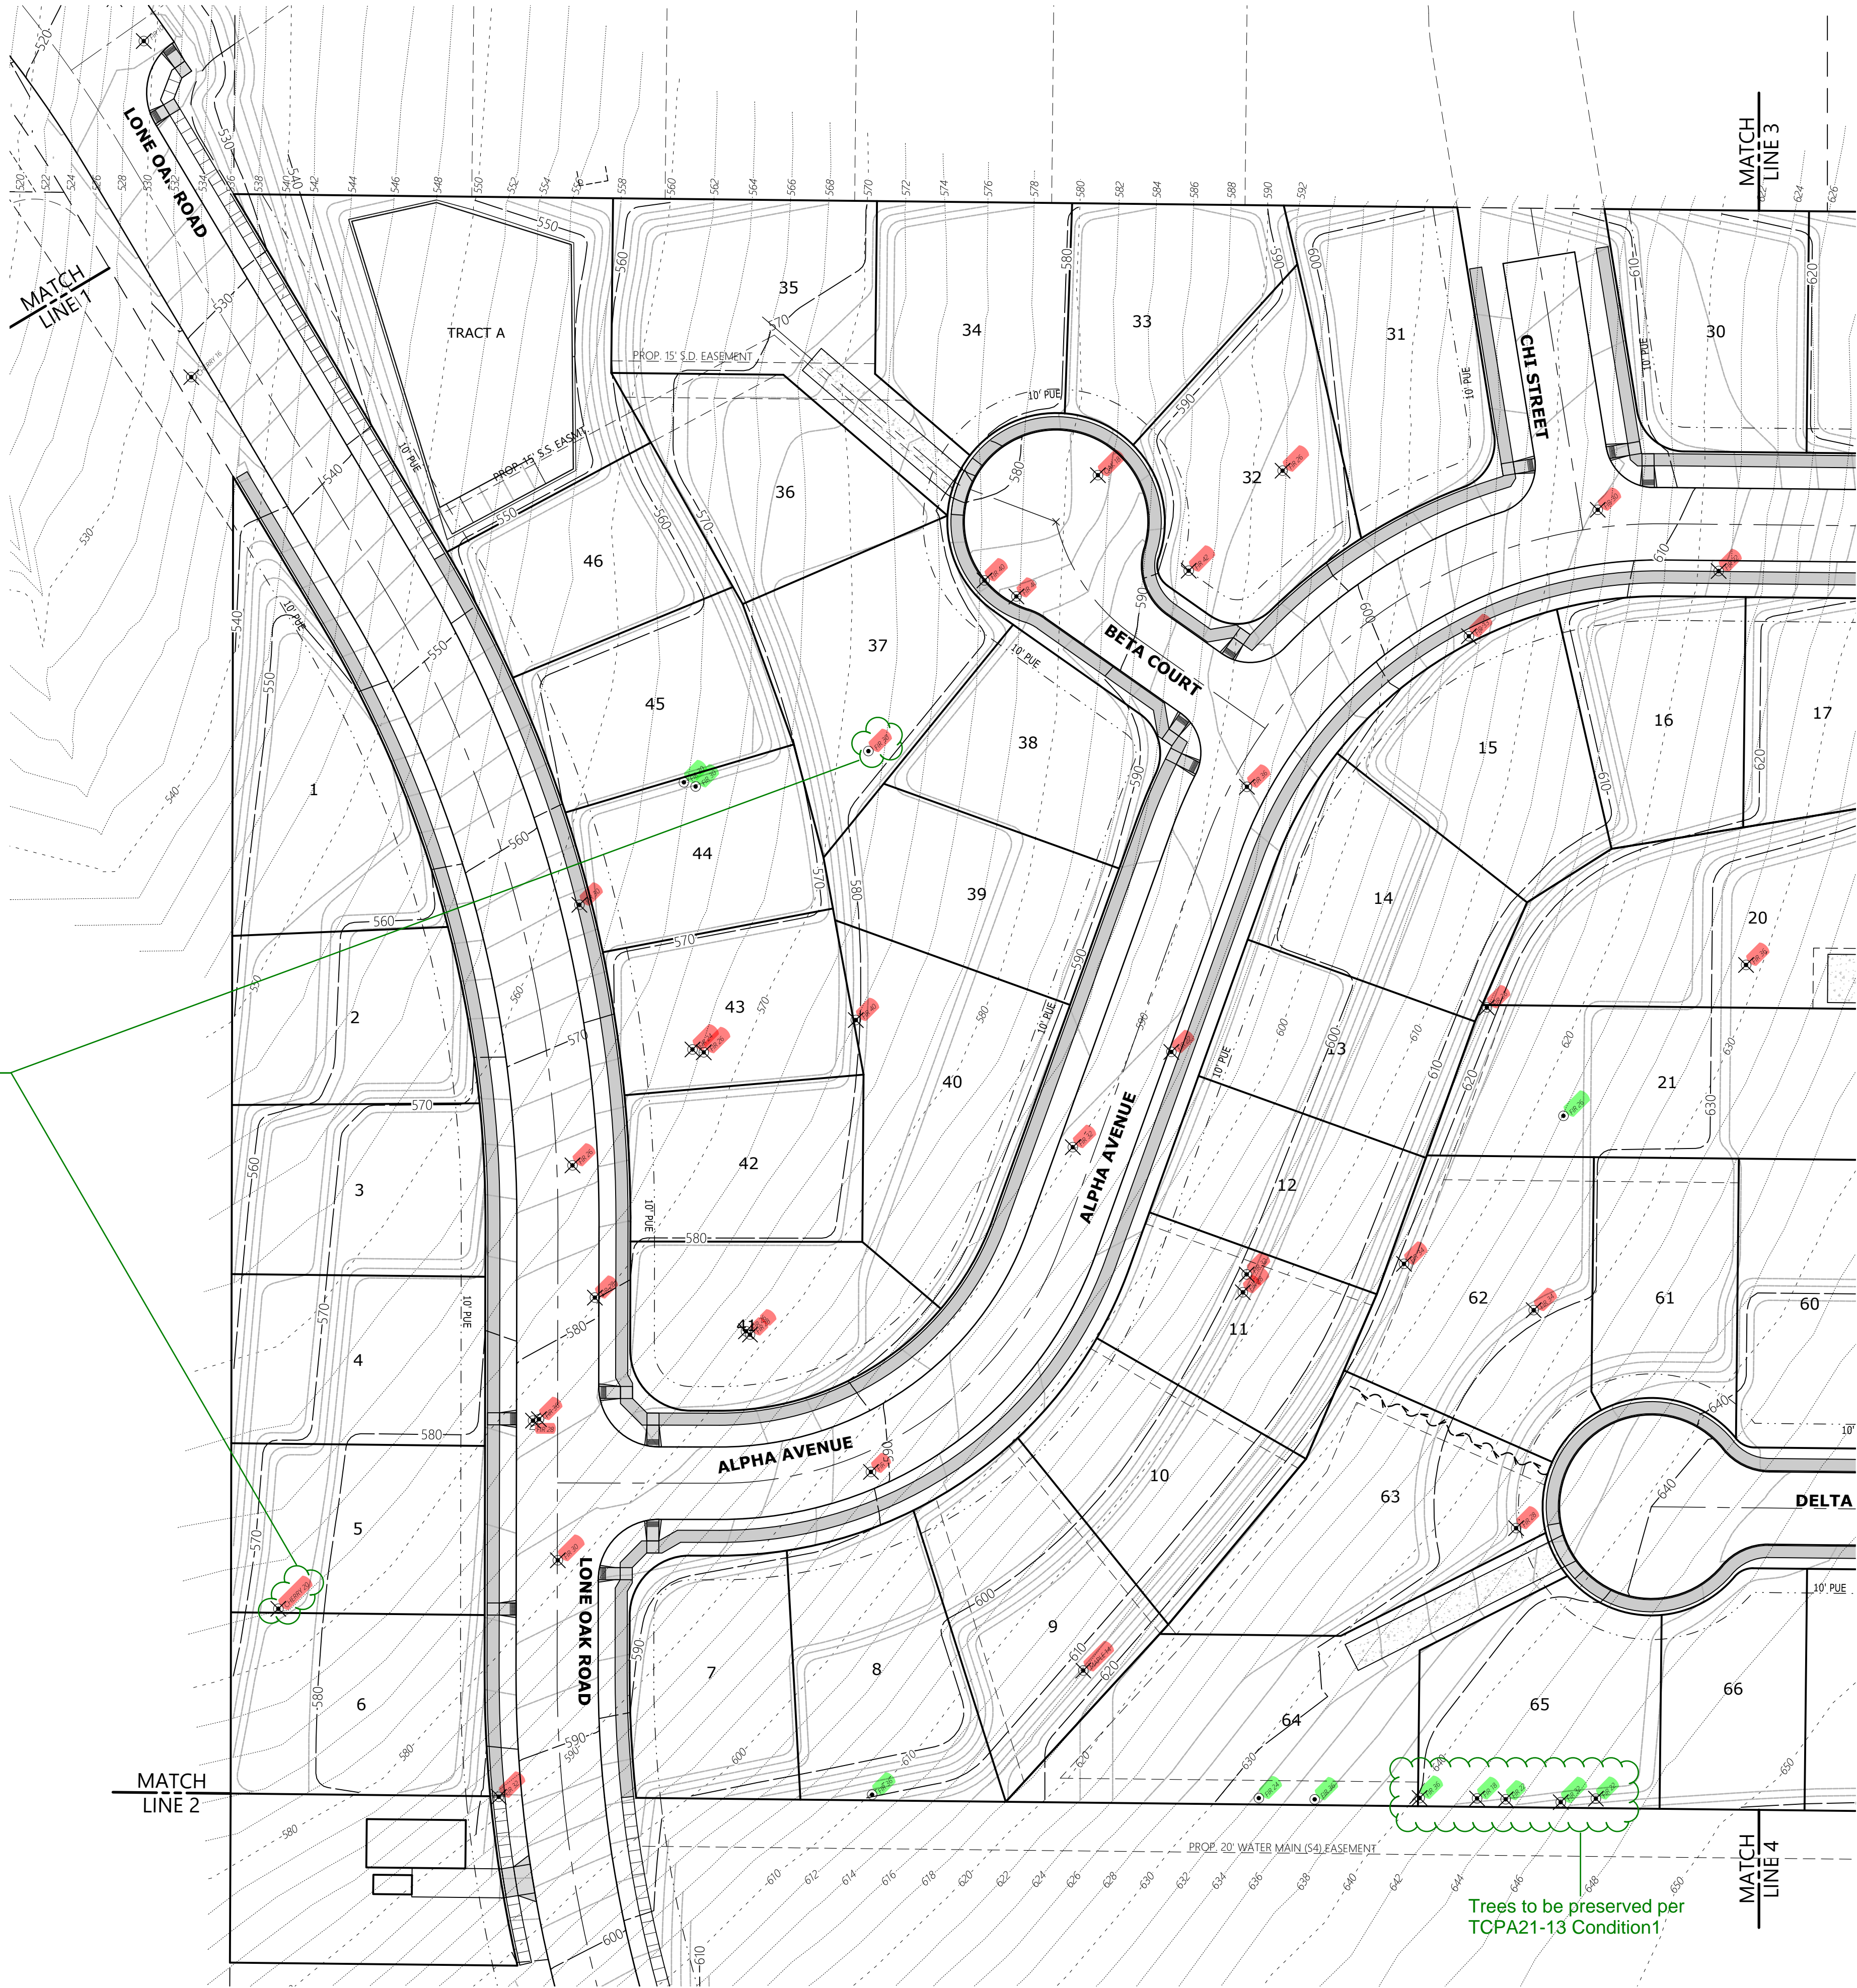
P103

Removal approved
under TCPA21-13

66 Total Trees within Boundary
17 Trees to be Preserved
49 Trees to be Removed
25.8% persevered

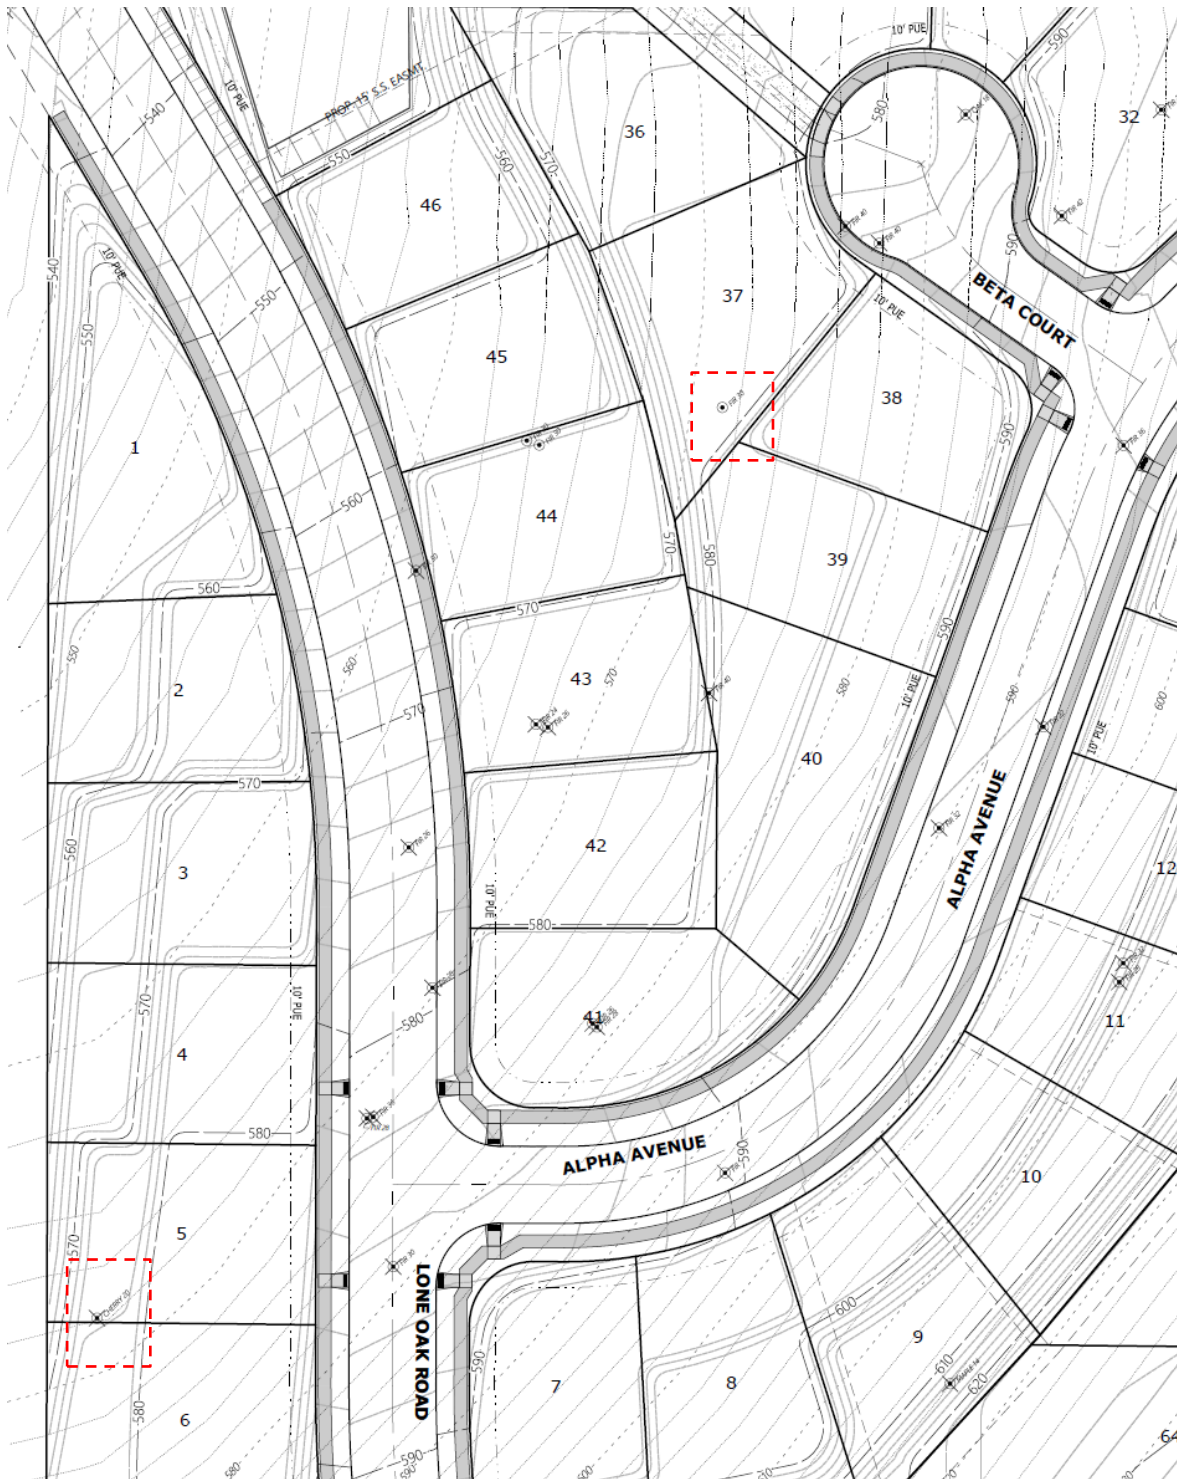
ENCLOSED IS A TREE CONSERVATION PLAN ADJUSTMENT FOR THE DEVON SUBDIVISION (SUB21-01). AFTER BEING OUT ON THE SITE, IT WAS DETERMINED THAT THE CHERRY TREE LOCATED ON LOT 5 NEEDS TO BE REMOVED. DUE TO GRADING ON THE SITE, THE FIR TREE ON LOT 37 NEEDS TO BE REMOVED AS WELL.

AFTER STARTING WORK AND GRADING ON THE SITE, IT WAS DETERMINED THAT THE CHERRY TREE ON LOT 5 AND THE FIR TREE ON LOT 37 BOTH NEED TO BE REMOVED.

AN ARBORIST REPORT DATED AUGUST 23, 2021, INDICATES THAT THE CHERRY TREE ON LOT 5 IS COVERED IN IVY WHICH IS CAUSING THE TREE TO DIE. THE TREE HAS A HIGH FAILURE RATE AND IT IS RECOMMENDED TO BE REMOVED (SEE ATTACHED ARBORIST REPORT).

SINCE THE TREE IS IN POOR HEALTH AND DYING, THERE ARE NO ALTERNATIVE DESIGNS THAT WOULD SAVE THE TREE. THE ARBORISTS RECOMMENDATION WARRANTS REMOVAL OF THE CHERRY TREE ON LOT 5 OF SUB21-01.
