June 21, 2022

Tree Protection for Vietnam War Memorial

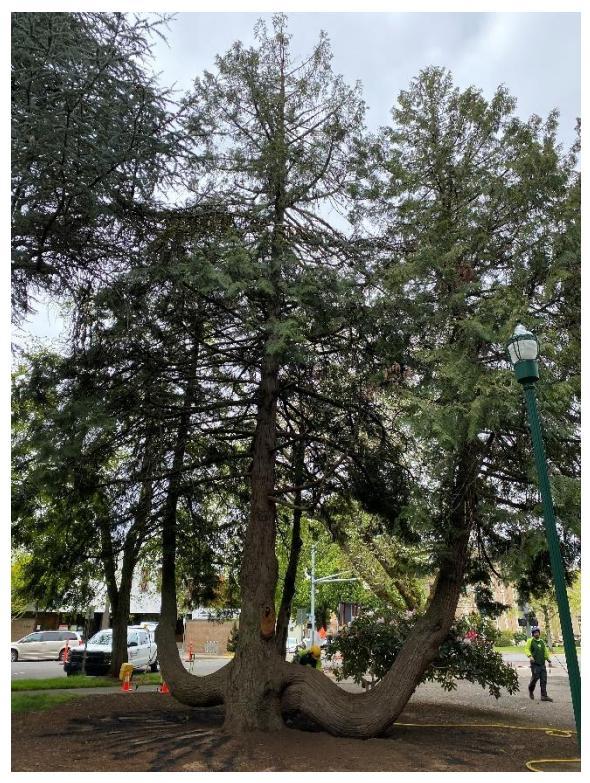
The three trees include the Embracing Tree, a western redcedar (*Thuja plicata*), which is planned to be the figurative foundation of the proposed memorial, largely due to its unique branch architecture (Photo 1). In addition, the Liberty Tree, an Atlas cedar (*Cedrus atlantica*) and a Douglas fir (*Pseudotsuga menziesii*) located slightly north of the two named trees, are located inside the construction envelope (See Page 4, Site Plan).

The Embracing Tree was assessed and the root system was surveyed in April 2022 in conjunction with a Root Invigoration[™] performed by Bartlett

Photo 1. The Embracing Tree during Root Invigoration procedure. (04.29.2022)

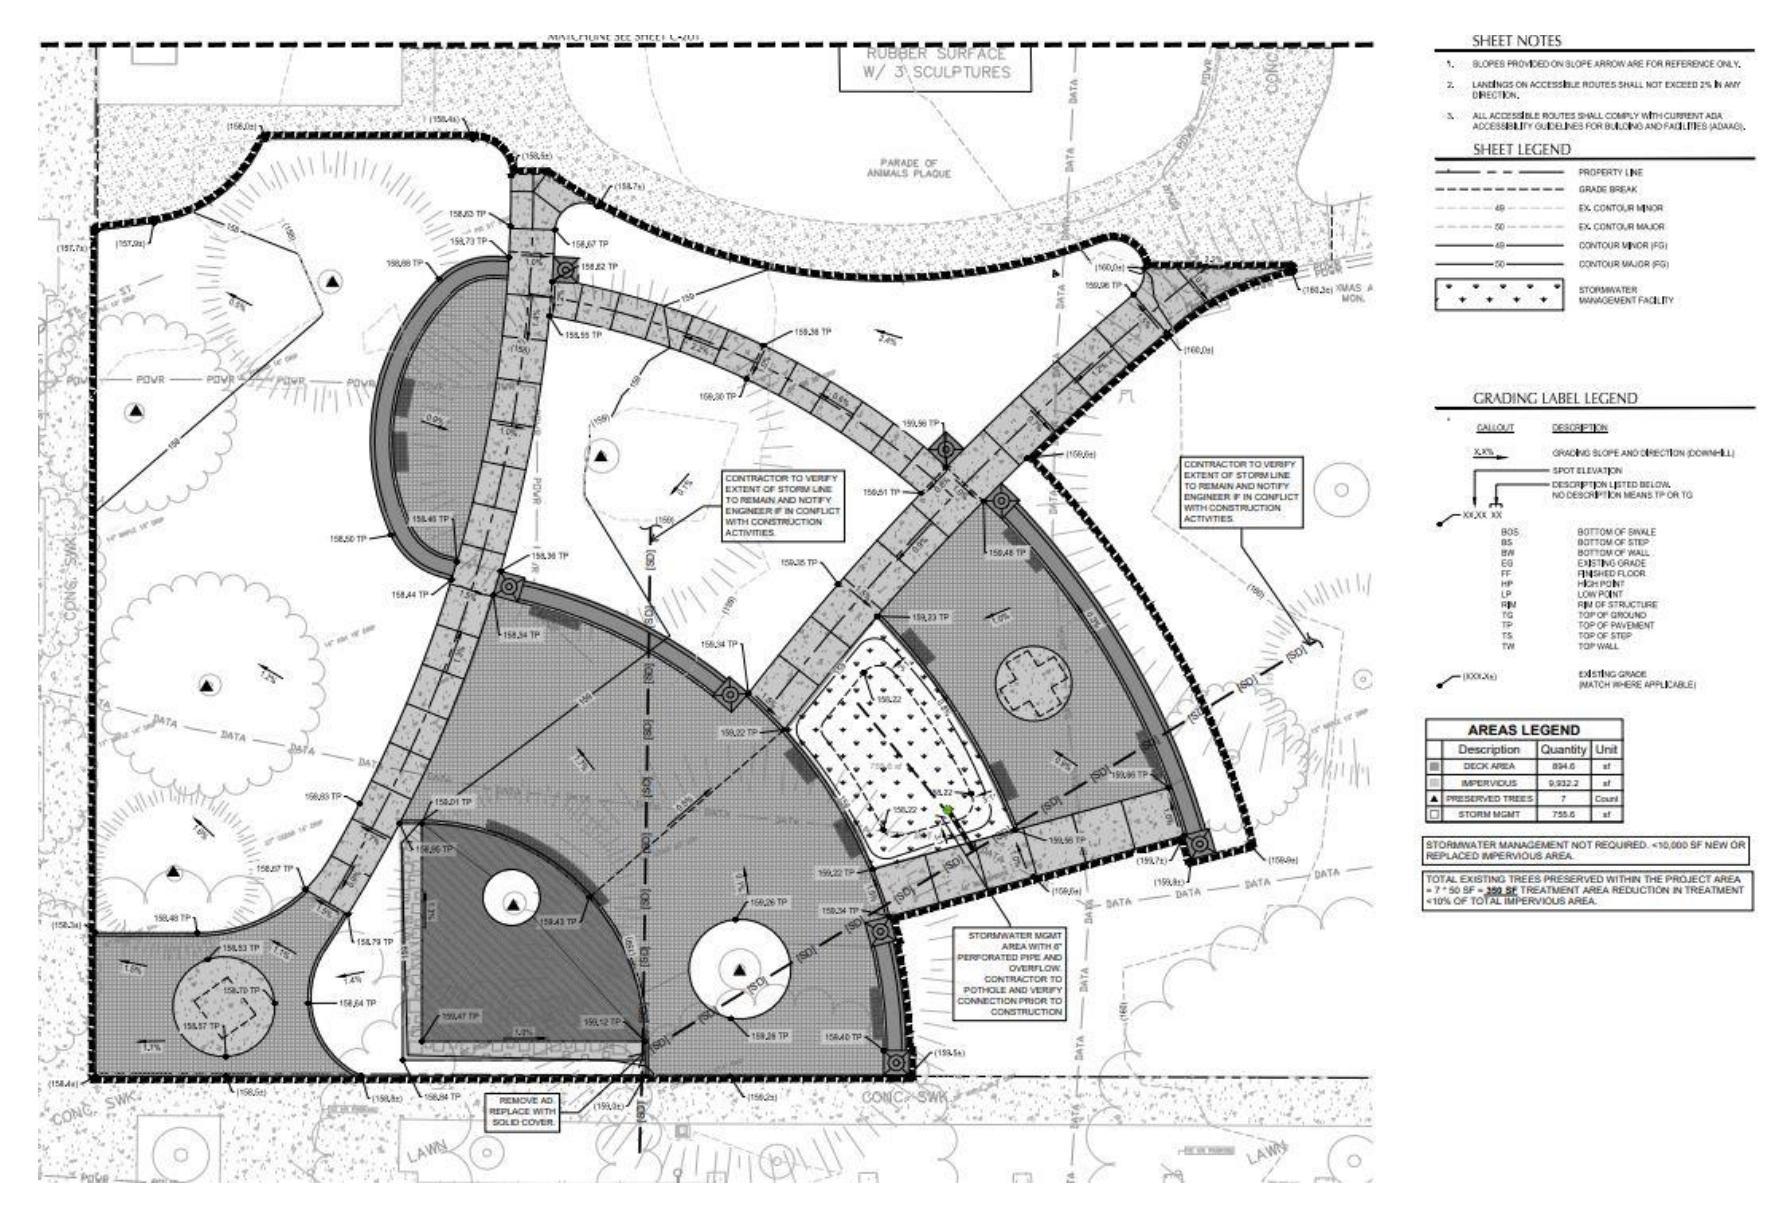
HARDSCAPE MAP

The Douglas fir will have two narrow concrete walkways installed just inside the north and west edges of its root zone, with an area of permeable concrete pavers between the western walkway and an interpretive panel. The remainder of the root zone is proposed to be kept as a planting area following construction (See Page 5, Hardscape Map).
