NOTICE OF DECISION

DECISION OF THE PLANNING ADMINISTRATOR

TREE REMOVAL PERMIT: TRP23-23

Basic Tree Risk Assessment Form

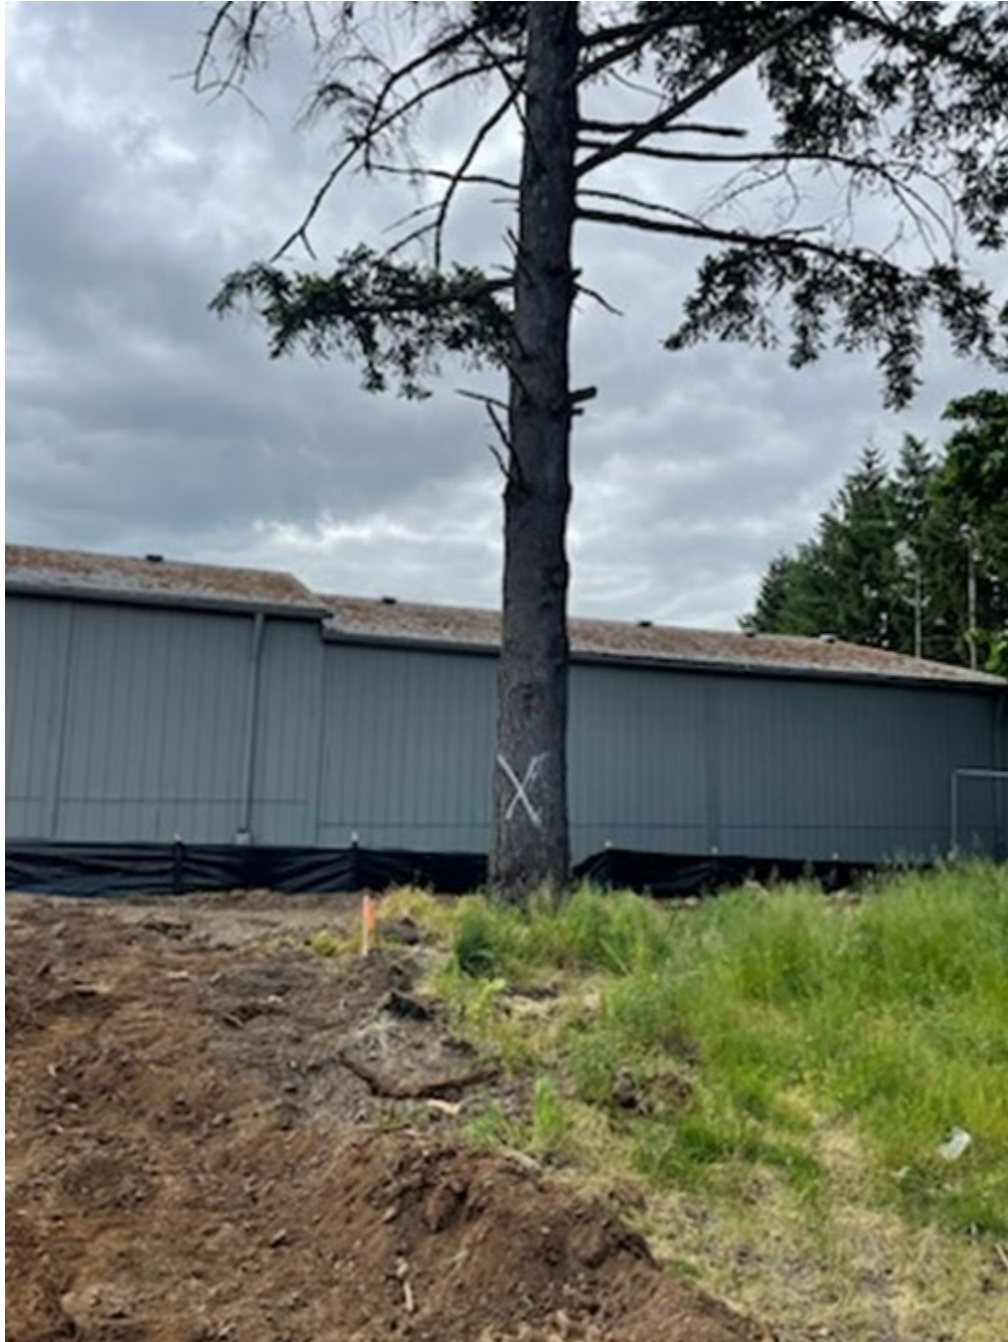
PICTURE 1
Taken 05/24/2023

Tree has large amount of deadwood limited crown and is in decline with significant loss of foliage and limbs.

New construction activity adjacent to tree will include a grade change and compaction, which will change the drainage of the area. The problem is oversaturation of this area may dramatically affect the tree's structure in biological integrity and can cause issues from root rot to root loss. The loss of roots will affect ability to uptake nutrients and water to sustain a healthy life. I recommend removing and replanting.
