State St. & Kettle Ct. Salem, Marion County, Oregon Wetland and Waters Delineation Report

Date: March 2024

Study Area: Marion County Assessor's Map 07 3W 25D
Tax Lot 1700
Salem, Oregon

AKS Job Number: 10900

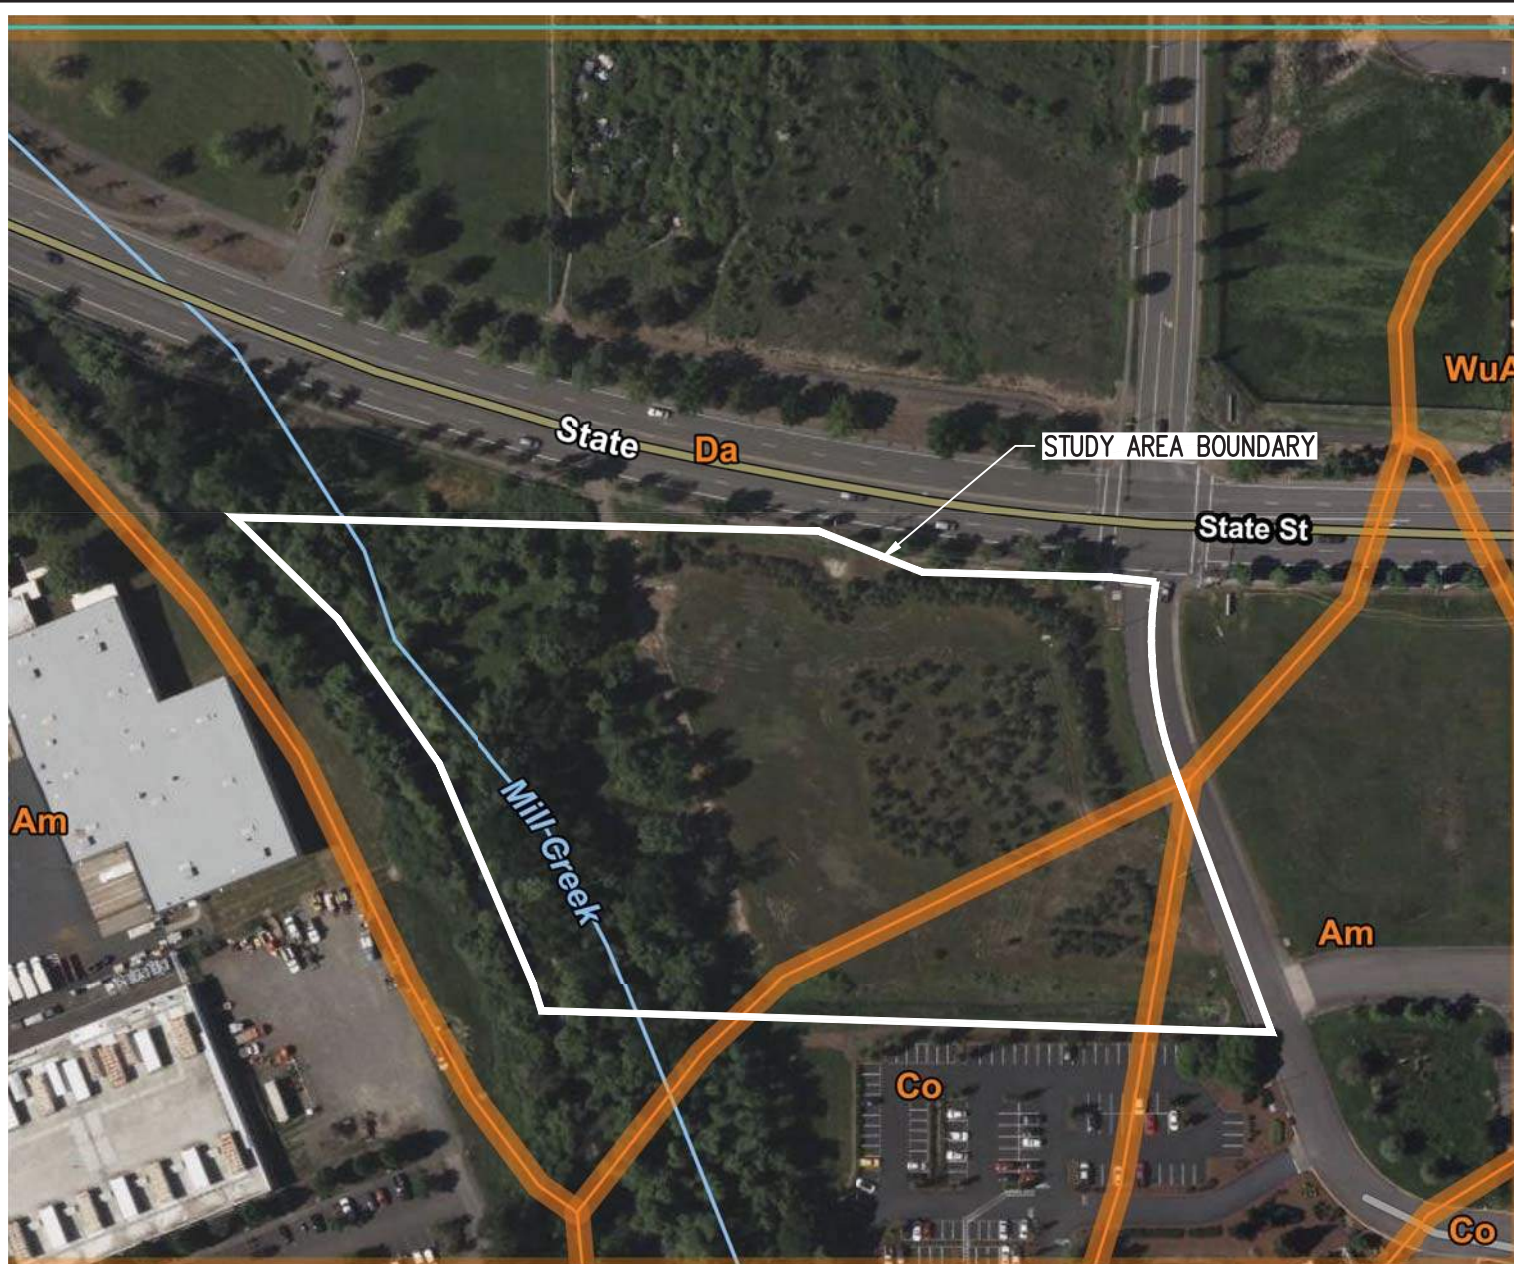
FIGURE
3
DRWN: GPM
CHKD: JWM
AKS JOB:
10900

MAP UNIT SYMBOL	MAP UNIT NAME
AM	AMITY SILT LOAM; NON-HYDRIC
CO	CONCORD SILT LOAM; HYDRIC
DA	DAYTON SILT LOAM; HYDRIC

NRCS WEB SOIL SURVEY FOR
MARION COUNTY

The following soil units are mapped within the study area, according to the Natural Resources Conservation Service (NRCS) Marion Conty Area Soil Survey Map (Figure 3 in Appendix A):

- Amity silt loam (Unit Am); Non-hydric
- Concord Silt loam (Unit Co); Hydric
- Dayton silt loam (Unit Da); Hydric

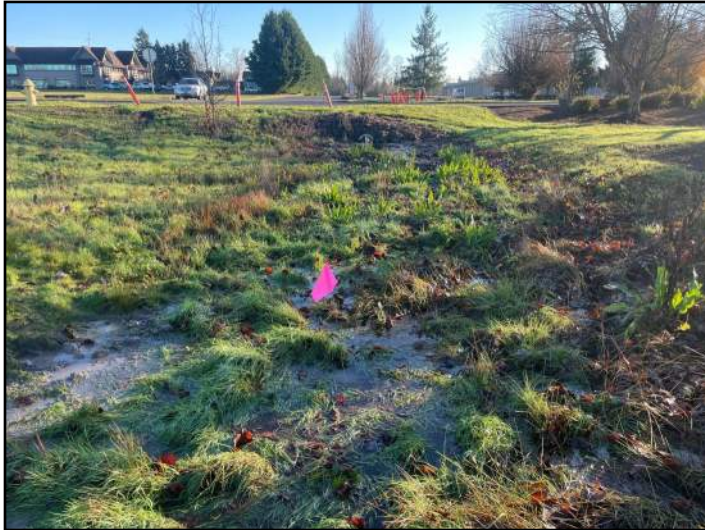
Photo A. View looking east within Wetland A towards Plot 1.

Wetland A is a Palustrine emergent (PEM) wetland that occupies the southern portion of the site within the created stormwater facility and located entirely in the study area. Surface water in Wetland A flows east to west before connecting to Mill Creek. Vegetation within Wetland A consists primarily of blue grass and common spike-rush. Other vegetation consisted of trace amounts of vetch (*Vicas* spp.; assumed FAC), lesser poverty rush (*Juncus tenuis*; FAC), and Oregon ash. The main hydrology source for Wetland A is surface water runoff directed from two stormwater outlets in addition to direct precipitation. A seasonally high groundwater table likely also contributes hydrology. During both site visits about 2 inches of surface water was observed within the limits of Wetland A. Because of this and the wetland's surface water connection to Mill Creek, Wetland A belongs to the Depressional Outflow (DOF) HGM classification.

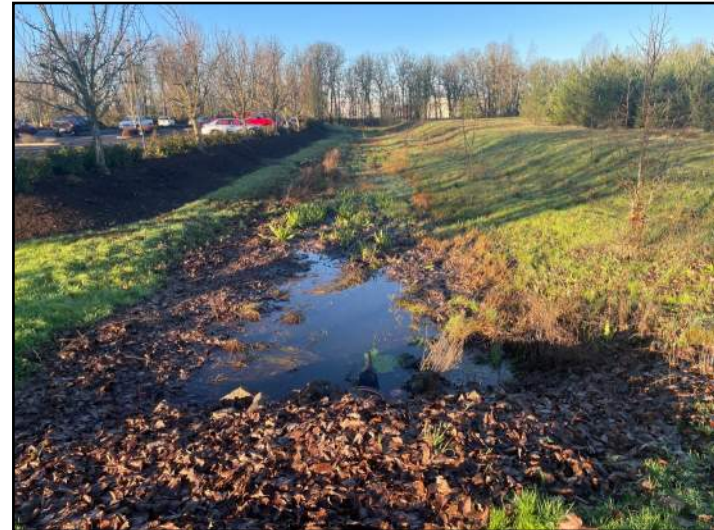
Photo B. View of Wetland A and stormwater facility looking west.

Wetland A is located within a constructed stormwater facility suggesting it is an artificially created wetland; however, the stormwater facility was likely created in part or in whole within waters of the state as it is located within mapped hydric soils and partially within mapped LWI wetlands. This is further evidenced by past saturation signatures seen in historic aerials. As a result, under OAR 141-085-515(6) Wetland A is likely to be determined jurisdictional to DSL.

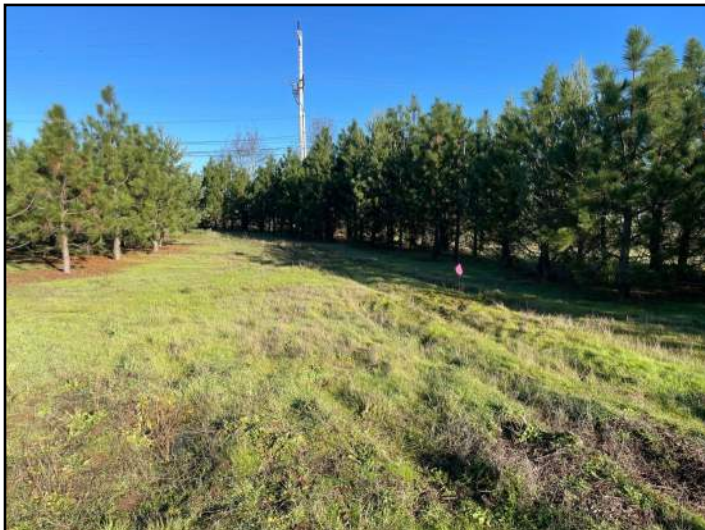
Photo C. Typical upland conditions with remaining pine trees from former tree farm, facing north.

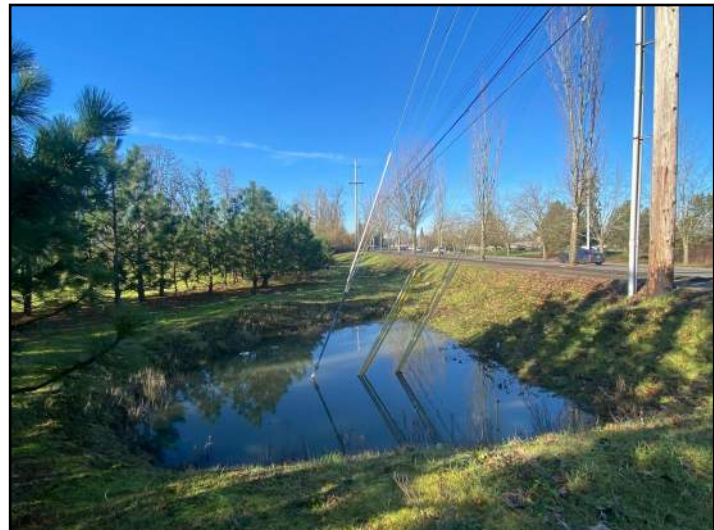
Photo D. View of Wetland C, facing west.

Wetland C is an isolated PEM wetland located in a confined depression in the northern limits of the study area. Wetland C's deepest observed surface water level was about 4 feet during the December 14, 2023, site visit. Because of this high water level the only observed vegetation within its limits was a sparse amount of fuller's teasel (*Dipsacus fullonum*; FAC). Wetland C has no apparent inlet, suggesting its main source of hydrology is runoff from adjacent roadways and uplands and direct precipitation. In addition, Wetland C appears isolated with no detectable outlet. As a result of this, Wetland C belongs to the Depressional non-permanently flooded (DCNP) HGM classification.

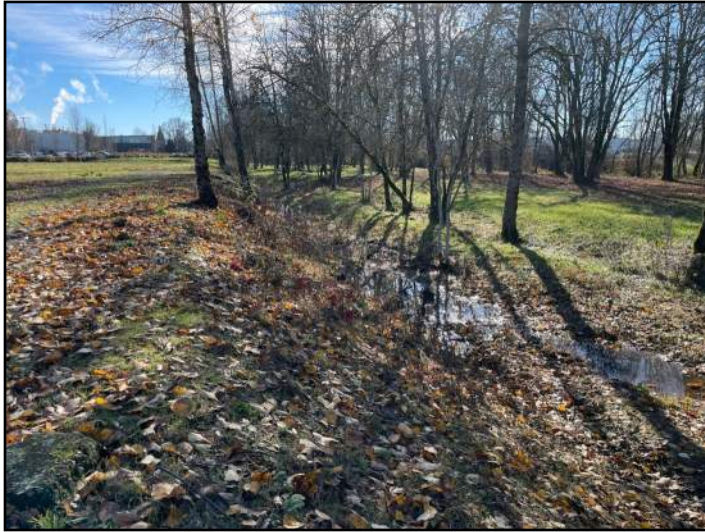
Photo E. View of Wetland B, facing south.

Wetland B is another PEM wetland stretching in a narrow band from south to north and continues off-site to the north before connecting to Mill Creek. Vegetation within Wetland B consisted mostly of Oregon ash and common velvet grass (*Hocus lanatus*; FAC). Other vegetation consisted of a brome species, spreading rush (*Juncus patens*; FACW) and shining geranium (*Geranium lucidum*; NOL). Wetland B's primary source of hydrology is from subsurface flows as evidenced by a high water table observed at 7 inches and saturation at 5 inches during the December 12, 2024 site visit. Water within Wetland B is

directed north off-site where it eventually connects with Mill Creek. As a result of this connection Wetland B belongs to the Slopes Valley (SV) HGM classification.

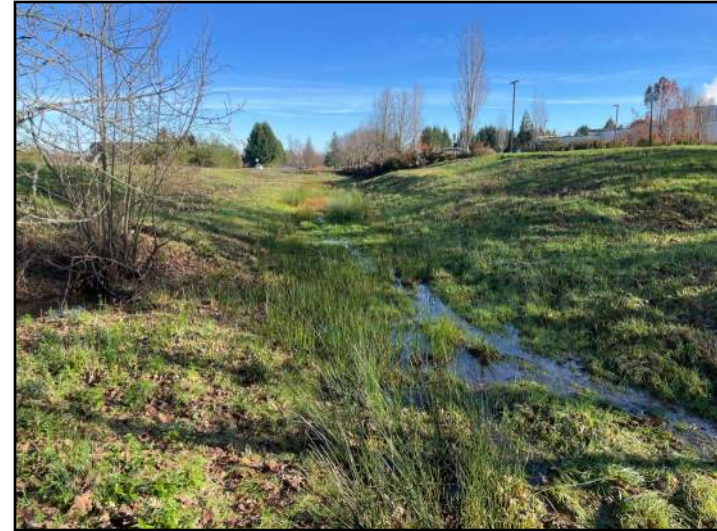
Photo F. View of western end of Wetland A, facing east.

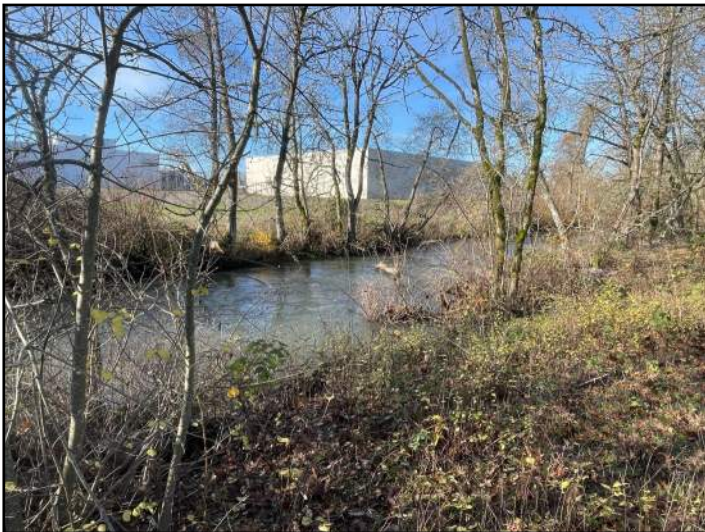
Photo G. View of Mill Creek looking northwest.

Mill Creek is a perennial stream flowing south to north along the western portion of the study area for ±456 linear feet. Mill Creek extends off-site to the north where it eventually flows into the Willamette River. Mill Creek is about 25 feet wide and is characterized by moderate banks on its east edge within the study area. The observable channel substrate consists mostly of sediment and fines intermixed with some cobbles. Vegetation along Mill Creek consists of scattered grasses and shrubs with Oregon ash providing canopy cover. Mill Creek is mapped as Essential Salmonid Habitat (ESH) for fall and spring run chinook (*Oncorhynchus tshawytscha*), summer and winter run steelhead (*O. mykiss*), and coastal cutthroat trout (*O. clarkii*) (ODFW 2023).

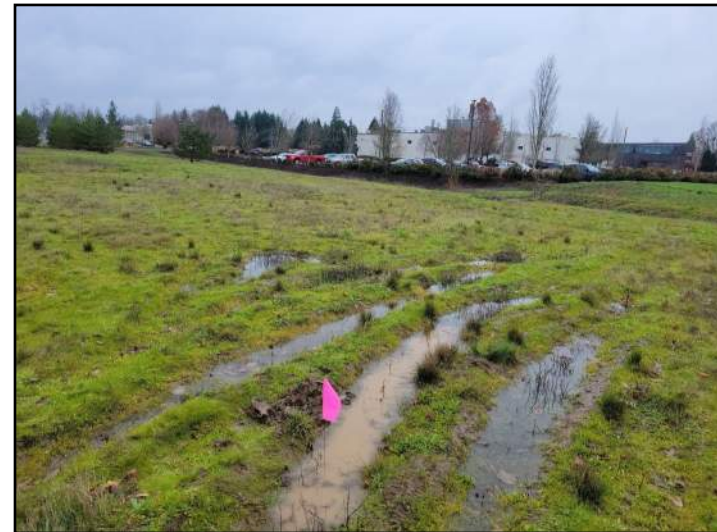
Photo H. View of Plot 20 and typical upland conditions on-site looking southeast. Ponded water due to high recent rainfall and compacted soils.
