**Geotechnical Investigation  
and  
Geologic Hazard Assessment Services  
Proposed Liberty Road Residential Subdivision Site  
Tax Lot No. 600  
5871 Liberty Road South  
Salem (Marion County), Oregon  
for  
Multi/Tech Engineering Services, Inc.**

**Project No. 1001.072.G  
November 13, 2020**

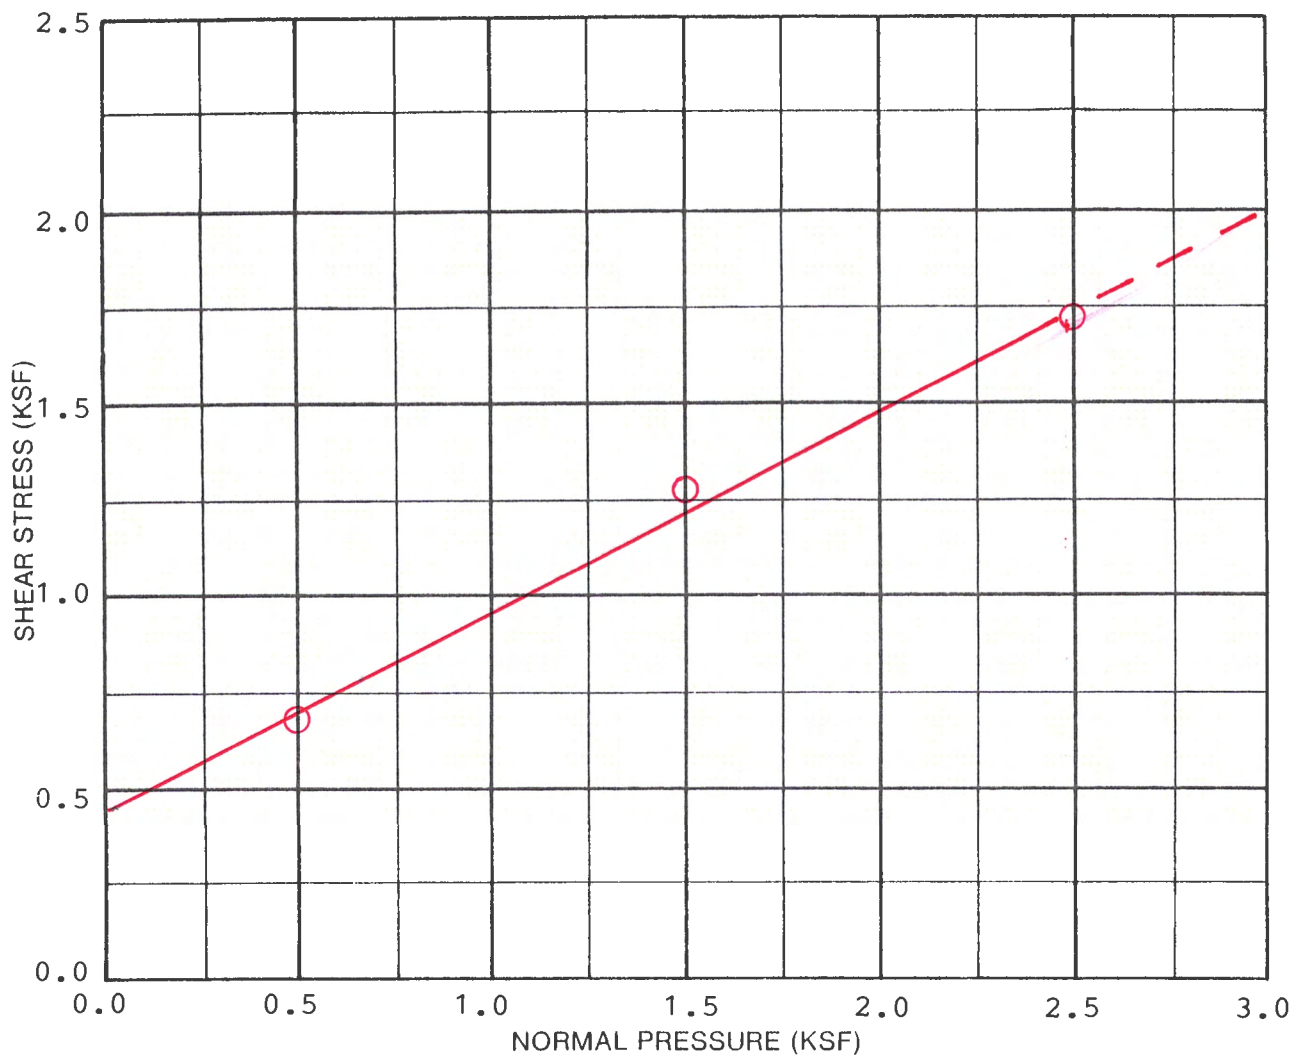
SAMPLE DATA	
DESCRIPTION: Medium to reddish-brown sandy, clayey SILT (ML) (Remolded)	
BORING NO.: TH-#10	
DEPTH (ft): 3.0'	ELEVATION (ft):
TEST RESULTS	
APPARENT COHESION (C): 450 psf	
APPARENT ANGLE OF INTERNAL FRICTION ( $\phi$ ): 26°

TEST DATA				
TEST NUMBER	1	2	3	4
NORMAL PRESSURE (KSF)	0.5	1.5	2.5	
SHEAR STRENGTH (KSF)	0.7	1.3	1.7	
INITIAL H <sub>2</sub> O CONTENT (%)	30.0	30.0	30.0	
FINAL H <sub>2</sub> O CONTENT (%)	31.1	25.5	19.3	
INITIAL DRY DENSITY (PCF)	91.0	91.0	91.0	
FINAL DRY DENSITY (PCF)	91.8	95.5	102.2	
STRAIN RATE: 0.02 inches per minute
