MEMORANDUM

RE: Lancaster Drive NE Property- Salem, Oregon DSL: WD2025-0038
PHS Project No. 8165

Wetland Delineation- No Wetland
Lancaster Drive NE Property - Salem, Oregon

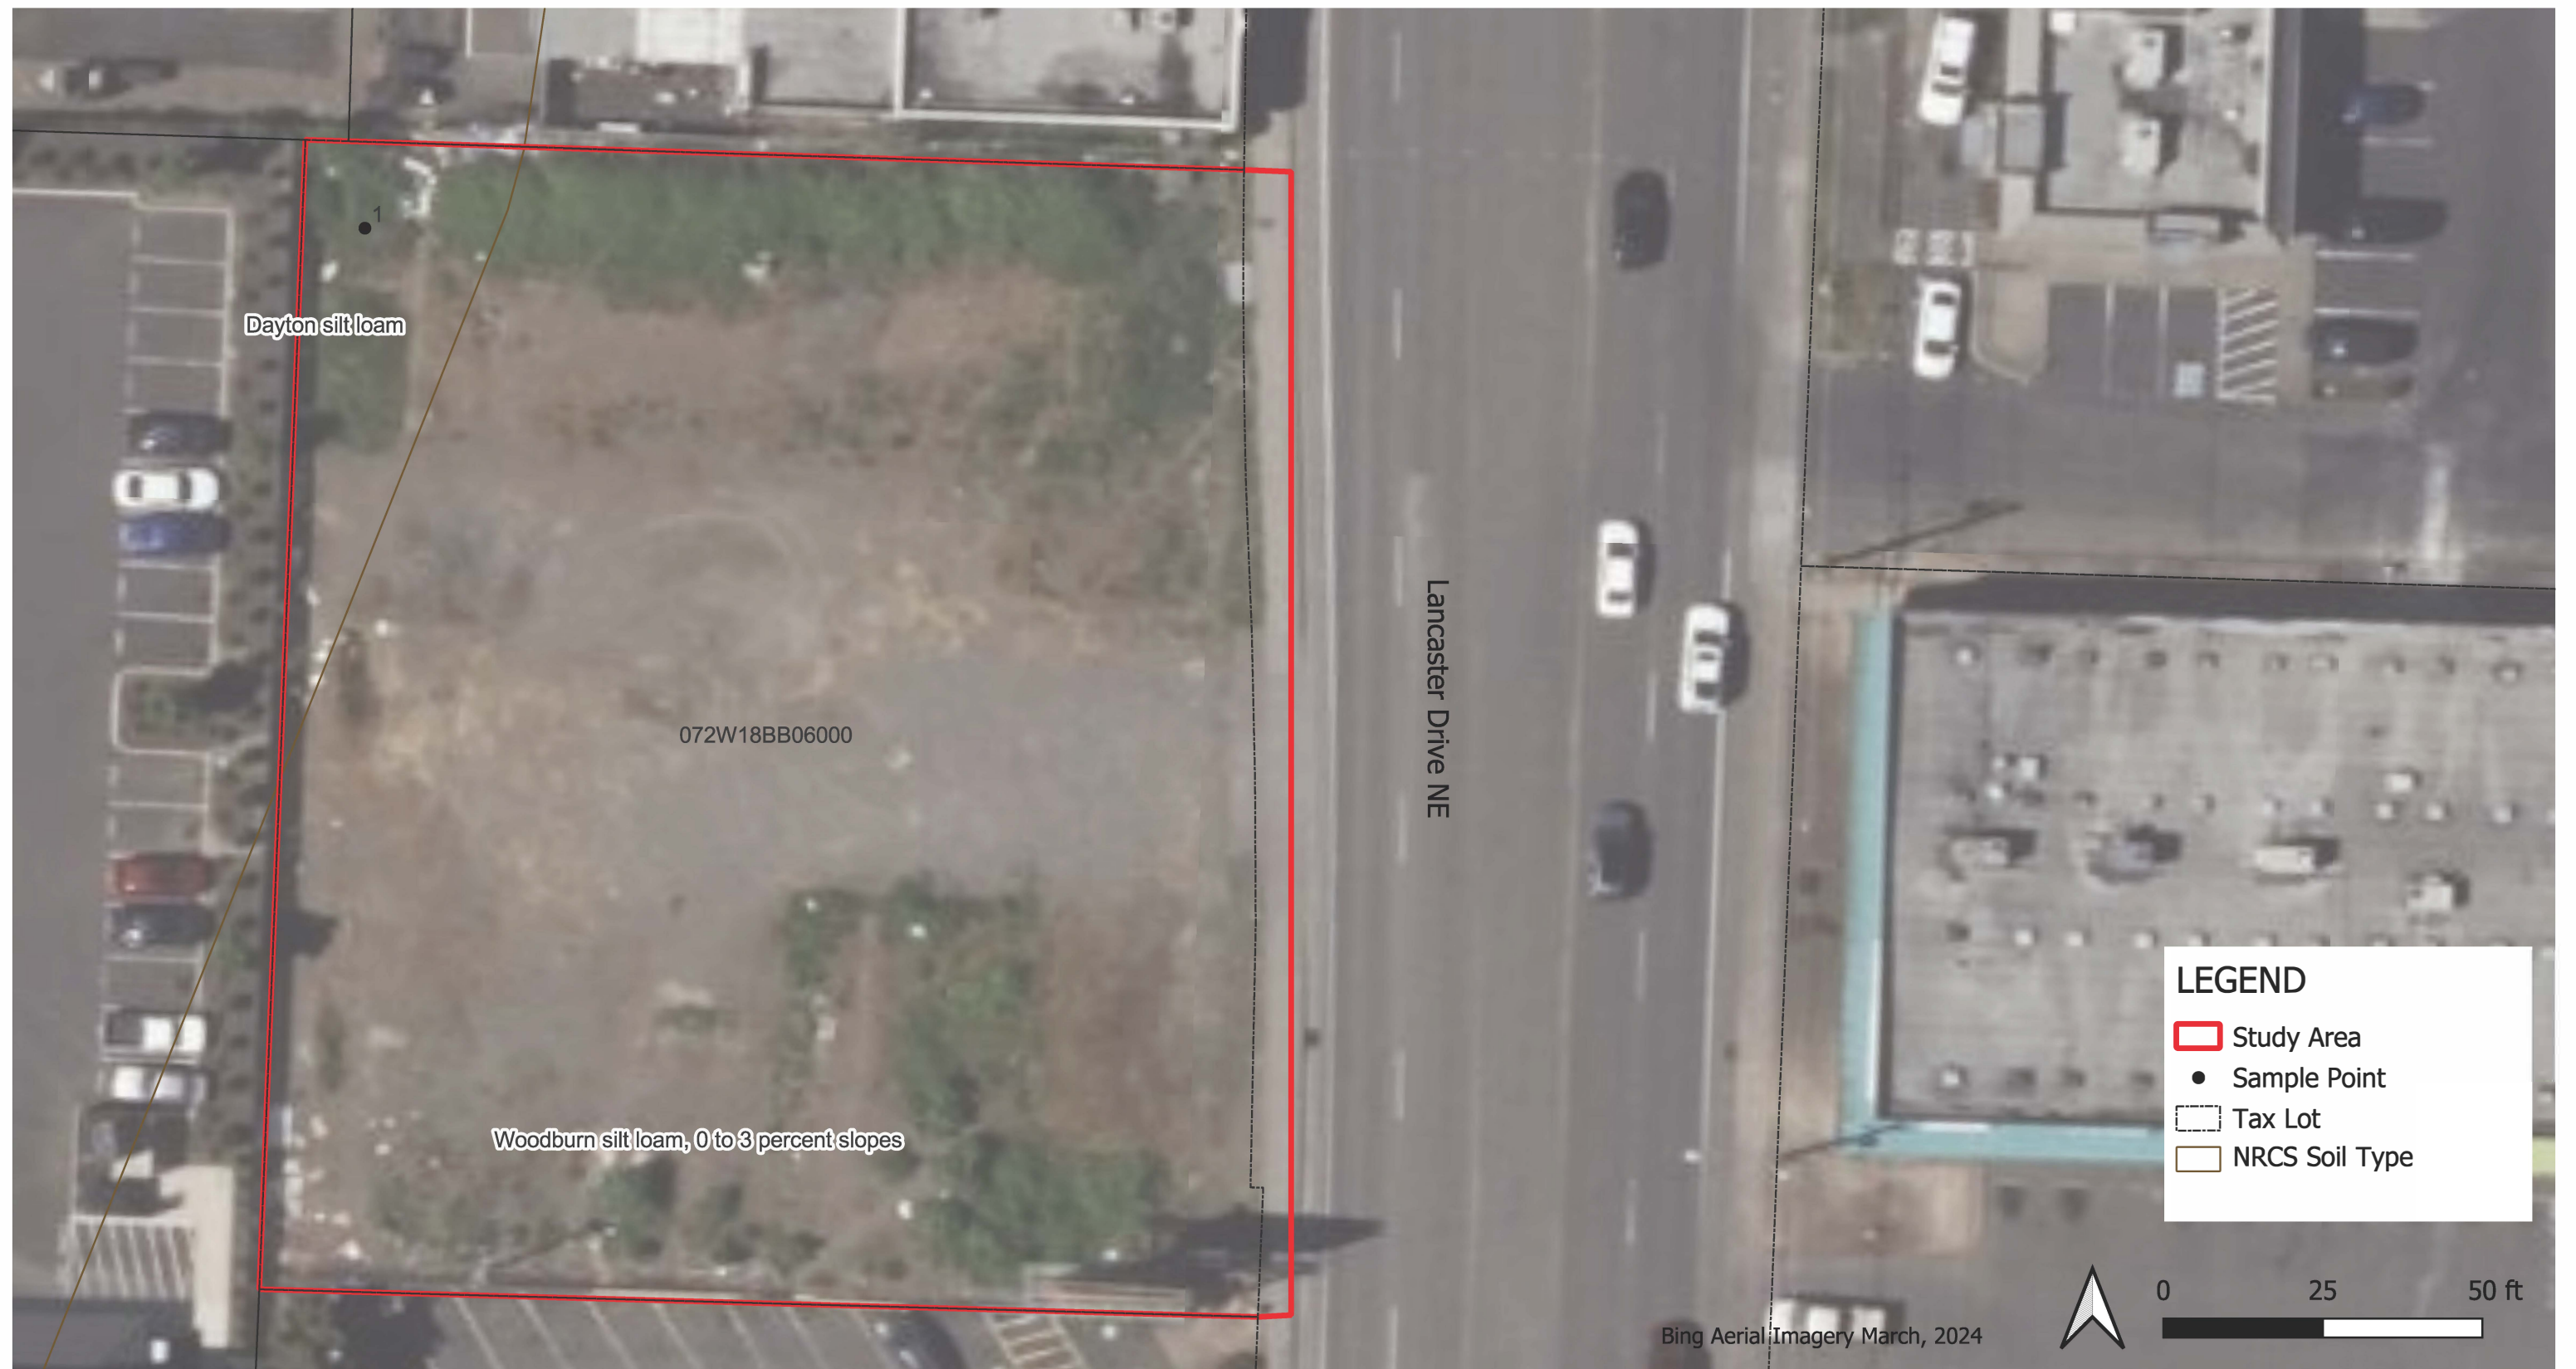
FIGURE
1

Tax Lot obtained from Marion County RLIS: +/- 3 feet
Sample Point surveyed by PHS using Juniper Geode: +/- 1 feet
Soil Map obtained from Natural Resources Conservation Service (NRCS) agronomic mapping: +/- 3 feet

The study area is bordered by commercial development on all sides, with Lancaster Drive NE bordering the eastern limits of the study area. The site itself is undeveloped with a narrow area of NRCS Dayton silt loam mapped in the northwest corner. Dayton silt loam is a hydric soil typically associated with wetland, so the representative sample point was collected in this location.
