From: Nicholas Maselli <nmaselli_pcs@comcast.net>
Sent: Tuesday, October 6, 2020 1:42 PM
To: Olivia Dias
Subject: CASE NO.: CPC-NPC-ZC-SPR-ADJ-DR20-03 ADDRESS: 905 & 925 Cottage Street NE

Testimony for the Public Hearing, October 6, 2020
Re: Case No. CPC-NPC-ZC-SPR-ADJ-DR20-03
920/925 Summer St.

Unreinforced Masonry Buildings and Earthquakes

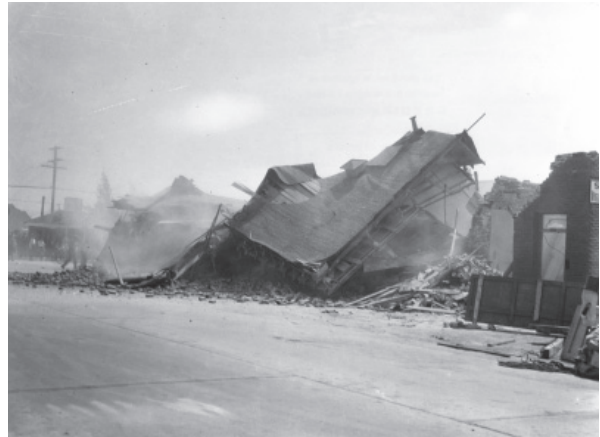
■ **Figure 3. Complete collapse of an unreinforced brick building.**

The most severe level of damage, with the greatest likelihood of fatalities, is complete collapse. After a few seconds of ground shaking in the 1933 Long Beach earthquake, the brick walls holding up the second floor and roof of this building broke apart. That not only caused the fall of hazardous brick debris—it also immediately led to complete collapse. —*Los Angeles Public Library*

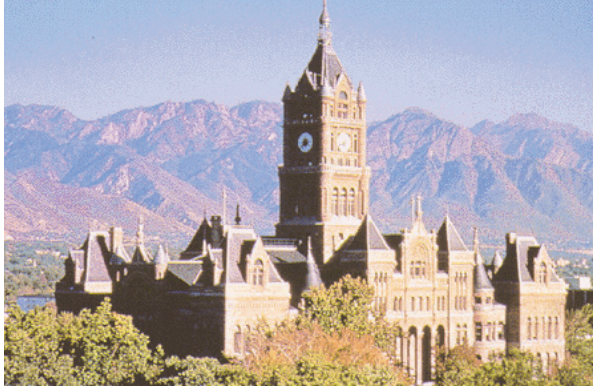
■ **Figure 4. The Salt Lake City and County Building, an architectural and historic community asset that could be lost, if damaged.**

The Salt Lake City and County Building was extensively seismically retrofitted, not only to make it safer but also to provide long-term protection for a valued historic building. —*U.S. Geological Survey*

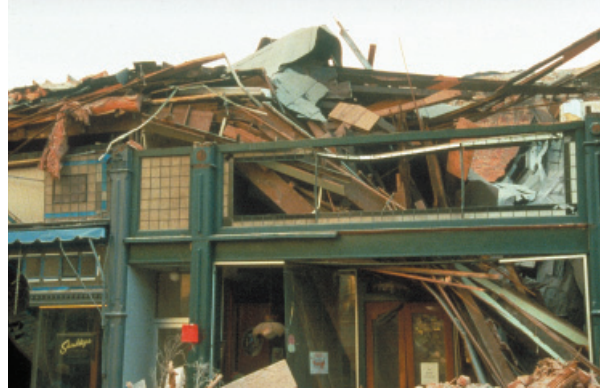
■ **Figure 5. Destruction of a historic building.**

Complete collapse of one of the historic buildings in the former Pacific Avenue Historic District of the City of Santa Cruz, California. —*James R. Blacklock, NISEE, U.C. Berkeley*

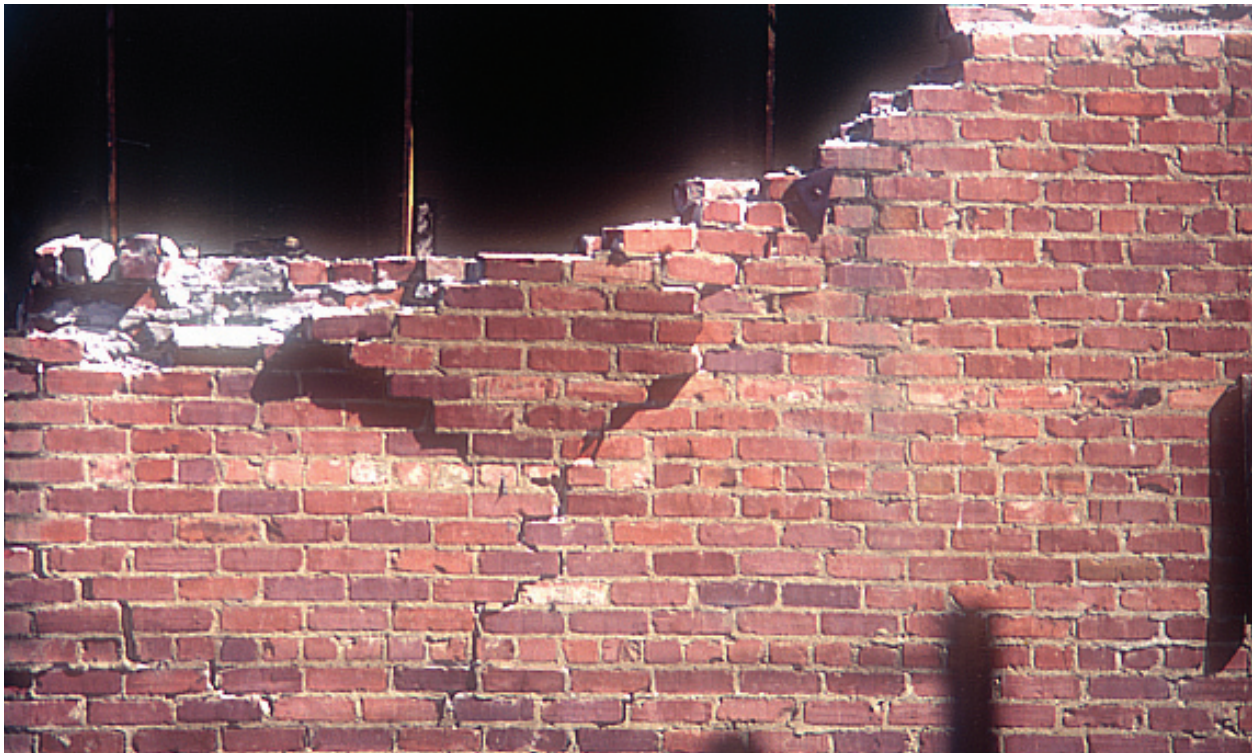
■ **Figure 6. Damaged URM wall in a red-tagged building, fated to be torn down or to undergo a multi-year closure for repairs and upgrading.**

Pre-earthquake retrofitting usually looks quite modest, compared to the comprehensive upgrading that building codes will require to repair a damaged, non-code-conforming building after an earthquake. —*Robert Reitherman*

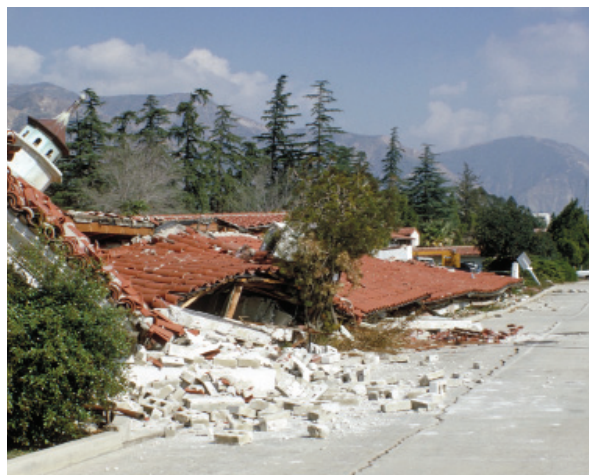
■ Figure 9. Complete collapse of an unreinforced concrete block building, 1971 San Fernando earthquake. —Karl Steinbrugge, NISEE, U.C. Berkeley

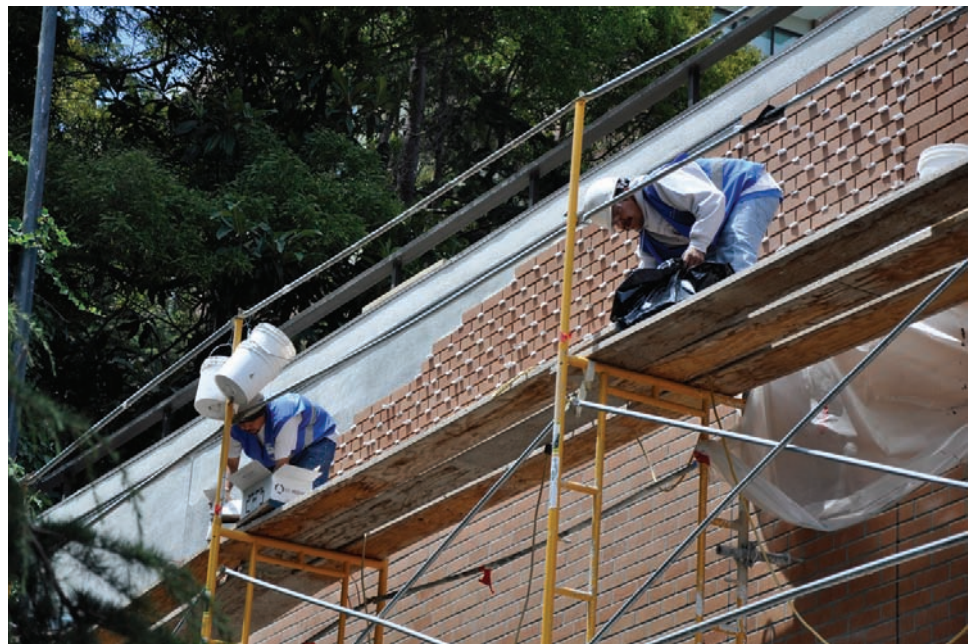
■ **Figure 12. Workers installing brick veneer.**

The individual pieces of veneer are being adhered to the reinforced concrete wall behind them. The result looks like a brick wall. —*Robert Reitherman*

Masonry veneer is usually composed of one layer of ordinary brick or of thinner brick that is applied to a supporting wall behind it, as shown in Figure 12. Veneer is typically about four inches (100 mm) or less in thickness. It may also consist of stone facing. The veneer is adhered to and literally hangs onto a wall behind it for vertical and horizontal support. Terra cotta, a ceramic material similar to brick

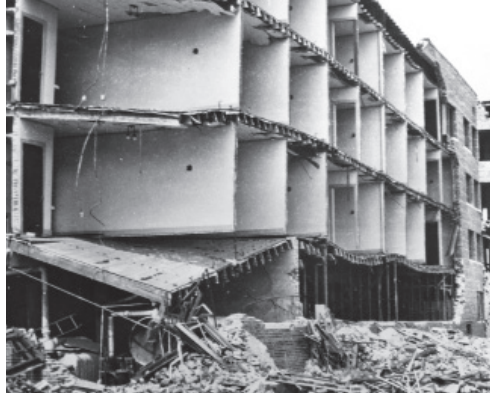
■ Figure 14. Heavily damaged Hotel Californian, 1925 Santa Barbara, California earthquake. —NISEE, U.C. Berkeley

1925 Santa Barbara Earthquake, Southern California, M 6.2: The most severe damage from this earthquake occurred among unreinforced brick commercial and residential construction and was a primary motivation for engineers in California to adapt seismic design ideas from Japan into the *Uniform Building Code*. Forty percent of the unreinforced masonry buildings were severely damaged or collapsed.⁶ See Figure 14, the Hotel Californian, in which extensive wood-frame and plaster partitions barely managed to hold the building up, after exterior brick walls failed.

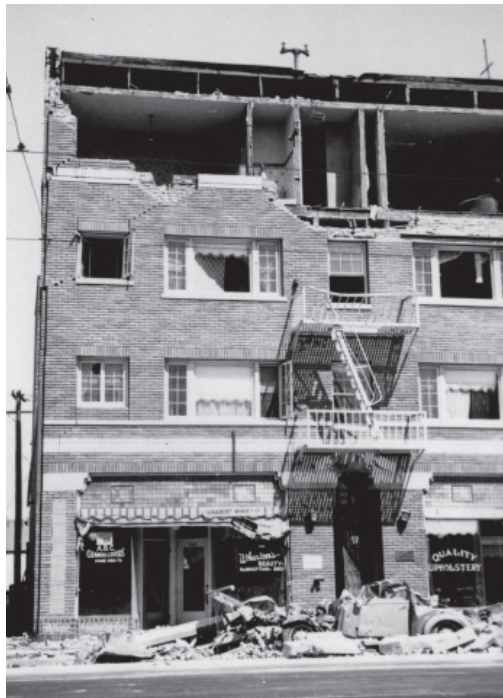
■ Figure 15. URM building damage, 1933 Long Beach, California earthquake. —Los Angeles County Public Library

1933 Long Beach Earthquake, Southern California, M 6.3: In the City of Long Beach (adjacent to the City of Los Angeles), 54% of the unreinforced masonry buildings ended up with damage that ranged from significant wall destruction to complete collapse. In 20% of the cases, damage fell in the categories of either damage to more than half the wall area, partial collapse, or complete collapse.⁷ See Figure 15, showing parapet (the short walls that often extend around the perimeter of a roof) and top story failure and the effect of the falling masonry debris.

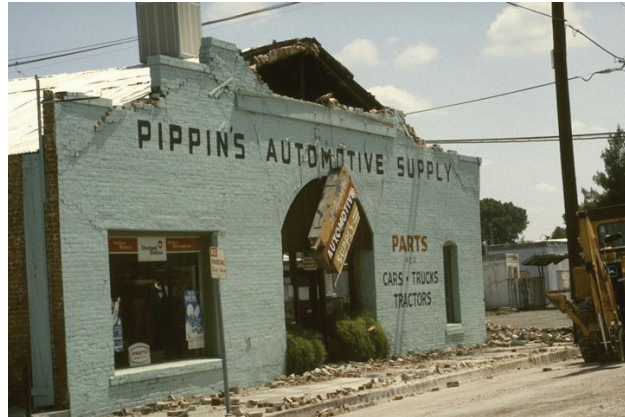
■ **Figure 16. URM building with end-wall failure, 1983 Coalinga, California earthquake.** Robert Reitherman
—NISEE, U.C. Berkeley

1983 Coalinga Earthquake, Central California, M 6.2: Out of 37 unreinforced masonry buildings—the core of the Coalinga business district—only one escaped damage. Sixty percent were damaged to the extent of having more than half of their walls ruined, up to complete collapse.⁸ The entire downtown area was cordoned off, until badly damaged buildings could be demolished and the debris removed. See Figure 16, which illustrates a common form of damage, in which the gable (peaked roof) end wall falls.

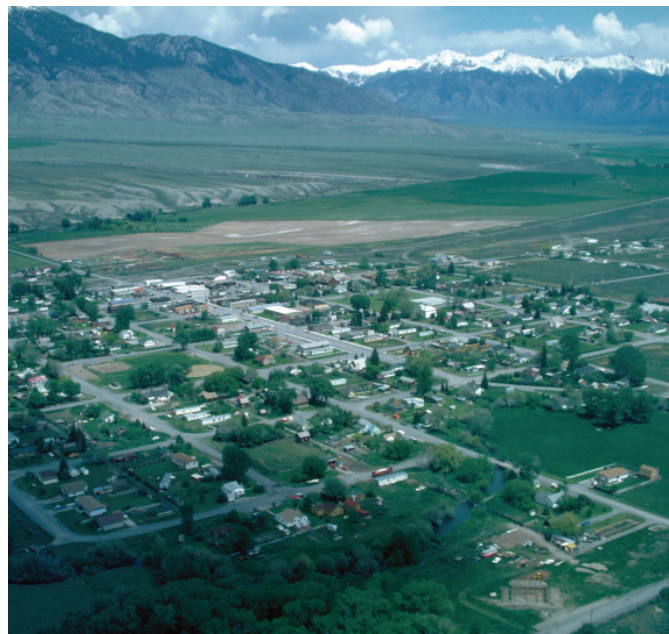
■ **Figure 17. Aerial view of heavily damaged Mackay, Idaho.** The unreinforced masonry buildings on the main commercial street of the small town were badly damaged in the 1983 Borah Peak, Idaho earthquake.
—NISEE, U.C. Berkeley

1983 Borah Peak Earthquake, Idaho, M 7.3: In the town of Challis, Idaho, the only earthquake-related fatalities occurred when an unreinforced masonry wall fell on two children on their way to school. In Mackay, the town's main street buildings, built of unreinforced brick, concrete block, or stone, were all damaged. Eight required demolition. In relative terms, when compared to the size of the town (see Figure 17), this amount of damage constituted a large disaster.

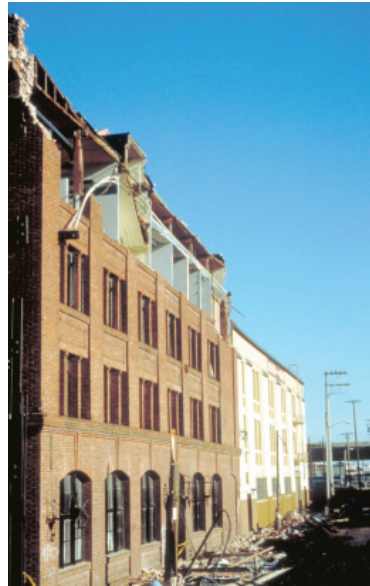
■ **Figure 18. Upper story wall collapse, with resulting fatalities.**

Five people were killed when the brick wall in the fourth story fell on top of cars and the sidewalk in the 1989 Loma Prieta earthquake. —James Blacklock, NISEE, U.C. Berkeley

1989 Loma Prieta Earthquake, Northern California, M 7.1: In this earthquake, 374 (16%) of the 2,400 unreinforced masonry buildings in the region experienced damage severe enough to require that they be vacated.⁹ The earthquake was centered 60 miles south of the San Francisco Bay Area, and the majority of these buildings were subjected to only light to moderate shaking. Figure 18 illustrates an upper-story failure of brickwork, which fell onto the sidewalk and cars below, killing five people.

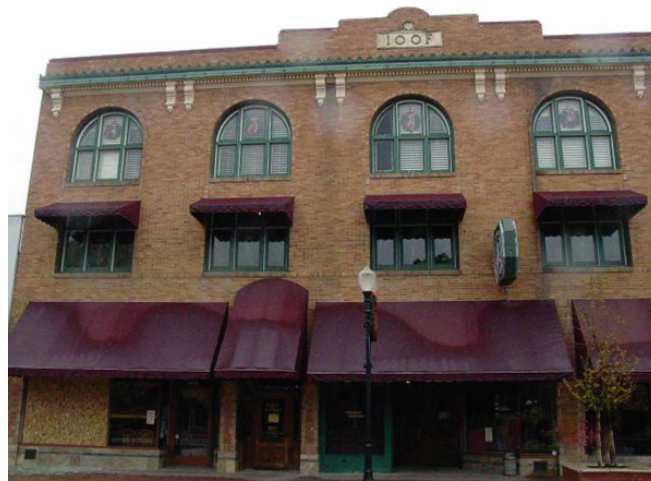
■ **Figure 20. Retrofitted URM building, 2003 San Simeon, California earthquake.**

Retrofitted prior to the earthquake, this unreinforced brick building experienced no damage. —Janise E. Rodgers, NISEE, U.C. Berkeley.

2003 San Simeon Earthquake, Central California, M 6.5: Of 53 unreinforced masonry buildings in Paso Robles, the nearest affected city, none of the nine that had been retrofitted experienced major damage. Many of the others were damaged so extensively that they were subsequently demolished. “During earthquakes unreinforced masonry buildings that have not been retrofitted continue to be the most dangerous buildings in California.” One building owner commented afterward: “I’m confident the building would have come down in the quake if we hadn’t done the retrofitting. There were times when we were bleeding so badly in paying for it, we wondered what in the heck we were doing. Now we know.”¹¹ See Figure 20. The two fatalities in the town were due to the collapse of an unretrofitted, unreinforced brick building.

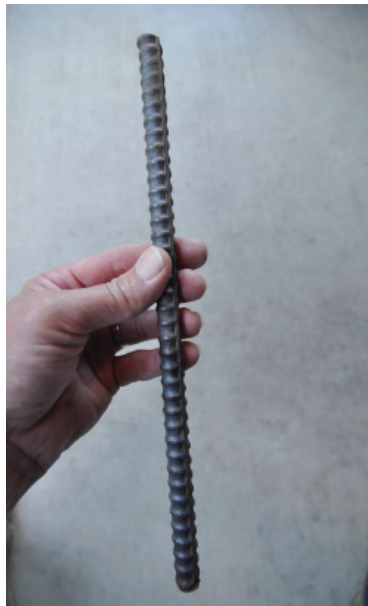
■ **Figure 26. A piece of #4 bar (a steel reinforcing bar that is 4/8 inch in diameter).**

Unreinforced masonry, as the name implies, is masonry without reinforcing. “Reinforcing” (see Figure 26) has a very specific meaning in this context. It refers to steel reinforcing bars (rebar), which vary in diameter from approximately 3/8 inch in diameter (9.5 mm, called a #3 bar) to an inch (25 mm) or more in diameter. A bar 4/8 inch in diameter is called a #4 bar, and so on. The bars have knobs or ridges along their length to increase their adhesion or bond with concrete or grout. Grout is essentially a very fluid form of concrete, with small pea-sized gravel instead of the larger aggregate in concrete.

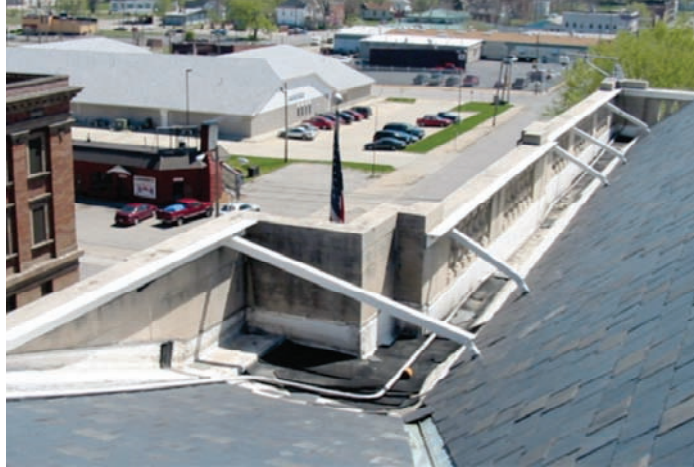
■ **Figure 29. Retrofit bracing of an unreinforced masonry parapet.**

Parapet safety programs do not provide protection, however, against the collapse of the building itself. The first additional increment of seismic protection, beyond parapet and appendage bracing, is provided by bolting the walls to the roof and to any floors above the ground floor level. Long steel bolts are typically inserted into holes drilled in the wall and attached to a steel angle, which in turn is bolted to the side of a wooden joist. The end of the bolt on the outside of the wall requires a large washer (the size of a teacup saucer) to prevent it from pulling through in an earthquake (see Figure 30). In many communities that have enacted seismic ret-

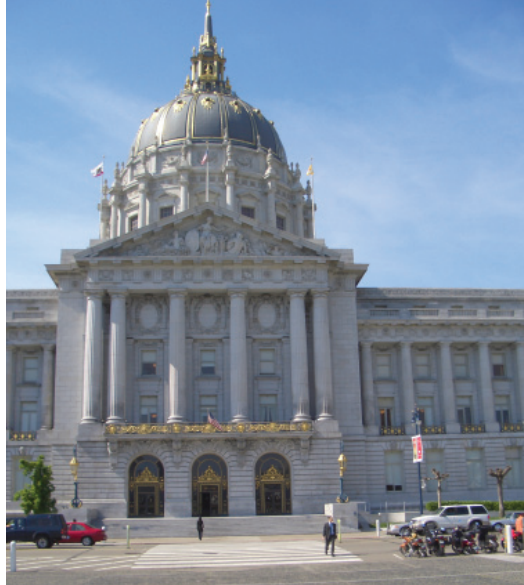
■ **Figure 33. The San Francisco City Hall seismic retrofit, which includes seismic isolators.** —*Robert Reitherman*
