## TECHNICAL MEMORANDUM

**Re:** **Strong Heights Subdivision and Reed Road Wetland Determination / SWCA Project No. 304070.10**

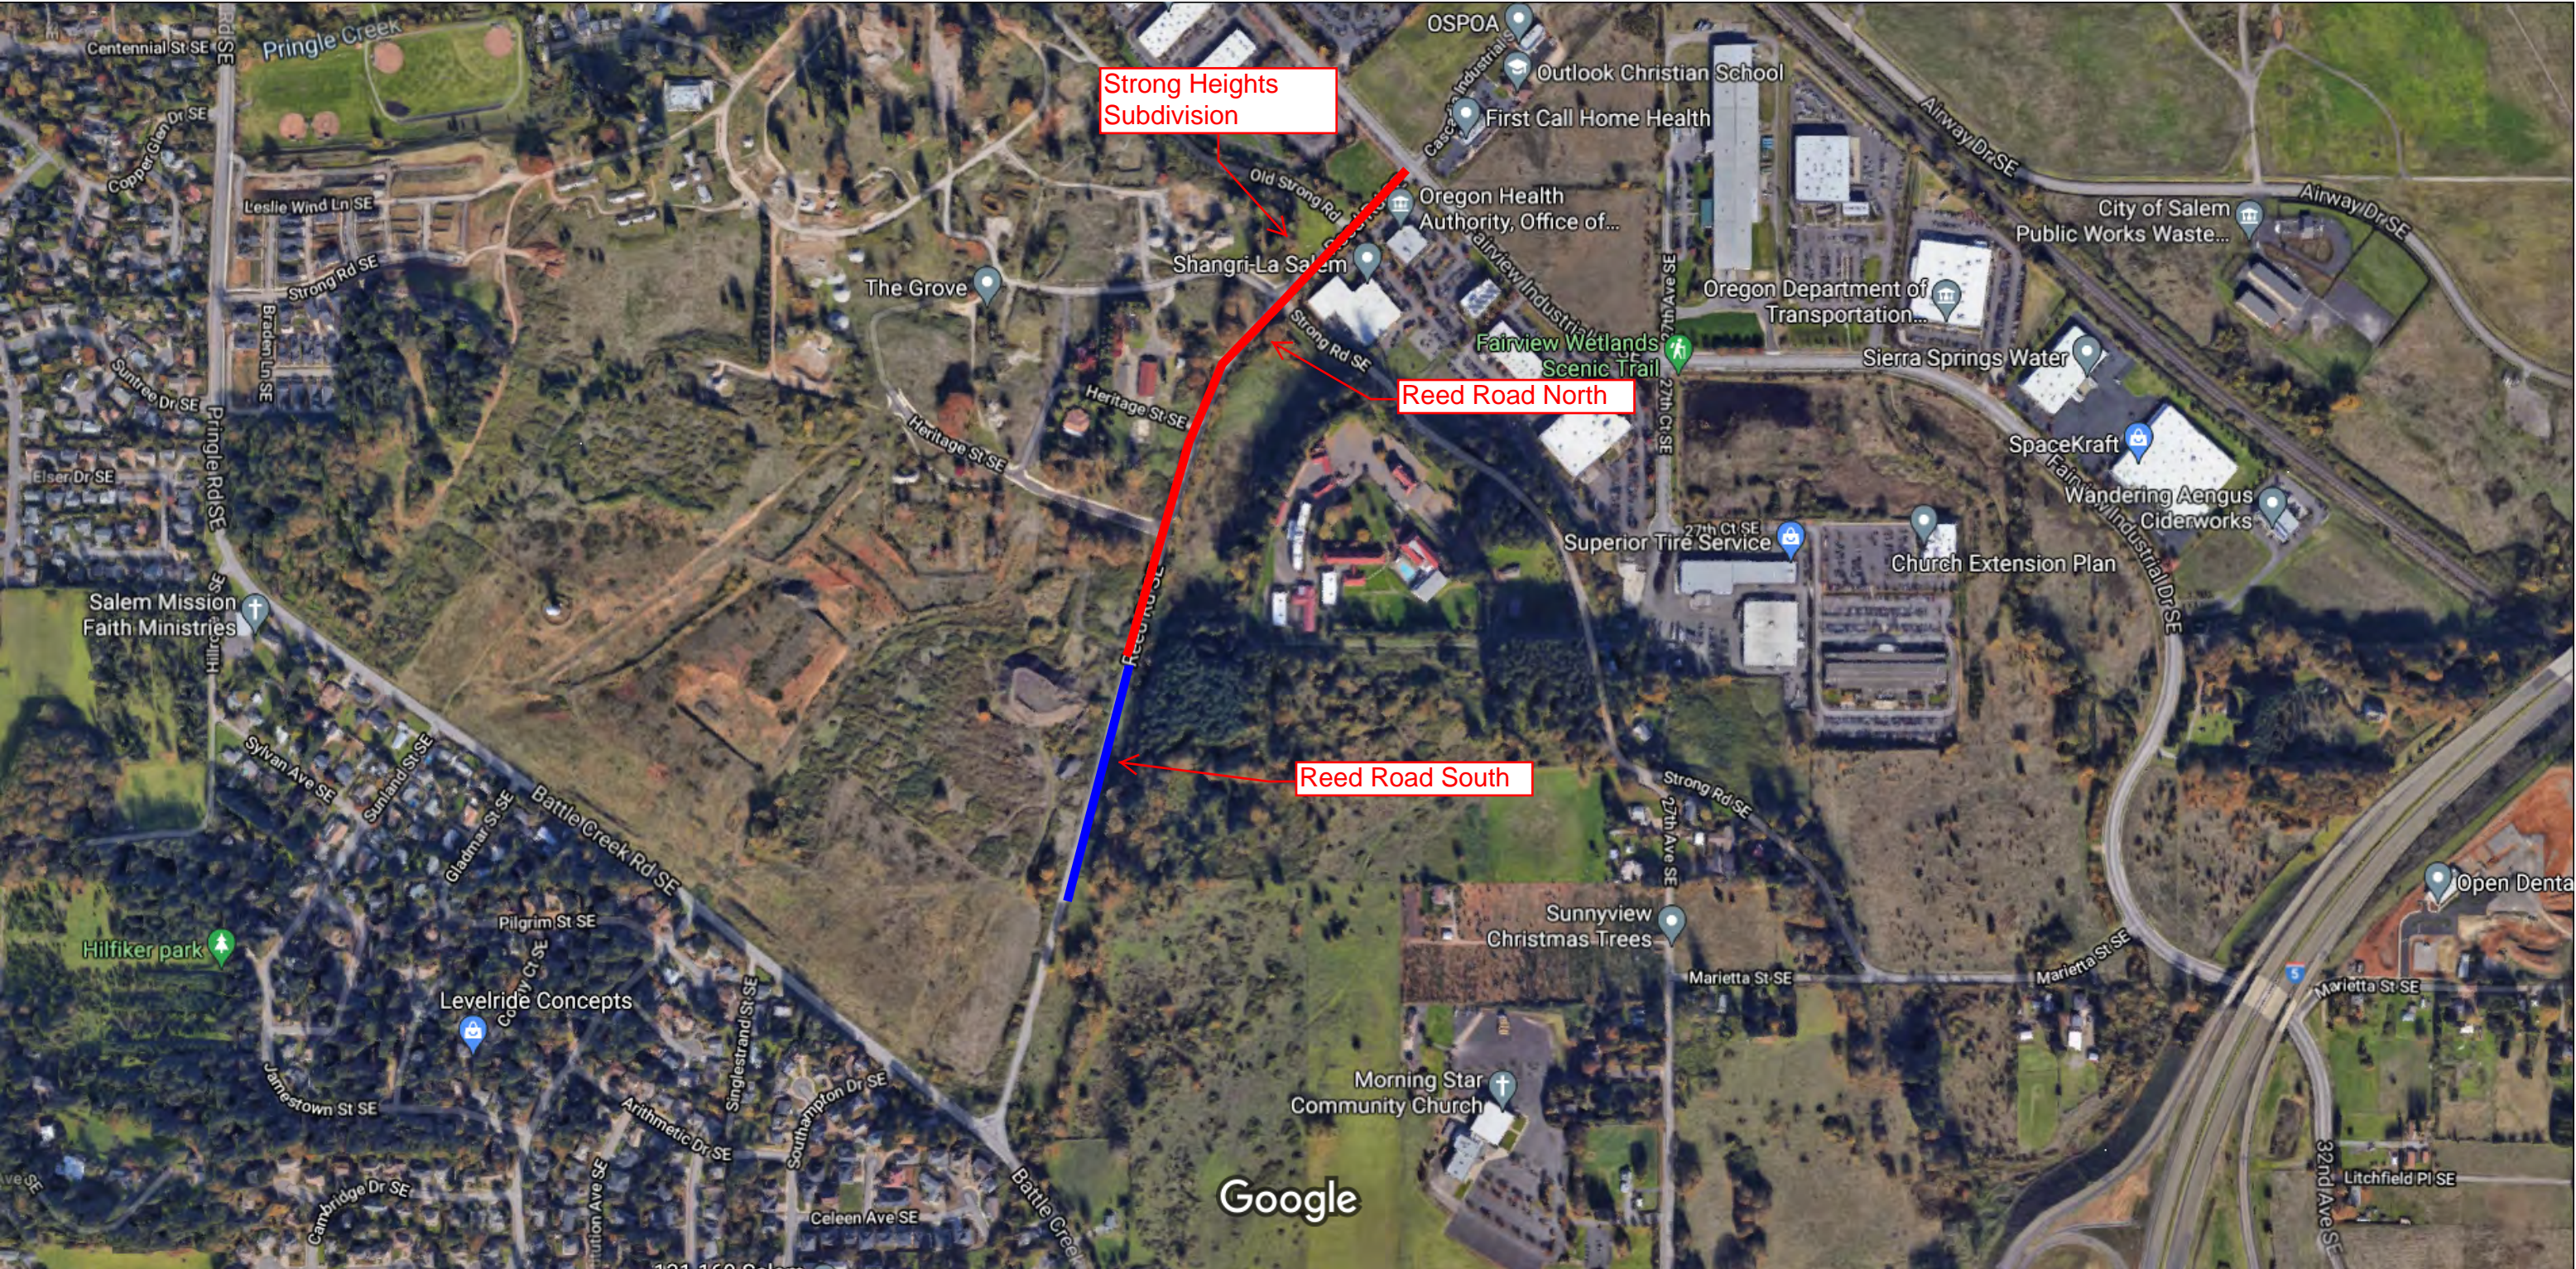
Figure 1. Strong Heights Subdivision site location and Reed Road SE widening north and south sections.

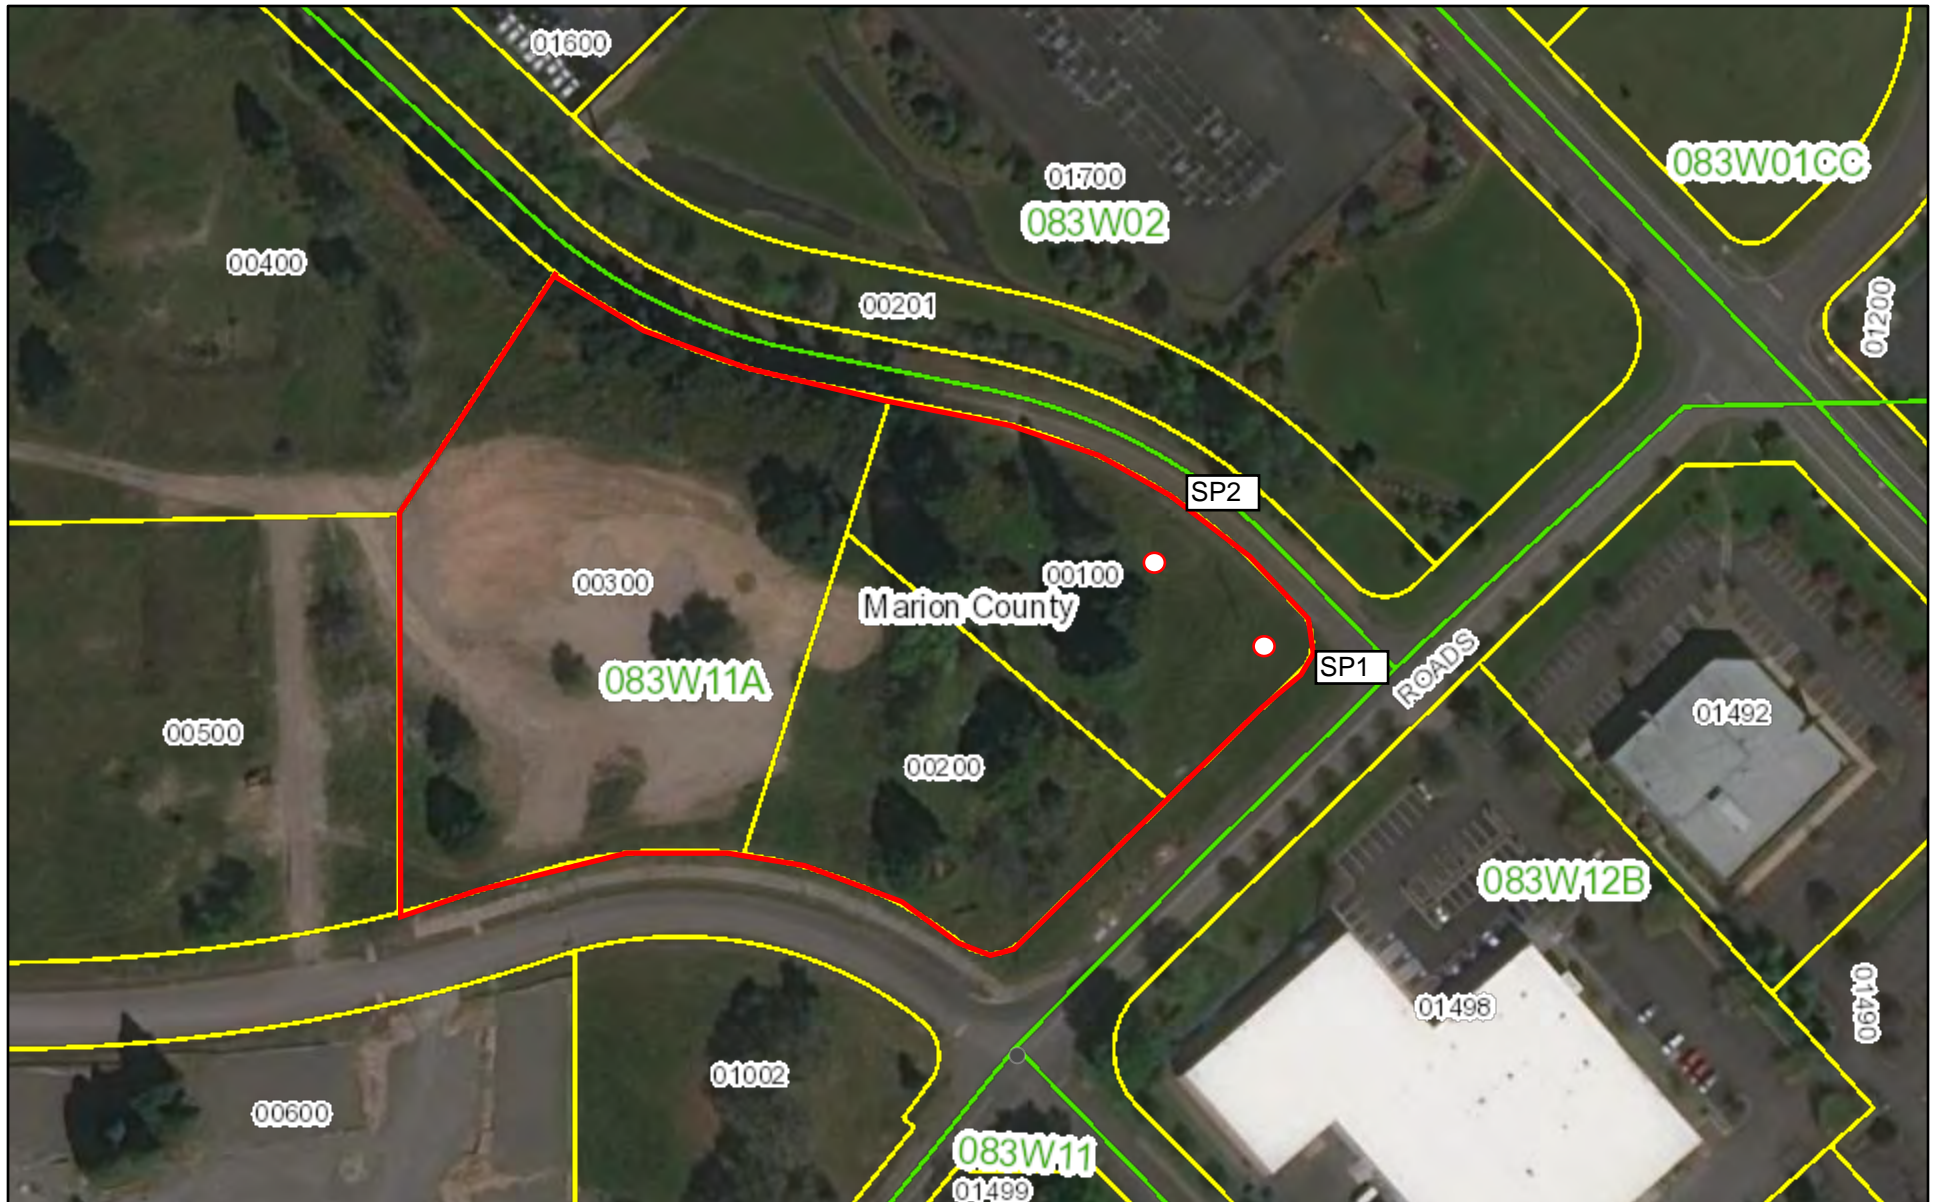
Figure 2. ORmap Aerial with Sample Plot (SP) Locations SP1 and SP2.

Two sample plots (SP1 and SP2) were documented in the northeast corner of the subject site (Figures 2 and 4 in Appendix A) where Reed Road SE and the West Middle Fork Pringle Creek had previously crossed the site. Soils were disturbed by gravel fill and were compacted and very hard to dig; vegetation was dominated by tall fescue (*Schedonorus arundinaceus*). No indicators of wetland hydrology were observed.

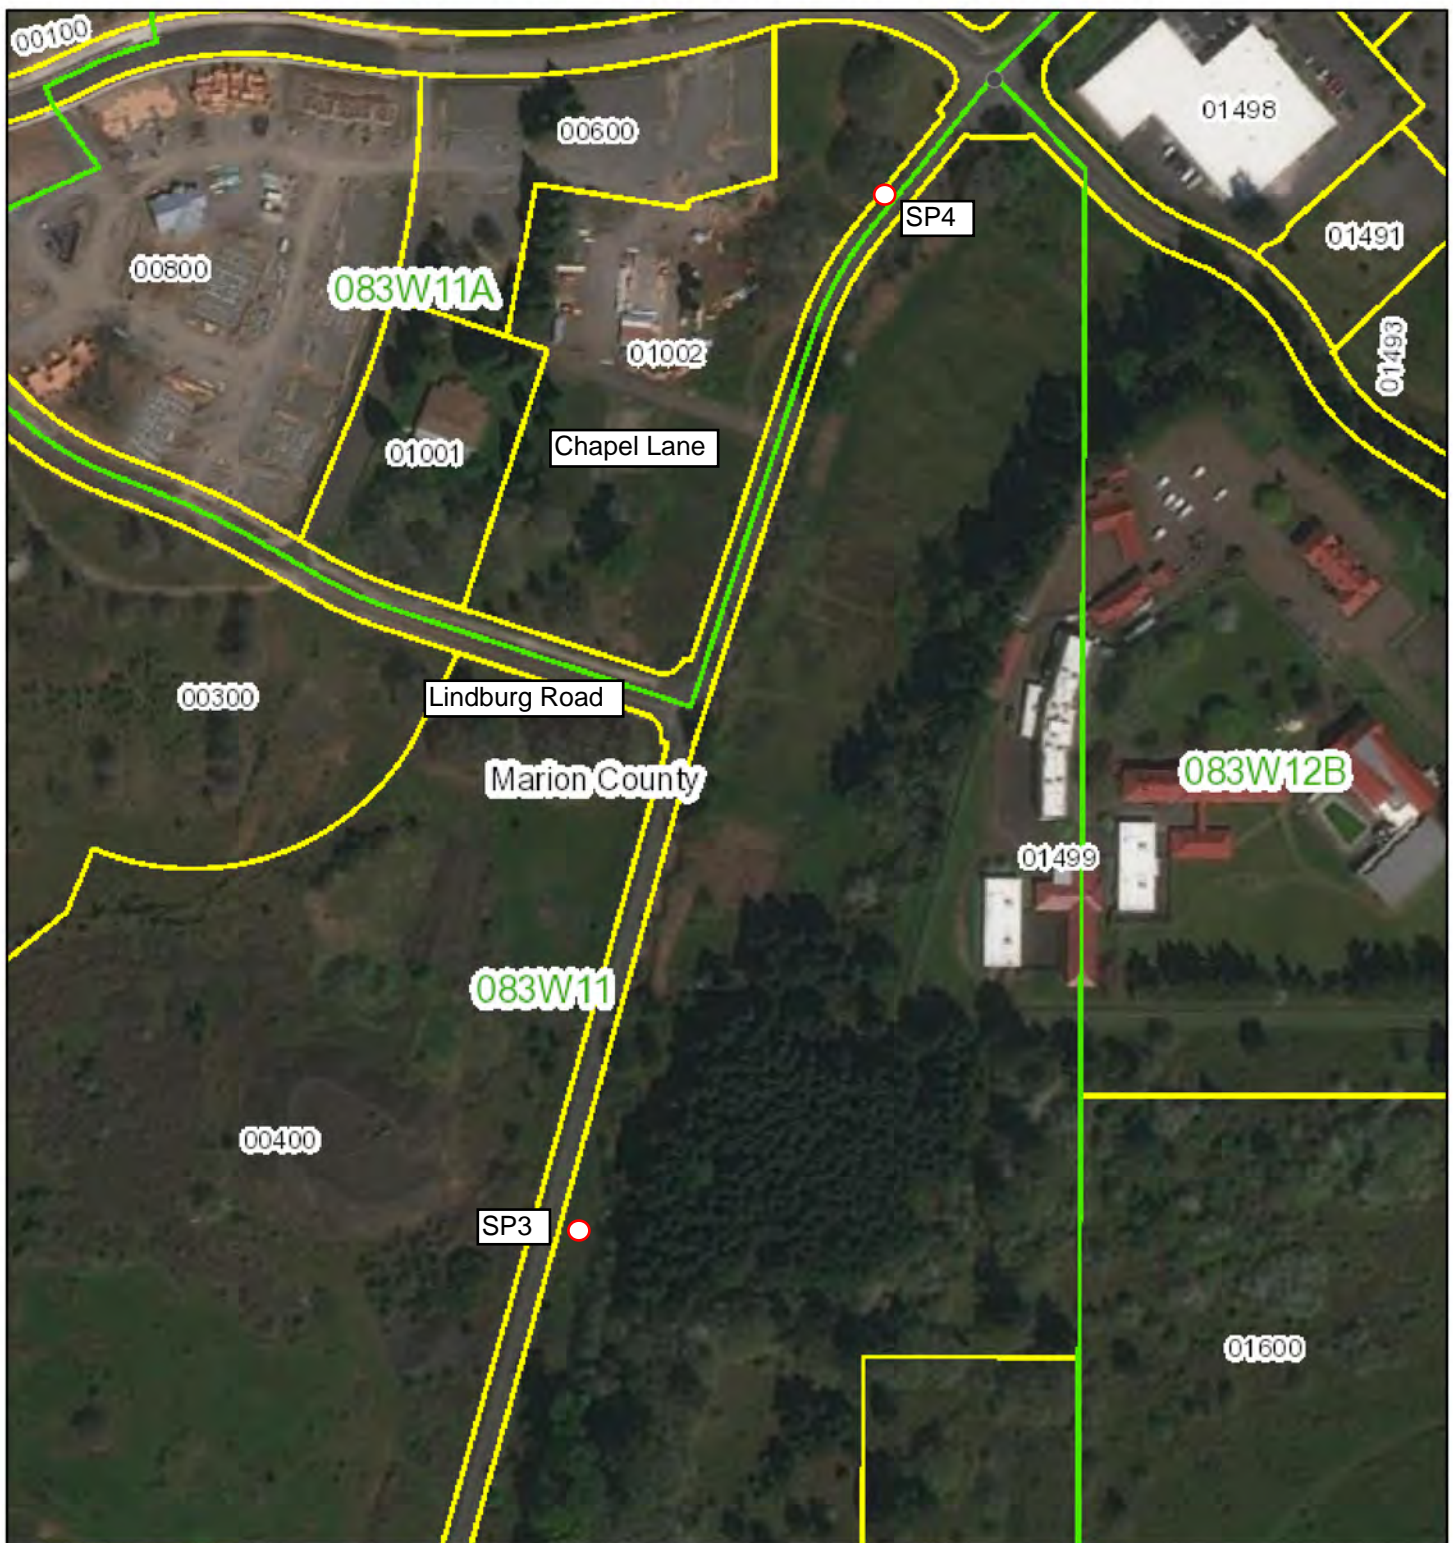
Figure 3. ORmap Aerial with SP3 and SP4.

One sample plot (SP4) was placed along Reed Road SE on the west side south of Strong Road and north of Chapel Lane SE (Figure 3 in Appendix A). Vegetation was dominated by Oregon white oak (*Quercus garryana*), field meadow-foxtail (*Alopecurus pratensis*), tall fescue, and tall oat grass (*Arrhenatherum elatius*). Soils were again constrained by gravels but no hydric soil indicators were observed in the surface 6 inches. No indicators of wetland hydrology were observed.

One sample plot (SP3) was placed along Reed Road SE on the east side where the West Middle Fork Pringle Creek swings away from the road (Figure 3 in Appendix A). Vegetation was dominated by tall fescue, field meadow-foxtail, and Kentucky blue grass (*Poa pratensis*). Soils were hard to dig and did not display any hydric soil indicators within the surface 4 inches. No indicators of wetland hydrology were observed. Wetlands may be present to the east, along the banks of the West Middle Fork Pringle Creek.
