## PACIFIC HABITAT SERVICES, INC.

**RE: Wetland Determination at 4375 Turner Road SE, Salem, OR**  
**PHS #7374**

Pacific Habitat Services, Inc. (PHS) conducted a wetland determination on October 21 and November 15, 2021, on City of Salem parcel no. 082W07C000200, consisting of 10.12 acres and located at 4375 Turner Road SE in Salem, Oregon (Township 8 South, Range 2 West, Section 7) (See attached Figures 1-2). The result of the wetland determination is that **a wetland confined to a ditch is located at the western boundary of the parcel. No other wetlands are present.**

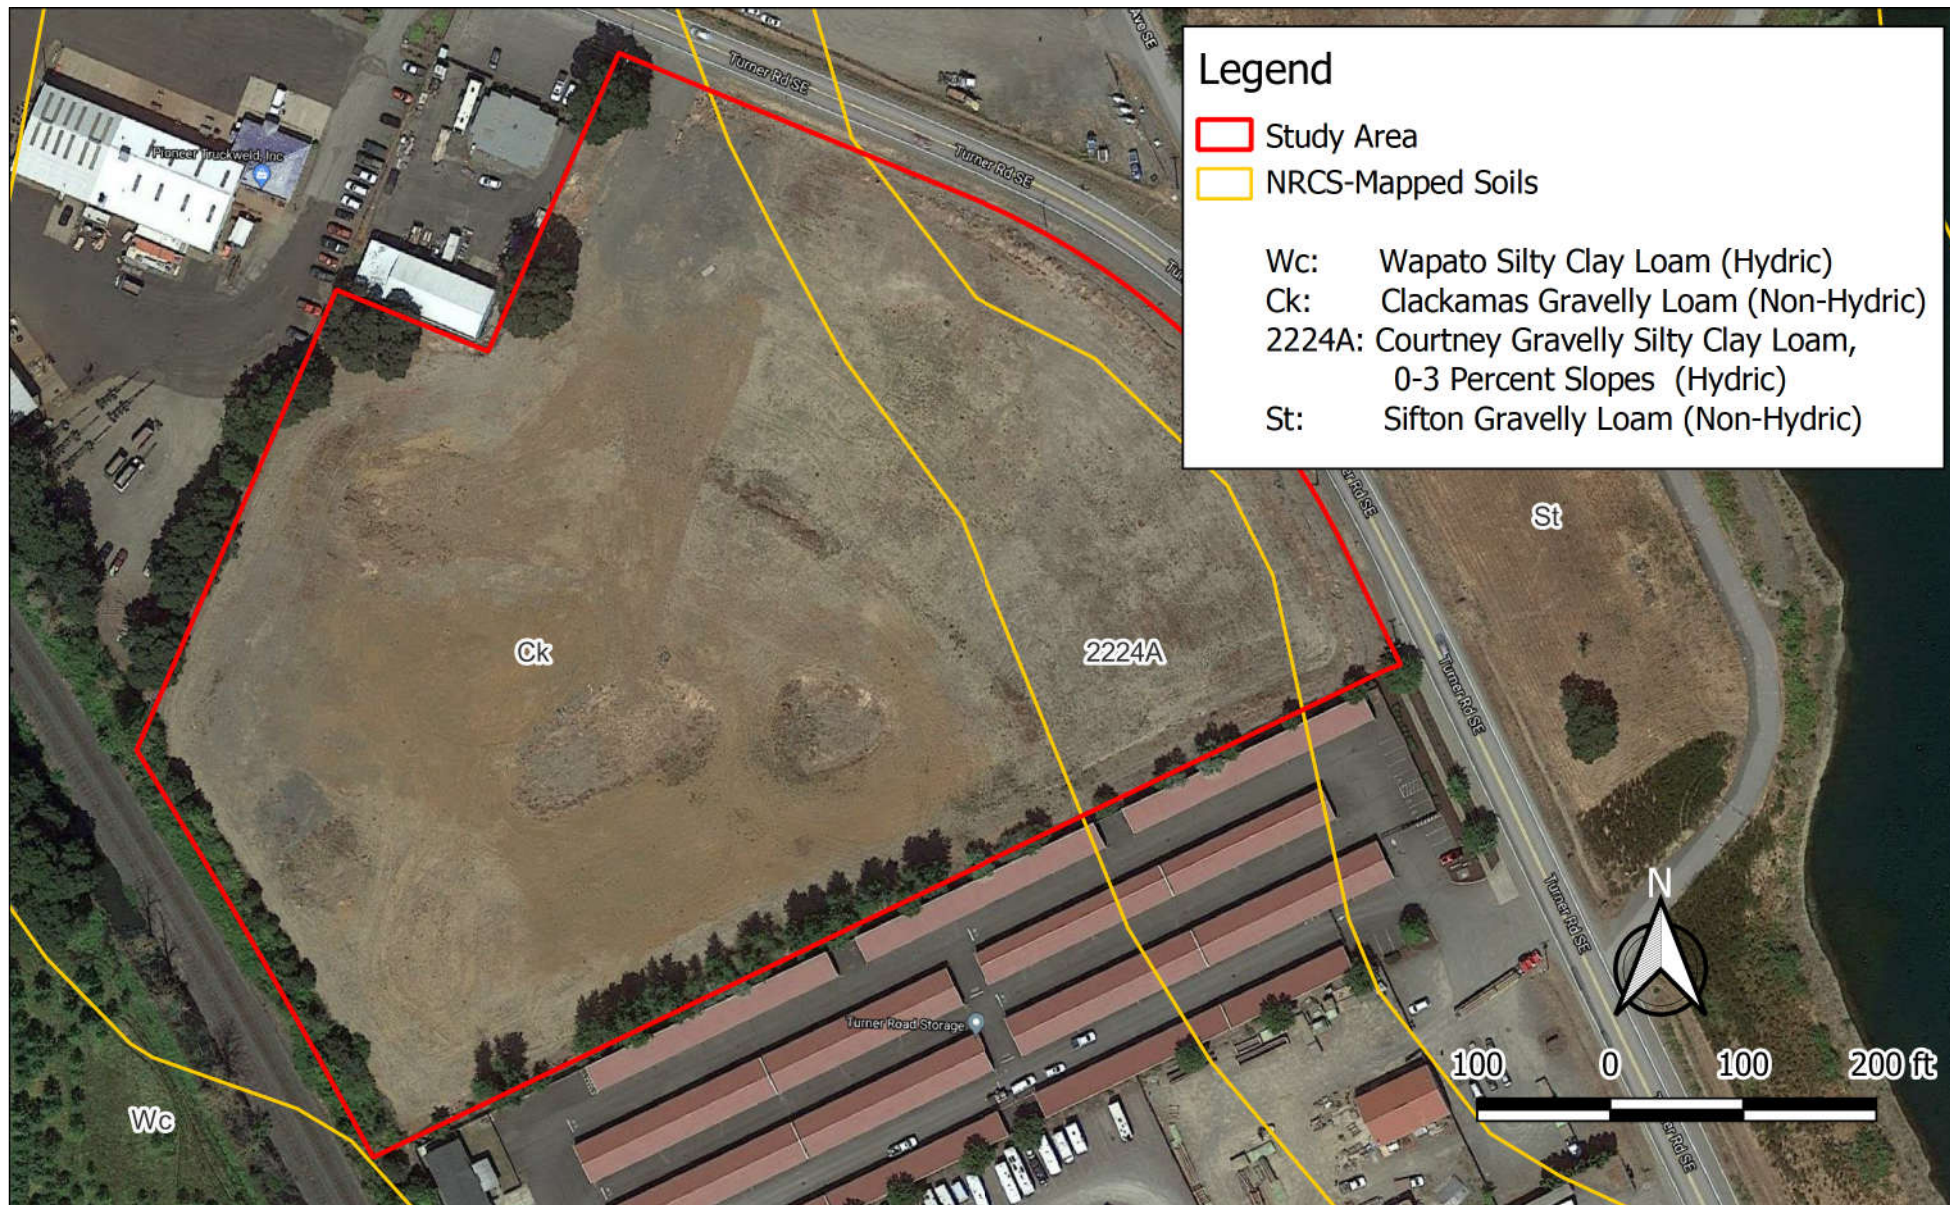
4

The overall study area topography is flat; however, four borrow pits and several drainage ditches are present. Courtney gravelly silty clay loam, 0-3 percent slopes, a hydric is mapped within a portion of the property. Drainage ditches are located adjacent to Turner Road SE; however, these are located in Sifton gravelly loam soils, which are not mapped as hydric, and no wetlands are present. The borrow pits do not have wetlands and are located in Clackamas gravelly loam soils, which are also not mapped as hydric.

4375 Turner Road SE, Salem, OR  
Soils

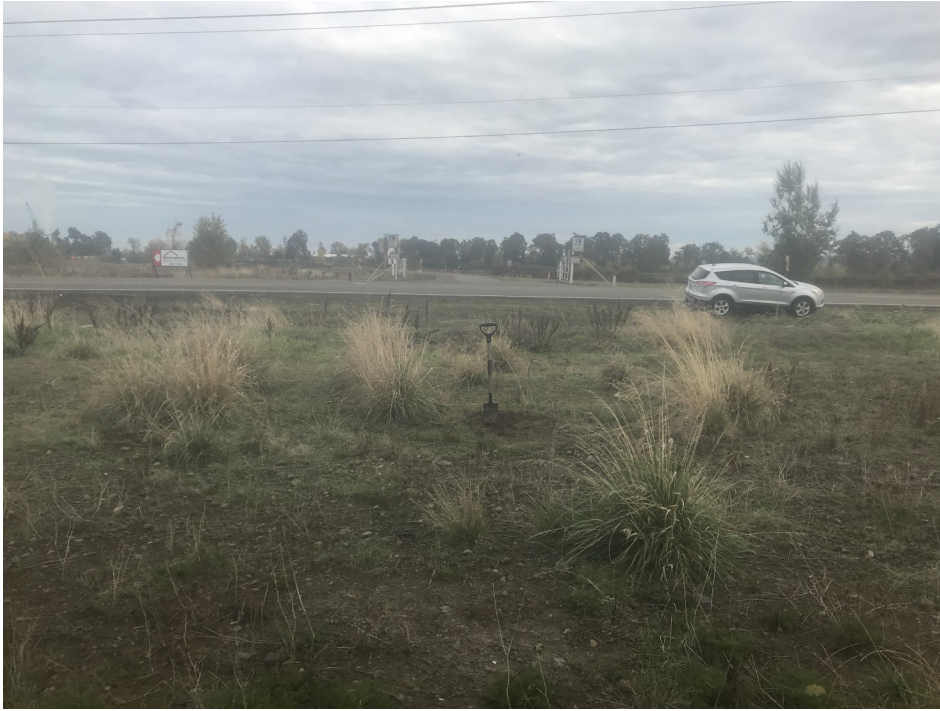
**Photo A:**

Sample point 1 was placed in a disturbed area in the eastern part of the study area with mapped Courtney clay loam soils. The dominant vegetation is dove's-foot geranium, tall fescue, and Queen Anne's lace. Wetland hydrology was not present; however, soils met the requirements for a depleted matrix, although the upper five inches of the soil had a high chroma (10YR 3/3) indicating that it was possibly fill.

Looking east at Sample Point 1

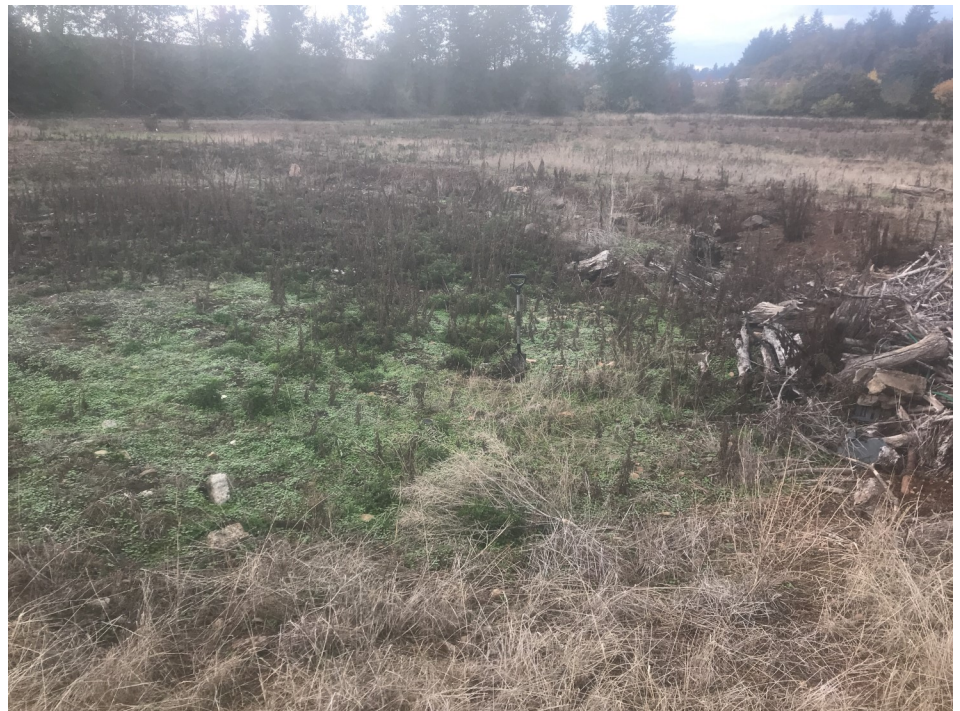
**Photo B:**

Sample point 2 was taken in a borrow pit midway between the eastern and western study area boundaries in the southern portion of the study area. Hydrophytic vegetation, hydric soils, and wetland hydrology were not present.

Looking southwest at Sample Point 2, located within a borrow pit.

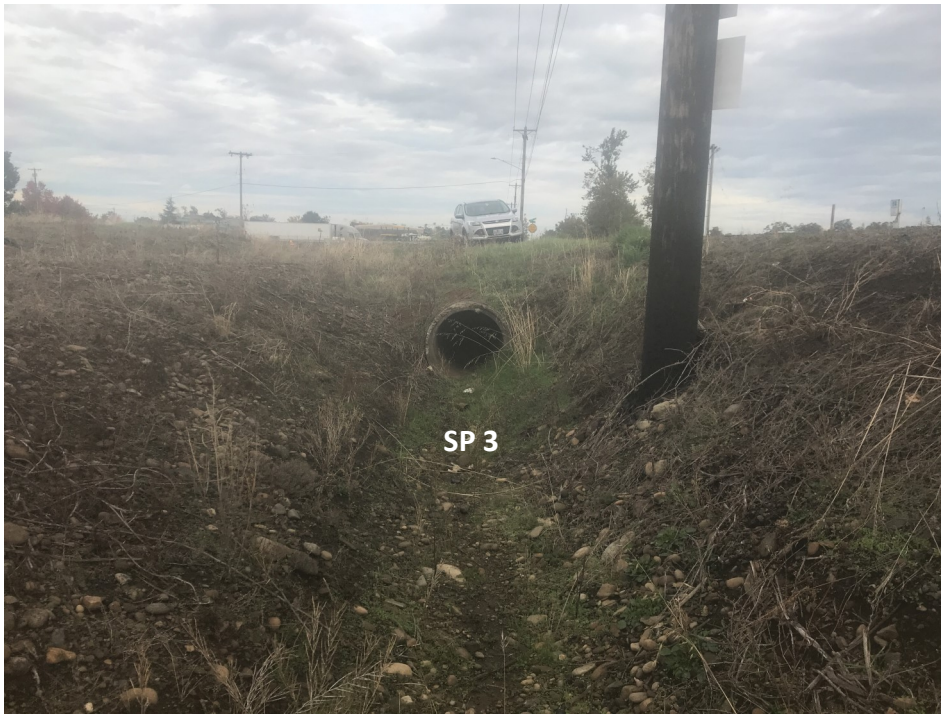
**Photo C:**

Sample point 3 was taken in a drainage ditch adjacent to Turner Road SE. The dominant vegetation was shiny geranium. Hydrophytic vegetation, hydric soils, and wetland hydrology were not present.

Looking north at Sample Point 3,  
located within a roadside ditch.

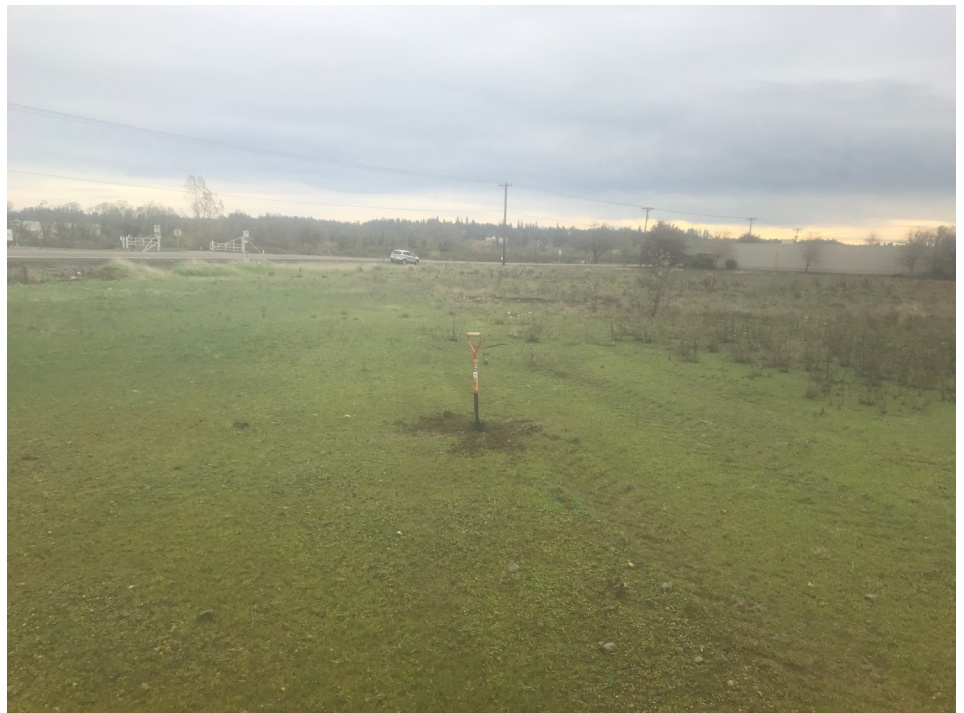
**Photo D:**

Sample point 4 was taken in a slight topographic depression in the northeastern portion of the study area is mapped Courtney clay loam soils. Wetland vegetation, soils, and hydrology were not present, and the soil profile appeared to be a mixture of native soil and fill.

Looking northwest at Sample  
Point 4.
