linea lab architecture

1205 Wallace Rd Class 2 Adjustment Application

Project Description: Interior remodel of existing building. Demo of existing partition walls & finishes. New partition walls , finishes, MEP & ADA upgrades. Change of use from medical office to Head Start day care/preschool.

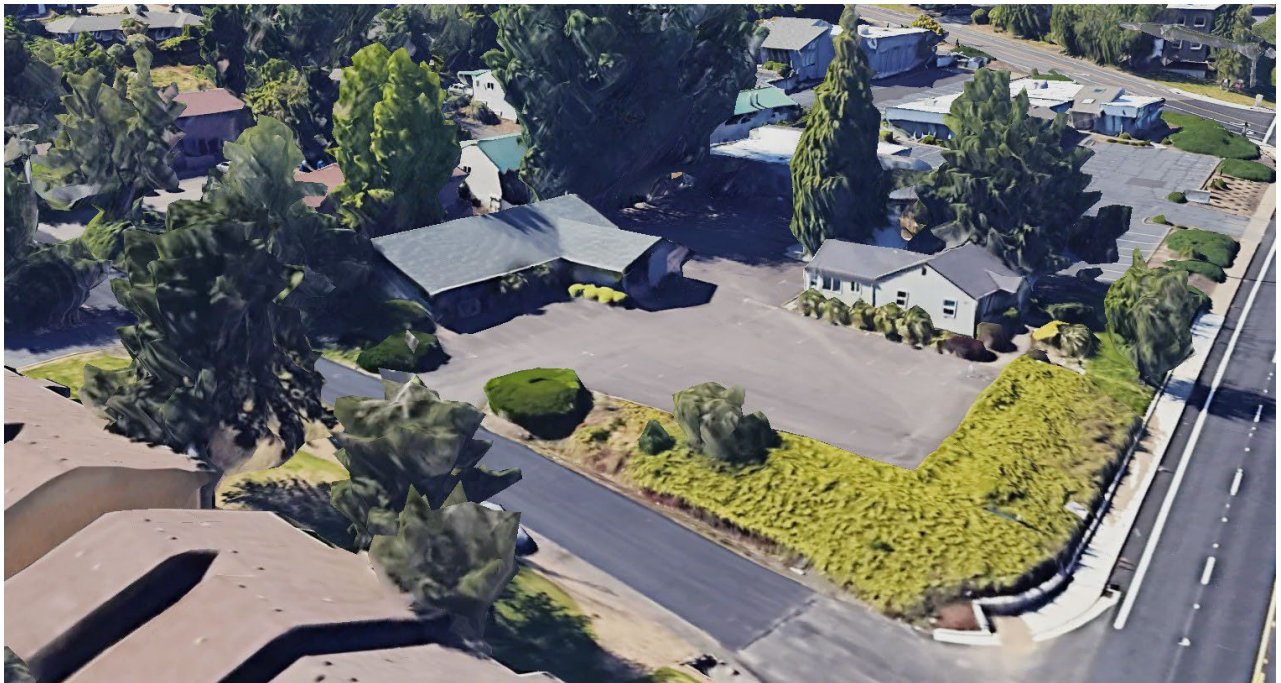
GOOGLE EARTH 3D IMAGE OF DEVELOPMENT SITE – CORNER OF WALLACE RD & TAYBIN RD FACING NW

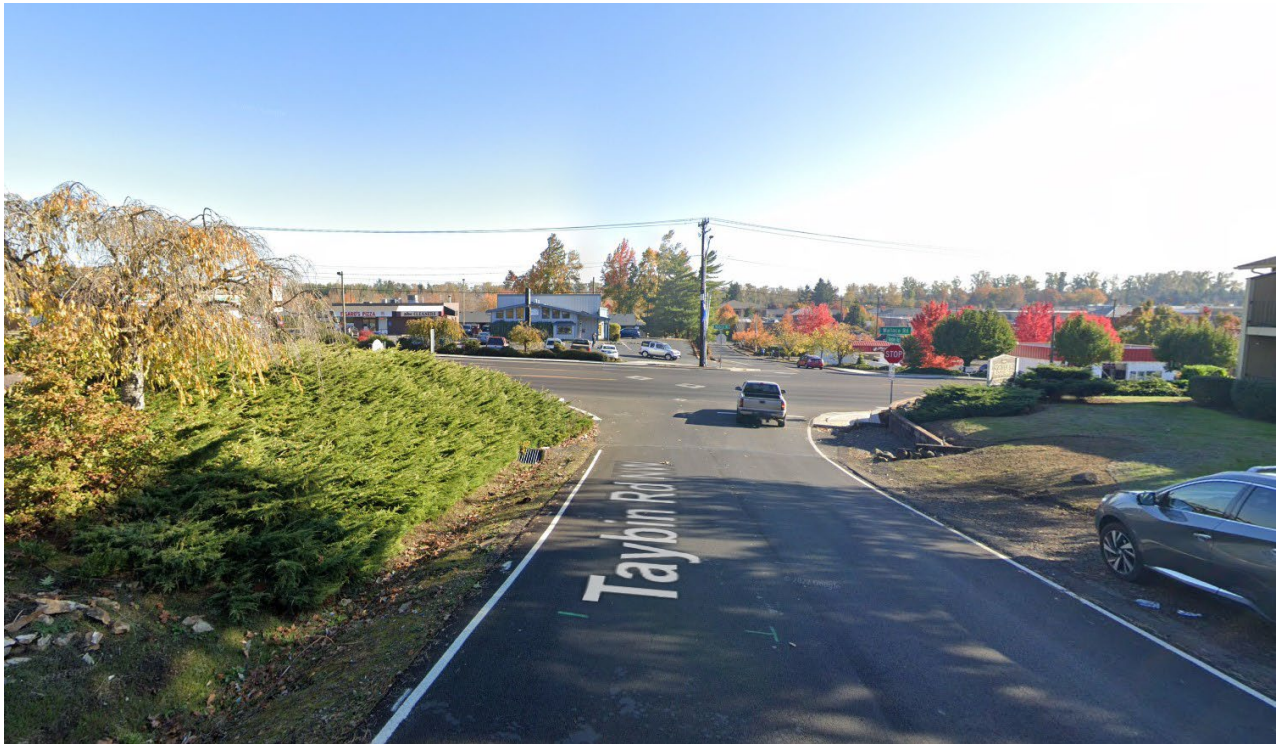
TAYBIN ROAD FACING EAST — NON-TRAVERSABLE DRAINAGE DITCH AND GRATED INLET ¹

- No sidewalk exists on either side of Taybin Rd.
- New sidewalk on Wallace Rd currently blocks pedestrians from turning corner up Taybin road with a retaining wall.
- Non-traversable drainage ditch occupies approximately 50% of the property line at Taybin Rd.
- Existing grated inlet and drain pipe at SW corner of property are installed very close to the surface and would need to be revised/reinstalled to allow for sidewalk / pedestrian walkway.

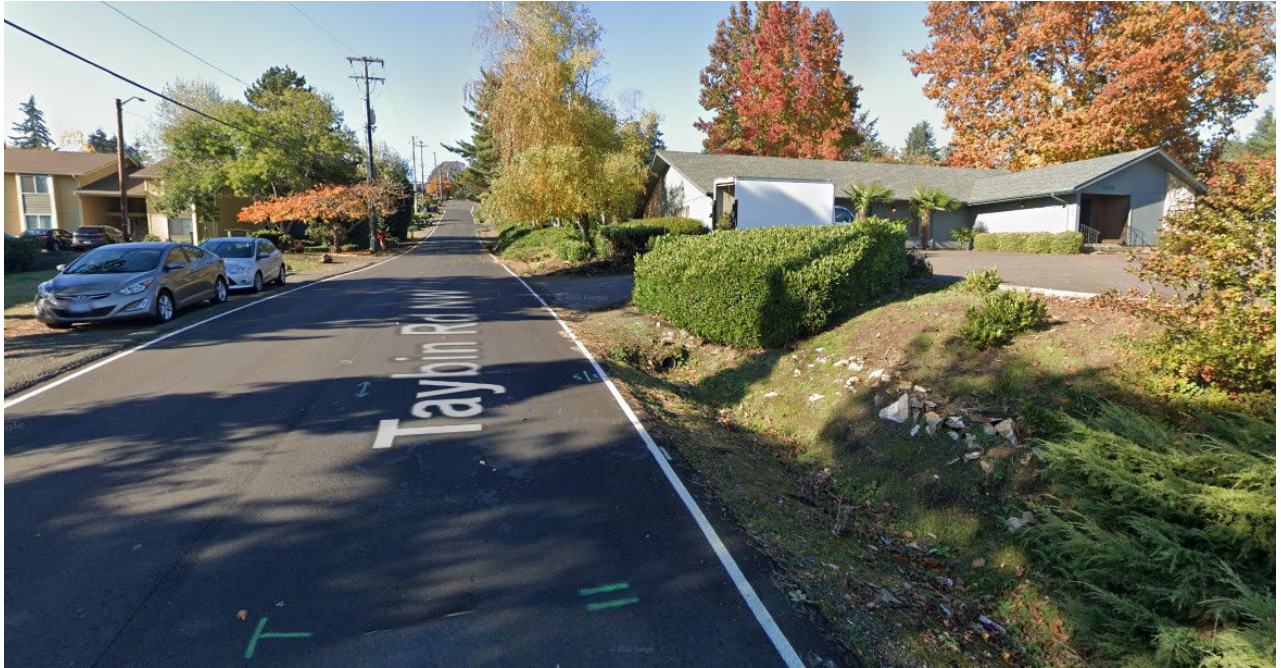
TAYBIN RD FACING WEST — NO EXISTING SIDEWALKS, NOTE EXISTING DRAINAGE DITCH¹

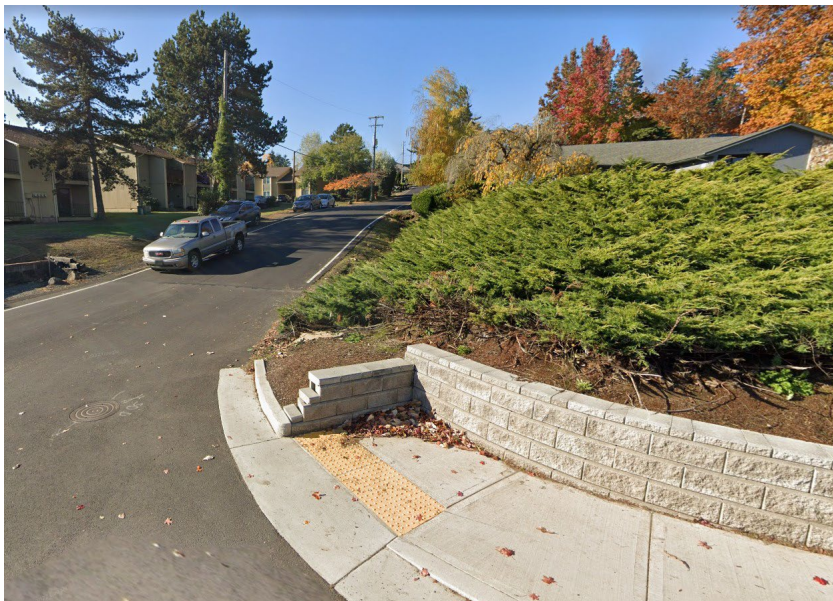
CORNER OF WALLACE RD & TAYBIN RD — RETAINING WALL BLOCKS PEDESTRIAN PATH UP TAYBIN RD¹
