# *Special Inspection*

*4828 San Miguel Ct*

June 4<sup>th</sup>, 2024

Our office has been requested to provide special inspections of the existing trees and the home located at 4828 San Miguel Ct in northeast Salem.

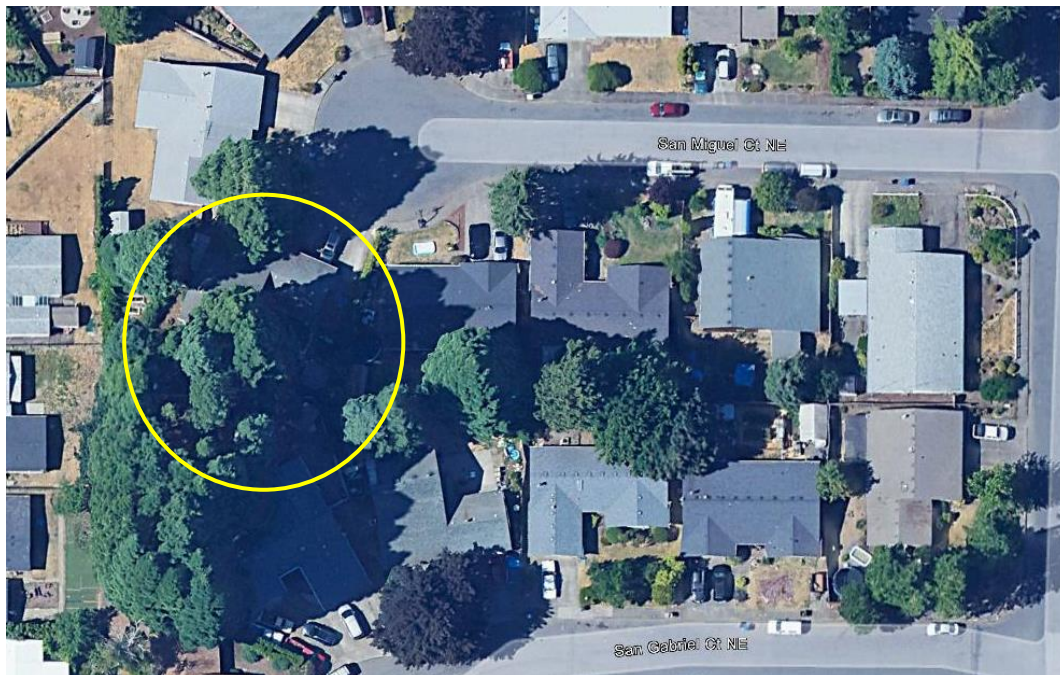
The subdivision was constructed in a site that was a wholesale nursery and had a lot of overgrown landscape trees. In the area of this home were sequoia trees.
