April 13, 2021

**Subject: Geotechnical Evaluation & Landslide Hazard Study  
Meyer Farm Subdivision  
GCN Project 1556-01**

The approximate 30-acre Meyer Farm site located in the hill area south of the Salem Airport is to be developed with single family homes. The site relative to surrounding features is shown in Figure 1.

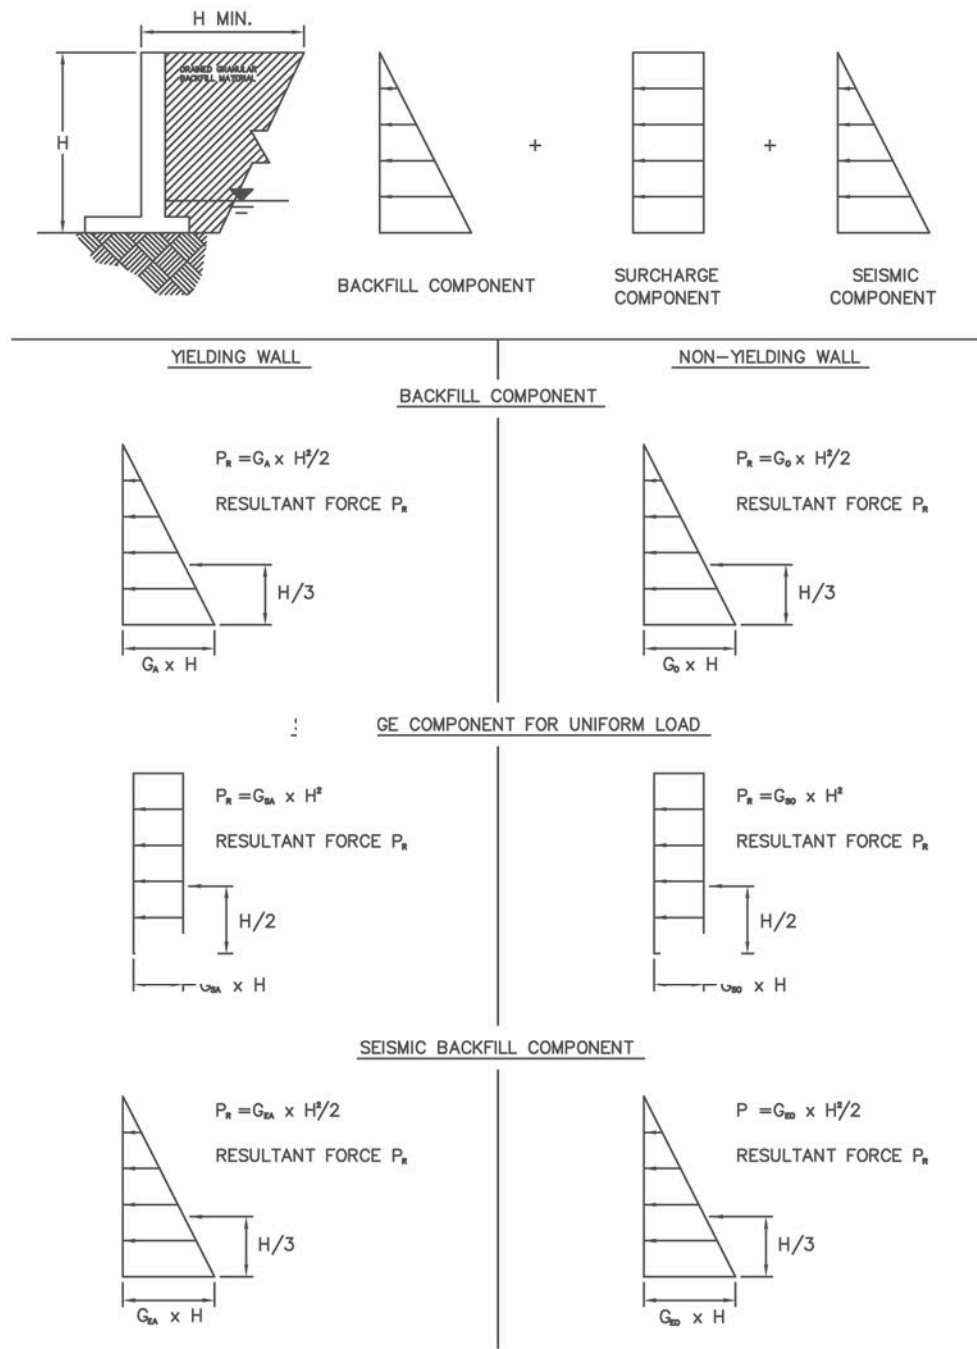
**FIGURE 5**

In general, cantilever retaining walls yield under lateral loads and should be designed with active lateral earth pressures. Restrained walls, such as embedded building walls and vaults should be designed to withstand at-rest lateral earth pressures. We recommend using the lateral earth pressures shown in Table 4. The loads are provided as equivalent fluid density (G). Diagrams showing use of the lateral earth pressures in design calculations are provided in Figure 3.

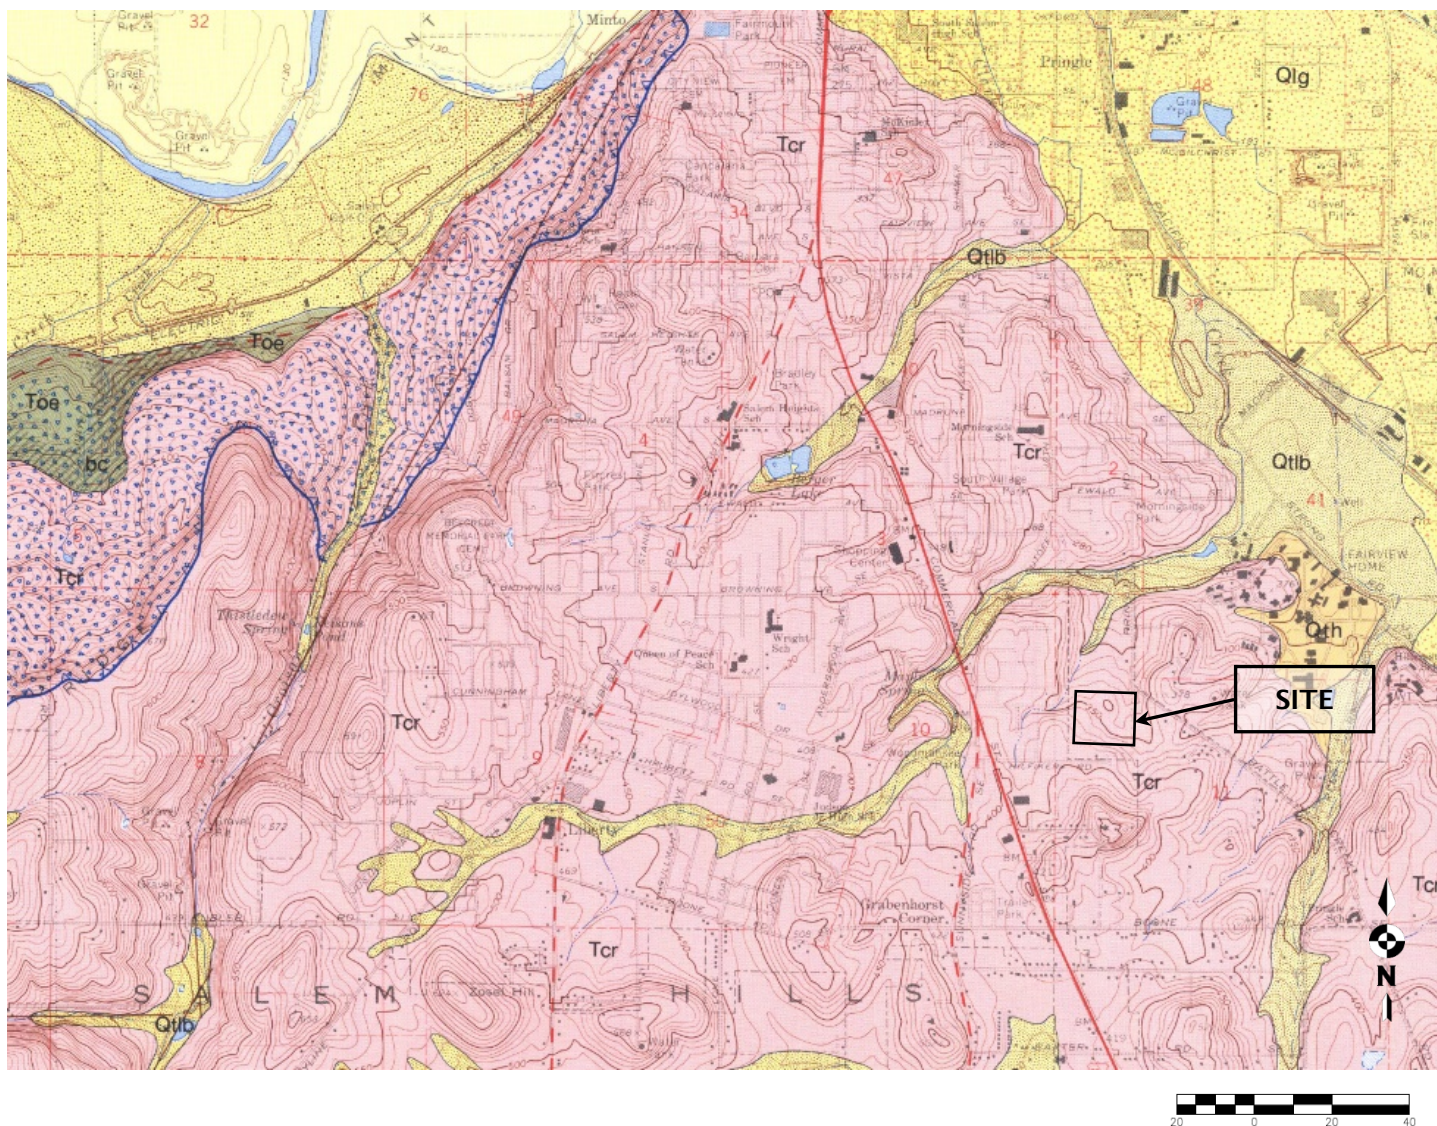
<b>GEO</b> CONSULTANTS NORTHWEST	PROJECT 1556	KEHOE MEYER FARM	
2839 SE Milwaukie Avenue Portland, OR 97202	APR 2021	<b>INTERPRETIVE GEOLOGY MAP</b>	<b>FIGURE B1</b>
	Drawn By: tac

Tcr - Columbia River Basalt Group (Miocene): Medium-gray to black, fine-grained, even-textured to slightly porphyritic basalt; unweathered flows generally dense, massive columnar jointing near base to diced or hackly jointing in entablature. Unit consists of weathered and unweathered basaltic lava flows with zones of vesicular flow-top breccia, ash, and baked soil. Maximum thickness generally ranges 400-600 feet. Individual flows range from 40 to 100 ft in thickness.

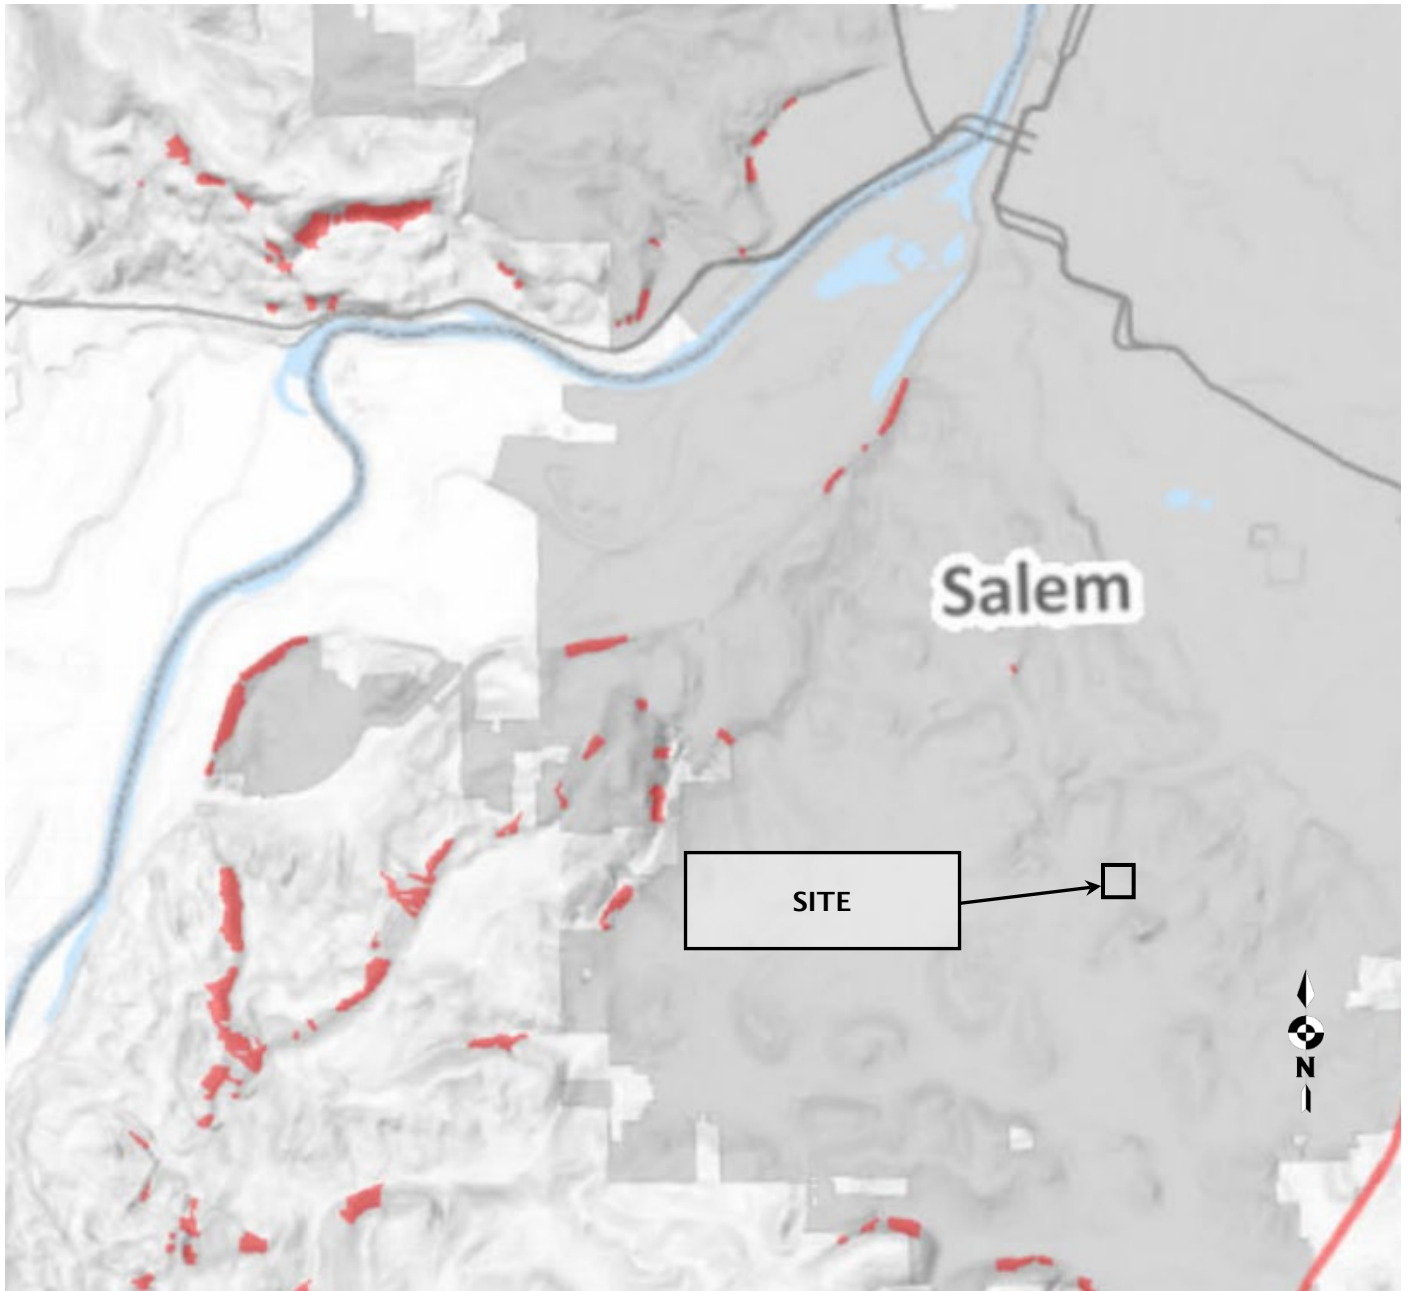
<b>GEO</b> CONSULTANTS NORTHWEST	PROJECT 1556	KEHOE MEYER FARM	
2839 SE Milwaukie Avenue Portland, OR 97202	APR 2021	LANDSLIDE SUSCEPTIBILITY	FIGURE B2
	Drawn By: tac

RED = POTENTIAL LANDSLIDE HAZARD ZONES
