ARBORIST REPORT

Located at: 490 Leffelle St S, Salem

Prepared for: Todd Hixson

Evaluation performed: August 8, 2022

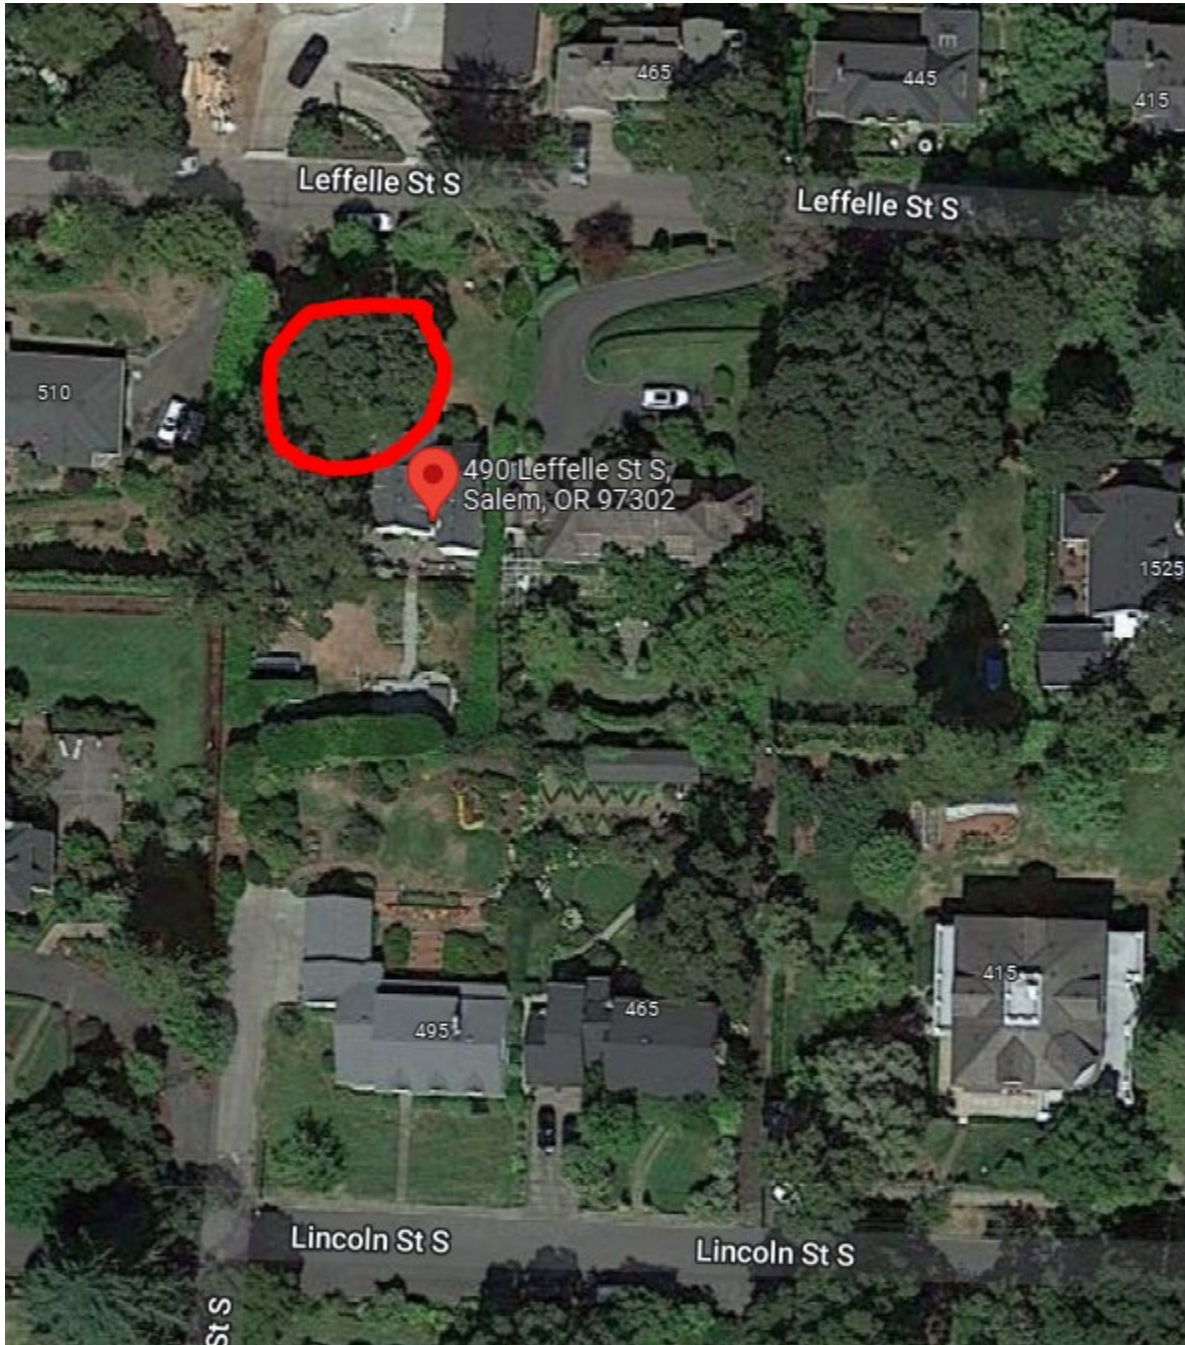
PICTURE 1
Taken 08/09/2022

I visited the property on August 8, 2022 to assess the health of the oak tree. During visual inspection of the tree, I noted fungal conk at the base of the trunk. The homeowner pointed out the tree has been shifting. I noted a large cavity in the base of the tree and using a rod, inserted into the cavity. As you can see by the attached pictures #2 & 3, I measured the cavity at approximately 46" deep.

The combination of conk at the trunk, a deep cavity and shifting indicate the tree is hazardous and should be removed as soon as possible.
