**Geotechnical Investigation and Geologic Hazard Assessment
Proposed Doakes Ferry Subdivision/Titan Hill Development Site**

Tax Lot No. 400

Salem (Polk County), Oregon

**Project No. 1004.033.G
November 4, 2022**

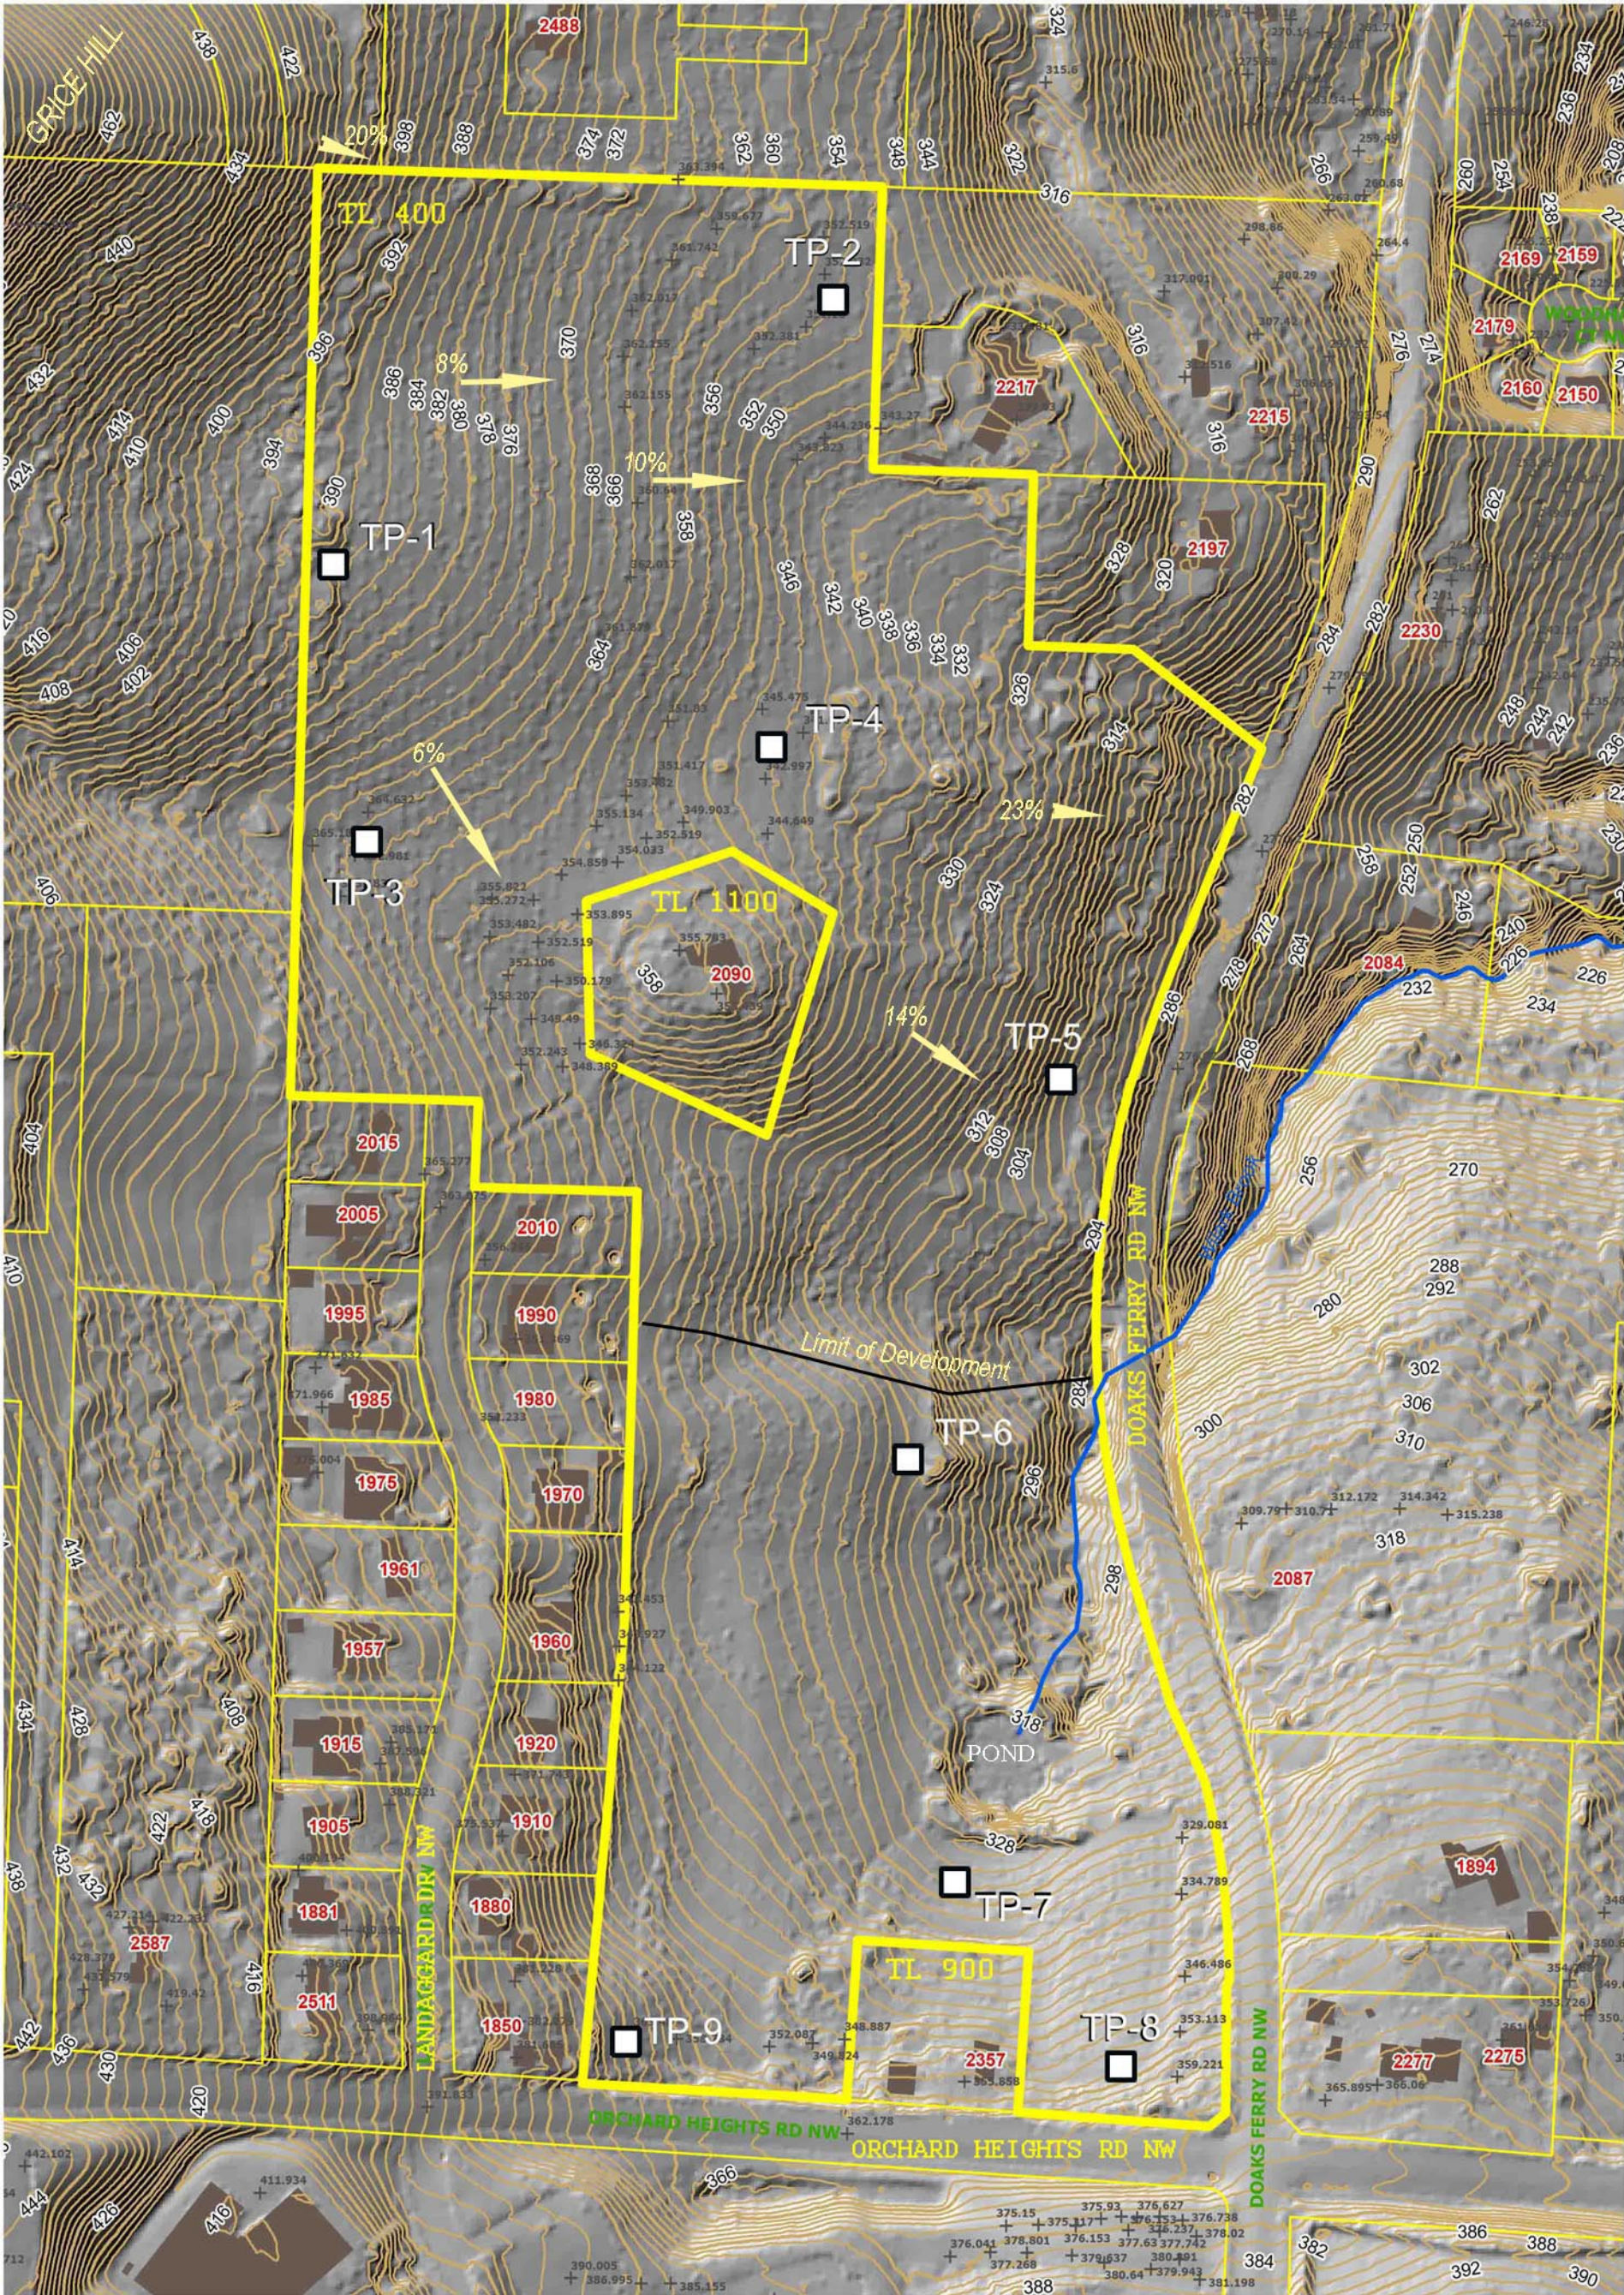
Chapman Corner		
7S/3W-17b TL 400, 900 & 1100		
Landslide Hazard Study		
State Landslide Hazard Map		
NGS, Inc.	November 2022	Figure 3

Figure 3 shows the Statewide Landslide Information Database for Oregon (SLIDO) compilation for the site area. According to SLIDO there are no nearby historic slope failures and none of the previous studies included in SLIDO show prehistoric failures nearby. Neither the topography (e.g., Figure 2) nor LIDAR (Figure 3, upper) show anomalies that indicate slope failures near the site. Consequently, SLIDO estimates an overall low to moderate landslide potential.

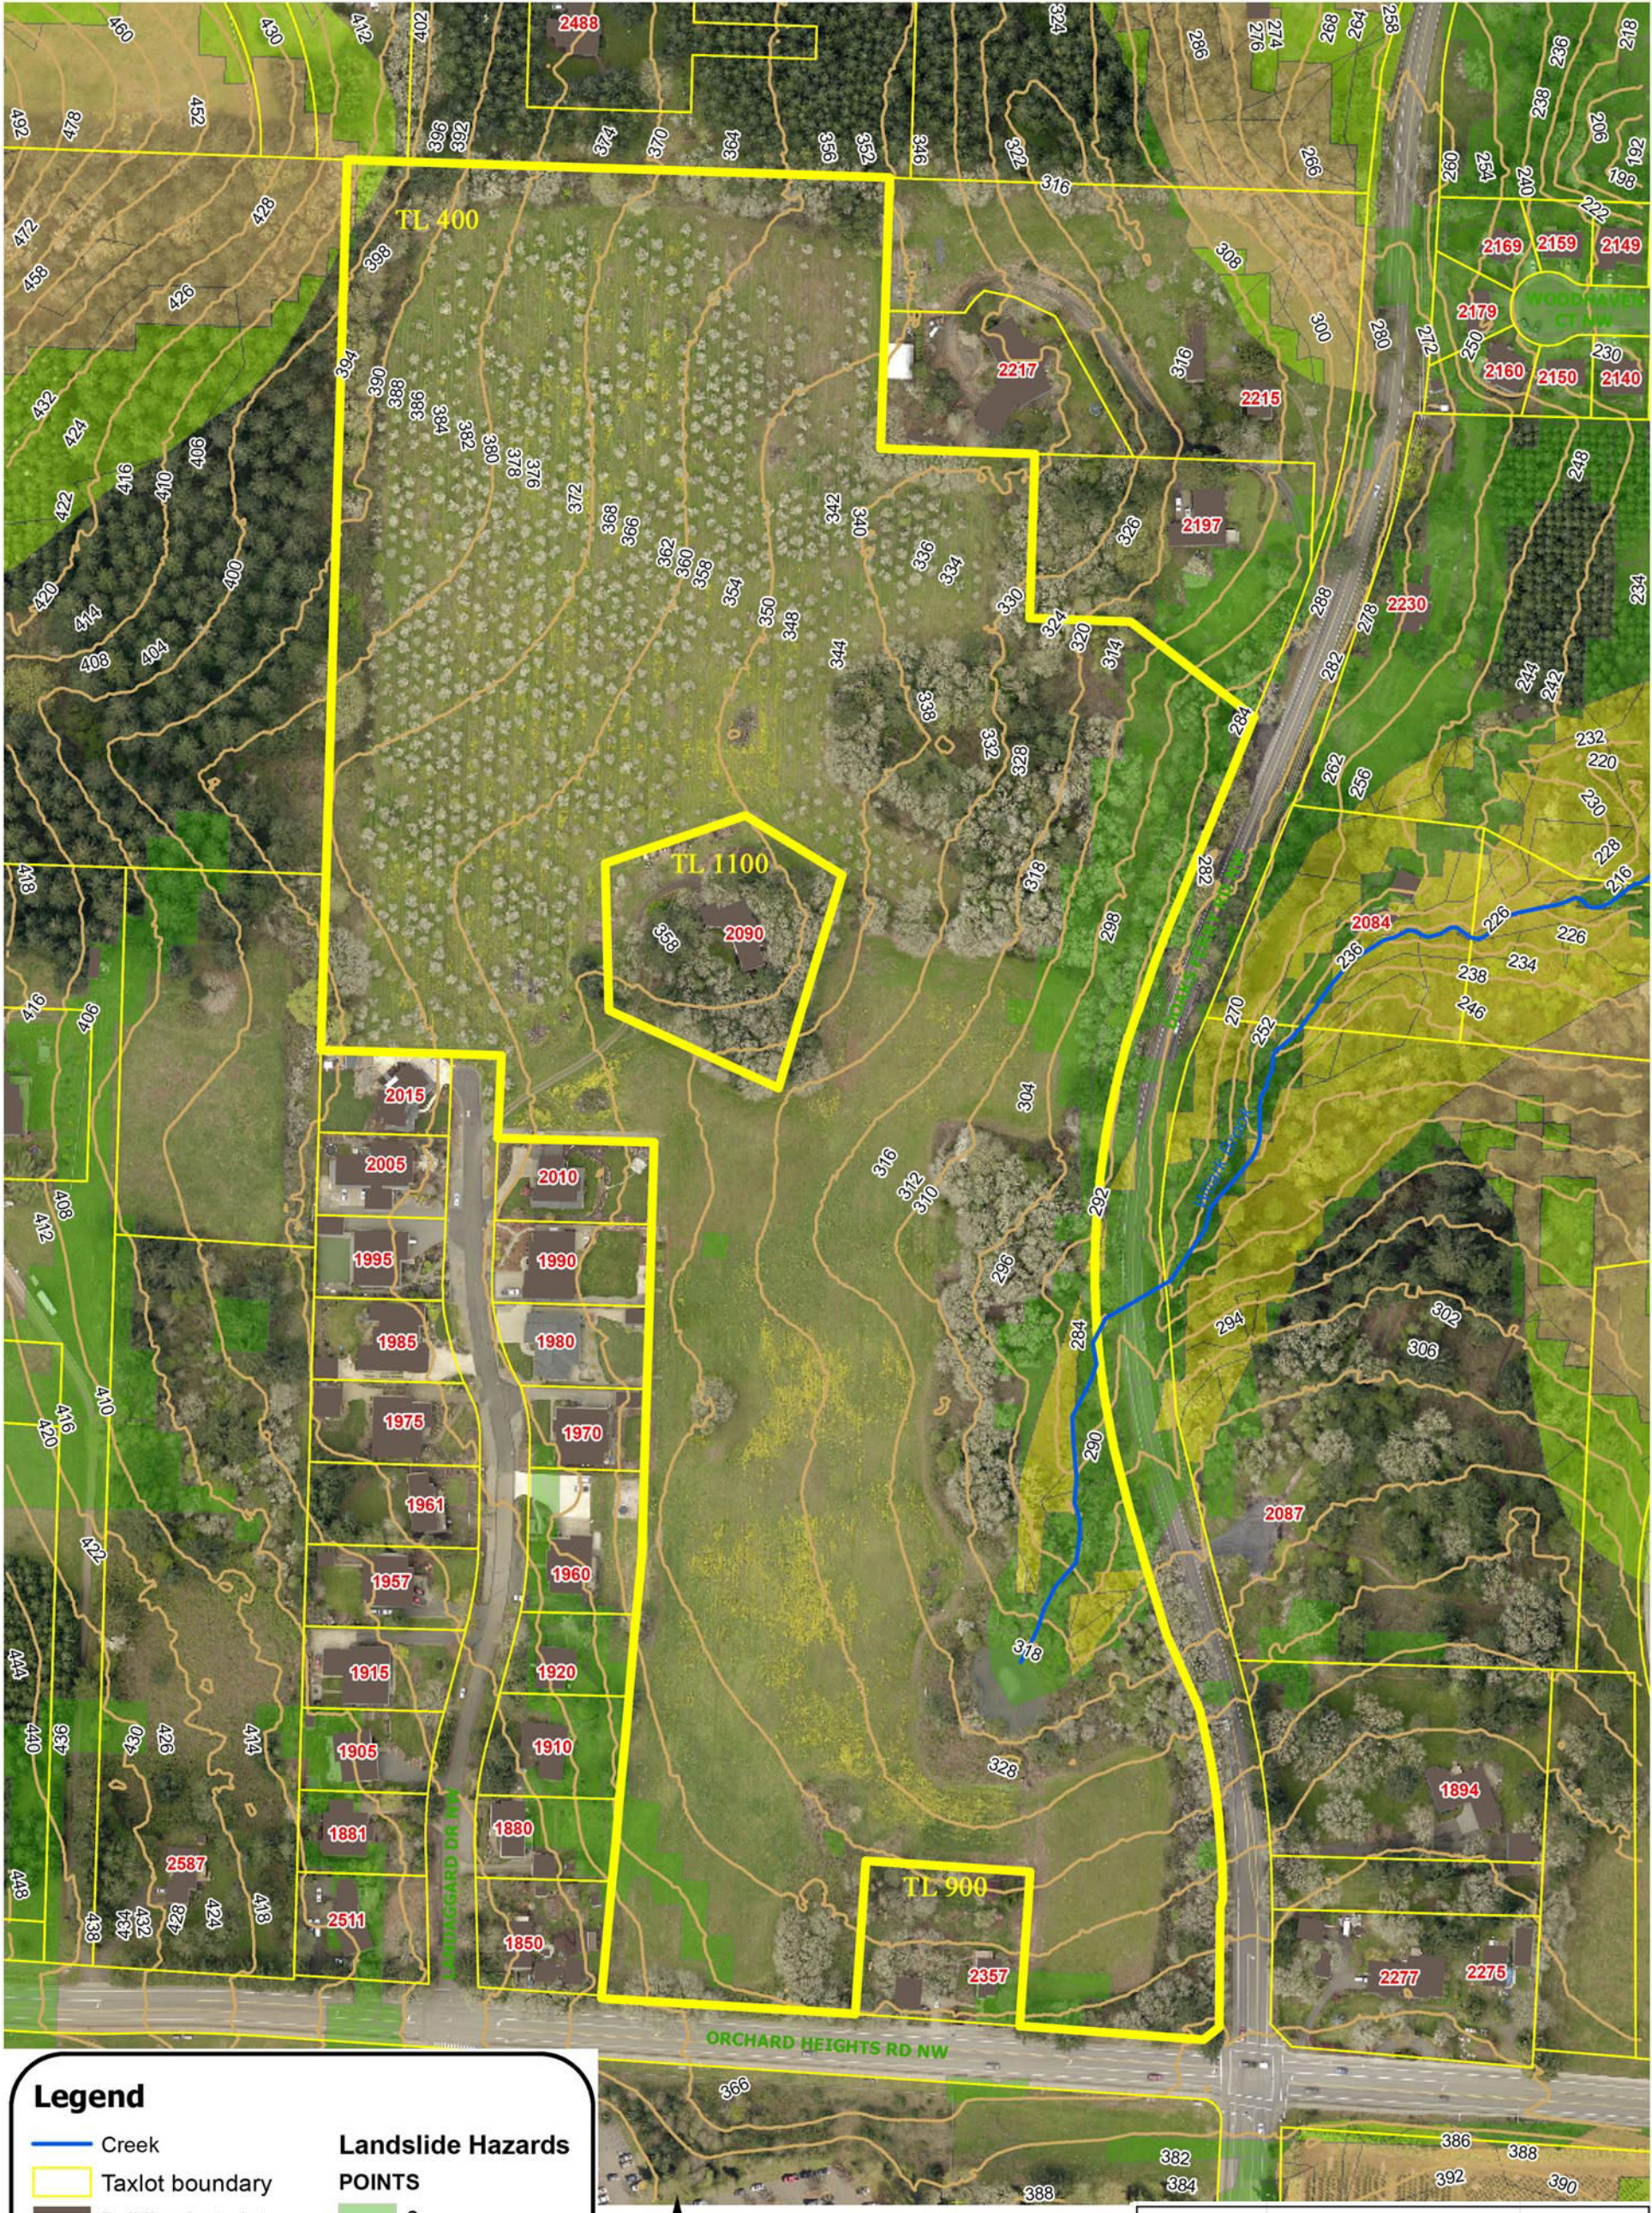
Chapman Corner		
7S/3W-17b TL 400, 900 & 1100		
Landslide Hazard Study		
Site Photographs		
NGS, Inc.	November 2022	Figure 5

The test pits show that the basalt flows are mantled by 3 to 6 feet of soil (e.g., Figure 5). The soil over most of the site is residual from weathering of the basalt: stiff to hard, red-brown clayey SILT. It generally has a trace of sand but ranges up to sandy at depth. Fragments of weathered basalt are scattered throughout. However, TP-7, located above the pond in the old drainageway found a ~4.5 ft of channel deposited medium stiff dark brown mottled grey SILT overlaying saturated medium stiff grey silty CLAY. Depth to water was 4 feet.

Above: View down into TP-2, showing gradation from clayey SILT to weathered basalt.

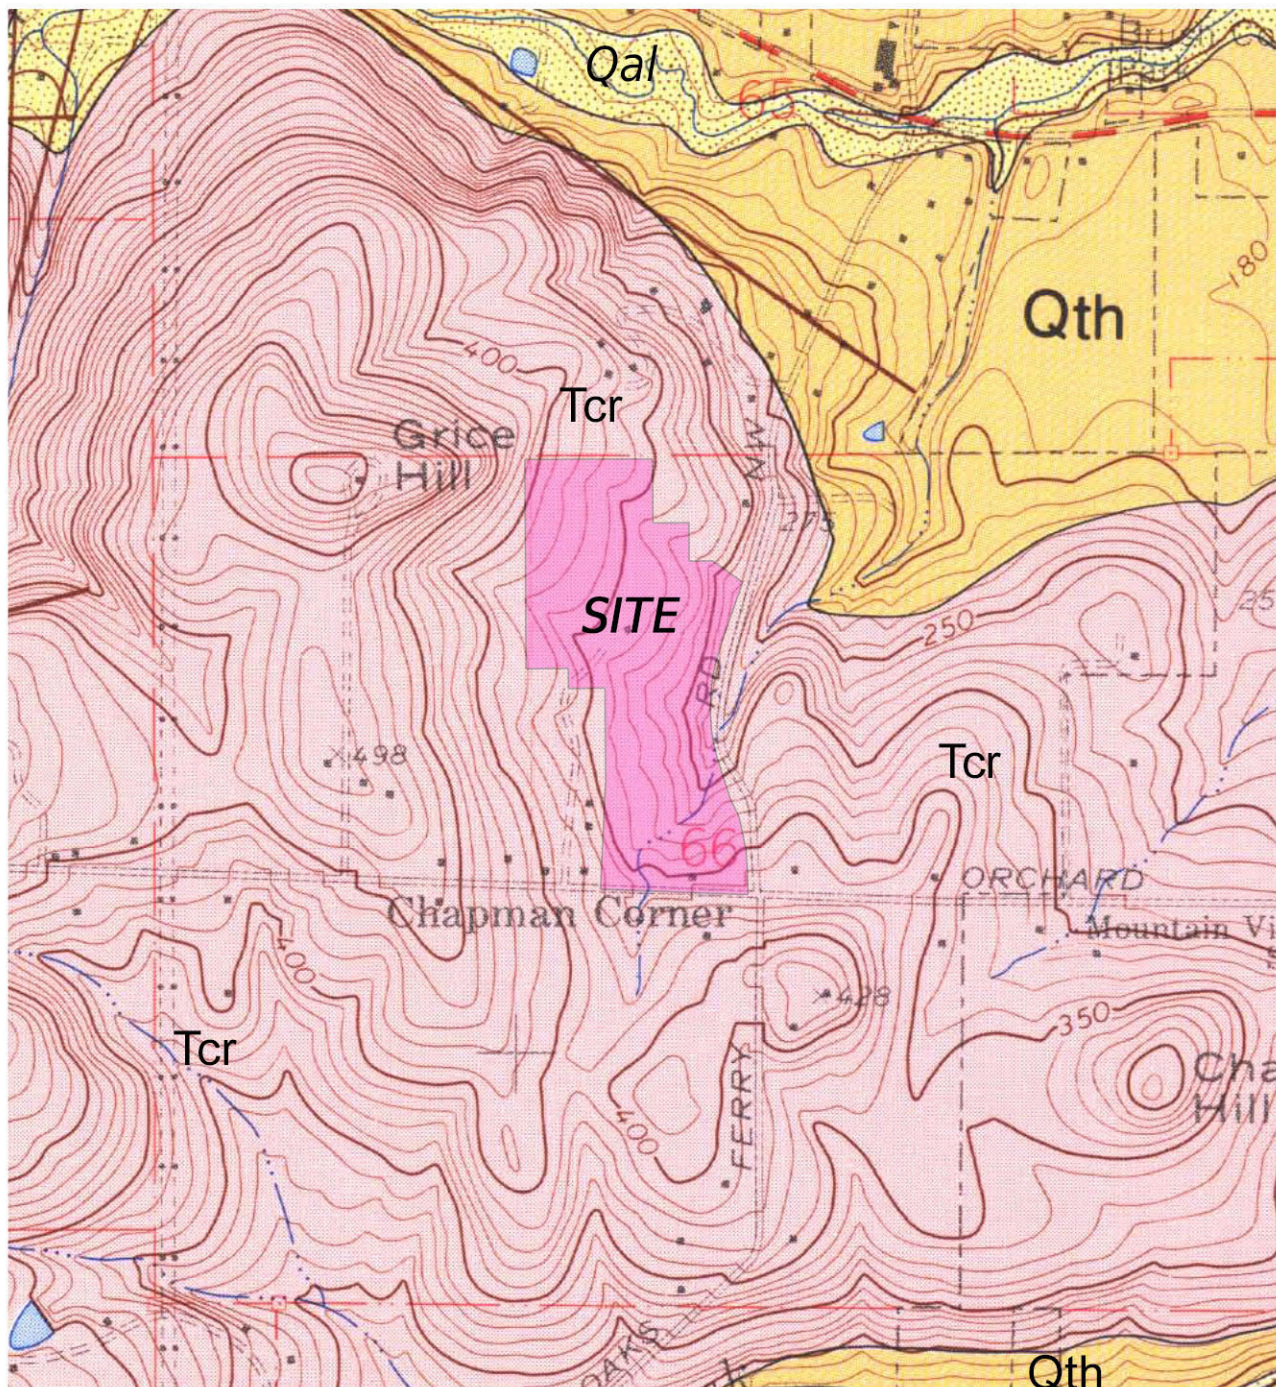
Chapman Corner		
7S/3W-17b TL 400, 900 & 1100		
Landslide Hazard Study		
DOGAMI Geologic Map		
NGS, Inc.	November 2022	Figure 6

The site is underlain by lava flows of Columbia River Basalt (Figures 5, 6 and 7). Residual soil and thin topsoil mantle the basalt. Nine test pits were dug 25 September 2018 to explore site conditions (locations on Figure 2 and summary on Table 1).

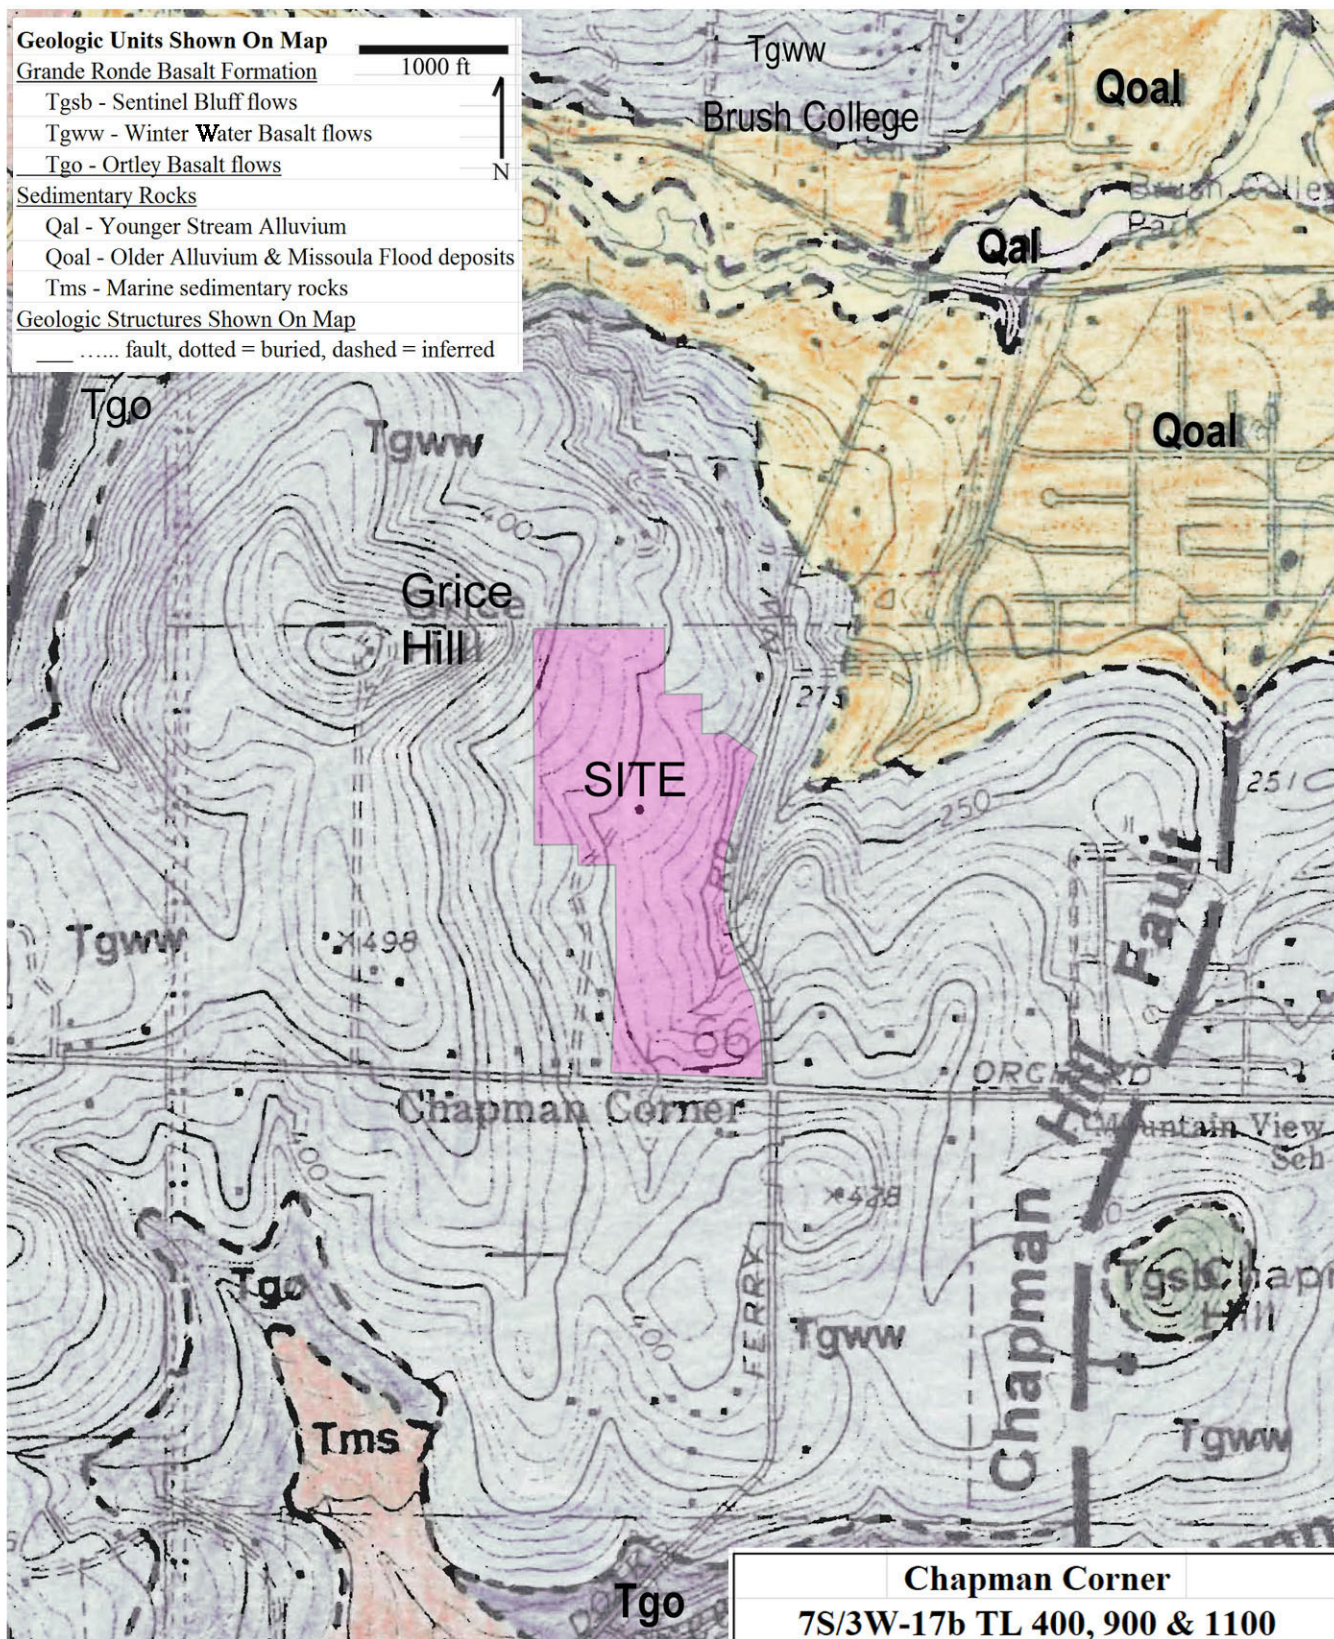
Chapman Corner		
7S/3W-17b TL 400, 900 & 1100		
Landslide Hazard Study		
USGS Geologic Map		
NGS, Inc.	November 2022	Figure 7

Mapping by USGS identified the basalt flows as part of the Winter Water basalt (Figure 7). The top several feet of the basalt are usually decomposed to a hard to very hard clayey silt (laterite). Most minerals are altered to clays, a volume positive reaction. The resulting overconsolidation leave only a subtle relict of the original crystalline texture (e.g., in TP-2, Figure 5). The weathered basalt turns from red-brown to grey with depth and some original minerals and textures are preserved. The upper parts of the Winter Water flows are often spheroidally weathered. This leaves rounded cobble to boulder sized remnants of weathered basalt in a matrix of gritty clayey SILT. Boulders range up to 2 or 3 ft in diameter, but occasionally reach the size of a small excavator.

As noted previously the site is on the east flank of the Eola Hills and the bedrock dips generally east at a low angle. Beeson and Tolan (2001) mapped several faults that trend generally N-S parallel to the axis of the Eola Hills. One (the Chapman Hill fault) passes about 2000 ft east of the site (Figure 7). These faults are mapped as buried under Holocene deposits and have not been associated with current tectonic activity.
