NOTICE OF DECISION

DECISION OF THE PLANNING ADMINISTRATOR

TREE REMOVAL PERMIT: TRP23-23

Basic Tree Risk Assessment Form

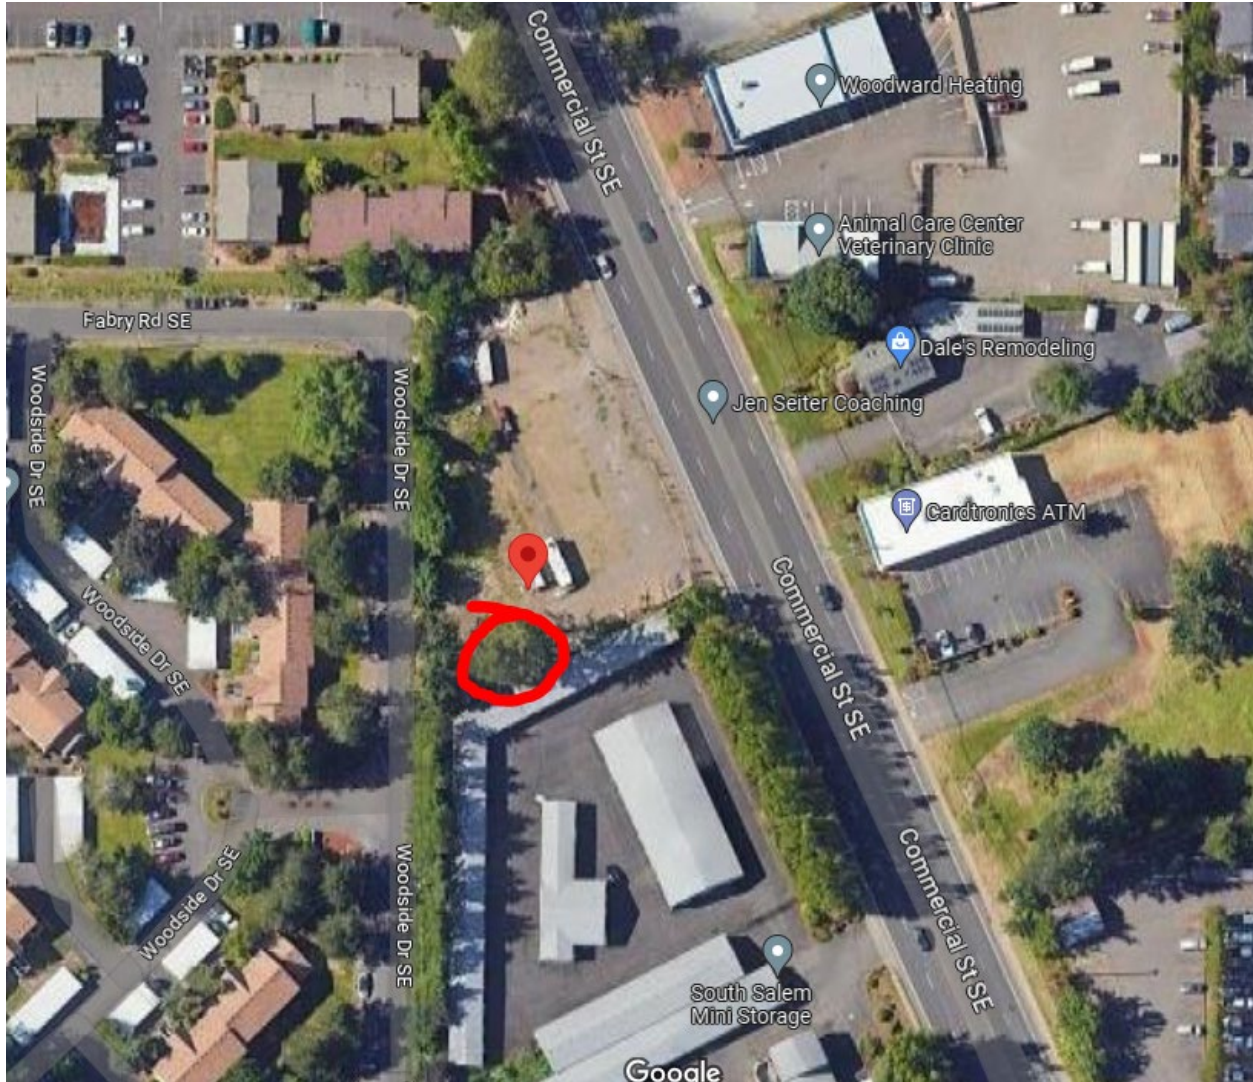
PICTURE 1
Taken 05/24/2023

Vigor Low ☒ Normal ☐ High ☐ Foliage None (seasonal) ☐ None (dead) ☐ Normal _____ % Chlorotic _____ % Necrotic 40 %
Pests/Biotic _____ Abiotic Construction equipment
Species failure profile Branches ☐ Trunk ☐ Roots ☒ Describe Prone to rot in oversaturation due to compaction

Unbalanced crown ☒ LCR 50 %
Dead twigs/branches ☒ 40 % overall Max. dia. 2"
Broken/Hangers Number _____ Max. dia. _____
Over-extended branches ☐
Pruning history
Crown cleaned ☐ Thinned ☐ Raised ☐
Reduced ☐ Topped ☐ Lion-tailed ☐
Flush cuts ☐ Other _____
Cracks ☐ Lightning damage ☐
Codominant ☐ Included bark ☐
Weak attachments ☐ Cavity/Nest hole _____ % circ.
Previous branch failures ☐ Similar branches present ☐
Dead/Missing bark ☐ Cankers/Galls/Burls ☐ Sapwood damage/decay ☐
Conks ☐ Heartwood decay ☐

Response growth _____
Condition(s) of concern _____
Part Size 2" Fall Distance 20'
Load on defect N/A ☐ Minor ☒ Moderate ☐ Significant ☐
Likelihood of failure Improbable ☐ Possible ☐ Probable ☒ Imminent ☐
Cracks ☐ Lightning damage ☐
Codominant ☐ Included bark ☐
Weak attachments ☐ Cavity/Nest hole _____ % circ.
Previous branch failures ☐ Similar branches present ☐
Dead/Missing bark ☐ Cankers/Galls/Burls ☐ Sapwood damage/decay ☐
Conks ☐ Heartwood decay ☐
