RE: SITE INFILTRATION TESTING
415 MOYER LANE
SALEM, OREGON
BRANCH ENGINEERING INC. PROJECT NO. 24-055

Branch Engineering Inc (BEI) visited the site, see Figure 1, on February 22, 2024 to set up three site infiltration tests and returned on February 24, 2024 to determine the rate of infiltration of the onsite soils for use in an onsite stormwater disposal system that will be designed by others. The results presented herein are for initial design and should be verified by the design engineer of record (EOR) at the time of construction. The following is a summary of our visit to the site and testing results.

Infiltration Test Results

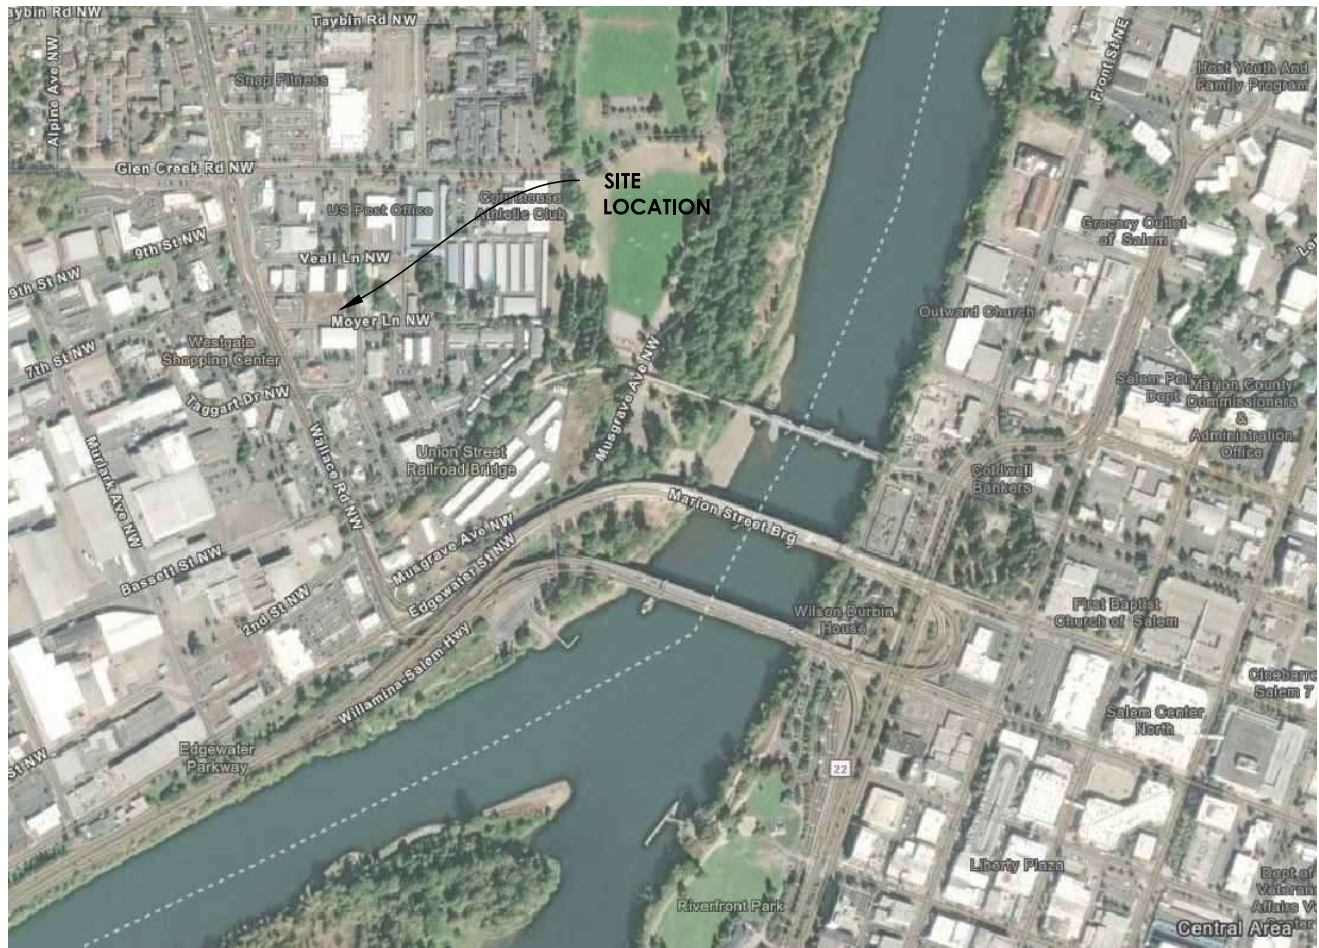
FIGURE-1

SITE VICINITY MAP - MOYER LANE MIXED USE

415 MOYER LANE NW SALEM, OREGON

Figure-1, Site Vicinity Map
Figure-2, Site Exploration Map
Infiltration Test Results
ORWD Well Log (1)
USDA NRCS Site Soil Mapping and Soil Descriptions

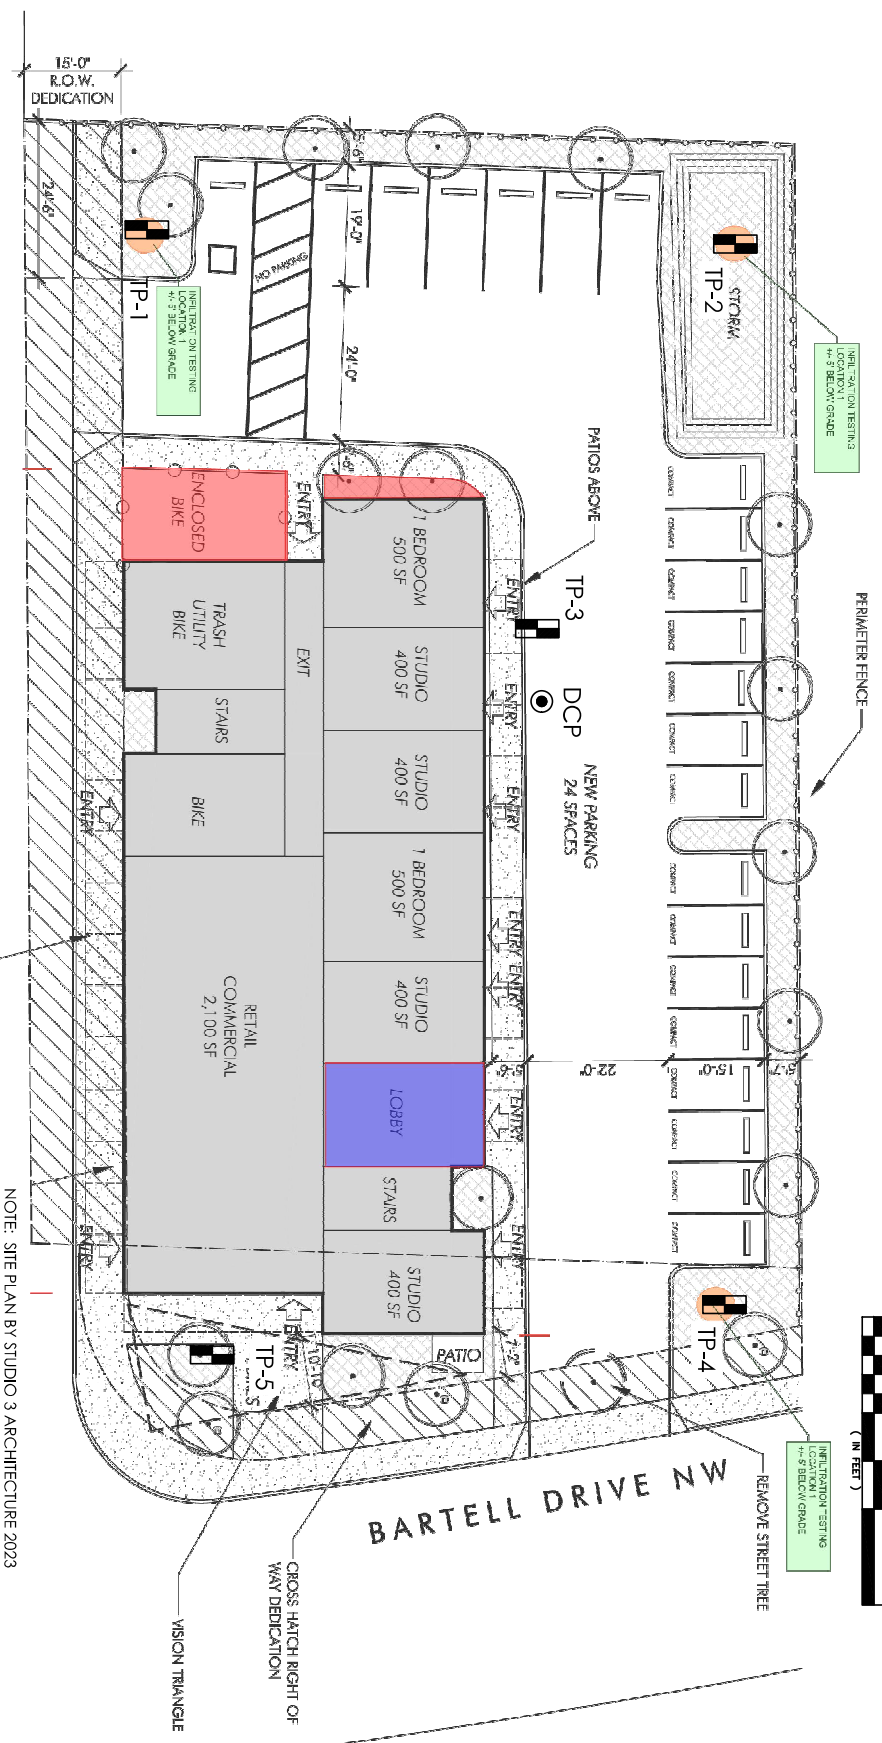
FIGURE-2

APPROXIMATE TEST PIT LOCATION
- IT-1

INFILTRATION TEST LOCATION
- DCP

SITE EXPLORATION MAP - MOYER LANE MIXED USE

415 MOYER LANE NW SALEM, OREGON

Five test pits were excavated using a rubber-tracked excavator on the site in the approximate locations shown on the attached Figure-2. Three of the pits (1, 2 & 4) were set up for infiltration testing of the subsurface soils at 4- to 5-feet below surface grade (BSG). The observed soils were visually classified using the American Society of Testing and Materials (ASTM) Method D-2488. The soils observed in the test pits were generally consistent in composition with 1.5- to 2-feet of either soft fill or topsoil overlying a clayey silt alluvium that is moist and medium stiff, a more detail description of the soils and logs of each test pits are presented in our *Geotechnical Investigation Report* for the site.

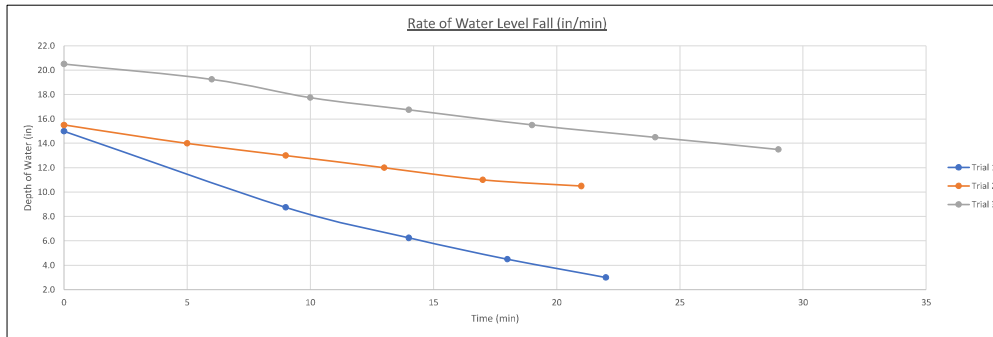
Infiltration Test 1 Trial 1		Elapsed Time (min)	Depth to Water Surface (in)	Height of Water (in)	Rate of Fall (in/min)	Rate of Fall (in/hr)	Avg Rate of Fall T-1 (in/hr)
Standpipe Diameter (in)	6	0	31.5	15.0			
Standpipe Height AGS (in)	0	9	37.8	8.8	0.69	41.7	
Test Depth BGS (in)	46.5	14	40.3	6.3	0.50	30.0	
Volume of Water Added (gal)	1.5	18	42.0	4.5	0.44	26.3	
Clocktime at Start	13:02	22	43.5	3.0	0.38	22.5	24.4
ASTM Soil Type	(CL)						
Infiltration Test 1 Trial 2		Elapsed Time (min)	Depth to Water Surface (in)	Height of Water (in)	Rate of Fall (in/min)	Rate of Fall (in/hr)	Avg Rate of Fall T-2 (in/hr)
Volume of Water Added (gal)	1.5	0	31.0	15.5			
Clocktime	14:01	5	32.5	14.0	0.30	18.0	
		9	33.5	13.0	0.25	15.0	
		13	34.5	12.0	0.25	15.0	
		17	35.5	11.00	0.25	15.0	
		21	36	10.5	0.13	7.5	13.1
Infiltration Test 1 Trial 3		Elapsed Time (min)	Depth to Water Surface (in)	Height of Water (in)	Rate of Fall (in/min)	Rate of Fall (in/hr)	Avg Rate of Fall T-3 (in/hr)

Volume of Water Added (gal)	1.5	0	26.0	20.5			
Clocktime	14:54	6	27.3	19.3	0.21	12.5	
		10	28.8	17.8	0.38	22.5	
		14	29.8	16.8	0.25	15.0	
		19	31.0	15.5	0.25	15.0	
		24	32	14.5	0.20	12.0	
		29	33	13.5	0.20	12.0	13.5

Site infiltration testing was conducted on February 24, 2024 in general accordance with the procedures set forth in the Salem Administrative Rules 109-004 Appendix C for the encased falling head method. The soil is assumed to be laterally homogeneous and that sidewall infiltration is negligible as a 6-inch diameter, open-ended, plastic standpipe was used for containment of the water column. Water was added to the pipe to pre-saturate the soil prior to testing. Infiltration testing commenced over three successive trials with water being added and the height of the water column being recorded over time. The measured infiltration rates are tabulated in the following Table and shown in the attached Field Data Sheet; no factor of safety has been applied to the rates.

<i>Test ID</i>	<i>Soil Description</i>	<i>Test Depth (inches)</i>	<i>Infiltration Rate (in/hr)</i>
TP-1	Light Reddish Brown silt with clay (ML)	48	13
TP-2	Light Reddish Brown silt with clay (ML)	60	28
TP-4	Light Reddish Brown silt with clay (ML)	60	25

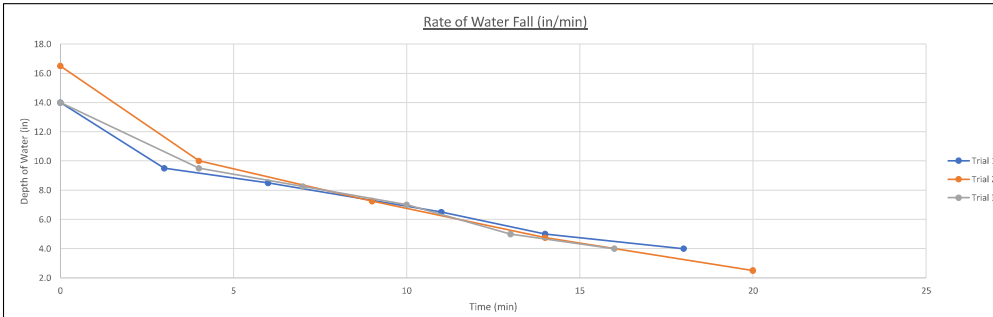
Infiltration Test 2 Trial 1		Elapsed Time (min)	Depth to Water Surface (in)	Height of Water (in)	Rate of Fall (in/min)	Rate of Fall (in/hr)	Avg Rate of Fall T-1 (in/hr)
Standpipe Diameter (in)	6	0	47.5	14.0			
Standpipe Height AGS (in)	0	3	52.0	9.5	1.50	90.0	
Test Depth BGS (in)	61.5	6	53.0	8.5	0.33	20.0	
Volume of Water Added (gal)	1.5	11	55.0	6.5	0.40	24.0	
Clocktime	14:05	14	56.5	5.0	0.50	30.0	
ASTM Soil Type	(CL)	18	57.5	4.0	0.25	15.0	23.0
Infiltration Test 2 Trial 2		Elapsed Time (min)	Depth to Water Surface (in)	Height of Water (in)	Rate of Fall (in/min)	Rate of Fall (in/hr)	AVG Rate of Fall T-2 (in/hr)
Volume of Water Added (gal)	1.5	0	45.0	16.5			
Clocktime	14:30	4	51.5	10.0	1.63	97.5	
		9	54.3	7.3	0.55	33.0	
		14	56.8	4.8	0.50	30.0	
		20	59.0	2.5	0.38	22.5	28.5
Infiltration Test 2 Trial 3		Elapsed Time (min)	Depth to Water Surface (in)	Height of Water (in)	Rate of Fall (in/min)	Rate of Fall (in/hr)	AVG Rate of Fall T-2 (in/hr)

Volume of Water Added (gal)	1.5	0	47.5	14.0			
Clocktime	15:58	4	52.0	9.5	1.13	67.5	
		7	53.3	8.3	0.42	25.0	
		10	54.5	7.0	0.42	25.0	
		13	56.5	5.0	0.67	40.0	
		16	57.5	4.0	0.33	20.0	28.3

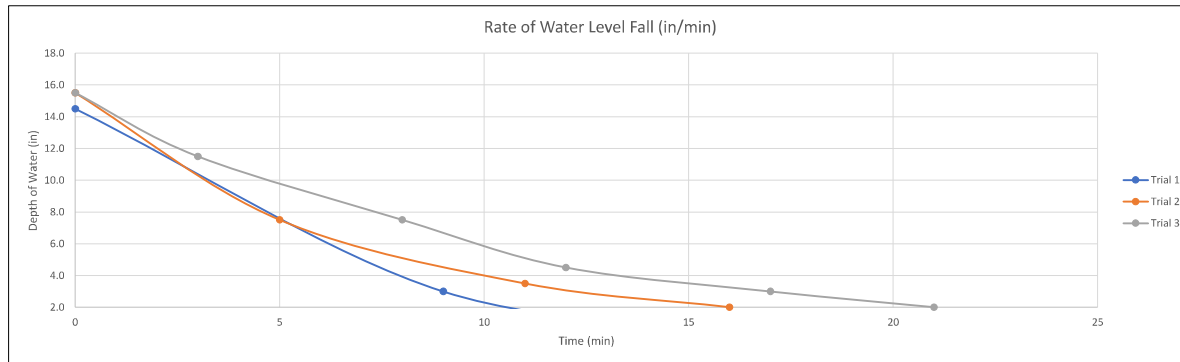
Infiltration Test 4 Trial 1		Elapsed Time (min)	Depth to Water Surface (in)	Height of Water (in)	Rate of Fall (in/min)	Rate of Fall (in/hr)	Avg Rate of Fall T-1 (in/hr)
Standpipe Diameter (in)	6	0	31.0	14.5			
Standpipe Height AGS (in)	0	9	42.5	3.0	1.28	76.7	
Test Depth BGS (in)	45.5	17	45.0	0.5	0.31	18.8	18.8
Volume of Water Added (gal)	1.5						
Clocktime at Start	12:48						
ASTM Soil Type	(CL)						
Infiltration Test 3 Trial 2		Elapsed Time (min)	Depth to Water Surface (in)	Height of Water (in)	Rate of Fall (in/min)	Rate of Fall (in/hr)	Avg Rate of Fall T-2 (in/hr)
Volume of Water Added (gal)	1.5	0	30.0	15.5			
Clocktime	14:26	5	38.0	7.5	1.60	96.0	
		11	42.0	3.5	0.67	40.0	
		16	43.5	2.0	0.30	18.0	
		21	45.0	0.50	0.30	18.0	25.3
Infiltration Test 3 Trial 3		Elapsed Time (min)	Depth to Water Surface (in)	Height of Water (in)	Rate of Fall (in/min)	Rate of Fall (in/hr)	Avg Rate of Fall T-3 (in/hr)
Volume of Water Added (gal)	1.5	0	30.0	15.5

Clocktime	14:58	3	34.0	11.5	1.33	80.0	
		8	38.0	7.5	0.80	48.0	
		12	41.0	4.5	0.75	45.0	
		17	42.5	3.0	0.30	18.0	
		21	43.5	2.0	0.25	15.0	26.0

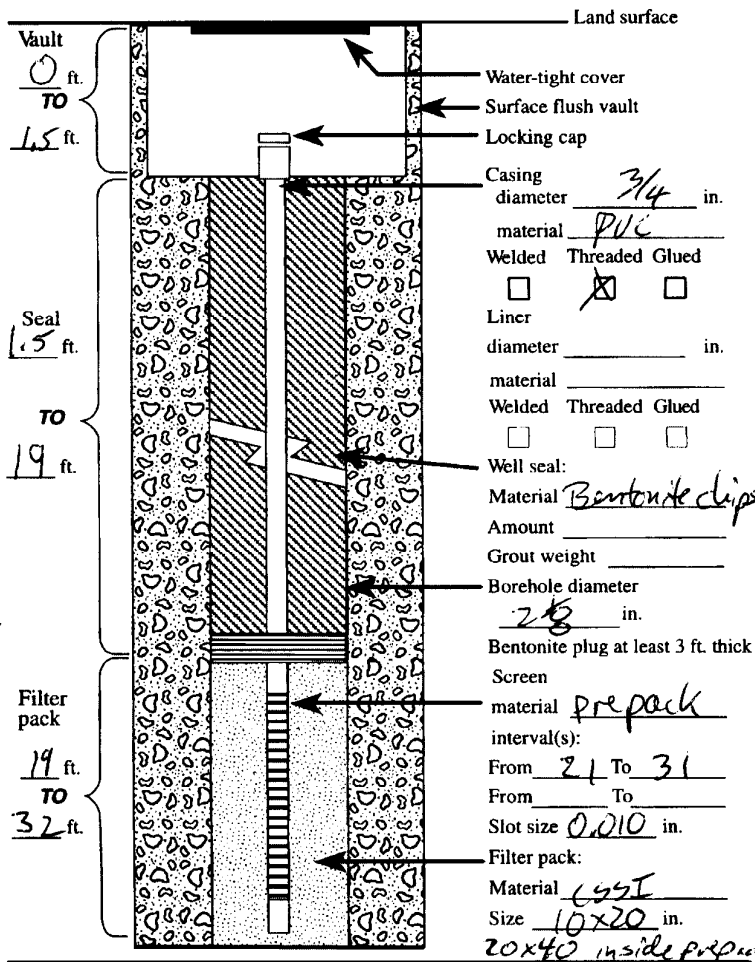
WELL NO. HG-4

☐ Rotary Air ☐ Rotary Mud ☐ Cable
☐ Hollow Stem Auger ☒ Other Post Probe

Special Standards Yes ☐ No ☒ Depth of Completed Well 32 ft.

☒ Pump ☐ Bailor ☐ Air ☐ Flowing Artesian
 Permeability — Yield < 1 GPM
 Conductivity 331 μ S PH 8.1
 Temperature of water 14.0 °F/C Depth artesian flow found — ft.
 Was water analysis done? ☒ Yes ☐ No
 By whom? North Creek Analytical
 Depth of strata to be analyzed. From 19 ft. to 32 ft.
 Remarks: 8260 HOCs

Depth at which water was first found 29 ft.

A nearby Oregon Water Resources Department (OWRD) well log, see attached, shows similar soil conditions as described above down to 27-feet BGS and transitioning to sandy silt down to 32-feet. The NRCS Web Soil Survey of Polk County maps the site soils as stream terrace deposits of Coburg and Malabon silty clay loam derived from mixed alluvium and are moderate to well drained.

We did not encounter any groundwater during our onsite explorations to a depth of 11-feet BGS. One nearby well log indicates that the groundwater is at depth of approximately 29-feet BGS.

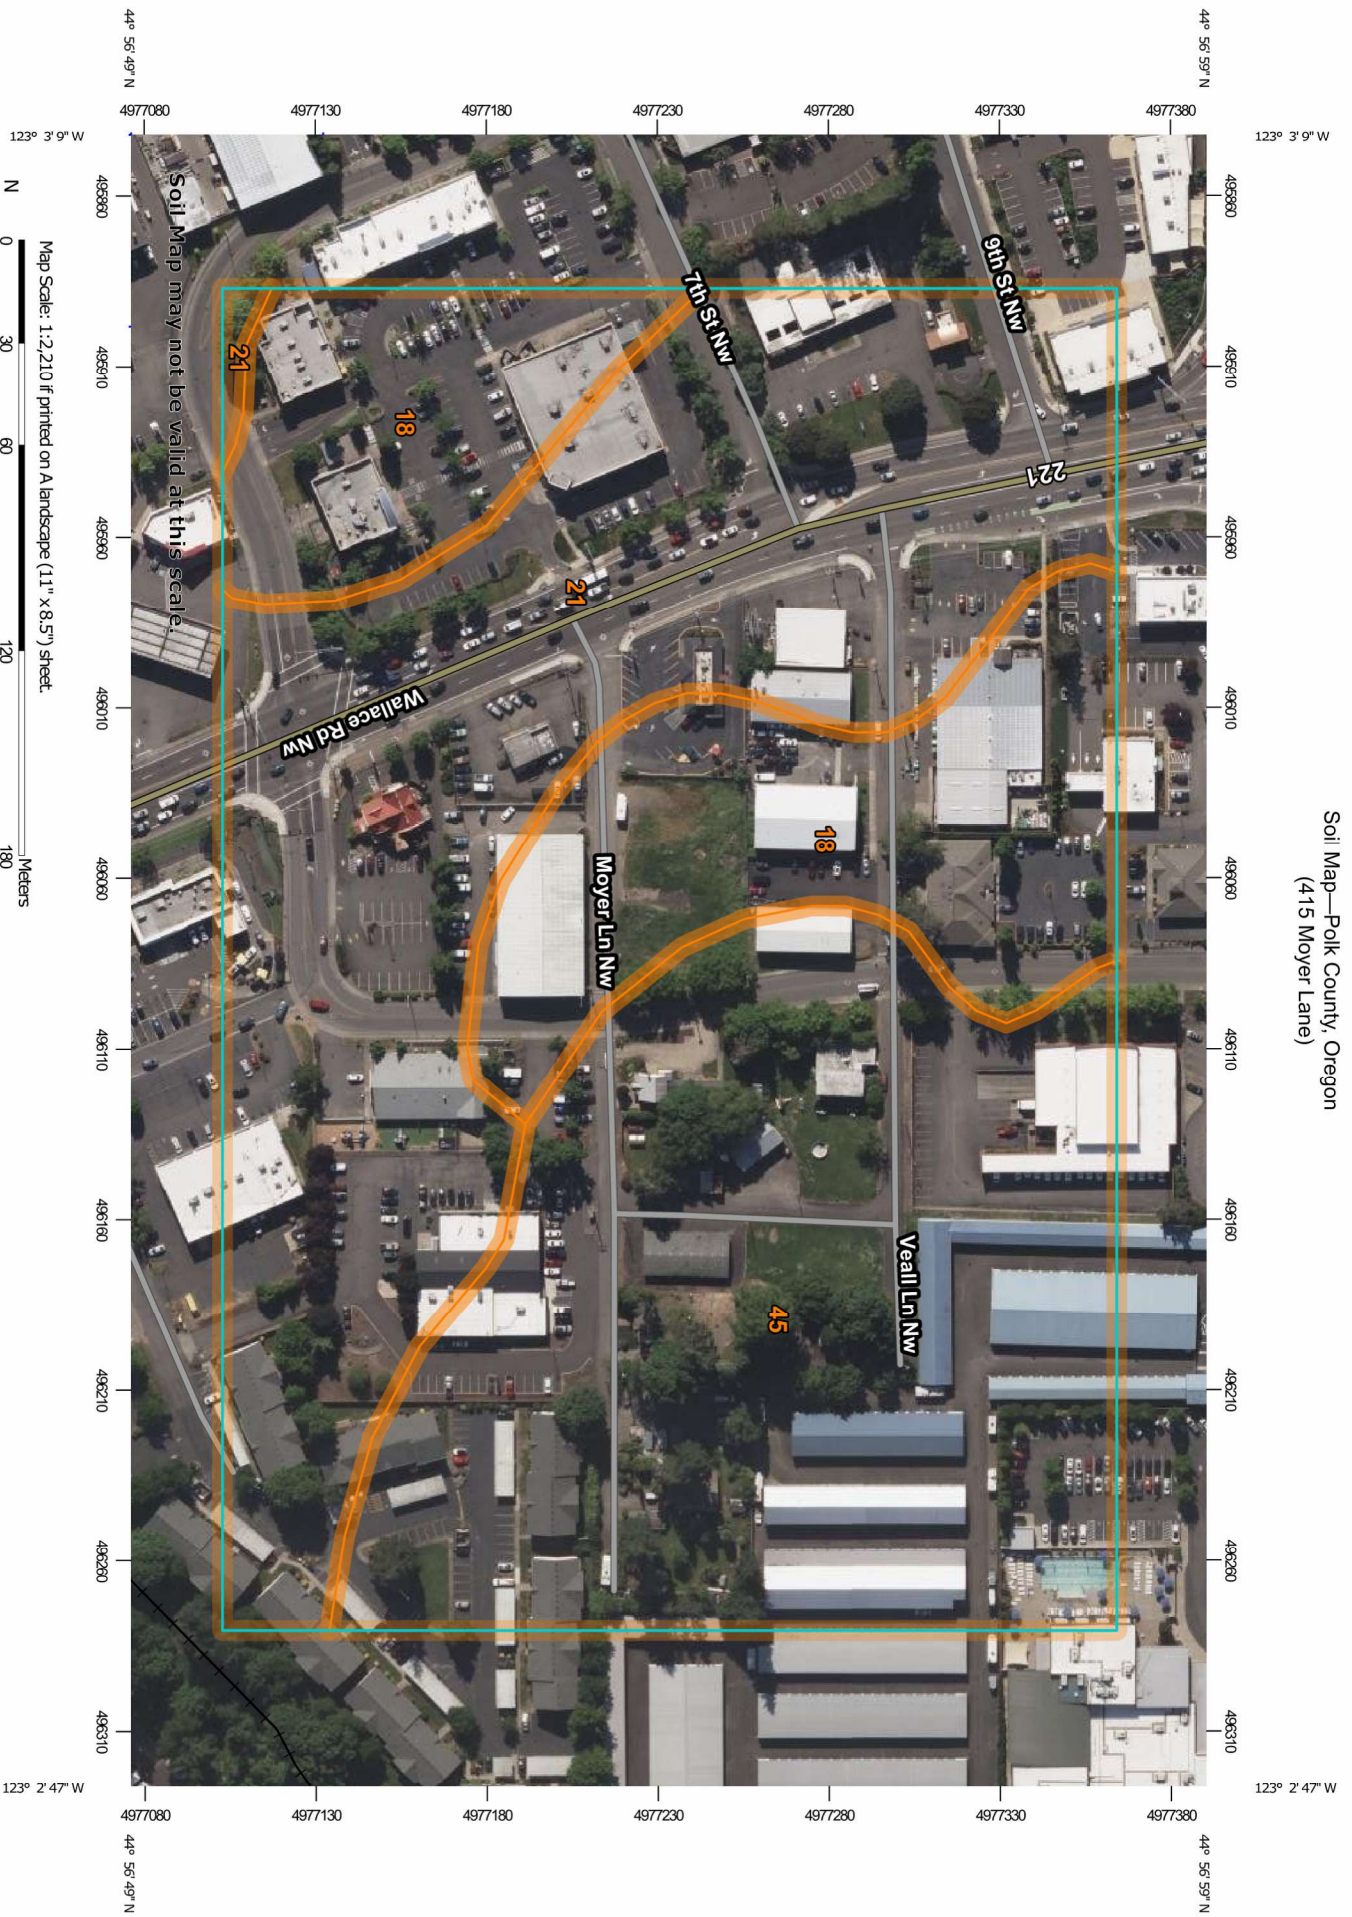
Soil Map—Polk County, Oregon
(415 Moyer Lane)
