APPENDIX F: GEOHAZARD/GEOTECHNICAL
REPORT

**Report of
Preliminary Geotechnical Investigation,
Infiltration Testing & Geologic Assessment
Fairview Subdivision
Pringle Creek Road SE & Battle Creek Road SE
Salem, Oregon**

CGT Project Number G1404007

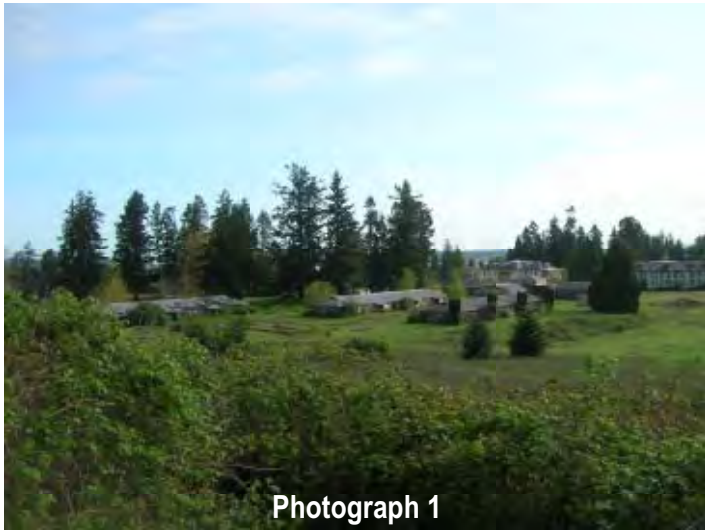
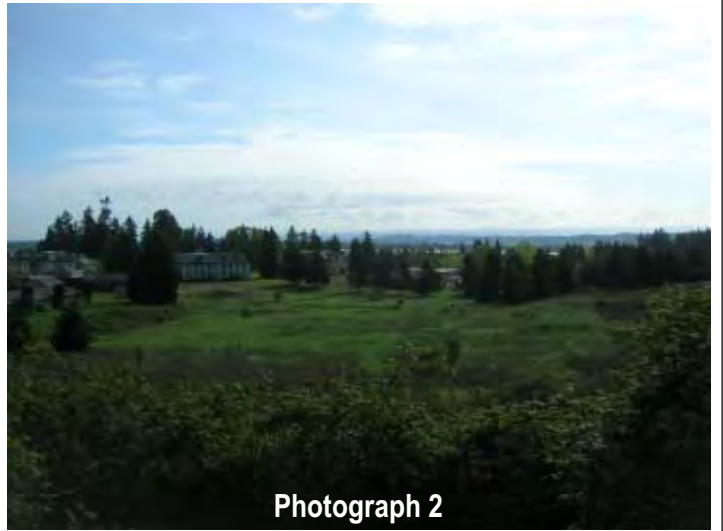
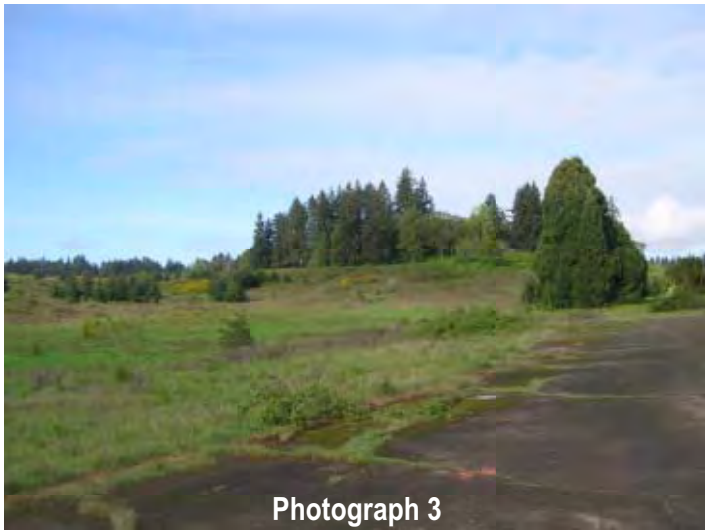
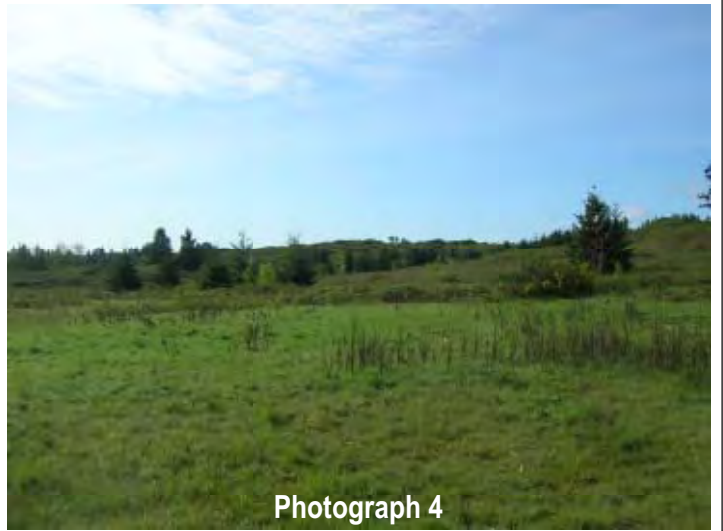
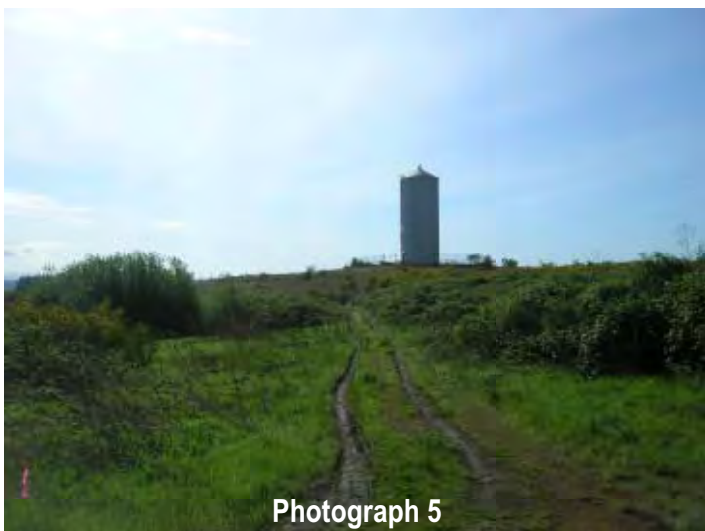
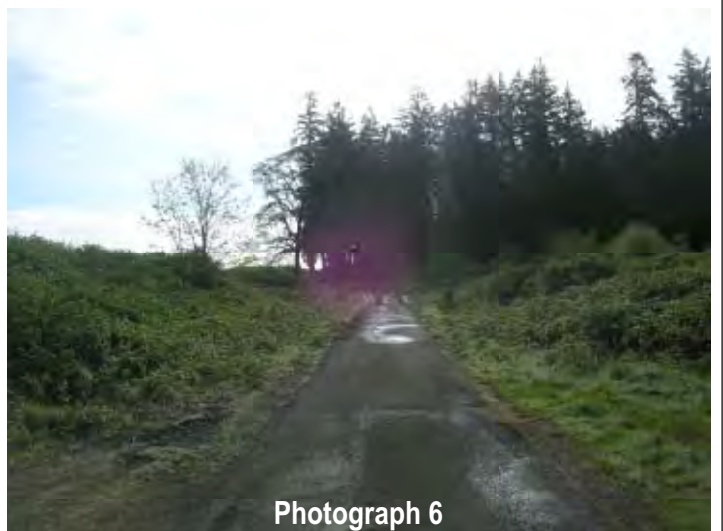
See Figure 2 for approximate photograph locations and directions. Photographs were taken at the time of our fieldwork.

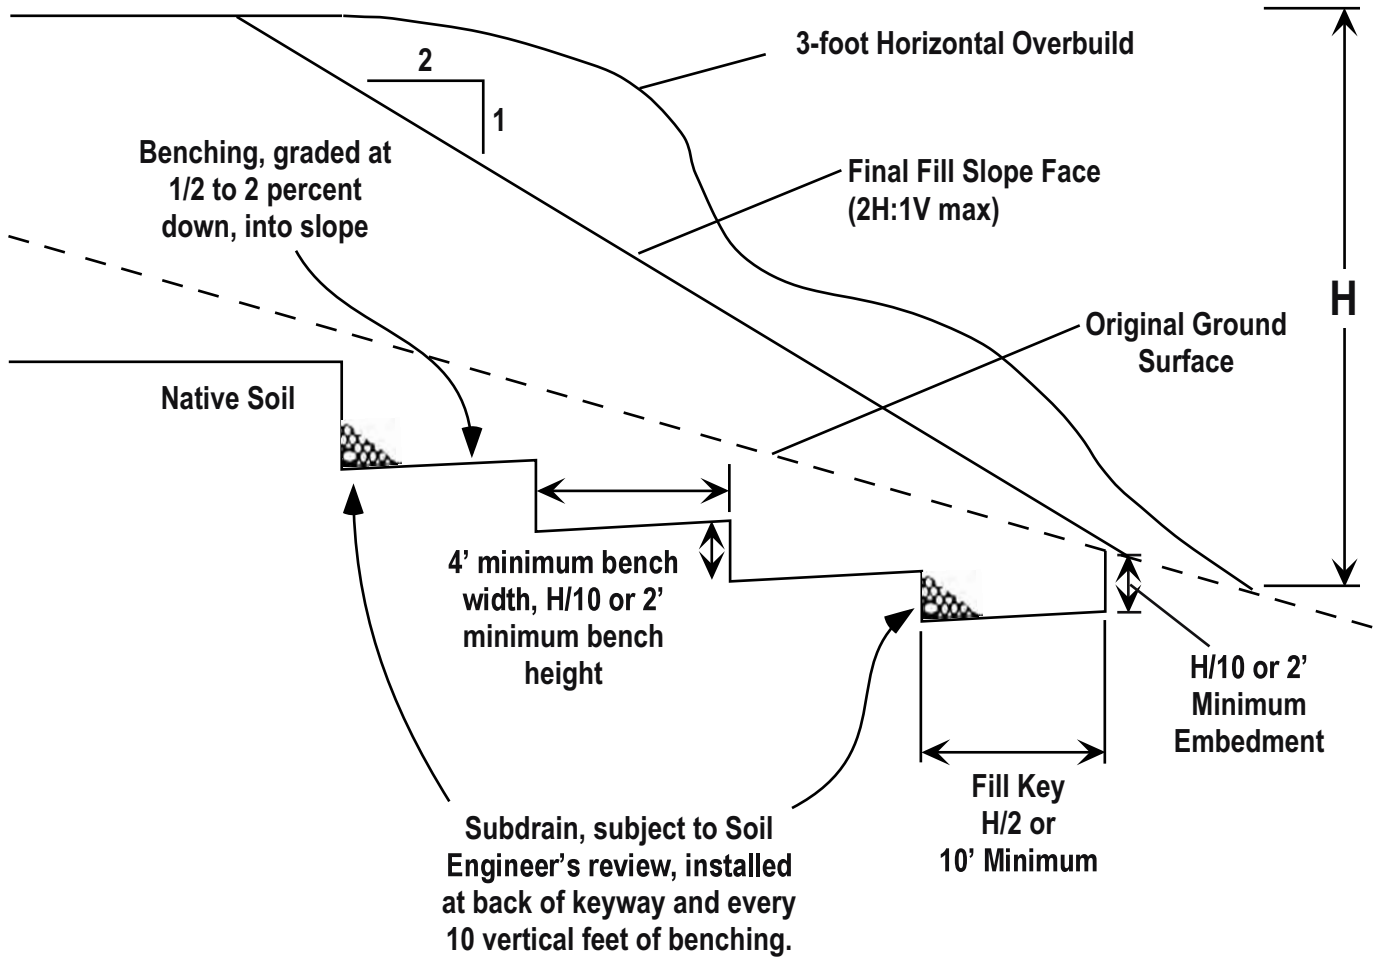
NOTE: Surfaces to receive fill with slopes steeper than 5H:1V (horizontal:vertical) should be benched and keyed as shown.

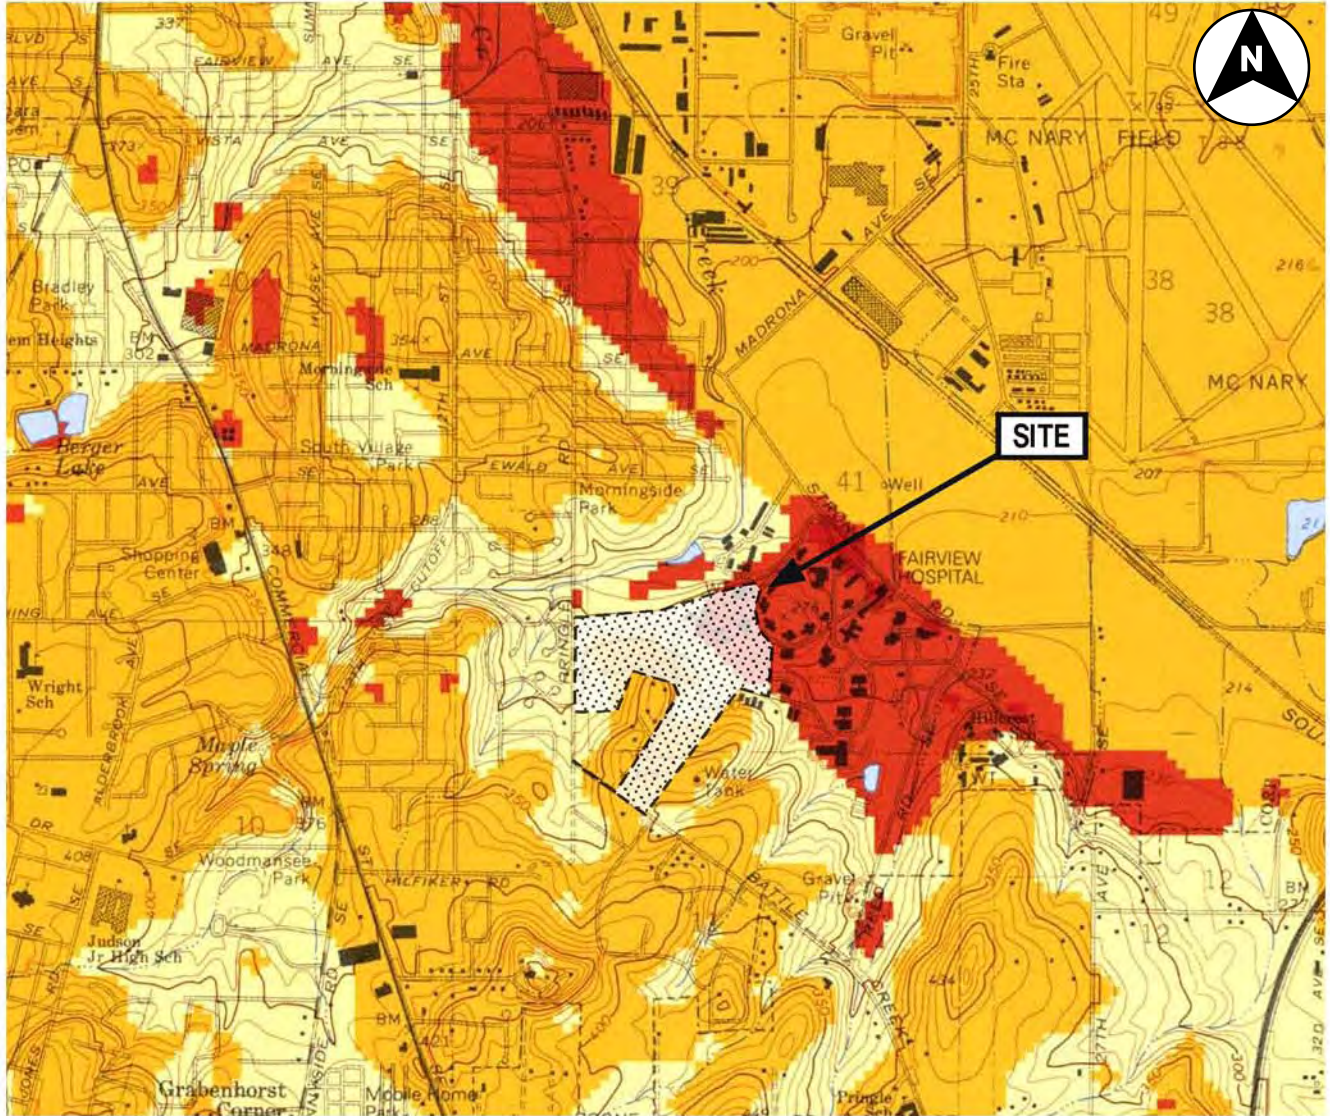
RELATIVE EARTHQUAKE HAZARD MAP

<p>Zone A Highest hazard</p>	<p>Zone C Low to intermediate hazard</p>
<p>Zone B Intermediate to high hazard</p>	<p>Zone D Lowest hazard</p>

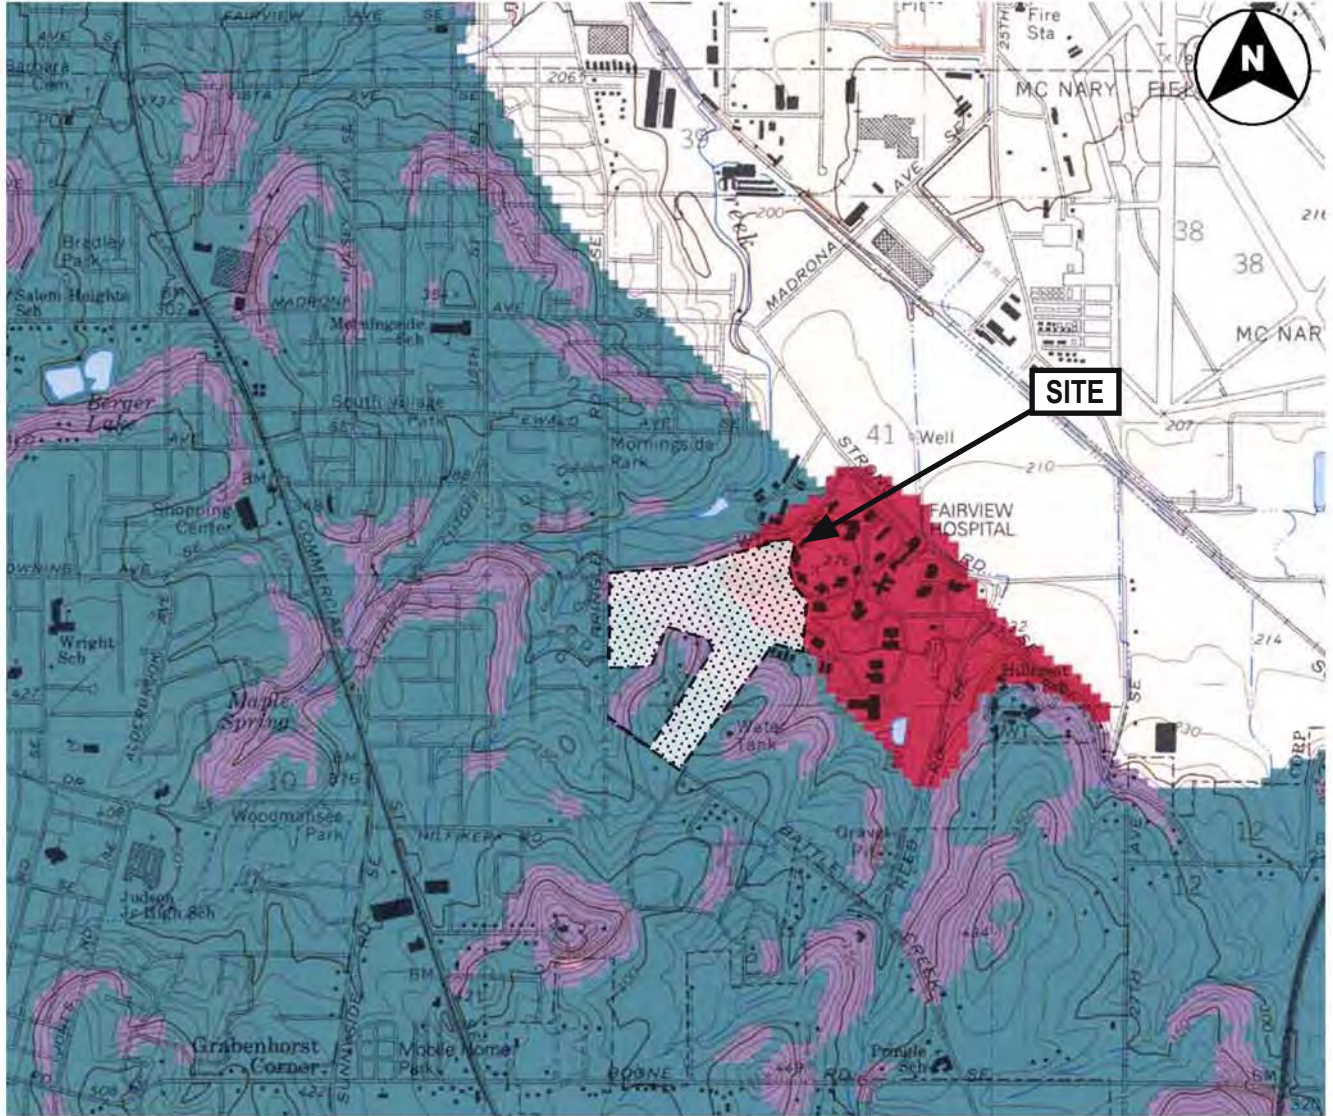
LANDSLIDE SUSCEPTIBILITY MAP

Category 5		High susceptibility to landsliding in areas with existing landslides	Category 2		≥6-14 degrees of slope angle
Category 4		>22 degrees of slope angle	Category 1		<6 degrees of slope angle in hills
Category 3		≥14-22 degrees of slope angle	Category 0		<6 degrees of slope angle in valley
