Re: Geotechnical Investigation and Geologic Hazard Assessment Services, Proposed Salem Heights Residential Subdivision Site, Tax Lot No's. 10400/10600/10601/10700 & 10800, 575 & 625 Salem Heights Avenue S, Salem (Marion County), Oregon

**GEOTECHNICAL INVESTIGATION AND GEOLOGIC HAZARD ASSESSMENT
PROPOSED SALEM HEIGHTS RESIDENTIAL DEVELOPMENT SITE
TAX LOT NO'S. 10400/10600/10601/10700 & 10800
575 & 625 SALEM HEIGHTS AVENUE S
SALEM (MARION COUNTY) OREGON**

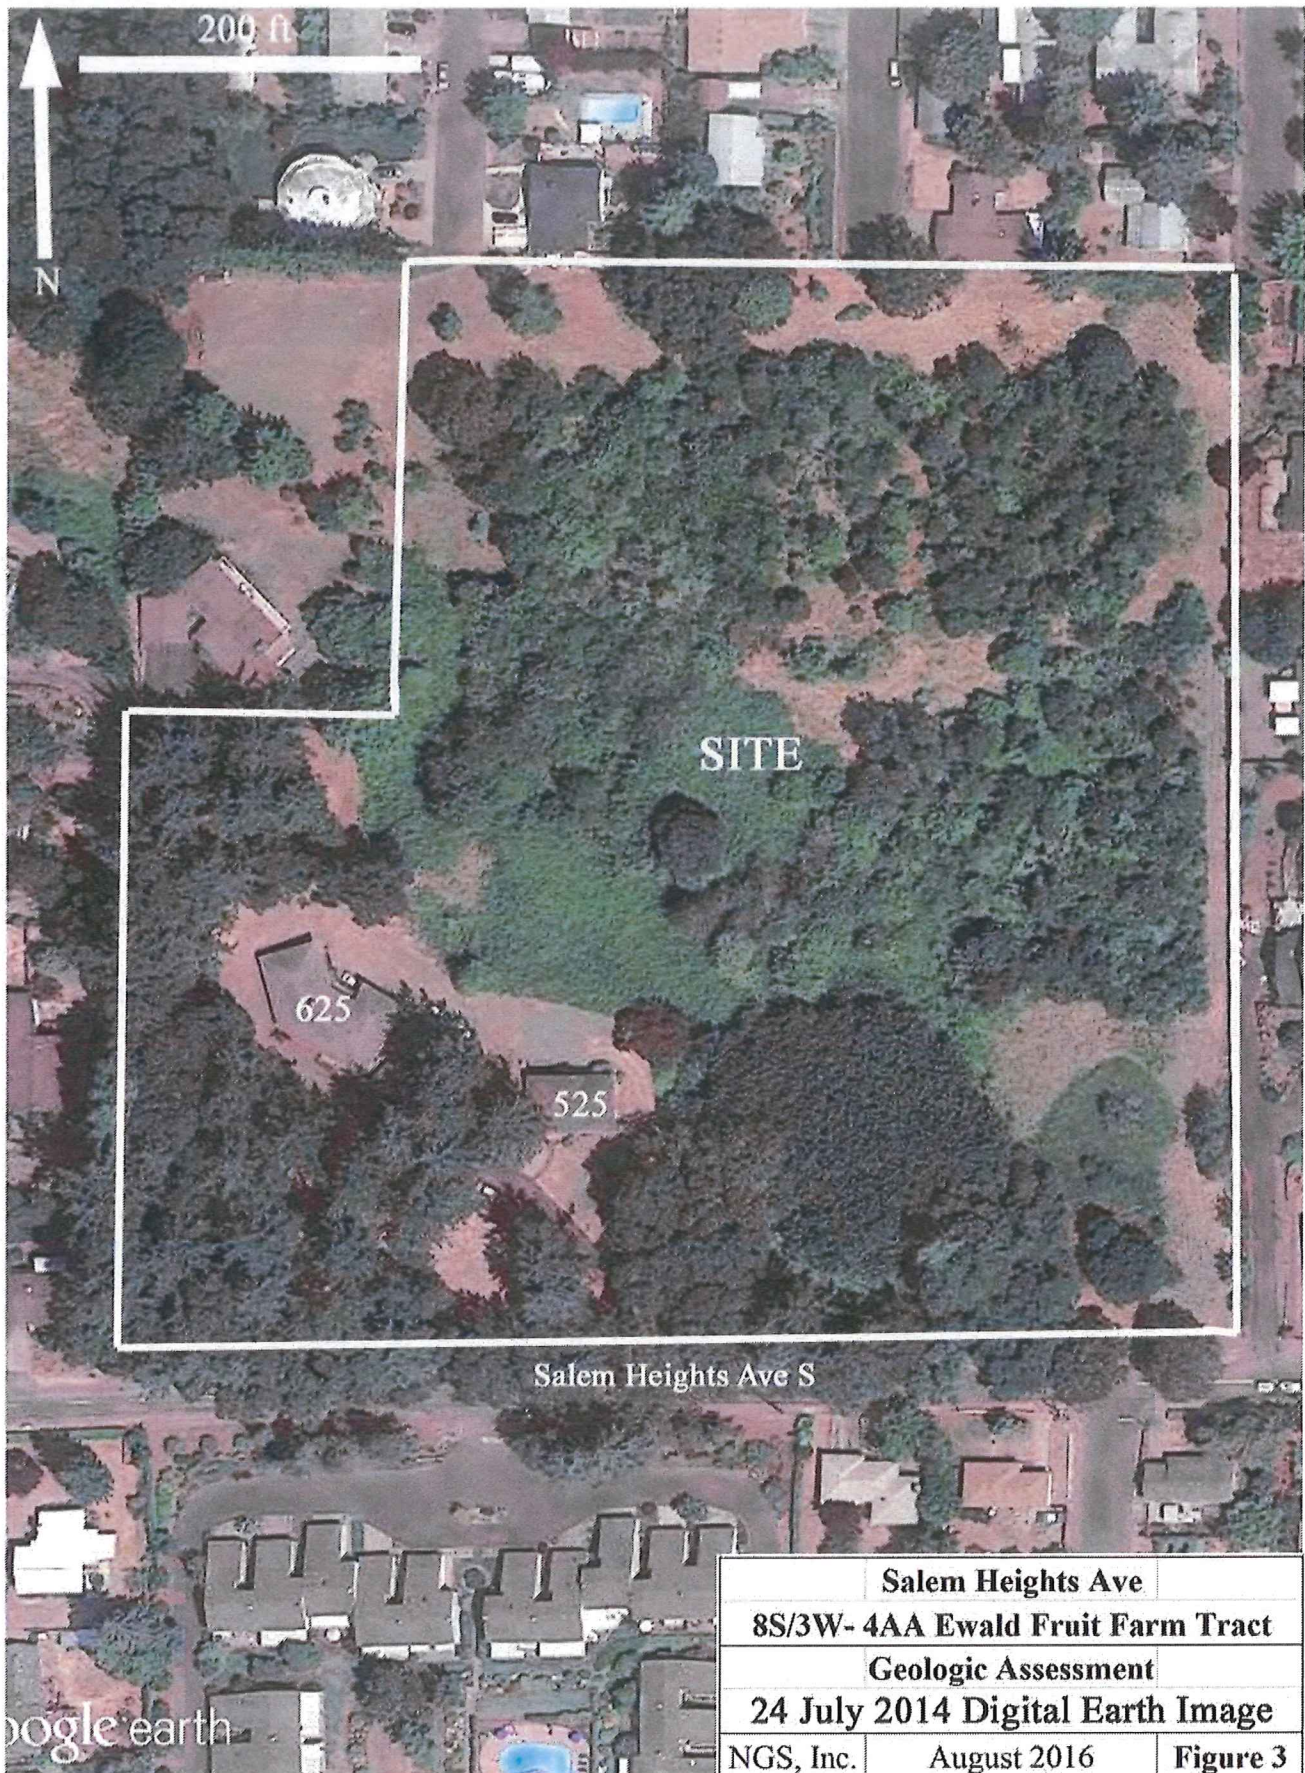
Property boundary approximate

Test Pit Location
TP-3
