STORMWATER ANALYSIS FOR

The Grove 2 Apartments Salem, Oregon

February 22, 2021

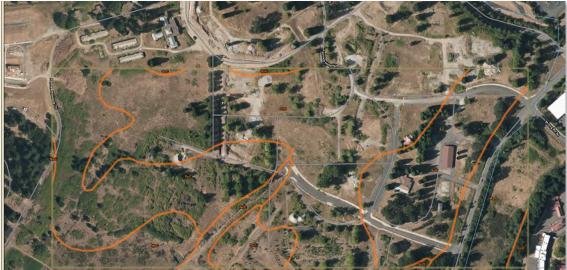
Figure 2: Web Soil Survey output for the site area.

The results of the NRCS Web Soil Survey indicate that there are three soil types located across the two properties: Santiam Silt Loam, Silverton silt loam, and McAlpin Silty Clay. The preliminary soil information indicates the site contains moderately well-draining soils, which is confirmed by the infiltration tests discussed below. A site with moderately well-draining soils may allow for the infiltration of stormwater. While the Fairview Refinement Plan indicates that stormwater should be infiltrated into the native soil, this is not always possible. The Fairview Refinement plan based this requirement off an infiltration rate of 3.1 inches per hour. However, infiltration tests performed on both sites showed a much lower infiltration rate for the native soil.

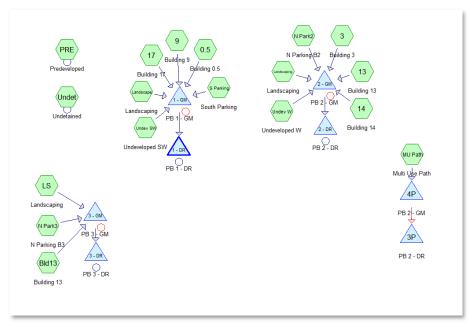
Figure 3: HydroCAD Schematic for East property.

The analysis for the stormwater was done using HydroCAD 10.00, with the Santa Barbara Unit Hydrograph and a Type 1A rainfall distribution. A design infiltration rate for the native soil is 0.70 inches per hour. The design infiltration rate through the growing media of the rain gardens is 2.0 inches per hour. The HydroCAD schematics can be seen below:

Each facility was designed through three nodes within HydroCAD. The basin node summarizes all the stormwater generating surface directed to each facility. This includes parking lot, sidewalk, lawn, and roof area. This node is then routed to a growing media facility node. The growing media node specifies the detention volume of the facility, with the primary outlet being infiltration through the growing media at 2 inches per hour. Each facility has been designed to ensure it can infiltrate/treat the entire water quality event.

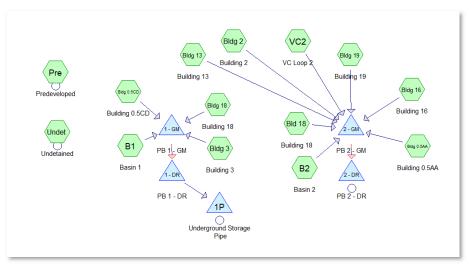
Figure 4: HydroCAD schematic for West property.

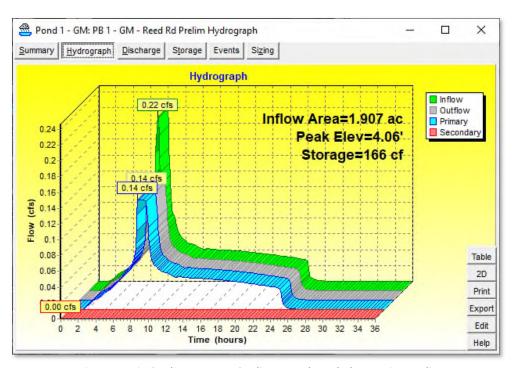
Figure 5: Rain Garden 1 - Water Quality Event through the growing media.

The hydrograph shows that all the stormwater entering the rain garden is leaving the facility through the primary outlet (BLUE line). This means that all the stormwater is infiltrating through the growing media. The hydrograph below demonstrates that the water flowing through the growing media then is stored in the drain rock until it is able to fully infiltrate into the native soil (RED line). The facility is empty by storm

The proposed planter box has a bottom area of 3000 square feet and an overall depth of 2 feet. These areas were used in the water quality facility geometry input, with a primary outlet being infiltration through the growing media at 2 inches per hour and a secondary outlet (rock box) located 1.5 feet above the bottom of the planter box.

The planter box is designed to provide treatment for the water quality event. This is shown in the hydrograph below:

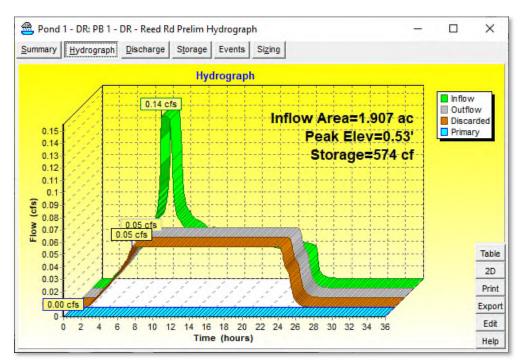
hour 26. All of the runoff for the water quality event is able to infiltrate into the native soil, with no water leaving the site.

Figure 6: Rain Garden 1 - Water Quality Event in Drain Rock.

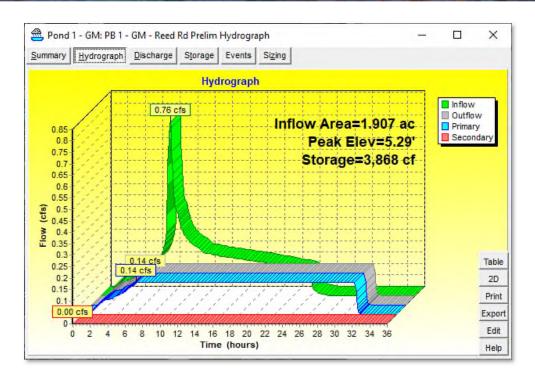
The first hydrograph shows the planter box above the growing media. The stormwater is stored within the planter box while it infiltrates through the growing media. No water enters the rock box to bypass the growing media.

During storm events in excess of the water quality event, water will be stored within the rain garden until it reaches a depth of 18 inches. After the depth reaches 18 inches, it will flow into the rock box and be diverted past the growing media into the drain rock storage area. This larger storage area allows the larger event to be stored while it infiltrates into the native soil. The hydrographs below shows the planter box facility during the 25 year event.

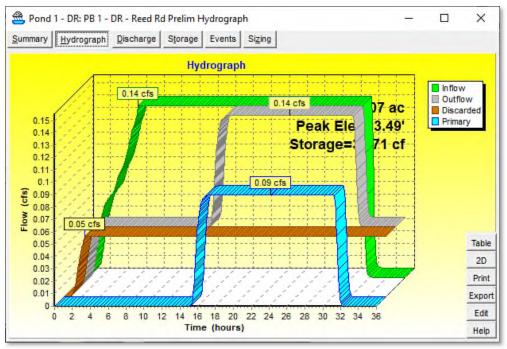
The second hydrograph shows the stormwater within the drain rock. At approximately storm hour 15, the runoff exceeds the ability of the native soil to infiltrate and it begins to leave through the perforated pipe at the top of the drain rock. These hydrographs demonstrate that the planter box is able to provide detention and limit the flow leaving during the 25 year storm event. Of the 0.76 cfs that comes into the planter box, only 0.09 cfs leaves.

Figure 7: Rain Garden 1 - 25 year Event Rock Gallery

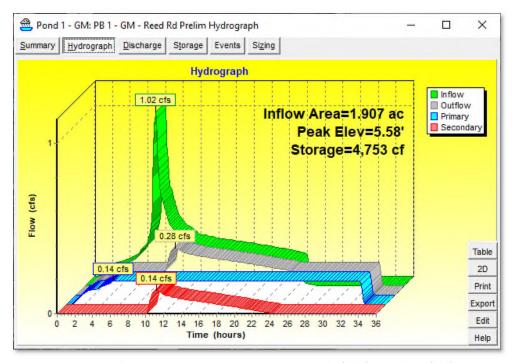
The 100 year storm hydrographs are shown below. First, the planter box hydrograph is shown with a water depth within the rain garden of 1.58 feet. Until storm hour 10, water is able to flow through the growing media to the drain rock below. After this, the stormwater flows through the rock box to bypass the growing media.

Figure 8: Planter Box 1 - 100 year Event Growing Media (blue) & Rock Box (red)

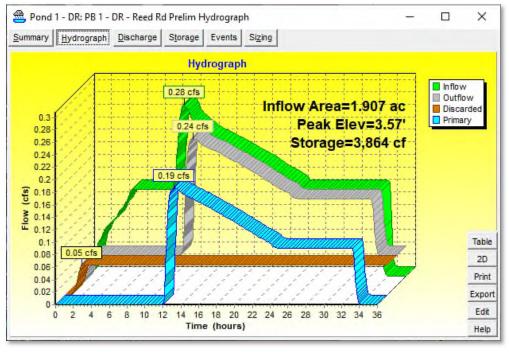
The second hydrograph shows the drain rock storage, with the 100 year event leaving through the 100 year overflow. At approximately storm hour 12, the storage in the drain rock and the infiltrate rate of the native soil are overpowered and water back up to leave through the perforate pipe. Of the 1.02 cfs coming into the planter box, only 0.19 cfs is leaving.

Figure 9: Rain Garden 1 - 100 year Event Rock Gallery

These hydrographs demonstrate that the facility is able to pass the 100 year event without overtopping.

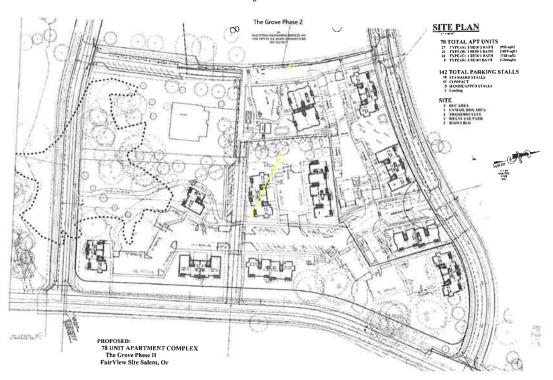
Conceptual Site Plan Reed Rd Site

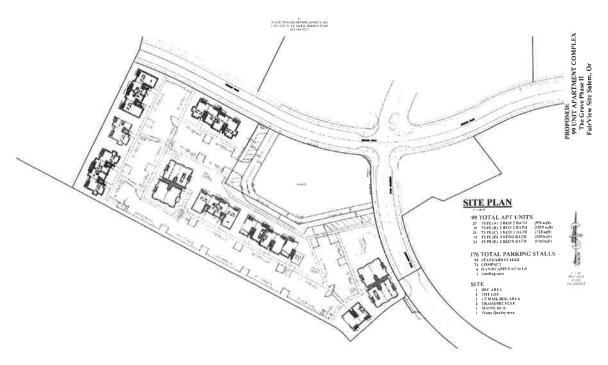
Conceptual Site Plan VC Site

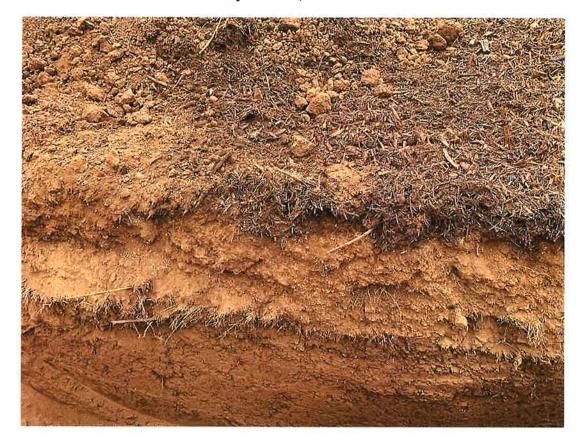
As note earlier, we did encounter very firm weathered basalt in the south east portion of the VC Site.

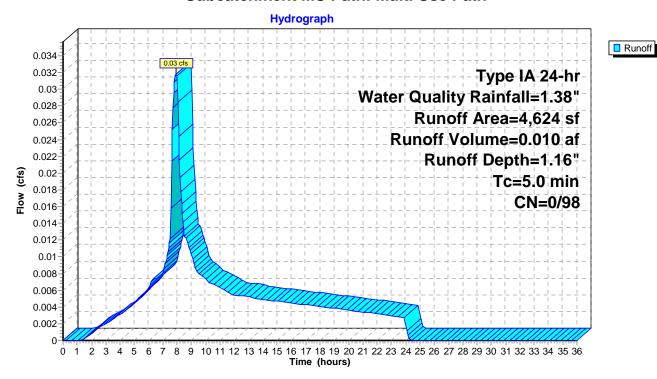
Subcatchment MU Path: Multi Use Path

A	rea (sf)	CN [Description							
	4,624	98 l	Unconnected pavement, HSG C							
	4,624	98 1	100.00% Impervious Area							
Tc (min)	Length (feet)	Slope (ft/ft)	e Velocity Capacity Description							
5.0			,	, ,	Direct Entry,

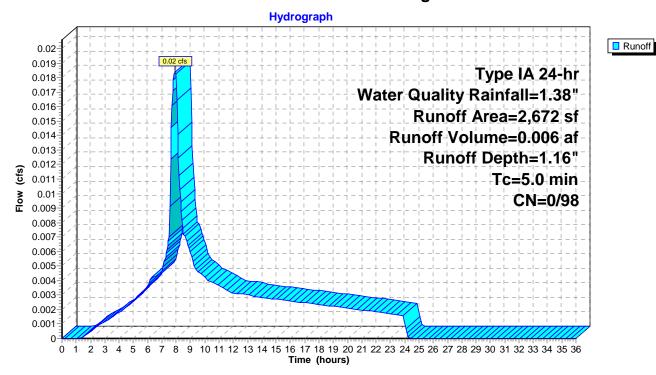
Subcatchment 0.5: Building 25

A	rea (sf)	CN [Description							
	2,672	98 F	Roofs, HSG C							
•	2,672	98 1	8 100.00% Impervious Area							
Tc (min)	Length (feet)	Slope (ft/ft)	Velocity (ft/sec)	Capacity (cfs)	Description					
5.0	, ,	, ,	, ,	, ,	Direct Entry,

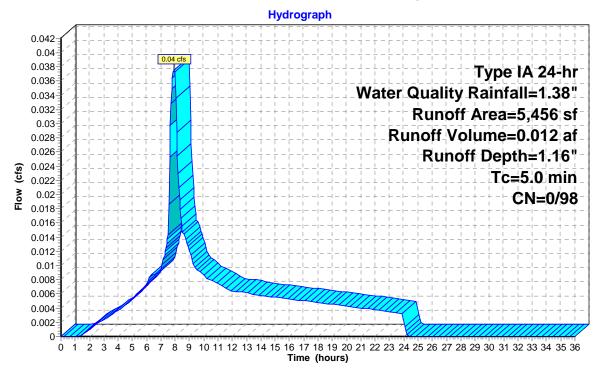
Subcatchment 9: Building 24

A	rea (sf)	CN [Description							
	5,456	98 F	8 Roofs, HSG C							
	5,456	98 1	98 100.00% Impervious Area							
Tc (min)	Length (feet)	Slope (ft/ft)	Velocity (ft/sec)	Capacity (cfs)	Description					
5.0					Direct Entry,

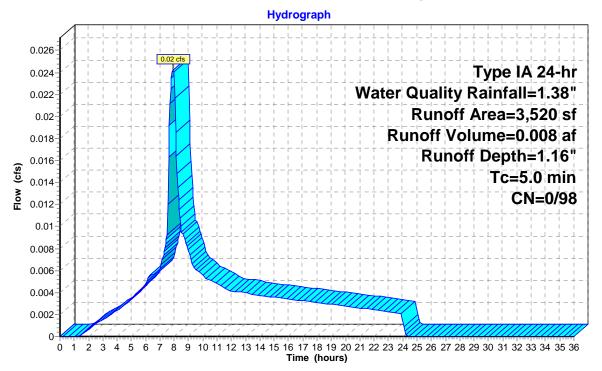
Subcatchment 17: Building 26

A	rea (sf)	CN [Description							
	3,520	98 F	8 Roofs, HSG C							
	3,520	98 ′	98 100.00% Impervious Area							
Tc (min)	Length (feet)	Slope (ft/ft)	Velocity (ft/sec)	Capacity (cfs)	Description					
5.0					Direct Entry,

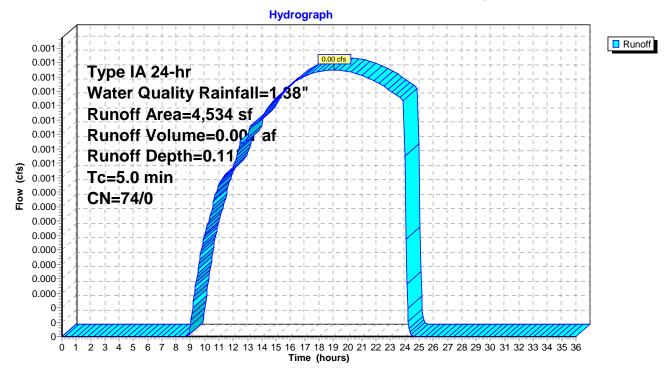
Subcatchment Landscape: Landscaping

A	rea (sf)	CN	Description								
	4,534	74	>75% Grass cover, Good, HSG C								
	4,534	74	100.00% Pervious Area								
Tc (min)	Length (feet)	Slope (ft/ft)	•	Capacity (cfs)	Description						
5.0					Direct Entry,

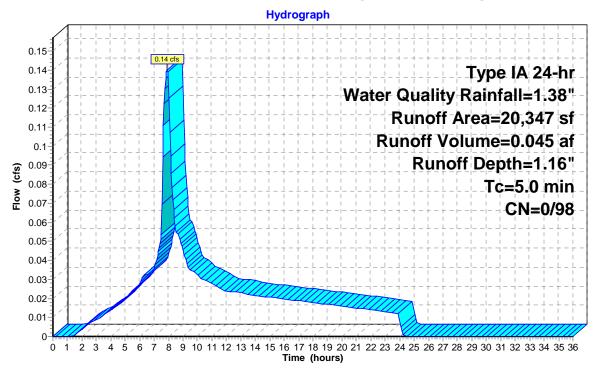
Subcatchment S Parking: South Parking

Are	ea (sf)	CN I	Description							
2	0,347	98 I	Paved parking, HSG C							
2	0,347	98 ′	8 100.00% Impervious Area							
Tc I (min)	Length (feet)	Slope (ft/ft)	Velocity (ft/sec)	Capacity (cfs)	Description					
5.0					Direct Entry,

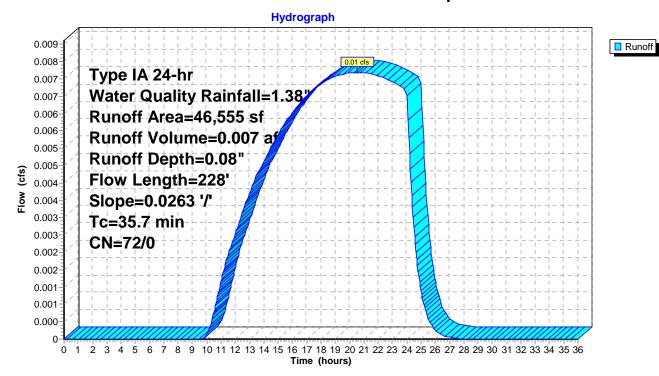
Subcatchment Undev SW: Undeveloped SW

Α	rea (sf)	CN I	Description							
*		46,555	72 (72 City of Salem Predeveloped, HSG C							
	46,555 72 100.00% Pervious Area										
	Тс	Length	Slope	,	Capacity	Description					
	(min)	(feet)	(ft/ft)	(ft/sec)	(cfs)						
	35.7	228	0.0263	0.11		Sheet Flow,					
						n= 0.300 P2= 2.20"

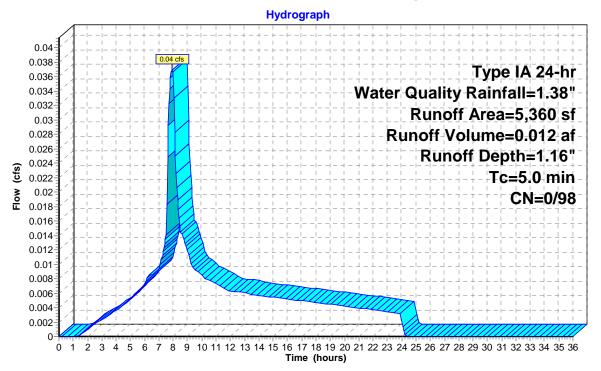
Subcatchment 3: Building 23

A	rea (sf)	CN [Description							
	5,360	98 F	Roofs, HSG C							
	5,360	98 1	3 100.00% Impervious Area							
Tc (min)	Length (feet)	Slope (ft/ft)	Velocity (ft/sec)	Capacity (cfs)	Description					
5.0					Direct Entry,

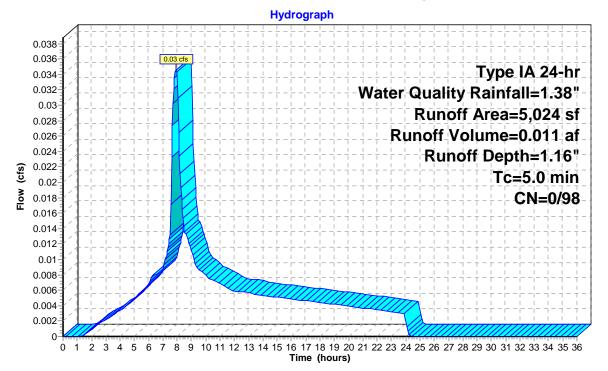
Subcatchment 13: Building 22

A	rea (sf)	CN I	Description						
	5,024	98 I	Roofs, HSG C						
	5,024	98 ′	100.00% Impervious Area						
Tc (min)	Length (feet)	Slope (ft/ft)	Velocity (ft/sec)	Capacity (cfs)	Description				
5.0					Direct Entry,

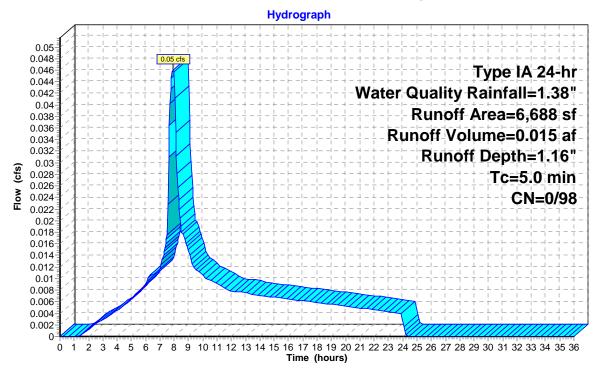
Subcatchment 14: Building 21

A	rea (sf)	CN [Description						
	6,688	98 F	Roofs, HSG C						
	6,688	98 ′	100.00% Impervious Area						
Tc (min)	Length (feet)	Slope (ft/ft)	Velocity (ft/sec)	Capacity (cfs)	Description				
5.0					Direct Entry,

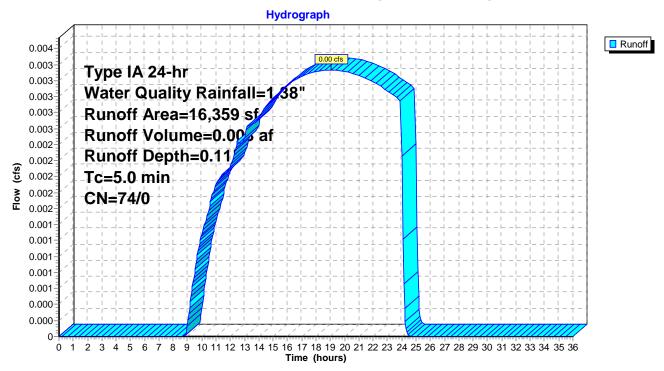
Subcatchment Landscaping: Landscaping

A	rea (sf)	CN	Description							
	16,359	74	>75% Grass cover, Good, HSG C							
	16,359	74	100.00% Pervious Area							
Tc (min)	Length (feet)	Slope (ft/ft)	Velocity (ft/sec)	Capacity (cfs)	Description					
5.0					Direct Entry,

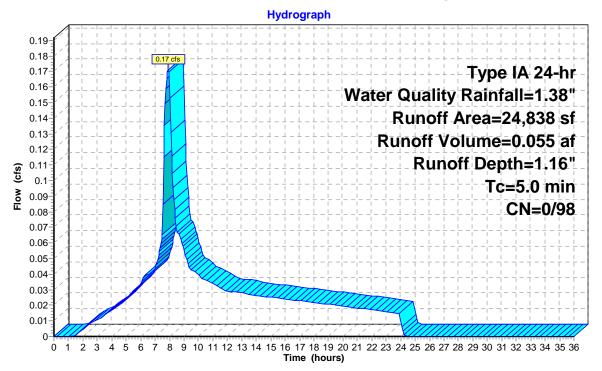
Subcatchment N Park2: N Parking B2

Area (s	sf) CN	Description							
24,83	38 98	Unconnecte	Unconnected pavement, HSG C						
24,83	38 98	100.00% Impervious Area							
Tc Len (min) (fe	gth Slop eet) (ft/	,	Capacity (cfs)	Description					
5.0				Direct Entry,

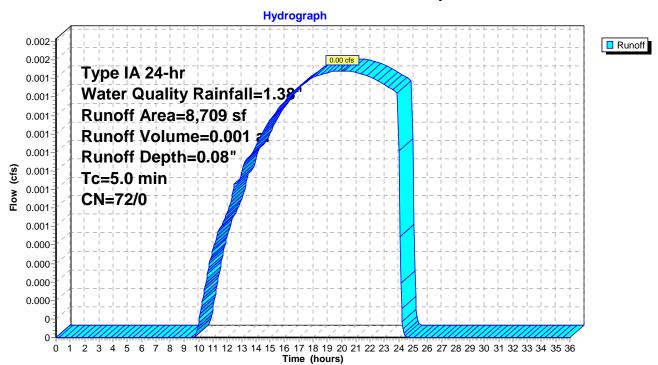
Subcatchment Undev W: Undeveloped W

Area (sf)	CN I	Description							
*	8,709	72	City of Salem Undeveloped, HSG C							
	8,709	72	100.00% Pervious Area							
Tc (min)	Length (feet)	Slope (ft/ft)	Velocity (ft/sec)	Capacity (cfs)	Description					
5.0	, ,	, ,	,	, ,	Direct Entry,

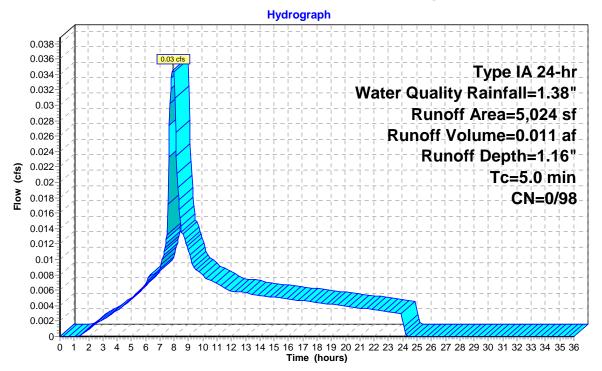
Subcatchment Bld13: Building 20

A	rea (sf)	CN I	Description		
	5,024	98 I	Roofs, HSG	G C	
	5,024	98 ′	100.00% lm	pervious A	Area
Tc (min)	Length (feet)	Slope (ft/ft)	Velocity (ft/sec)	Capacity (cfs)	Description
5.0					Direct Entry,

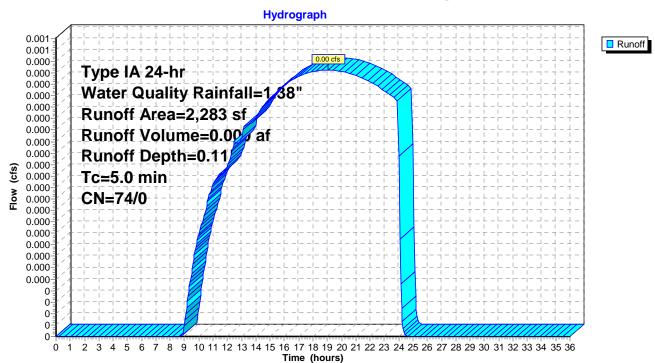
Subcatchment LS: Landscaping

A	rea (sf)	CN [Description		
	2,283	74 >	75% Gras	s cover, Go	ood, HSG C
	2,283	74 ′	100.00% Pe	ervious Are	ea
Tc (min)	Length (feet)	Slope (ft/ft)	Velocity (ft/sec)	Capacity (cfs)	Description
5.0					Direct Entry,

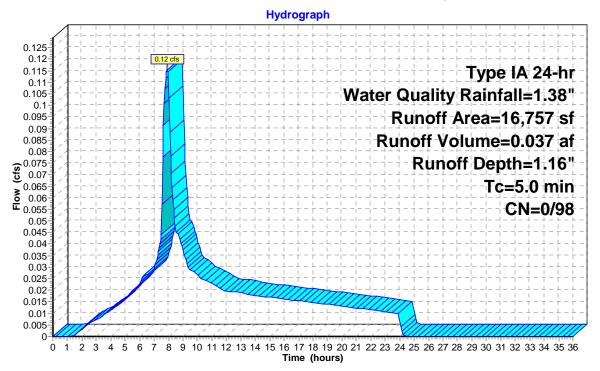
Subcatchment N Park3: N Parking B3

Area	(sf) CN	Description		
16,	757 98	Paved park	ing, HSG C	
16,	757 98	100.00% lm	pervious A	Area
	ength Slop (feet) (ft/	•	Capacity (cfs)	Description
5.0				Direct Entry,

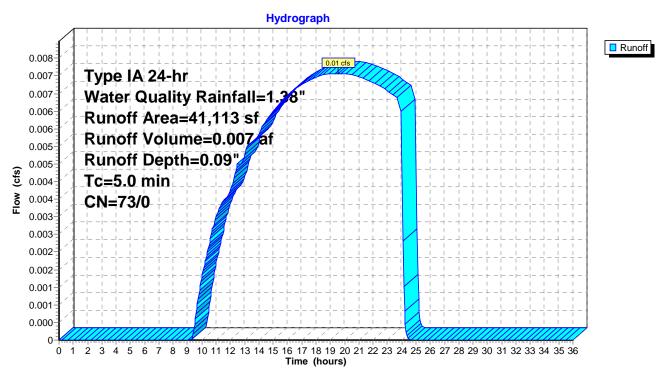
Subcatchment Undet: Undetained

Area (sf)	CN	Description						
	3,680	74	>75% Grass cover, Good, HSG C	_					
	3,296	74	>75% Grass cover, Good, HSG C	>75% Grass cover, Good, HSG C					
	7,604	74	>75% Grass cover, Good, HSG C						
	1,317	74	>75% Grass cover, Good, HSG C						
*	25,216	72	City of Salem Predeveloped, HSG C						
	41,113	73	Weighted Average						
	41,113	73	100.00% Pervious Area						
_		٥.							
To		Slop							
(min) (feet)	(ft/f	ft) (ft/sec) (cfs)						
5.0)		Direct Entry,

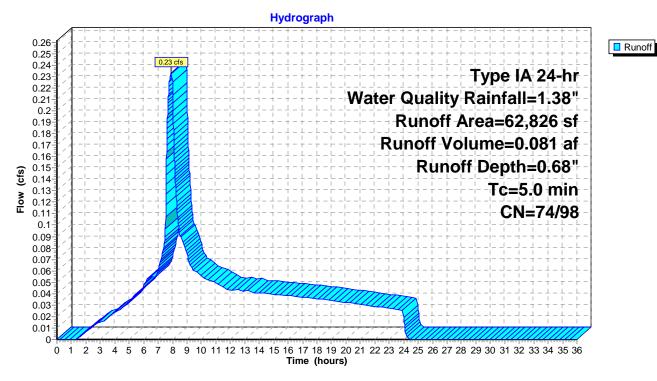
Subcatchment B1: Basin 1

Area (sf)	CN	Description	Description					
	33,861	98	Paved park	Paved parking, HSG C					
	27,754	74	>75% Gras	>75% Grass cover, Good, HSG C					
*	1,211	72	Planter Box						
	62,826	87	Weighted A	Weighted Average					
	28,965	74	46.10% Per	46.10% Pervious Area					
	33,861	98	53.90% Imp	53.90% Impervious Area					
	Tc Length		,	Capacity	Description				
(r	min) (feet)	(ft/1	ft) (ft/sec)	(cfs)					
	5.0				Direct Entry,

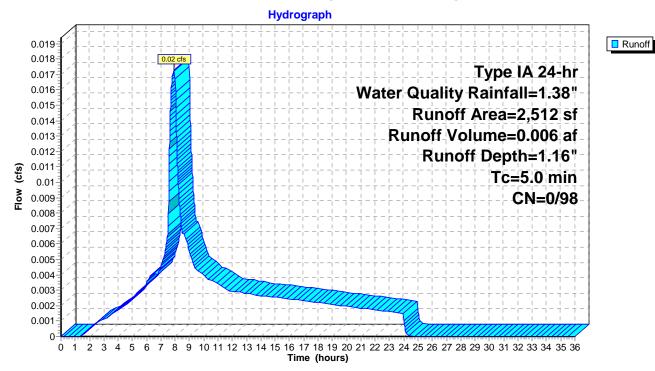
Subcatchment Bldg 0.5CD: Building 33

rea (sf)	CN [Description						
	2,512	98 F	98 Roofs, HSG C						
	2,512	98 ′	98 100.00% Impervious Area						
Tc (min)	Length (feet)	Slope (ft/ft)	Velocity (ft/sec)	Capacity (cfs)	Description				
5.0					Direct Entry,

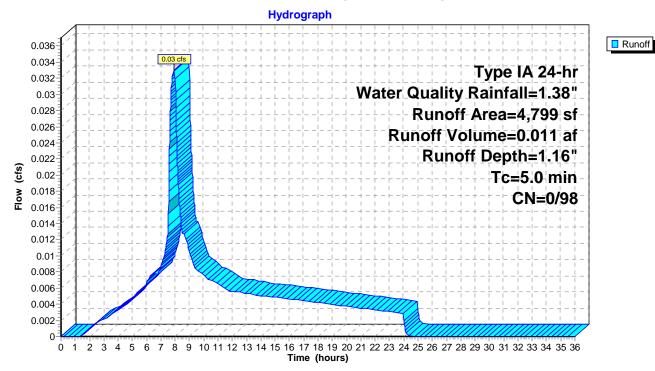
Subcatchment Bldg 18: Building 34

_	Α	rea (sf)	CN	Description							
		4,799	98	Roofs, HSG C							
		4,799	98	98 100.00% Impervious Area							
	Tc	Length	Slope	Velocity	Capacity	Description					
	(min)	(feet)	(ft/ft)	(ft/sec)	(cfs)						
	5.0					Direct Entry

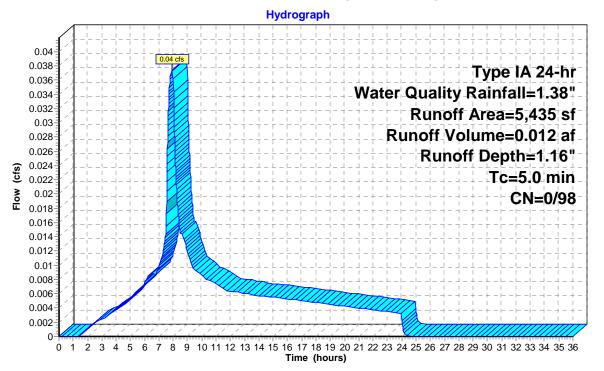
Subcatchment Bldg 3: Building 35

_	Α	rea (sf)	CN	Description							
		5,435	98	Roofs, HSG C							
		5,435	98	98 100.00% Impervious Area							
	Tc	Length	Slope	Velocity	Capacity	Description					
	(min)	(feet)	(ft/ft)	(ft/sec)	(cfs)						
_	5.0					Direct Entry

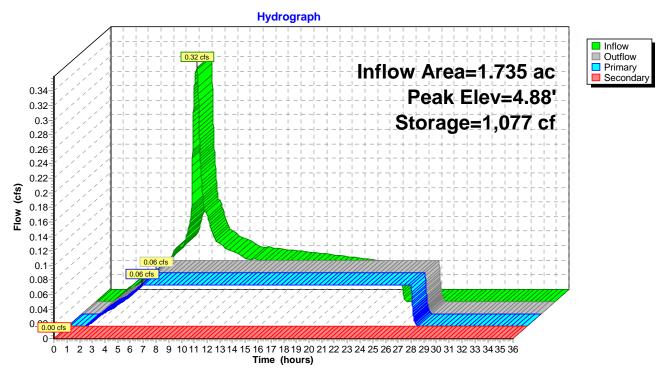
Pond 1 - GM: PB 1 - GM

Volume	Inver	: Avail.Sto	rage Storage	Storage Description				
#1	0.00	1,7		ock Storage f Overall x 3		c) Listed below (Recalc) s		
Elevation (fee		urf.Area (sq-ft)	Inc.Store (cubic-feet)	Cum.St (cubic-fe				
0.0	00	1,229	0		0			
4.0	00	1,229	4,916	4,9	916			
Device	Routing	Invert	Outlet Device	es				
#1	#1 Discarded 0.00' 0.7		0.700 in/hr N	700 in/hr Native Infiltration over Surface area				
#2	Primary	3.00'	12.0" Vert. U	nderdrain	C = 0.600	Limited to weir flow at low heads

Discarded OutFlow Max=0.02 cfs @ 3.29 hrs HW=0.04' (Free Discharge) **1=Native Infiltration** (Exfiltration Controls 0.02 cfs)

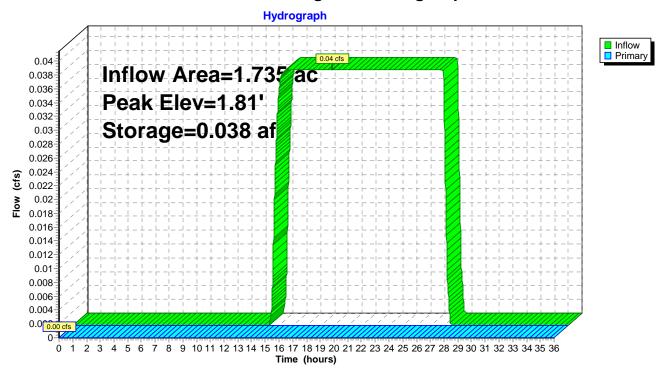
Pond 1P: Underground Storage Pipe

Primary OutFlow Max=0.00 cfs @ 0.00 hrs HW=0.00' (Free Discharge)
1=Orifice/Grate (Controls 0.00 cfs)

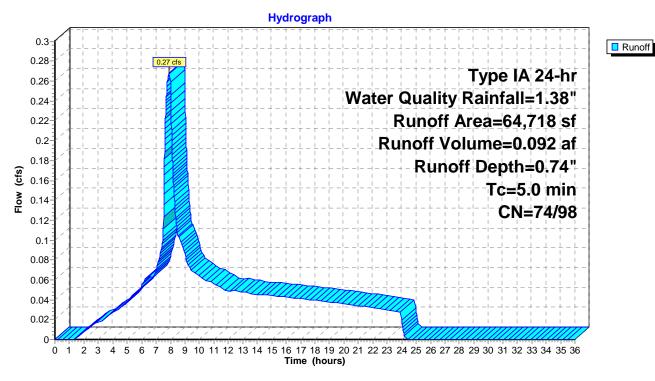
Subcatchment B2: Basin 2

Area (sf)	CN	Description						
	21,385	74	>75% Gras	s cover, Go	lood, HSG C				
	38,965	98	Paved park	Paved parking, HSG C					
*	4,368	72	Planter Box						
	64,718	88	Weighted A	Weighted Average					
	25,753	74	39.79% Per	39.79% Pervious Area					
	38,965	98	60.21% lmp	60.21% Impervious Area					
	Tc Length	Slop	,	Capacity	•				
(n	nin) (feet)	(ft/f	ft) (ft/sec)	(cfs)					
	5.0				Direct Entry,

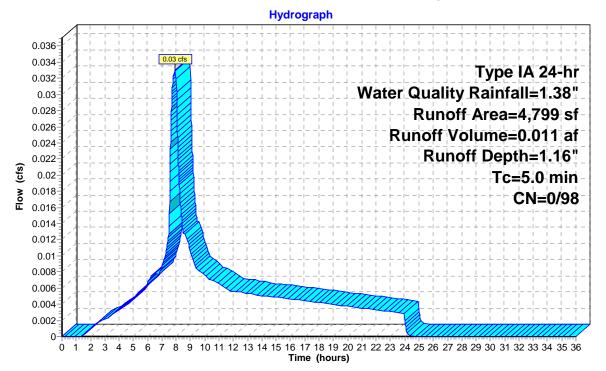
Subcatchment Bld 18: Building 30

A	rea (sf)	CN [Description						
	4,799	98 F	Roofs, HSG C						
•	4,799	98 ′	98 100.00% Impervious Area						
Tc (min)	Length (feet)	Slope (ft/ft)	Velocity (ft/sec)	Capacity (cfs)	Description				
5.0					Direct Entry,

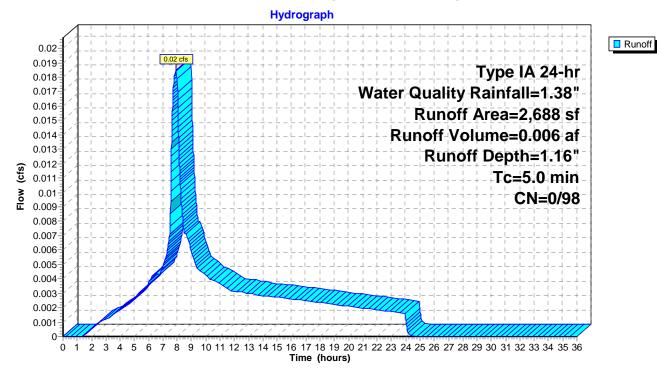
Subcatchment Bldg 0.5AA: Building 28

A	rea (sf)	CN I	Description						
	2,688	98 I	98 Roofs, HSG C						
	2,688	98	98 100.00% Impervious Area						
Tc (min)	Length (feet)	Slope (ft/ft)	Velocity (ft/sec)	Capacity (cfs)	Description				
5.0					Direct Entry,

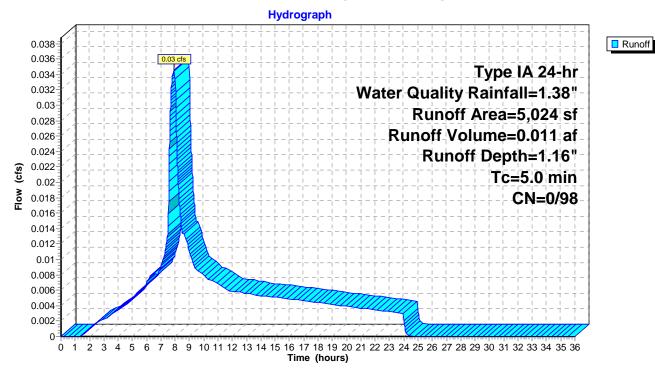
Subcatchment Bldg 13: Building 32

A	rea (sf)	CN I	Description						
	5,024	98 I	Roofs, HSG C						
	5,024	98 ′	3 100.00% Impervious Area						
Tc (min)	Length (feet)	Slope (ft/ft)	Velocity (ft/sec)	Capacity (cfs)	Description				
5.0					Direct Entry,

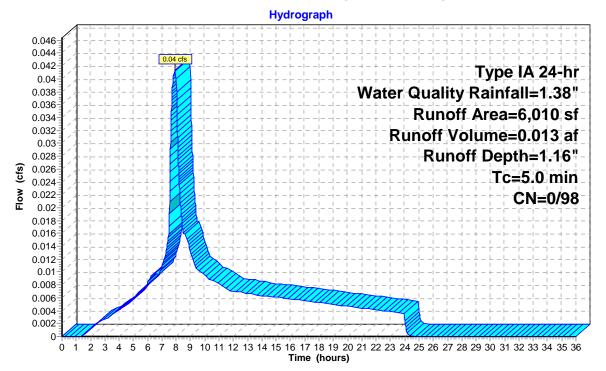
Subcatchment Bldg 16: Building 27

_	Α	rea (sf)	CN	Description								
		6,010	98	Roofs, HSG C								
		6,010	98	100.00% Impervious Area								
	Tc	Length	Slope	 Velocity 	Capacity	Description						
	(min)	(feet)	(ft/ft)	(ft/sec)	(cfs)							
	5.0					Direct Entry

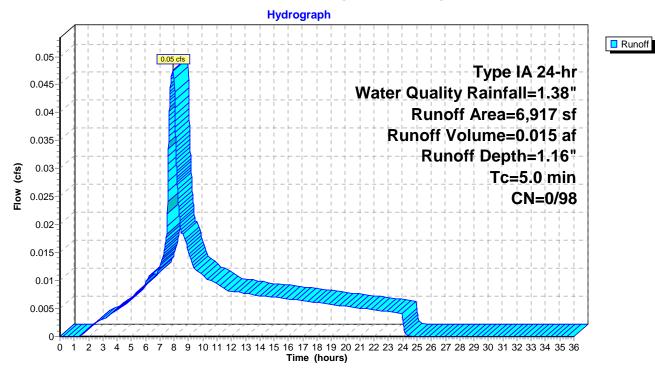
Subcatchment Bldg 19: Building 29

_	Α	rea (sf)	CN	Description								
		6,917	98	Roofs, HSG C								
		6,917	98	8 100.00% Impervious Area								
	Tc	Length	Slope	e Velocity	Capacity	Description						
	(min)	(feet)	(ft/ft)	(ft/sec)	(cfs)							
	5.0					Direct Entry

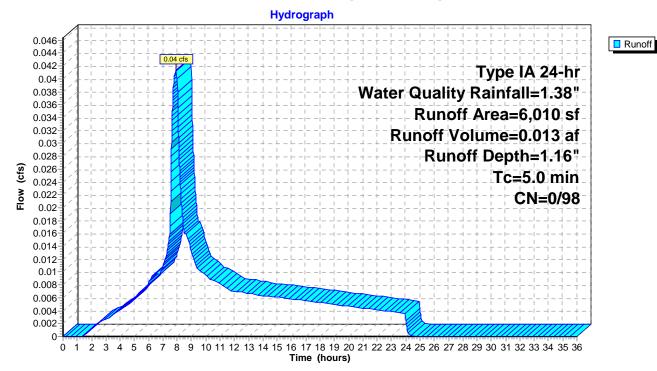
Subcatchment Bldg 2: Building 31

A	rea (sf)	CN [Description							
	6,010	98 F	Roofs, HSG C							
	6,010	98 ′	8 100.00% Impervious Area							
Tc (min)	Length (feet)	Slope (ft/ft)	Velocity (ft/sec)	Capacity (cfs)	Description					
5.0					Direct Entry,

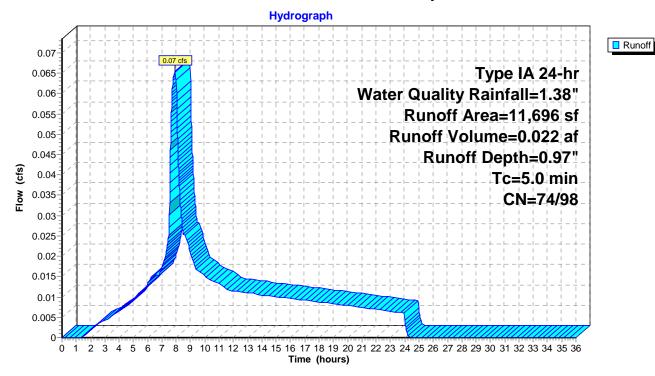
Subcatchment VC2: VC Loop 2

Aı	rea (sf)	CN	Description						
	2,181	74	>75% Grass cover, Good, HSG C						
	9,515	98	Paved park	ing, HSG C					
	11,696	94	Weighted A	verage					
	2,181	74	18.65% Per	vious Area					
	9,515	98	81.35% lmp	pervious Ar	ea				
Тс	Length	Slop	e Velocity	Capacity	Description				
 (min)	(feet)	(ft/f	,	(cfs)	•				
 5.0					Direct Entry.

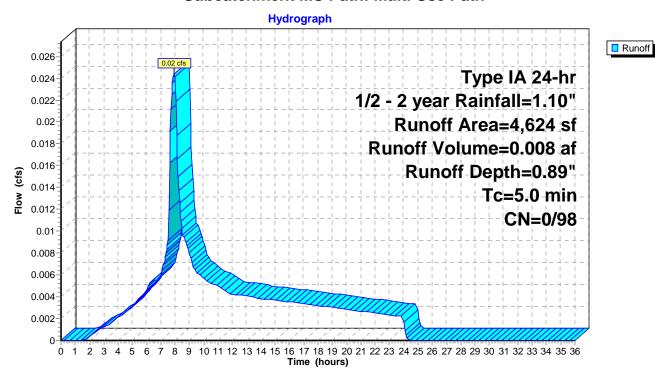
Subcatchment MU Path: Multi Use Path

_	Α	rea (sf)	CN	Description						
		4,624	98	Unconnected pavement, HSG C						
		4,624	98	100.00% Impervious Area						
	Tc	Length	Slope	Velocity	Capacity	Description				
	(min)	(feet)	(ft/ft)	(ft/ft) (ft/sec) (cfs)						
	5.0					Direct Entry

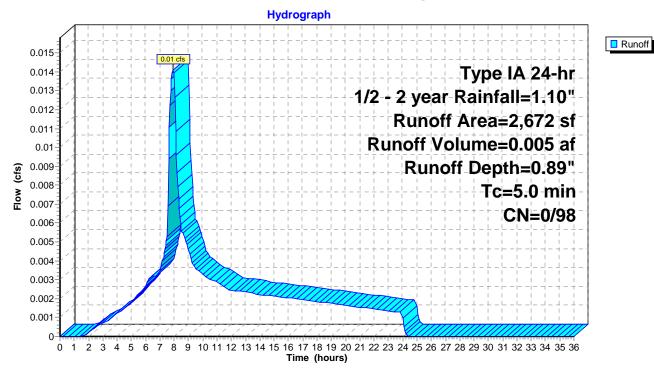
Subcatchment 0.5: Building 25

A	rea (sf)	CN [Description					
	2,672	98 F	Roofs, HSG C					
•	2,672	98 1	98 100.00% Impervious Area					
Tc (min)	Length (feet)	Slope (ft/ft)	Velocity (ft/sec)	Capacity (cfs)	Description			
5.0	, ,	, ,	, ,	, ,	Direct Entry,

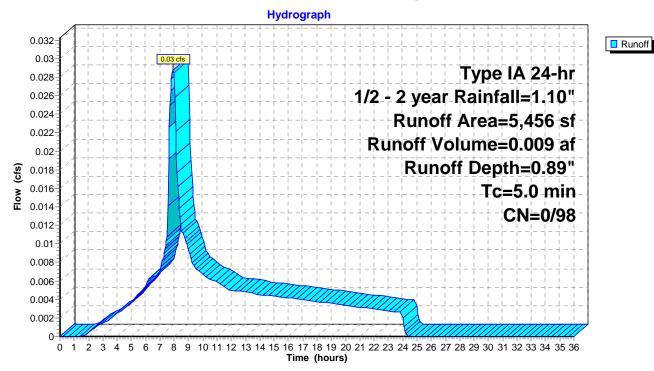
Subcatchment 9: Building 24

A	rea (sf)	CN [Description						
	5,456	98 F	Roofs, HSG C						
	5,456	98 1	98 100.00% Impervious Area						
Tc (min)	Length (feet)	Slope (ft/ft)	Velocity (ft/sec)	Capacity (cfs)	Description				
5.0					Direct Entry,

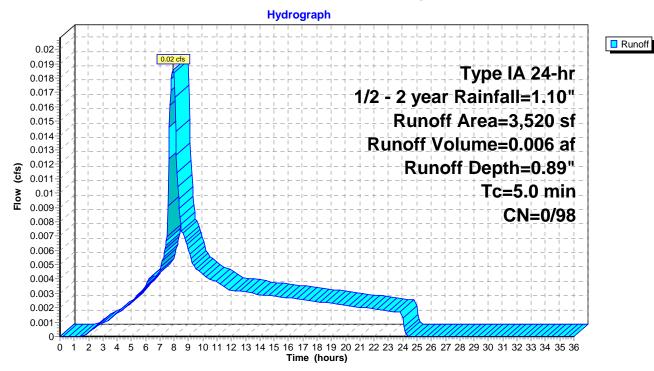
Subcatchment 17: Building 26

A	rea (sf)	CN [Description						
	3,520	98 F	Roofs, HSG C						
	3,520	98 ′	98 100.00% Impervious Area						
Tc (min)	Length (feet)	Slope (ft/ft)	Velocity (ft/sec)	Capacity (cfs)	Description				
5.0					Direct Entry,

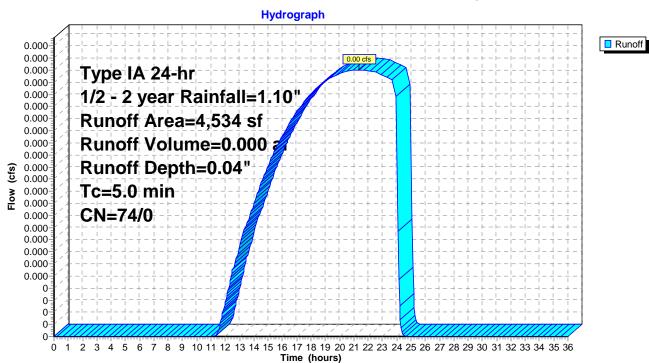
Subcatchment Landscape: Landscaping

Area (sf)	CN	Description						
	4,534	74	>75% Grass cover, Good, HSG C						
	4,534	74	00.00% Pervious Area						
Tc (min)	Length (feet)	Slope (ft/ft)	,	Capacity (cfs)	v Description				
5.0					Direct Entry,

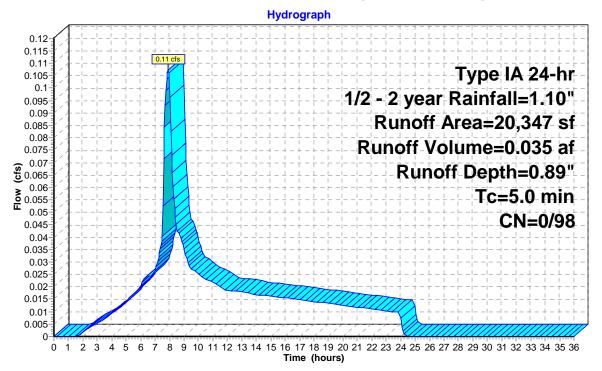
Subcatchment S Parking: South Parking

Α	rea (sf)	CN	Description						
	20,347	98	Paved parking, HSG C						
	20,347 98 100.00% Impervious Area								
.	1	01	- Mala a'i	0 11	Description				
	Length	Siop	•	Capacity	Description				
(min)	(feet)	(ft/f	t) (ft/sec)	(cfs)					
5.0					Direct Entry

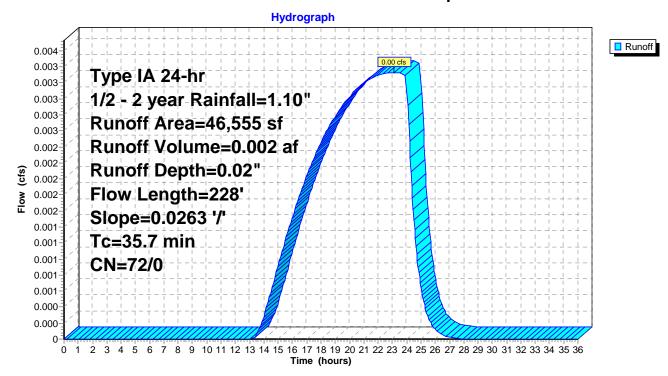
Subcatchment Undev SW: Undeveloped SW

Α	rea (sf)	CN I	Description					
*		46,555	72 (City of Salem Predeveloped, HSG C					
	46,555 72 100.00% Pervious Area								
	Тс	Length	Slope	,	Capacity	Description			
	(min)	(feet)	(ft/ft)	(ft/sec)	(cfs)				
	35.7	228	0.0263	0.11		Sheet Flow,			
						n= 0.300 P2= 2.20"

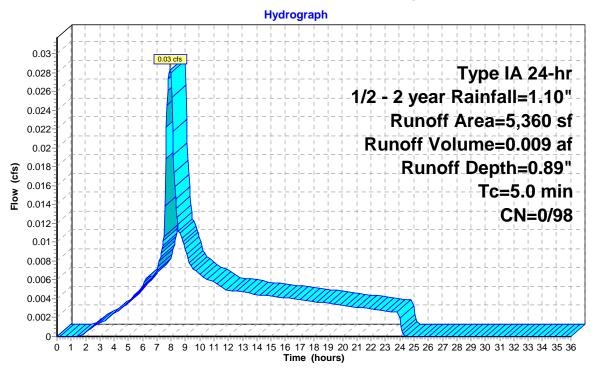
Subcatchment 3: Building 23

A	rea (sf)	CN [Description						
	5,360	98 F	Roofs, HSG C						
	5,360	98 1	8 100.00% Impervious Area						
Tc (min)	Length (feet)	Slope (ft/ft)	Velocity (ft/sec)	Capacity (cfs)	Description				
5.0					Direct Entry,

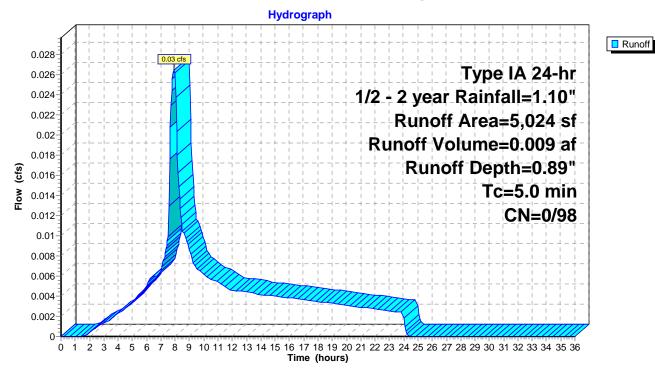
Subcatchment 13: Building 22

A	rea (sf)	CN I	Description					
	5,024	98 I	Roofs, HSG C					
	5,024	98 ′	100.00% Impervious Area					
Tc (min)	Length (feet)	Slope (ft/ft)	Velocity (ft/sec)	Capacity (cfs)	Description			
5.0					Direct Entry,

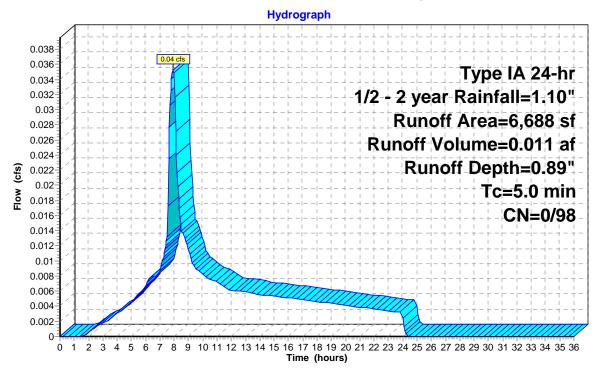
Subcatchment 14: Building 21

A	rea (sf)	CN [Description						
	6,688	98 F	Roofs, HSG C						
	6,688	98 1	3 100.00% Impervious Area						
Tc (min)	Length (feet)	Slope (ft/ft)	Velocity (ft/sec)	Capacity (cfs)	Description				
5.0					Direct Entry,

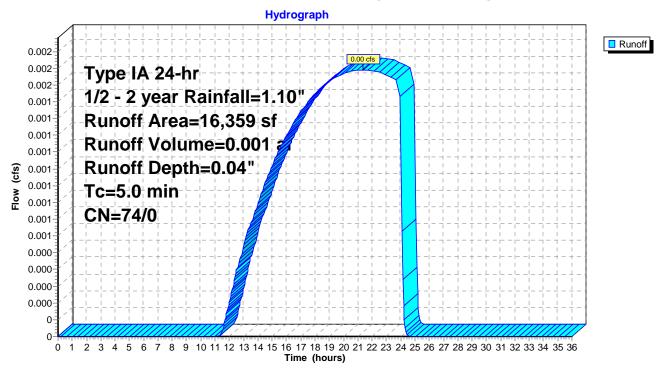
Subcatchment Landscaping: Landscaping

A	rea (sf)	CN I	Description						
	16,359	74 :	75% Grass cover, Good, HSG C						
	16,359	74 <i>′</i>	100.00% Pervious Area						
Tc (min)	Length (feet)	Slope (ft/ft)	Velocity (ft/sec)	Capacity (cfs)	Description				
5.0					Direct Entry,

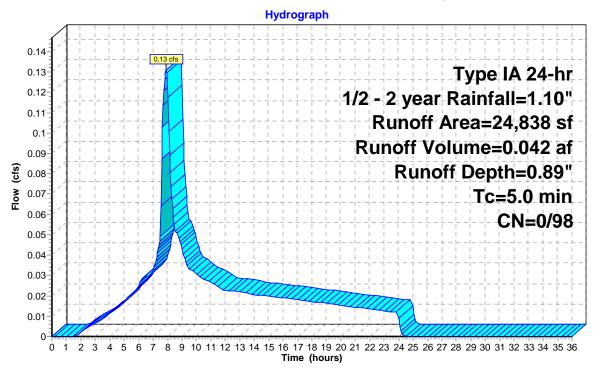
Subcatchment N Park2: N Parking B2

Α	rea (sf)	CN	Description						
	24,838	98	Unconnected pavement, HSG C						
	24,838	98	100.00% Impervious Area						
To	Longth	Slope	\/olooity	Capacity	Description				
(min)	Length (feet)	(ft/ft							
5.0	· /	,	Direct Entry

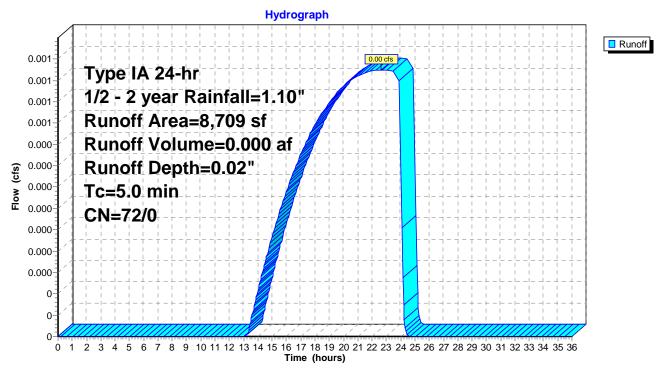
Subcatchment Undev W: Undeveloped W

Α	rea (sf)	CN	Description						
*		8,709	72	City of Salem Undeveloped, HSG C						
		8,709	72	100.00% Pervious Area						
	Tc (min)	Length (feet)	Slope (ft/ft)							
	5.0					Direct Entry,

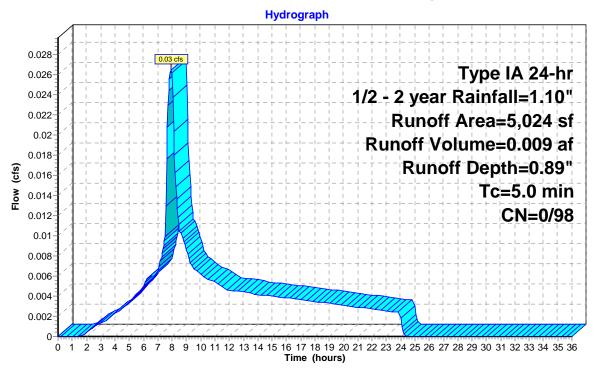
Subcatchment Bld13: Building 20

_	Α	rea (sf)	CN	Description						
		5,024	98	Roofs, HSG C						
		5,024	98	100.00% Impervious Area						
	_									
	Tc	Length	Slope	Velocity	Capacity	Description				
_	(min)	(feet)	(ft/ft)	(ft/sec)	(cfs)					
	5.0				•	Direct Entry

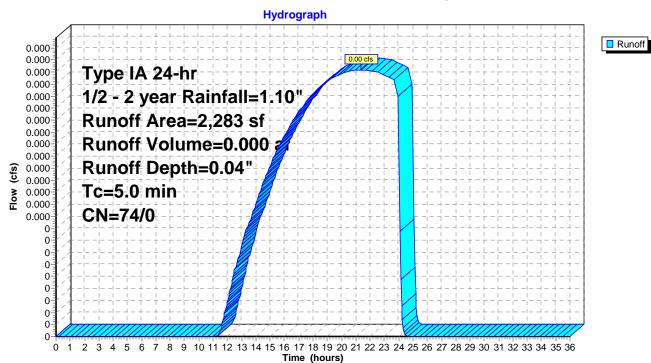
Subcatchment LS: Landscaping

A	rea (sf)	CN [Description						
	2,283	74 >	75% Grass cover, Good, HSG C						
	2,283	74 1	100.00% Pervious Area						
Tc (min)	Length (feet)	Slope (ft/ft)	Velocity (ft/sec)	Capacity (cfs)	Description				
5.0					Direct Entry,

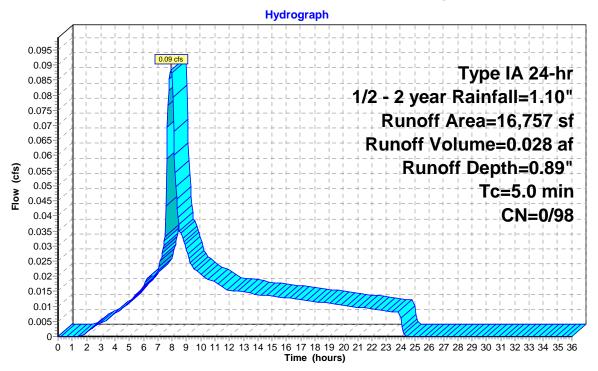
Subcatchment N Park3: N Parking B3

Α	rea (sf)	CN	Description						
	16,757	98	Paved parking, HSG C						
	16,757	98	100.00% Impervious Area						
_									
Tc	Length	Slope	e Velocity	Capacity	Description				
 (min)	(feet)	(ft/ft) (ft/sec)	(cfs)					
 5.0	•			•	Direct Entry

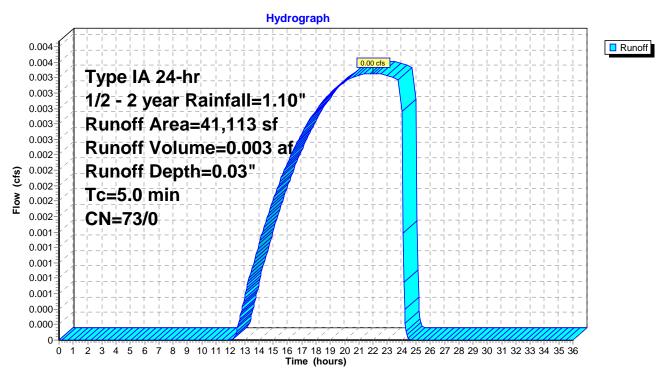
Subcatchment Undet: Undetained

Area (sf)	CN	Description					
	3,680	74	>75% Grass cover, Good, HSG C					
	3,296	74	>75% Grass cover, Good, HSG C					
	7,604	74	>75% Grass cover, Good, HSG C					
	1,317	74	>75% Grass cover, Good, HSG C					
*	25,216	72	City of Salem Predeveloped, HSG C					
	41,113	73	Weighted Average					
	41,113	73	100.00% Pervious Area					
т.	l tl-	Ola -	Valante Consolte Description					
Tc	- 3	Slop	, , , , , , , , , , , , , , , , , , , ,					
(min)	(feet)	(ft/f	ft) (ft/sec) (cfs)					
5.0			Direct Entry,

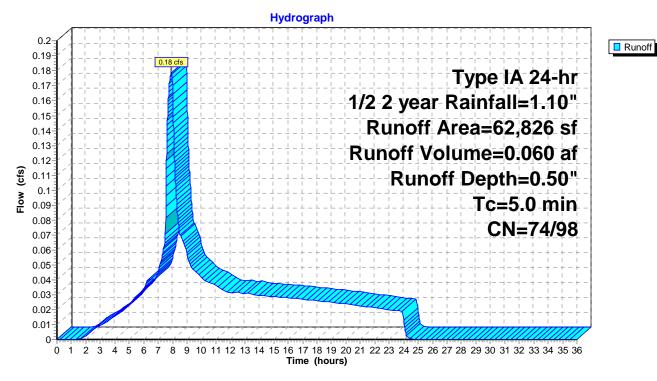
Subcatchment B1: Basin 1

Area (sf)	CN	Description	Description				
	33,861	98	Paved park	ing, HSG C	C			
	27,754	74	>75% Gras	>75% Grass cover, Good, HSG C				
*	1,211	72	Planter Box					
	62,826	87	Weighted A	verage				
	28,965	74	46.10% Per	46.10% Pervious Area				
	33,861	98	53.90% Imp	53.90% Impervious Area				
	Tc Length		,	Capacity	Description			
(r	min) (feet)	(ft/1	ft) (ft/sec)	(cfs)				
	5.0				Direct Entry,

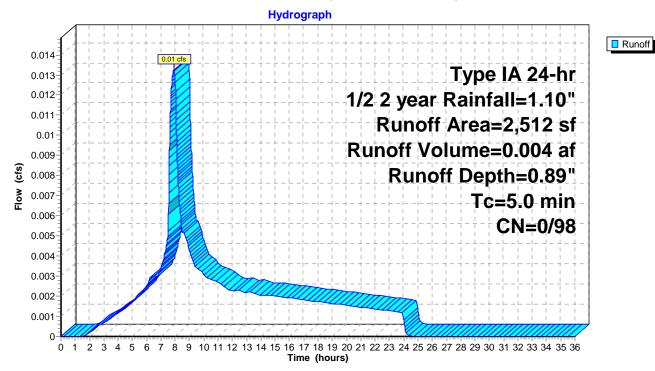
Subcatchment Bldg 0.5CD: Building 33

Area (sf)	CN	Description						
	2,512	98	Roofs, HSG C						
_	2,512	98	08 100.00% Impervious Area						
Tc	Length	Slope	Velocity	Capacity	Description				
(min)	(feet)	(ft/ft)	(ft/sec)	(cfs)					
5.0					Direct Entry

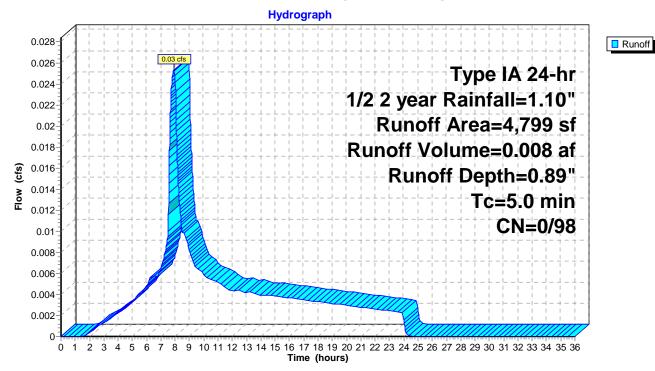
Subcatchment Bldg 18: Building 34

_	Α	rea (sf)	CN	Description						
		4,799	98	Roofs, HSG C						
		4,799	98	8 100.00% Impervious Area						
	Tc	Length	Slope	e Velocity	Capacity	Description				
	(min)	(feet)	(ft/ft) (ft/sec)	(cfs)					
	5.0			-		Direct Entry

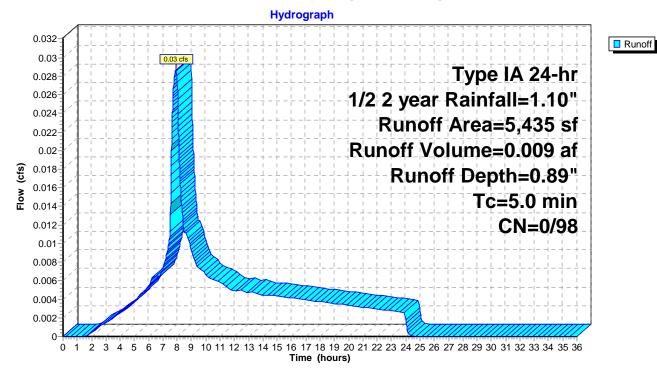
Subcatchment Bldg 3: Building 35

A	rea (sf)	CN [Description					
	5,435	98 F	Roofs, HSG C					
	5,435	98 1	98 100.00% Impervious Area					
Tc (min)	Length (feet)	Slope (ft/ft)	Velocity (ft/sec)	Capacity (cfs)	Description			
5.0					Direct Entry,

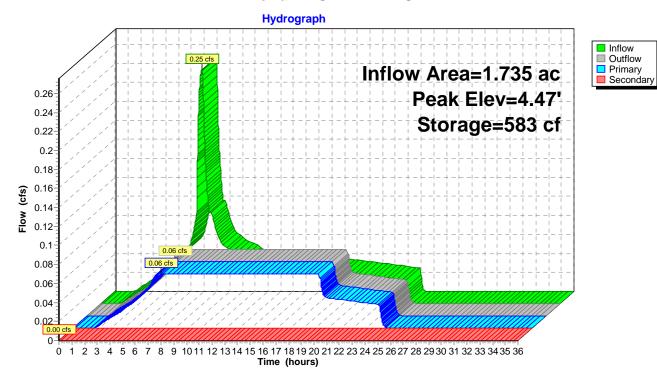
Pond 1 - GM: PB 1 - GM

Volume	Invert	Avail.Sto	rage Storage	ge Storage Description				
#1	0.00'	1,77		Rock Storage of Overall x 3	•	c) Listed below (Recalc)		
Elevatio		urf.Area (sq-ft)	Inc.Store (cubic-feet)	Cum.Sto (cubic-fe				
0.0	00	1,229	0		0			
4.0	00	1,229	4,916	4,9	916			
Device	Routing	Invert	Outlet Devic	es				
#1	Discarded	0.00'	0.700 in/hr N	Native Infiltra	tion over S	Surface area		
#2	Primary	3.00'	12.0" Vert. U	Jnderdrain	C = 0.600	Limited to weir flow at low heads

Discarded OutFlow Max=0.02 cfs @ 4.20 hrs HW=0.04' (Free Discharge) 1=Native Infiltration (Exfiltration Controls 0.02 cfs)

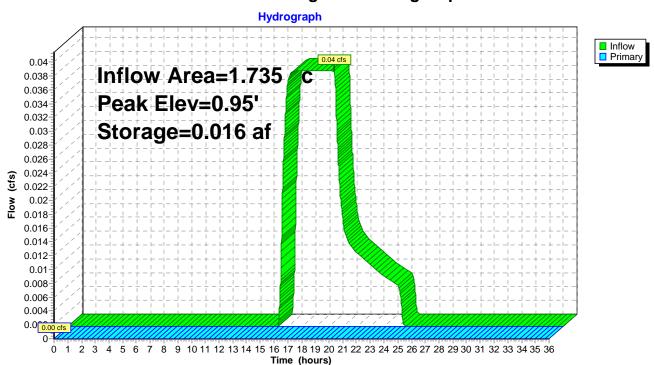
Pond 1P: Underground Storage Pipe

Primary OutFlow Max=0.00 cfs @ 0.00 hrs HW=0.00' (Free Discharge) 1=Orifice/Grate (Controls 0.00 cfs)

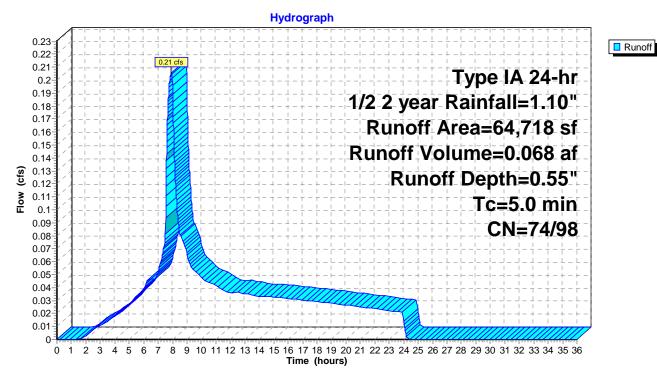
Subcatchment B2: Basin 2

Area (sf)	CN	Description	Description				
·	21,385	74	>75% Gras	s cover, Go	lood, HSG C			
	38,965	98	Paved park	Paved parking, HSG C				
*	4,368	72	Planter Box	Planter Box				
	64,718	88	Weighted A	Weighted Average				
	25,753	74	39.79% Per	39.79% Pervious Area				
	38,965	98	60.21% Impervious Area					
_		٠.			-			
T		Slop	•	Capacity	•			
(min) (feet)	(ft/f	ft) (ft/sec)	(cfs)				
5.0	0				Direct Entry,

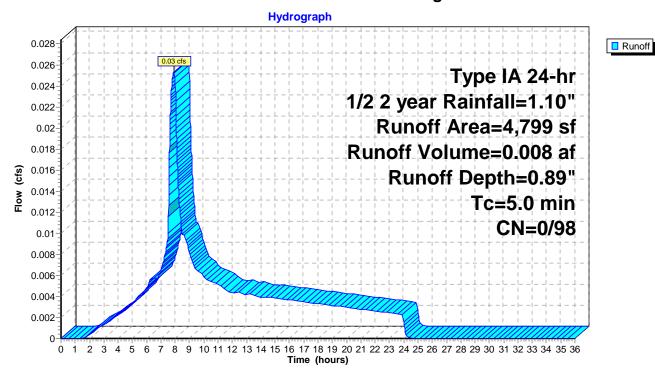
Subcatchment Bld 18: Building 30

_	Α	rea (sf)	CN	Description					
		4,799	98	Roofs, HSG C					
		4,799	98	100.00% Impervious Area					
	Tc	Length	Slope	e Velocity	Capacity	Description			
	(min)	(feet)	(ft/ft) (ft/sec)	(cfs)				
	5.0			-		Direct Entry

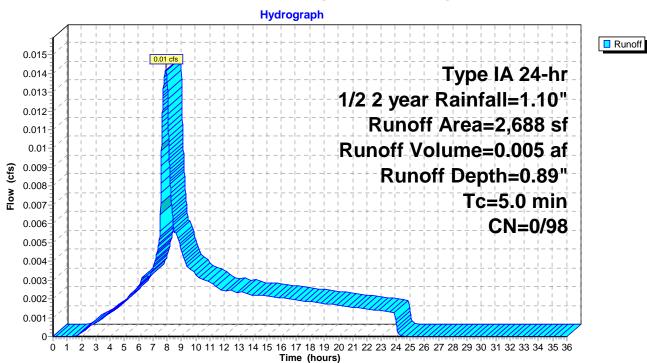
Subcatchment Bldg 0.5AA: Building 28

_	Α	rea (sf)	CN	Description					
		2,688	98	Roofs, HSG C					
		2,688	98	100.00% Impervious Area					
	Tc	Length	Slope	e Velocity	Capacity	Description			
	(min)	(feet)	(ft/ft	(ft/sec)	(cfs)				
	5.0				•	Direct Entry

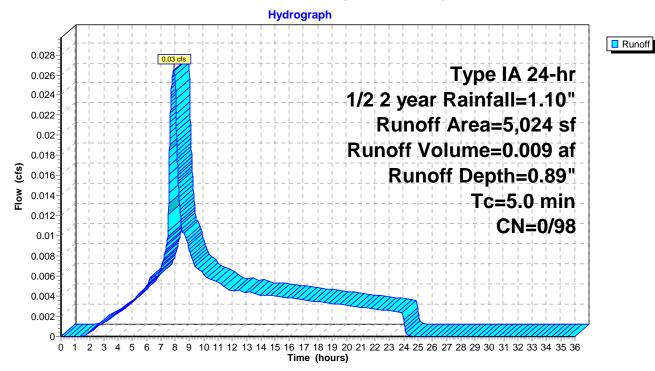
Subcatchment Bldg 13: Building 32

_	Α	rea (sf)	CN	Description						
		5,024	98	Roofs, HSG C						
_		5,024	98	100.00% Impervious Area						
	Tc	Length	Slope	e Velocity	Capacity	Description				
	(min)	(feet)	(ft/ft) (ft/sec)	(cfs)					
	5.0			-		Direct Entry

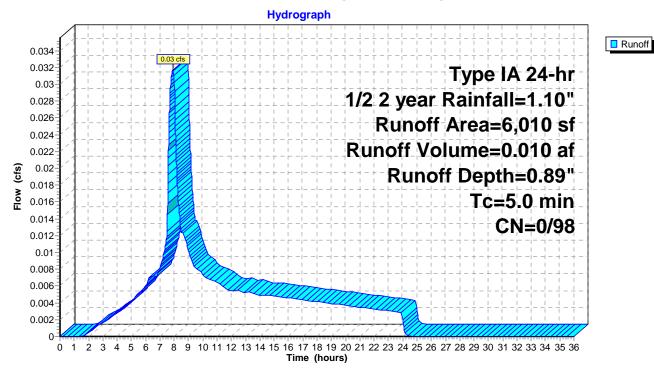
Subcatchment Bldg 16: Building 27

_	Α	rea (sf)	CN	Description						
		6,010	98	Roofs, HSG C						
		6,010	98	100.00% Impervious Area						
	Tc	Length	Slope	 Velocity 	Capacity	Description				
	(min)	(feet)	(ft/ft)	(ft/sec)	(cfs)					
	5.0		·			Direct Entry
