STORMWATER ANALYSIS FOR

The Grove 2 Apartments Salem, Oregon

February 22, 2021

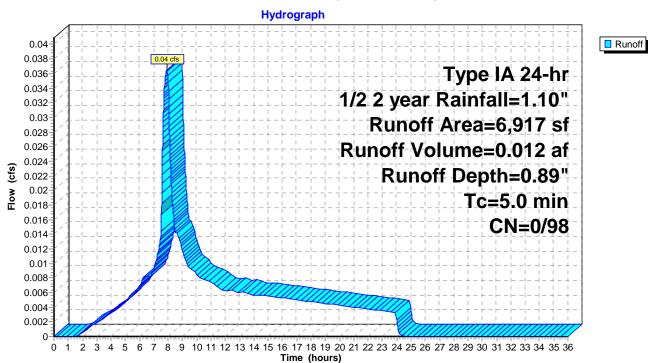
Subcatchment Bldg 19: Building 29

_	Α	rea (sf)	CN	Description					
		6,917	98	Roofs, HSG C					
		6,917	98	100.00% Impervious Area					
	т.	1 (1)	01	M-11	0 11	Describer			
	IC	Length	Siope	e velocity	Capacity	Description			
	(min)	(feet)	(ft/ft)	(ft/sec)	(cfs)				
	5.0					Direct Entry

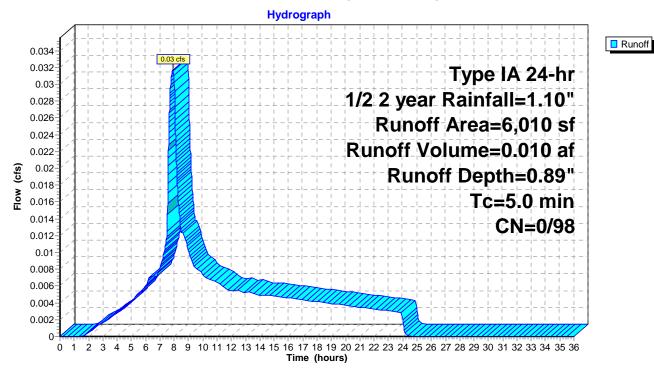
Subcatchment Bldg 2: Building 31

_	Α	rea (sf)	CN	Description						
		6,010	98	Roofs, HSG C						
		6,010	98	100.00% Impervious Area						
	Tc	Length	Slope	 Velocity 	Capacity	Description				
	(min)	(feet)	(ft/ft)	(ft/sec)	(cfs)					
	5.0		·			Direct Entry

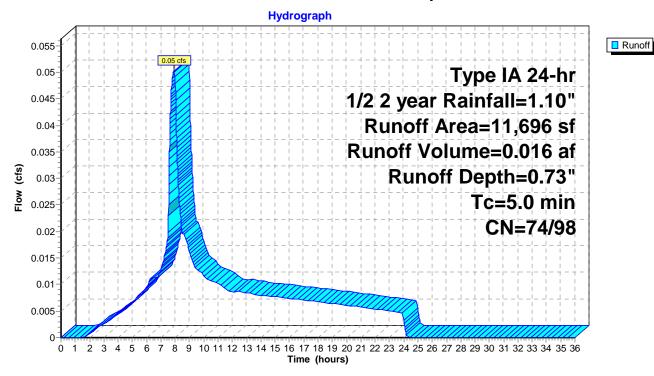
Subcatchment VC2: VC Loop 2

Area	(sf) CN	Description	Description					
2,	181 74	>75% Gras	s cover, Go	Good, HSG C				
9,5	515 98	Paved park	ing, HSG C	C				
11,6	696 94	Weighted A	Weighted Average					
2,1	181 74	18.65% Pei	vious Area	a				
9,5	515 98	81.35% lmp	ervious Ar	rea				
	ngth Slop	•	Capacity	•				
(min) (1	eet) (ft/	ft) (ft/sec)	(cfs)					
5.0				Direct Entry.

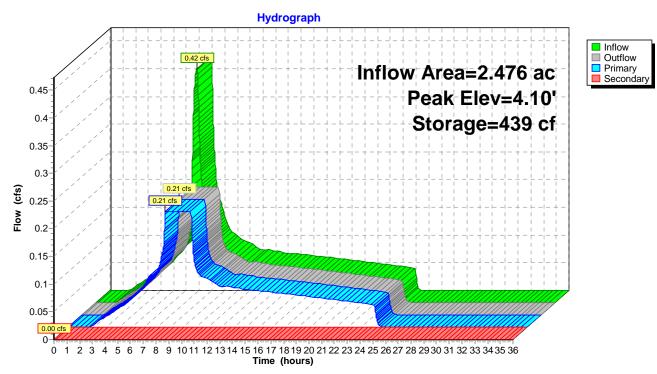
Pond 2 - GM: PB 2 - GM

Volume	Invert	: Avail.Sto	rage Sto	Storage Description			
#1	0.00	6,5		nin Rock Storage (Prismatic) Listed below (Recalc) 076 cf Overall x 36.0% Voids			
Elevation (fee		urf.Area (sq-ft)	Inc.Stor (cubic-fee				
0.0	00	4,519		0 0			
4.0	00	4,519	18,07	76 18,076			
Device	Routing	Invert	Outlet De	evices			
#1	Discarded	0.00'	0.700 in/l	hr Native Infiltration over Surface area			
#2	Primary	3.33'	8.0" Vert	 Underdrain C= 0.600 Limited to weir flow at low heads

Discarded OutFlow Max=0.07 cfs @ 6.13 hrs HW=0.04' (Free Discharge) **1=Native Infiltration** (Exfiltration Controls 0.07 cfs)

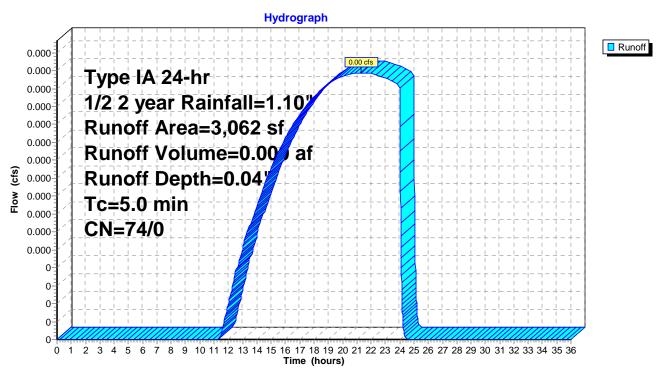
Subcatchment Undet: Undetained

rea (sf)	CN	Description						
	3,062	74	>75% Gras	75% Grass cover, Good, HSG C					
	3,062	74	100.00% Pe	00.00% Pervious Area					
Tc (min)	Length (feet)	Slope (ft/ft)	,	Capacity (cfs)	Description				
5.0					Direct Entry,

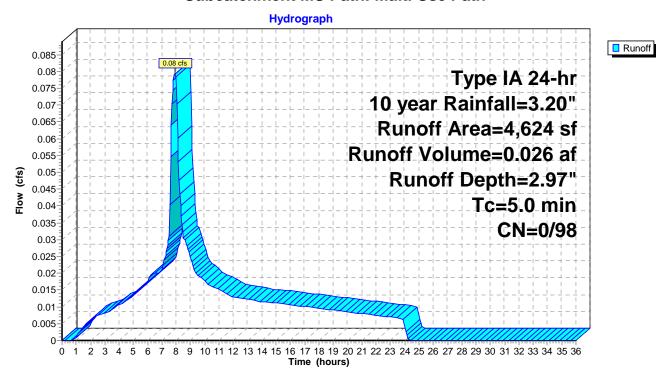
Subcatchment MU Path: Multi Use Path

A	rea (sf)	CN [Description					
	4,624	98 l	Jnconnected pavement, HSG C					
	4,624	98 1	00.00% Impervious Area					
Tc (min)	Length (feet)	Slope (ft/ft)	e Velocity Capacity Description					
5.0			,	, ,	Direct Entry,

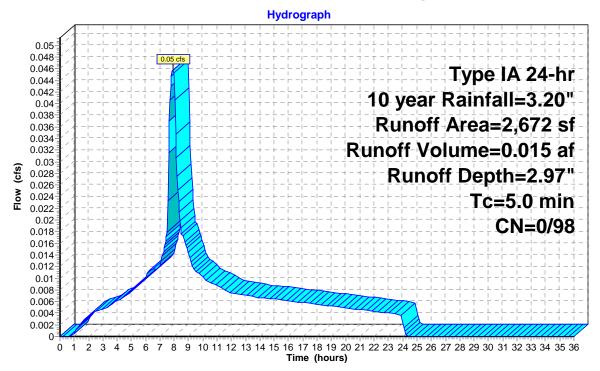
Subcatchment 0.5: Building 25

_	Α	rea (sf)	CN	Description						
		2,672	98	Roofs, HSG C						
		2,672	98	100.00% Impervious Area						
	_									
	Tc	Length	Slope	e Velocity	Capacity	Description				
_	(min)	(feet)	(ft/ft) (ft/sec)	(cfs)					
	5.0			•		Direct Entry

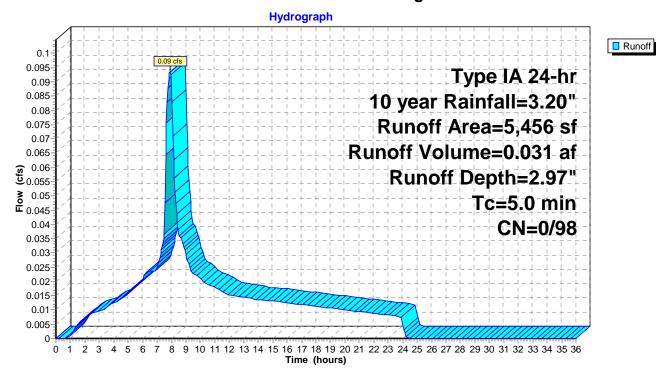
Subcatchment 9: Building 24

A	rea (sf)	CN [Description						
	5,456	98 F	Roofs, HSG C						
	5,456	98 1	8 100.00% Impervious Area						
Tc (min)	Length (feet)	Slope (ft/ft)	Velocity (ft/sec)	Capacity (cfs)	Description				
5.0					Direct Entry,

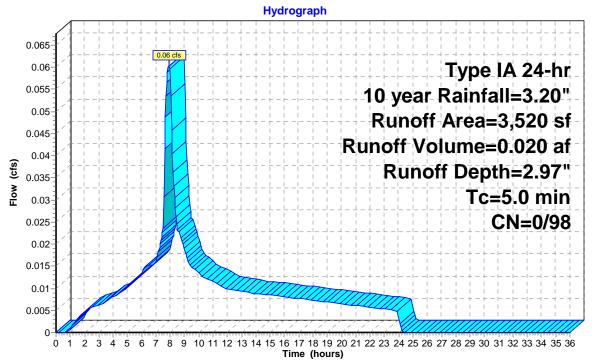
Subcatchment 17: Building 26

_	Α	rea (sf)	CN	Description						
		3,520	98	Roofs, HSG C						
		3,520	98	100.00% Impervious Area						
	Tc	Length	Slope	e Velocity	Capacity	Description				
	(min)	(feet)	(ft/ft) (ft/sec)	(cfs)					
	5.0					Direct Entry

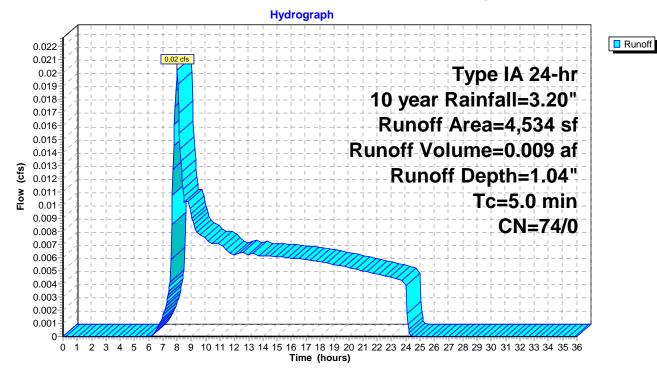
Subcatchment Landscape: Landscaping

_	Α	rea (sf)	CN	Description							
		4,534	74	>75% Grass cover, Good, HSG C							
		4,534	74	100.00% Pervious Area							
	Tc	Length	Slope	e Velocity	Capacity	Description					
	(min)	(feet)	(ft/ft)	ft) (ft/sec) (cfs)							
	5.0					Direct Entry

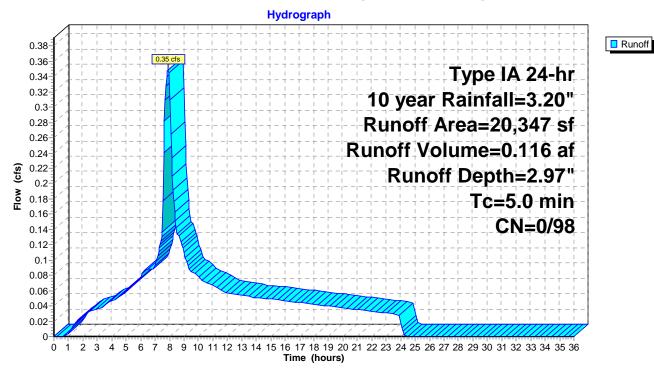
Subcatchment S Parking: South Parking

Α	rea (sf)	CN	Description						
	20,347	98	Paved parking, HSG C						
	20,347 98 100.00% Impervious Area								
.	1	01	- Mala a'i	0 11	Description				
	Length	Siop	•	Capacity	Description				
(min)	(feet)	(ft/f	t/ft) (ft/sec) (cfs)						
5.0					Direct Entry

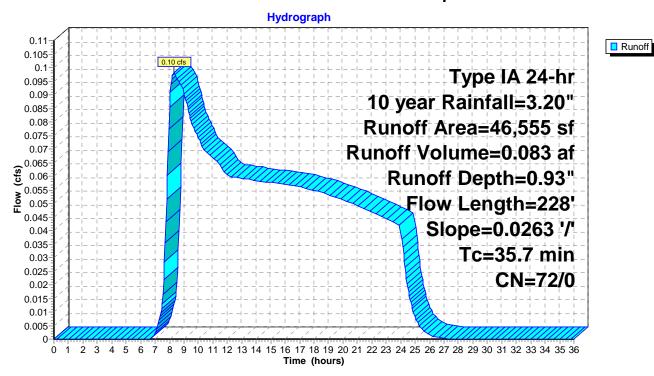
Subcatchment Undev SW: Undeveloped SW

Α	rea (sf)	CN	Description							
*		46,555	72	City of Sale	City of Salem Predeveloped, HSG C						
_	46,555 72 100.00% Pervious Area										
	Tc	- 3	Slope	,	Capacity	Description					
_	(min)	(feet)	(ft/ft)	(ft/sec)	(cfs)						
	35.7	228	0.0263	0.11		Sheet Flow,					
						n= 0.300 P2= 2.20"

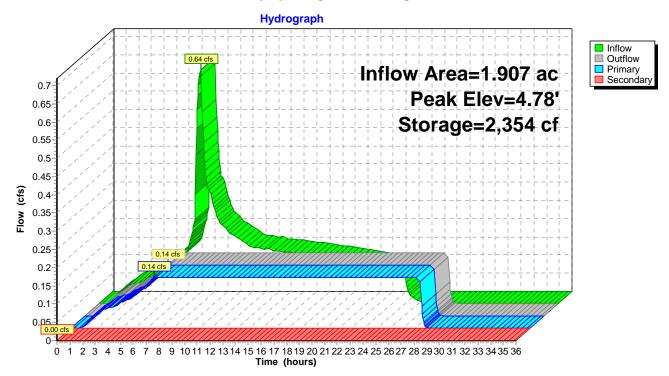
Pond 1 - GM: PB 1 - GM

Secondary OutFlow Max=0.00 cfs @ 0.00 hrs HW=4.00' (Free Discharge) 2=Rock Box (Controls 0.00 cfs)

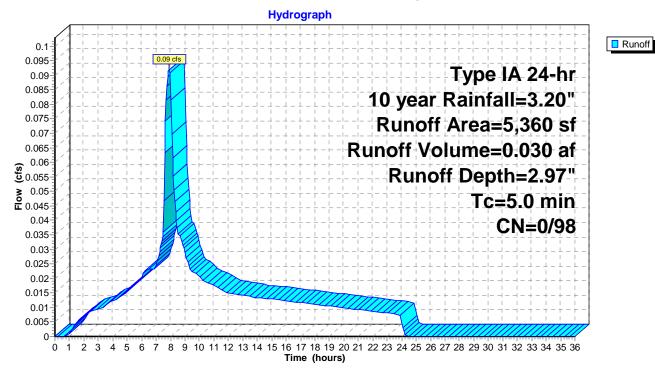
Subcatchment 3: Building 23

A	rea (sf)	CN [Description						
	5,360	98 F	Roofs, HSG C						
	5,360	98 1	8 100.00% Impervious Area						
Tc (min)	Length (feet)	Slope (ft/ft)	Velocity (ft/sec)	Capacity (cfs)	Description				
5.0					Direct Entry,

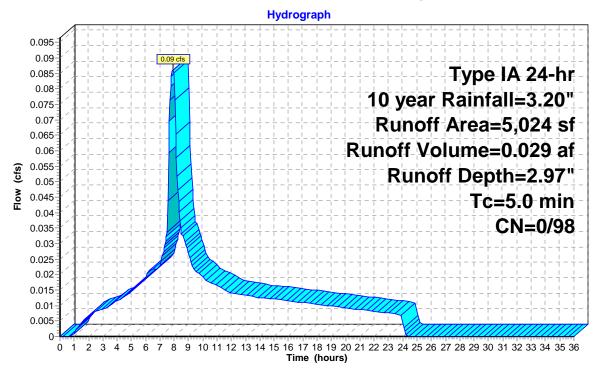
Subcatchment 13: Building 22

A	rea (sf)	CN I	Description						
	5,024	98 I	Roofs, HSG C						
	5,024	98 ′	3 100.00% Impervious Area						
Tc (min)	Length (feet)	Slope (ft/ft)	Velocity (ft/sec)	Capacity (cfs)	Description				
5.0					Direct Entry,

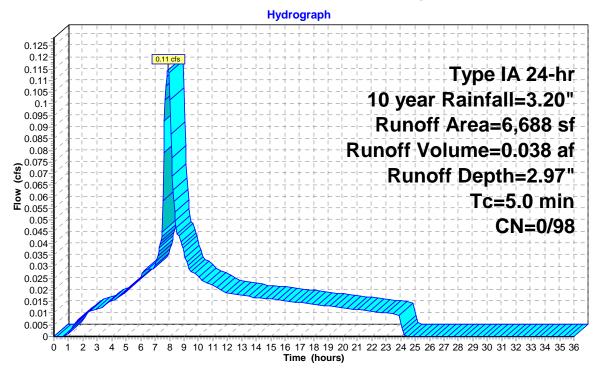
Subcatchment 14: Building 21

A	rea (sf)	CN [Description						
	6,688	98 F	Roofs, HSG C						
	6,688	98 1	3 100.00% Impervious Area						
Tc (min)	Length (feet)	Slope (ft/ft)	Velocity (ft/sec)	Capacity (cfs)	Description				
5.0					Direct Entry,

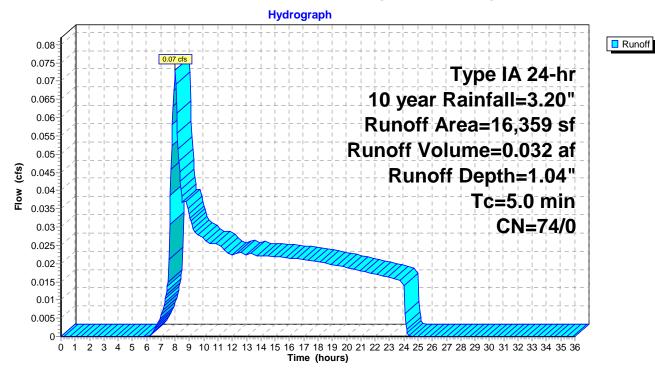
Subcatchment Landscaping: Landscaping

Are	ea (sf)	CN I	Description						
1	6,359	74 :	74 >75% Grass cover, Good, HSG C						
1	6,359	74 ′	100.00% Pe	ervious Are	ea				
Tc (min)	Length (feet)	Slope (ft/ft)	Velocity (ft/sec)	Capacity (cfs)	Description				
5.0					Direct Entry,

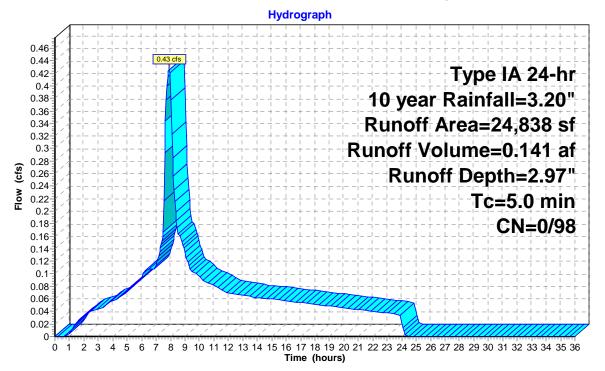
Subcatchment N Park2: N Parking B2

A	rea (sf)	CN [Description						
	24,838	98 l	Unconnected pavement, HSG C						
	24,838	98 ′	100.00% Im	pervious A	Area				
Tc (min)	Length (feet)	Slope (ft/ft)	Velocity (ft/sec)	Capacity (cfs)	Description				
5.0					Direct Entry,

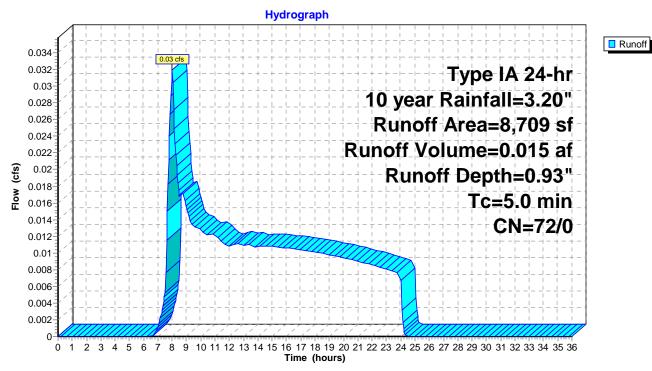
Subcatchment Undev W: Undeveloped W

Α	rea (sf)	CN	Description						
*		8,709	72	2 City of Salem Undeveloped, HSG C						
		8,709	72	100.00% Pe	ervious Are	ea				
	Tc (min)	Length (feet)	Slope (ft/ft)	•	Capacity (cfs)	Description				
	5.0					Direct Entry,

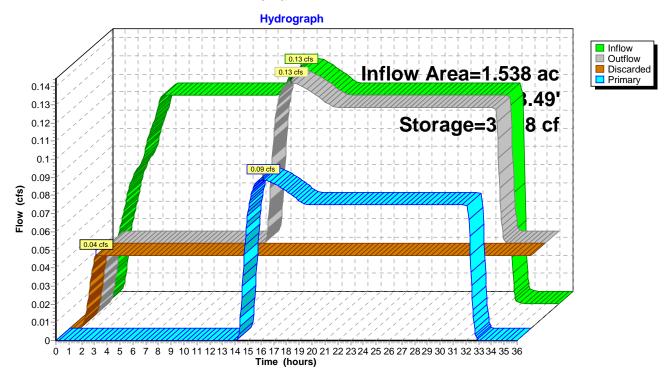
Pond 2 - DR: PB 2 - DR

Primary OutFlow Max=0.09 cfs @ 16.16 hrs HW=3.49' (Free Discharge) 2=Underdrain (Orifice Controls 0.09 cfs @ 1.36 fps)

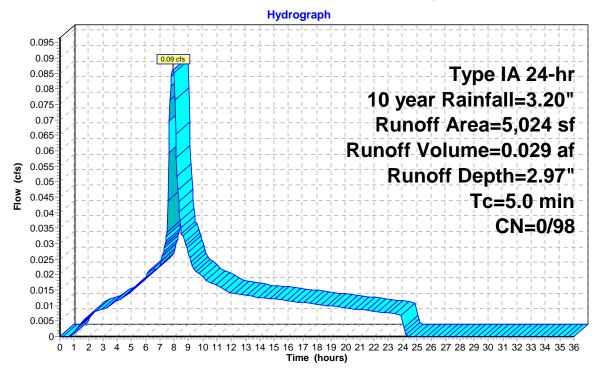
Subcatchment Bld13: Building 20

A	rea (sf)	CN I	Description					
	5,024	98 I	Roofs, HSG	G C				
	5,024	98 ′	8 100.00% Impervious Area					
Tc (min)	Length (feet)	Slope (ft/ft)	Velocity (ft/sec)	Capacity (cfs)	Description			
5.0					Direct Entry,

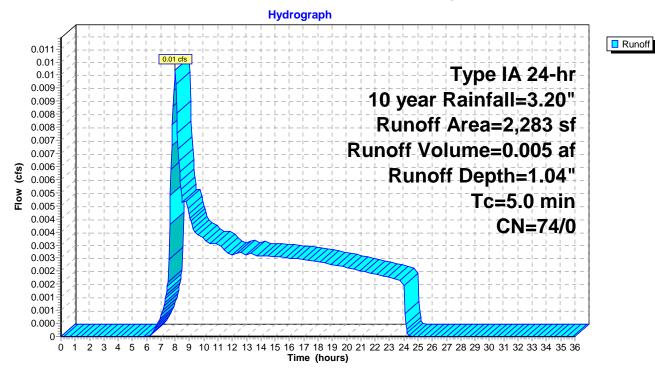
Subcatchment LS: Landscaping

A	rea (sf)	CN I	Description						
	2,283	74	74 >75% Grass cover, Good, HSG C						
	2,283	74	4 100.00% Pervious Area						
Tc (min)	Length (feet)	Slope (ft/ft)	Velocity (ft/sec)	Capacity (cfs)	Description				
5.0					Direct Entry,

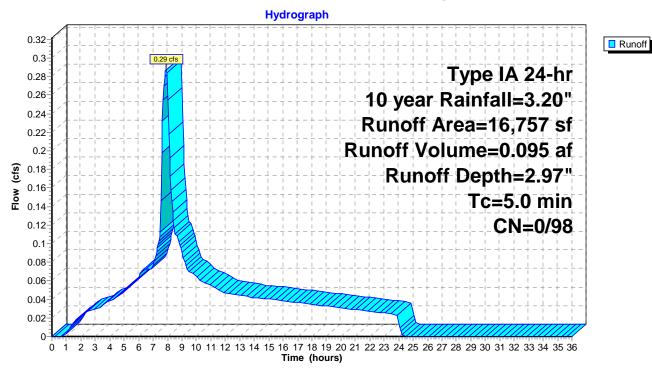
Subcatchment N Park3: N Parking B3

_	Α	rea (sf)	CN	Description						
		16,757	98	8 Paved parking, HSG C						
		16,757	98	100.00% Im	pervious A	rea				
	Tc	Length	Slope	e Velocity	Capacity	Description				
	(min)	(feet)	(ft/ft) (ft/sec)	(cfs)					
_	5.0			•	•	Direct Entry

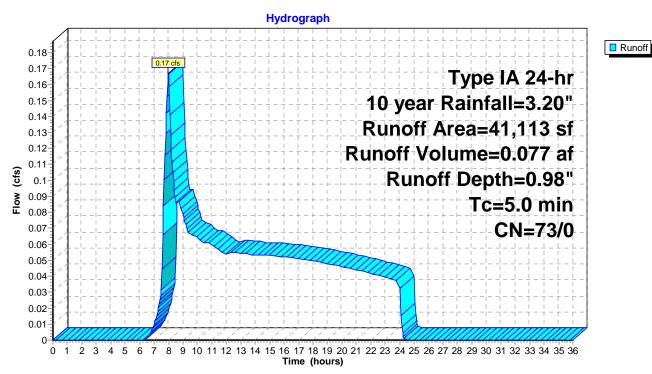
Subcatchment Undet: Undetained

Area (sf)	CN	Description						
-	3,680	74	>75% Grass cover, Good, HSG C	_					
	3,296	74	>75% Grass cover, Good, HSG C						
	7,604	74	75% Grass cover, Good, HSG C						
	1,317	74	75% Grass cover, Good, HSG C						
*	25,216	72	ity of Salem Predeveloped, HSG C						
	41,113	73	73 Weighted Average						
	41,113	73	100.00% Pervious Area						
(Tc Lengtl min) (feet								
	5.0		Direct Entry.

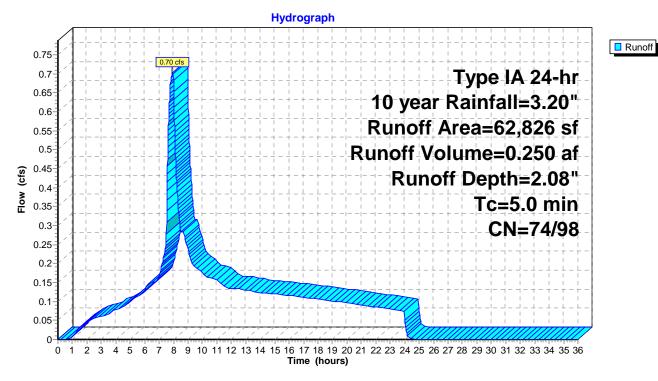
Subcatchment B1: Basin 1

Area (sf)	CN	Description					
	33,861	98	Paved parking, HSG C					
	27,754	74						
*	1,211	72	Planter Box					
	62,826	87	Weighted Average					
	28,965	74	46.10% Pervious Area					
	33,861	98	53.90% Impervious Area					
7	c Lenath	Slor	e Velocity	Capacity	Description			
	- 3	Slop	,		•			
(mii	n) (feet)	(ft/1	ft) (ft/sec)	(cfs)				
5	.0				Direct Entry,

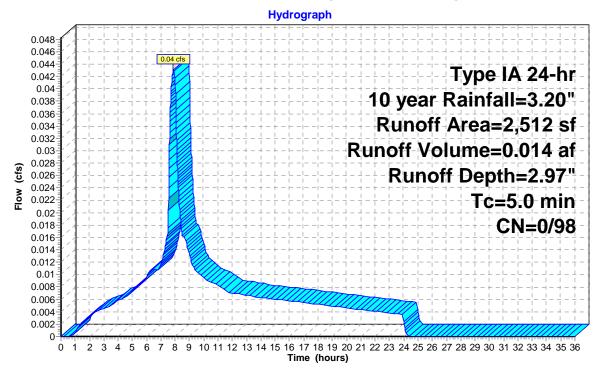
Subcatchment Bldg 0.5CD: Building 33

_	Α	rea (sf)	CN	N Description				
		2,512	98	Roofs, HSG				
		2,512	98	98 100.00% Impervious Area				
	Tc	Length	Slope	Velocity	Capacity	Description		
	(min)	(feet)	(ft/ft)	(ft/sec)	(cfs)			
_	5.0					Direct Entry

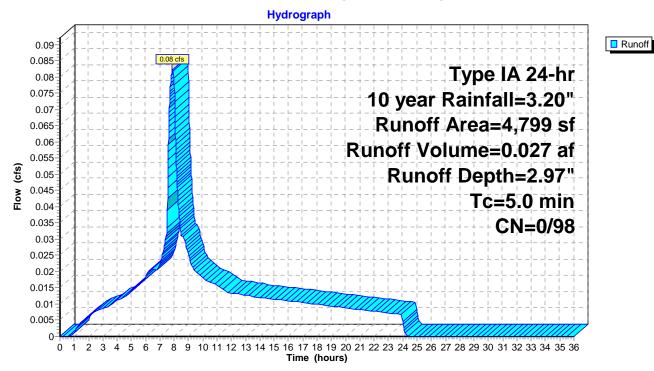
Subcatchment Bldg 18: Building 34

_	Α	rea (sf)	CN	N Description				
		4,799	98	Roofs, HSG				
		4,799	98	8 100.00% Impervious Area				
	Tc	Length	Slope	e Velocity	Capacity	Description		
	(min)	(feet)	(ft/ft) (ft/sec)	(cfs)			
	5.0					Direct Entry

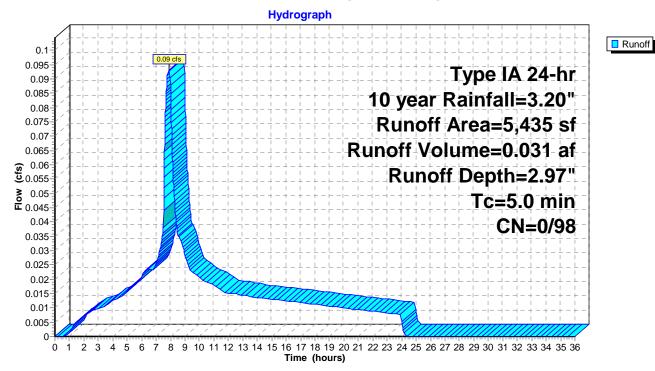
Subcatchment Bldg 3: Building 35

A	rea (sf)	CN [Description						
	5,435	98 F	Roofs, HSG C						
	5,435	98 1	98 100.00% Impervious Area						
Tc (min)	Length (feet)	Slope (ft/ft)	Velocity (ft/sec)	Capacity (cfs)	Description				
5.0					Direct Entry,

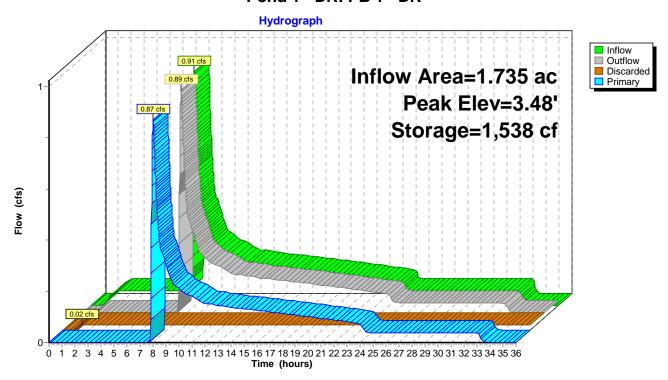
Pond 1 - DR: PB 1 - DR

Volume	Invert	Avail.Sto	rage Storage	e Description		
#1	0.00'	1,77		Rock Storage of Overall x 3	•	c) Listed below (Recalc)
Elevatio		urf.Area (sq-ft)	Inc.Store (cubic-feet)	Cum.Sto (cubic-fe		
0.0	00	1,229	0		0	
4.0	00	1,229	4,916	4,9	916	
Device	Routing	Invert	Outlet Devic	es		
#1	Discarded	0.00'	0.700 in/hr N	Native Infiltra	tion over S	Surface area
#2	Primary	3.00'	12.0" Vert. U	Jnderdrain	C = 0.600	Limited to weir flow at low heads

Discarded OutFlow Max=0.02 cfs @ 1.45 hrs HW=0.04' (Free Discharge) **1=Native Infiltration** (Exfiltration Controls 0.02 cfs)

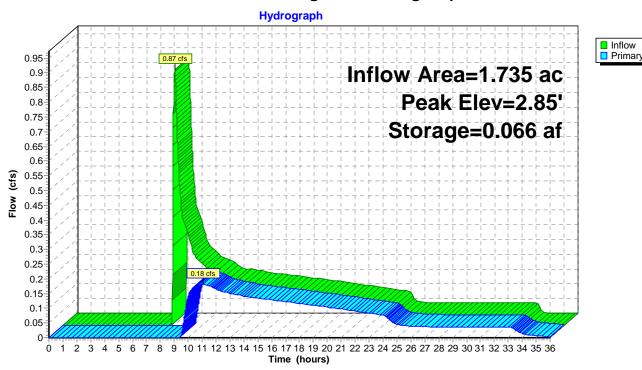
Pond 1P: Underground Storage Pipe

Primary OutFlow Max=0.18 cfs @ 11.05 hrs HW=2.85' (Free Discharge) 1=Orifice/Grate (Orifice Controls 0.18 cfs @ 2.07 fps)

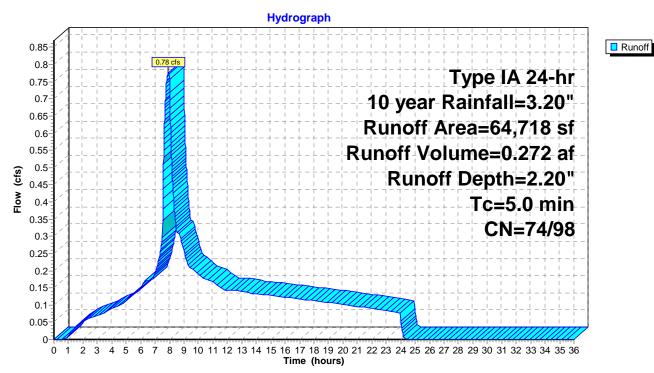
Subcatchment B2: Basin 2

Area (sf)	CN	Description	Description							
	21,385	74	>75% Gras	>75% Grass cover, Good, HSG C							
	38,965	98	Paved park	Paved parking, HSG C							
*	4,368	72	Planter Box								
	64,718	88	Weighted A	Weighted Average							
	25,753	74	39.79% Per	39.79% Pervious Area							
	38,965	98	60.21% lmp	ervious Ar	rea						
	Tc Length	Slop	,	Capacity	•						
(n	nin) (feet)	(ft/f	ft) (ft/sec)	(cfs)							
	5.0				Direct Entry,

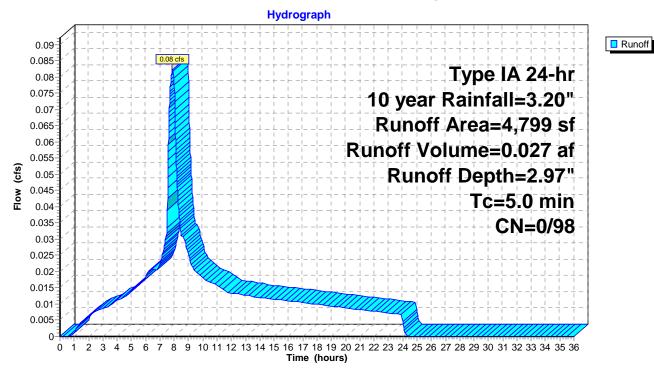
Subcatchment Bld 18: Building 30

A	rea (sf)	CN [Description						
	4,799	98 F	Roofs, HSG C						
•	4,799	98 ′	98 100.00% Impervious Area						
Tc (min)	Length (feet)	Slope (ft/ft)	Velocity (ft/sec)	Capacity (cfs)	Description				
5.0					Direct Entry,

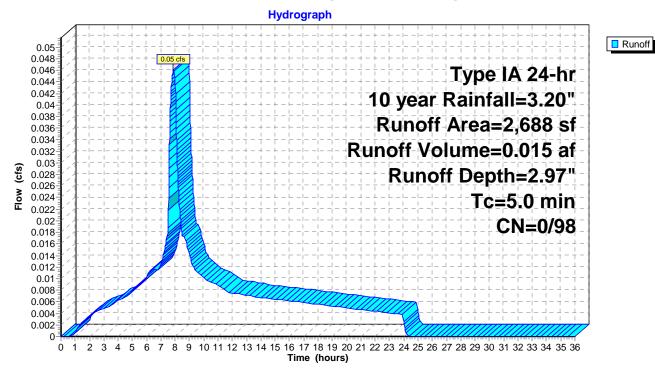
Subcatchment Bldg 0.5AA: Building 28

Α	rea (sf)	CN	Description							
		2,688	98	Roofs, HSG C							
		2,688	98	8 100.00% Impervious Area							
	Tc	Length	Slope	e Velocity	Capacity	Description					
((min)	(feet)	(ft/ft) (ft/sec)	(cfs)						
	5.0					Direct Entry

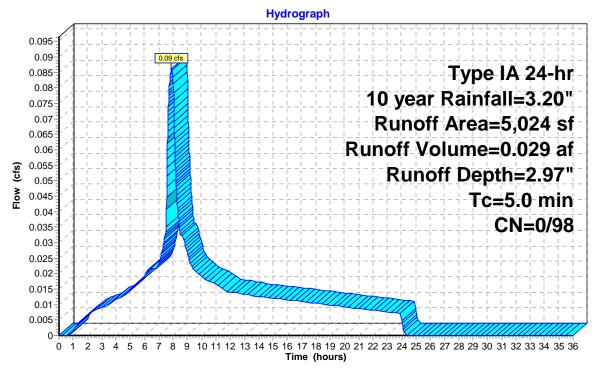
Subcatchment Bldg 13: Building 32

A	rea (sf)	CN I	Description						
	5,024	98 I	Roofs, HSG C						
	5,024	98 ′	98 100.00% Impervious Area						
Tc (min)	Length (feet)	Slope (ft/ft)	Velocity (ft/sec)	Capacity (cfs)	Description				
5.0					Direct Entry,

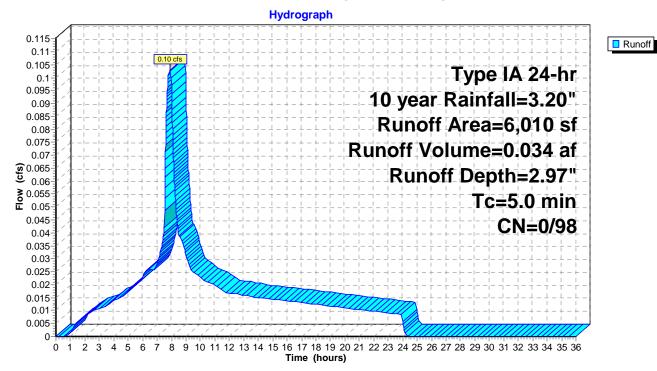
Subcatchment Bldg 16: Building 27

_	Α	rea (sf)	CN	Description							
		6,010	98	Roofs, HSG C							
		6,010	98	98 100.00% Impervious Area							
	_		-								
	IC	Length	Slope	e Velocity	Capacity	Description					
	(min)	(feet)	(ft/ft)	(ft/sec)	(cfs)						
	5.0	•			•	Direct Entry

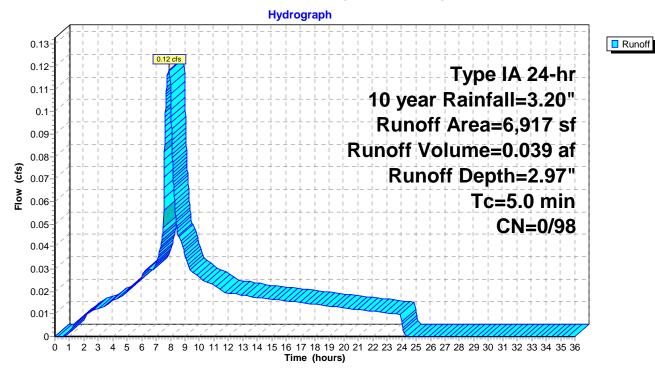
Subcatchment Bldg 19: Building 29

A	rea (sf)	CN [Description						
	6,917	98 F	Roofs, HSG C						
	6,917	98 ′	98 100.00% Impervious Area						
To	Length	Slope	Velocity	Canacity	Description				
(min)	(feet)	(ft/ft)	(ft/sec)	(cfs)	Description				
5.0		•			Direct Entry,

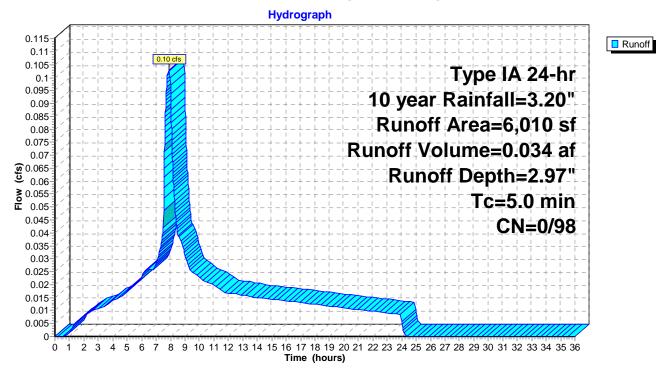
Subcatchment Bldg 2: Building 31

A	rea (sf)	CN [Description						
	6,010	98 F	98 Roofs, HSG C						
	6,010	98 ′	98 100.00% Impervious Area						
Tc (min)	Length (feet)	Slope (ft/ft)	Velocity (ft/sec)	Capacity (cfs)	Description				
5.0					Direct Entry,

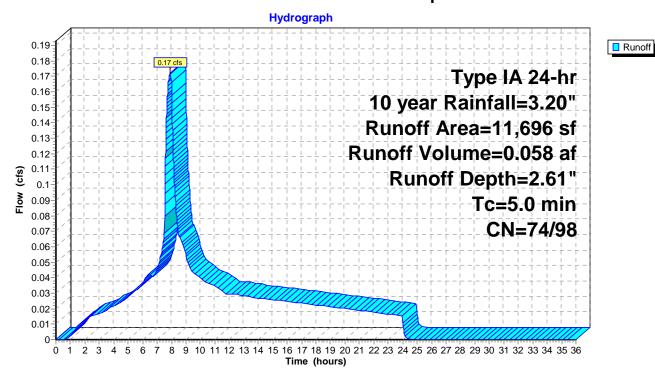
Subcatchment VC2: VC Loop 2

Ar	ea (sf)	CN	Description					
	2,181	74	>75% Gras	s cover, Go	ood, HSG C			
	9,515	98	Paved park	ing, HSG C	•			
	11,696	94	Weighted A	Weighted Average				
	2,181	74	18.65% Pervious Area					
	9,515	98	81.35% Imp	ervious Ar	ea			
Tc	Length	Slop	,	Capacity	Description			
(min)	(feet)	(ft/f1	t) (ft/sec) (cfs)					
5.0					Direct Entry.

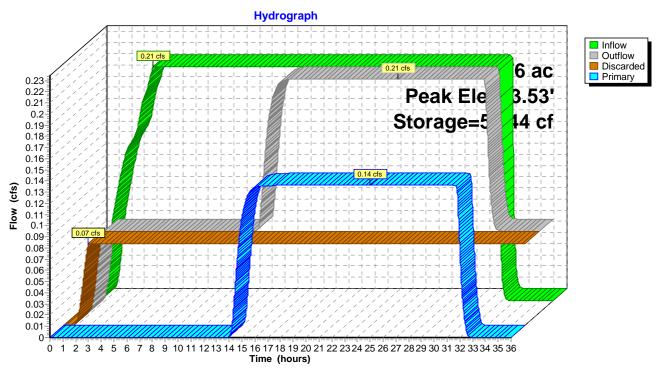
Pond 2 - DR: PB 2 - DR

Volume	Invert	Avail.Sto	rage Stora	ge Description		
#1	0.00'	6,50		Name of the Rock Storage 76 cf Overall x	•	atic) Listed below (Recalc) oids
Elevatio	_	urf.Area (sq-ft)	Inc.Store (cubic-feet)			
0.0	00	4,519	C		0	
4.0	00	4,519	18,076	18,0	76	
Device	Routing	Invert	Outlet Dev	rices		
#1	Discarded	0.00'	0.700 in/h	Native Infiltrat	ion ove	Surface area
#2	Primary	3.33'	8.0" Vert.	Underdrain C	= 0.600	Limited to weir flow at low heads

Discarded OutFlow Max=0.07 cfs @ 1.90 hrs HW=0.04' (Free Discharge) **1=Native Infiltration** (Exfiltration Controls 0.07 cfs)

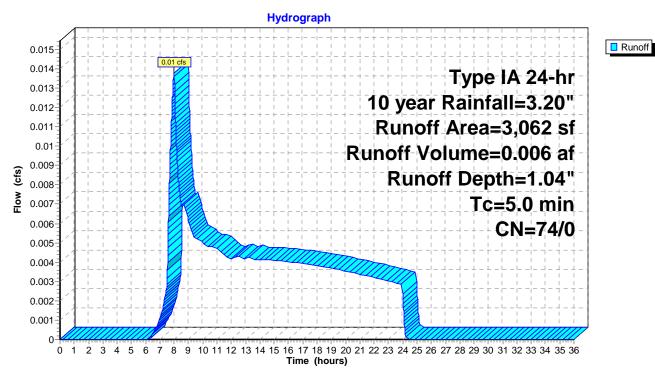
Subcatchment Undet: Undetained

rea (sf)	CN	Description						
	3,062	74	>75% Grass cover, Good, HSG C						
	3,062	74	74 100.00% Pervious Area						
Tc (min)	Length (feet)	Slope (ft/ft)	,	Capacity (cfs)	Description				
5.0					Direct Entry,

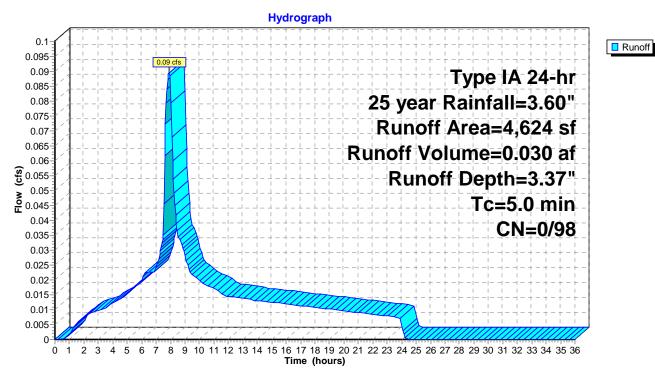
Subcatchment MU Path: Multi Use Path

A	rea (sf)	CN [Description						
	4,624	98 l	B Unconnected pavement, HSG C						
	4,624	98 1	98 100.00% Impervious Area						
Tc (min)	Length (feet)	Slope (ft/ft)	Velocity (ft/sec)	Capacity (cfs)	Description				
5.0			,	, ,	Direct Entry,

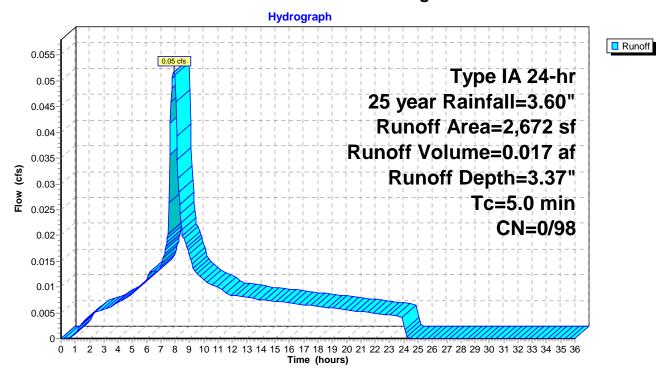
Subcatchment 0.5: Building 25

_	Α	rea (sf)	CN	N Description						
		2,672	98	98 Roofs, HSG C						
_		2,672	98	98 100.00% Impervious Area						
	Tc	Length	Slope	e Velocity	Capacity	Description				
	(min)	(feet)	(ft/ft) (ft/sec)	(cfs)					
	5.0		·			Direct Entry

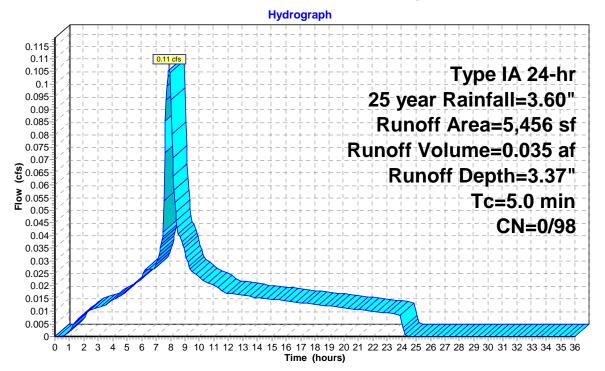
Subcatchment 9: Building 24

A	rea (sf)	CN [Description						
	5,456	98 F	98 Roofs, HSG C						
	5,456	98 1	98 100.00% Impervious Area						
Tc (min)	Length (feet)	Slope (ft/ft)	Velocity (ft/sec)	Capacity (cfs)	Description				
5.0					Direct Entry,

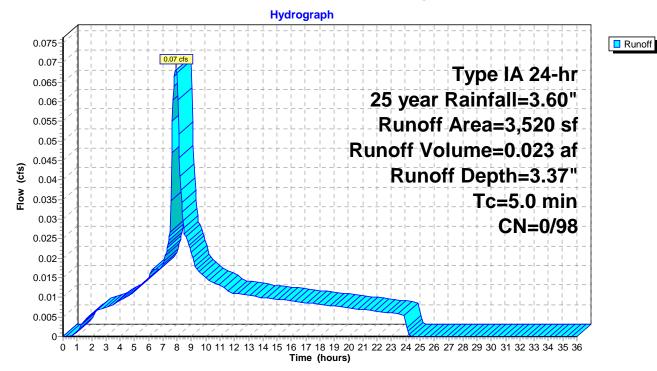
Subcatchment 17: Building 26

A	rea (sf)	CN [Description						
	3,520	98 F	98 Roofs, HSG C						
	3,520	98 ′	98 100.00% Impervious Area						
Tc (min)	Length (feet)	Slope (ft/ft)	Velocity (ft/sec)	Capacity (cfs)	Description				
5.0					Direct Entry,

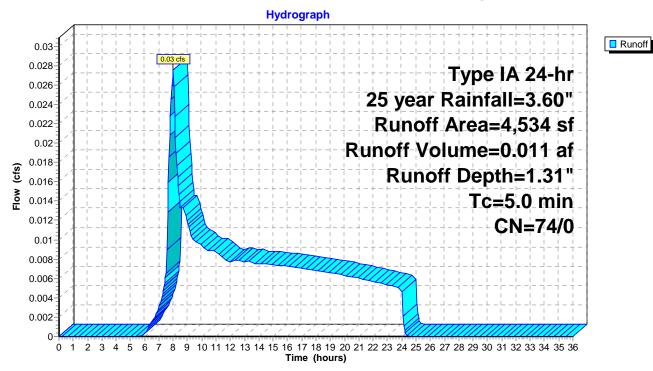
Subcatchment Landscape: Landscaping

A	rea (sf)	CN I	Description						
	4,534	74	>75% Grass cover, Good, HSG C						
	4,534	74	74 100.00% Pervious Area						
Tc (min)	Length (feet)	Slope (ft/ft)	Velocity (ft/sec)	Capacity (cfs)	Description				
5.0					Direct Entry,

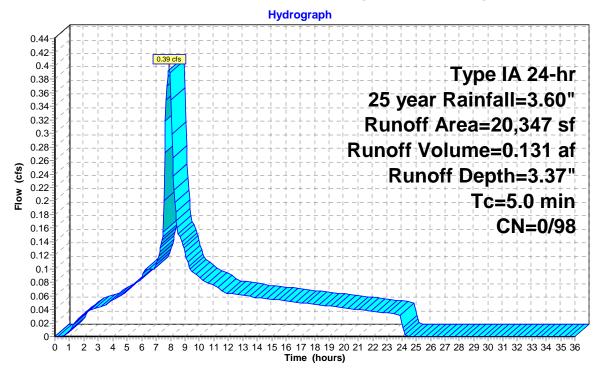
Subcatchment S Parking: South Parking

Area	a (sf) CN	Description			
20	,347 98	98 Paved parking, HSG C			
20	,347 98	100.00% lm	npervious A	Area	
Tc L (min)	ength Slo (feet) (ft	pe Velocity /ft) (ft/sec)	Capacity (cfs)	Description	
5.0				Direct Entry,

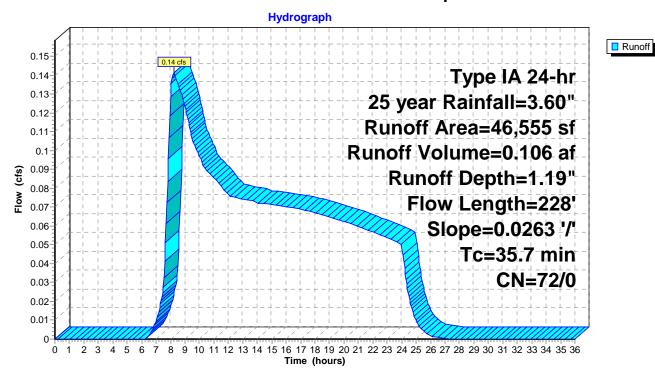
Subcatchment Undev SW: Undeveloped SW

Α	rea (sf)	CN	Description				
*		46,555	72	City of Salem Predeveloped, HSG C				
_	46,555 72 100.00% Pervious Area							
	Tc	- 3	Slope	,	Capacity	Description		
_	(min)	(feet)	(ft/ft)	(ft/sec)	(cfs)			
	35.7	228	0.0263	0.11		Sheet Flow,		
						n= 0.300 P2= 2.20"

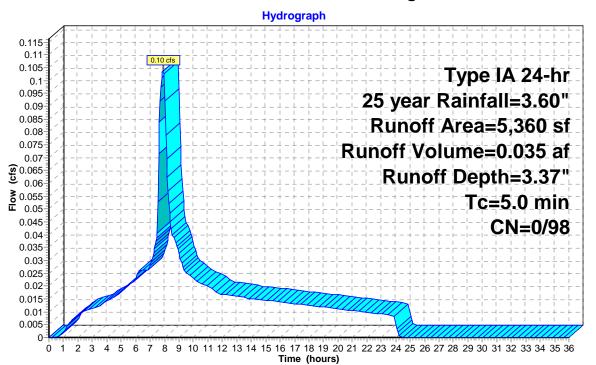
Subcatchment 3: Building 23

A	rea (sf)	CN [Description					
	5,360	98 F	Roofs, HSG C					
	5,360	98 1	98 100.00% Impervious Area					
Tc (min)	Length (feet)	Slope (ft/ft)	Velocity (ft/sec)	Capacity (cfs)	Description			
5.0					Direct Entry,

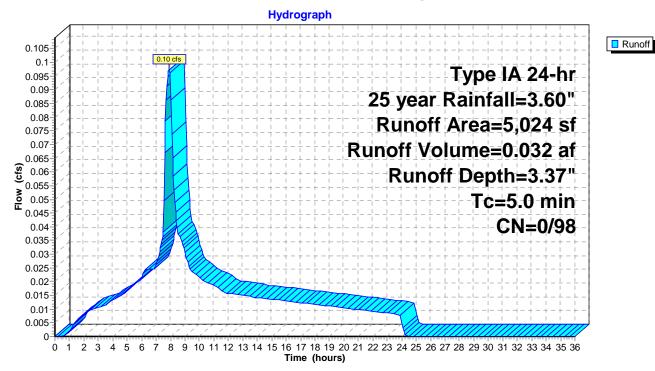
Subcatchment 13: Building 22

A	rea (sf)	CN I	Description					
	5,024	98 I	Roofs, HSG C					
	5,024	98 ′	98 100.00% Impervious Area					
Tc (min)	Length (feet)	Slope (ft/ft)	Velocity (ft/sec)	Capacity (cfs)	Description			
5.0					Direct Entry,

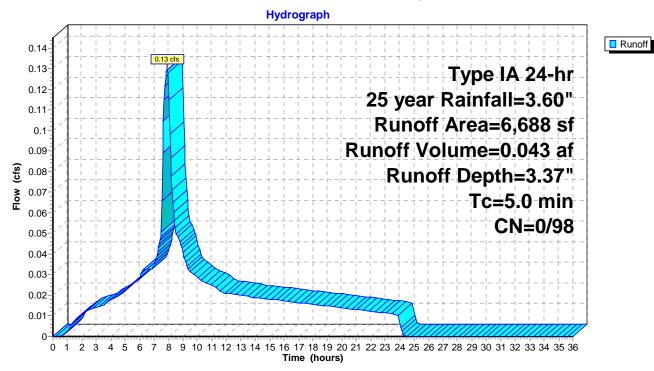
Subcatchment 14: Building 21

A	rea (sf)	CN [Description					
	6,688	98 F	Roofs, HSG C					
	6,688	98 1	98 100.00% Impervious Area					
Tc (min)	Length (feet)	Slope (ft/ft)	Velocity (ft/sec)	Capacity (cfs)	Description			
5.0					Direct Entry,

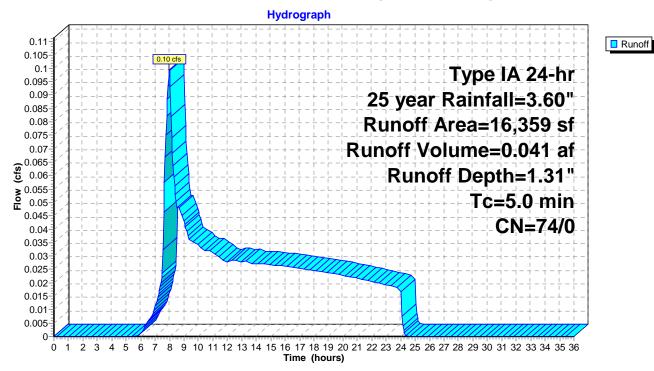
Subcatchment Landscaping: Landscaping

Are	ea (sf)	CN I	Description						
1	6,359	74 :	>75% Grass cover, Good, HSG C						
1	6,359	74 ′	74 100.00% Pervious Area						
Tc (min)	Length (feet)	Slope (ft/ft)	Velocity (ft/sec)	Capacity (cfs)	Description				
5.0					Direct Entry,

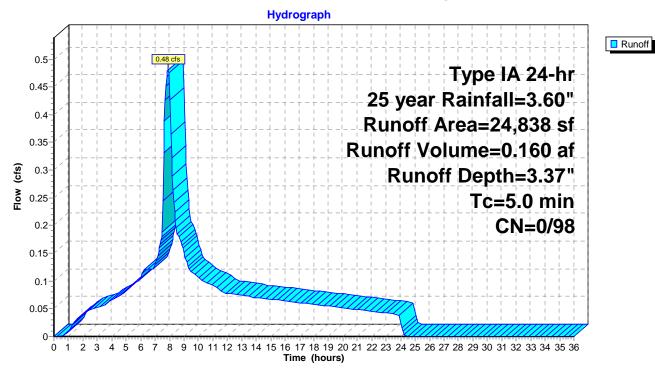
Subcatchment N Park2: N Parking B2

A	rea (sf)	CN [Description					
	24,838	98 l	Unconnected pavement, HSG C					
	24,838	98 ′	100.00% Impervious Area					
Tc (min)	Length (feet)	Slope (ft/ft)	Velocity (ft/sec)	Capacity (cfs)	Description			
5.0					Direct Entry,

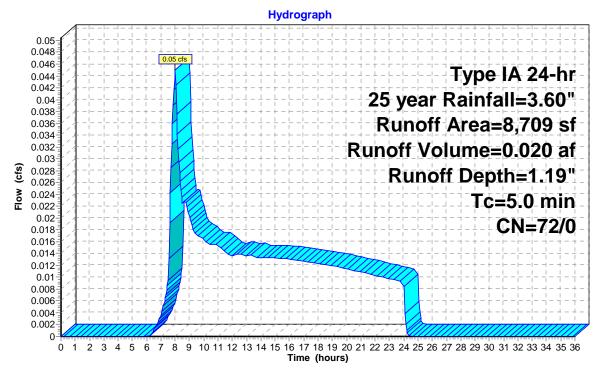
Subcatchment Undev W: Undeveloped W

Α	rea (sf)	CN	Description						
*		8,709	72	City of Salem Undeveloped, HSG C						
		8,709	72	100.00% Pervious Area						
	Tc (min)	Length (feet)	Slope (ft/ft)	•	Capacity (cfs)	Description				
	5.0					Direct Entry,

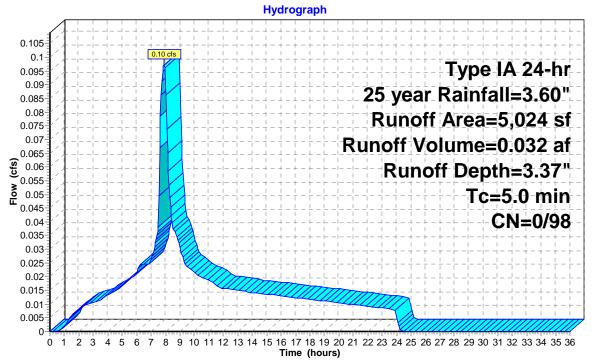
Subcatchment Bld13: Building 20

A	rea (sf)	CN I	Description					
	5,024	98 I	Roofs, HSG C					
	5,024	98 ′	98 100.00% Impervious Area					
Tc (min)	Length (feet)	Slope (ft/ft)	Velocity (ft/sec)	Capacity (cfs)	Description			
5.0					Direct Entry,

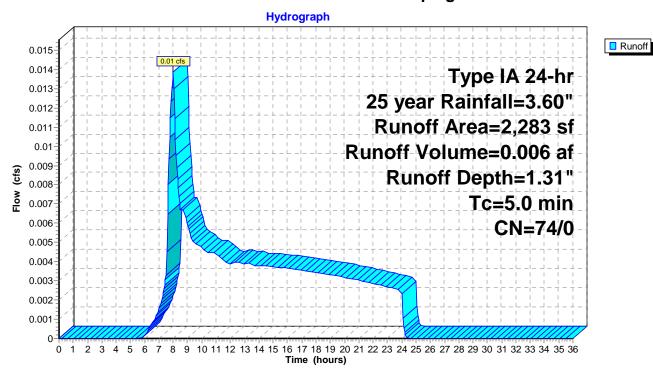
Subcatchment LS: Landscaping

_	Α	rea (sf)	CN	Description						
		2,283	74	>75% Grass cover, Good, HSG C						
		2,283	74	100.00% Pervious Area						
	Tc	Length	Slope	e Velocity	Capacity	Description				
_	(min)	(feet)	(ft/ft)	(ft/sec)	(cfs)					
	5.0	•	Direct Entry

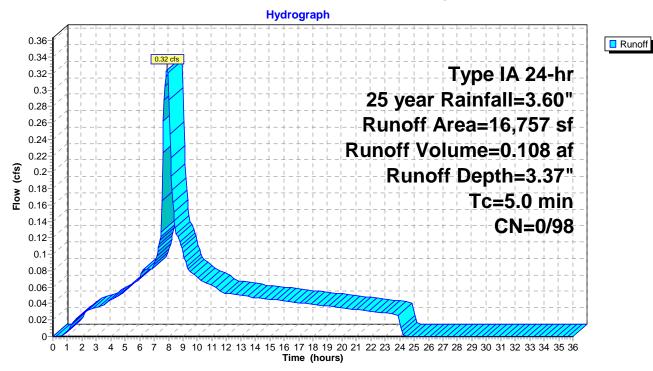
Subcatchment N Park3: N Parking B3

A	rea (sf)	CN [Description						
	16,757	98 F	Paved parking, HSG C						
•	16,757	98 ′	100.00% lm	pervious A	Area				
Tc (min)	Length (feet)	Slope (ft/ft)	Velocity (ft/sec)	Capacity (cfs)	Description				
5.0					Direct Entry,

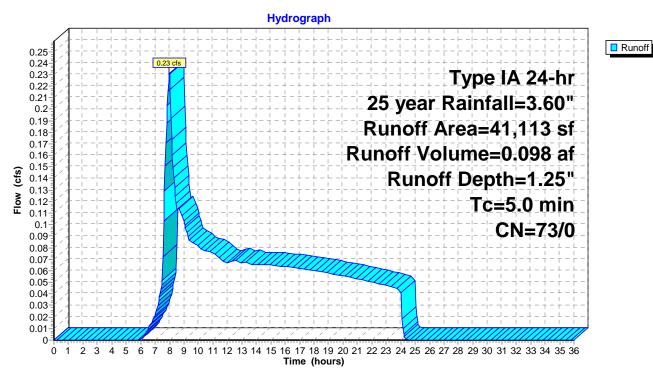
Subcatchment Undet: Undetained

Area (sf)	CN	Description					
-	3,680	74	>75% Grass cover, Good, HSG C	_				
	3,296	74	>75% Grass cover, Good, HSG C					
	7,604	74	>75% Grass cover, Good, HSG C					
	1,317	74	>75% Grass cover, Good, HSG C					
*	25,216	72	City of Salem Predeveloped, HSG C					
	41,113	73	Weighted Average					
	41,113	73	100.00% Pervious Area					
(Tc Lengtl min) (feet							
	5.0		Direct Entry.

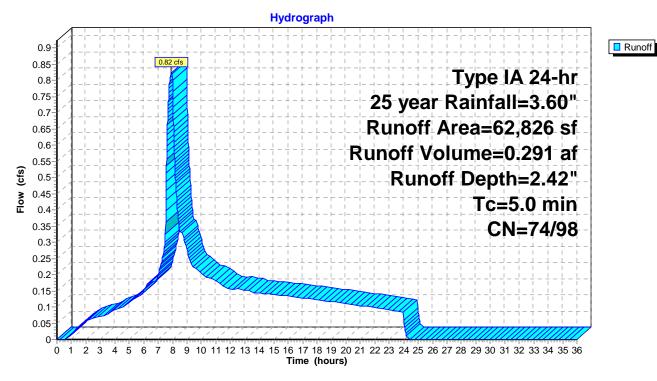
Subcatchment B1: Basin 1

Area (sf)	CN	Description					
	33,861	98	Paved park	ing, HSG C	C			
	27,754	74	>75% Grass	s cover, Go	lood, HSG C			
*	1,211	72	Planter Box					
	62,826	87	Weighted A	verage				
	28,965	74	46.10% Per	46.10% Pervious Area				
	33,861	98	53.90% Imp	ervious Ar	rea			
7	c Lenath	Slor	e Velocity	Capacity	Description			
	- 3	Slop	,		•			
(mii	n) (feet)	(ft/1	ft) (ft/sec)	(cfs)				
5	.0				Direct Entry,

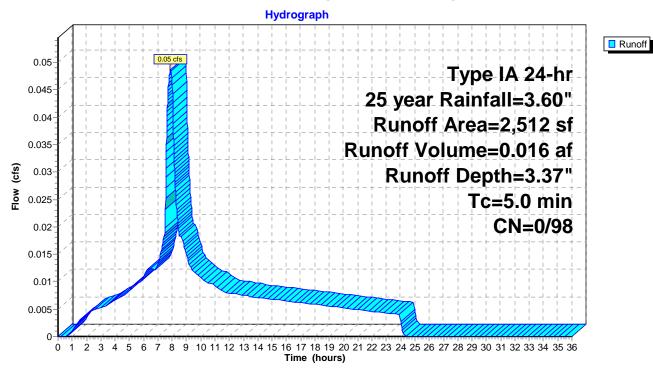
Subcatchment Bldg 0.5CD: Building 33

Area (sf)	CN	Description					
	2,512	98	Roofs, HSG	G C				
	2,512	98	98 100.00% Impervious Area					
Tc	Length	Slope	Velocity	Capacity	Description			
(min)	(feet)	(ft/ft)	(ft/sec)	(cfs)				
5.0					Direct Entry

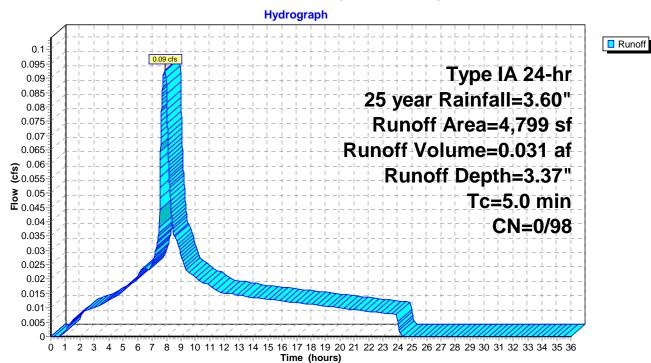
Subcatchment Bldg 18: Building 34

A	rea (sf)	CN [Description		
	4,799	98 F	Roofs, HSG	G C	
•	4,799	98 ′	100.00% Im	pervious A	Area
Tc (min)	Length (feet)	Slope (ft/ft)	Velocity (ft/sec)	Capacity (cfs)	Description
5.0					Direct Entry,

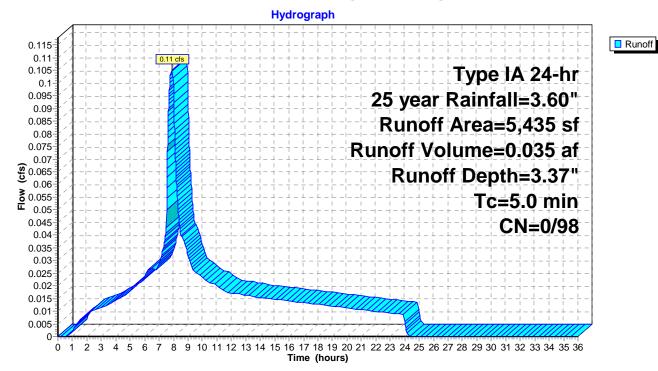
Subcatchment Bldg 3: Building 35

A	rea (sf)	CN [Description					
	5,435	98 F	Roofs, HSG	G C				
	5,435	98 1	98 100.00% Impervious Area					
Tc (min)	Length (feet)	Slope (ft/ft)	Velocity (ft/sec)	Capacity (cfs)	Description			
5.0					Direct Entry,

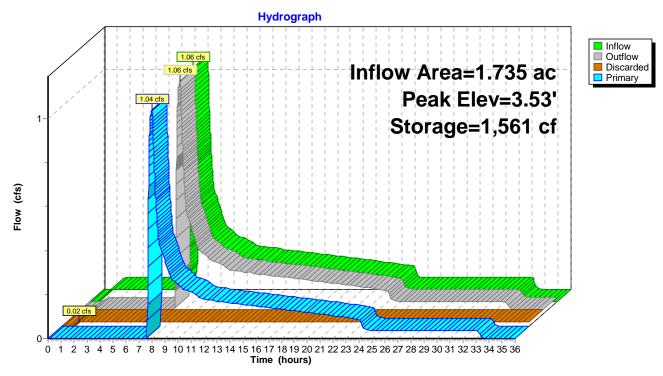
Pond 1 - DR: PB 1 - DR

Volume	Invert	: Avail.Sto	rage Storage	e Description		
#1	0.00'	1,7		Rock Storage (Prisr f Overall x 36.0% \	matic) Listed below (Recalc) /oids	
Elevation (fee	_	urf.Area (sq-ft)	Inc.Store (cubic-feet)	Cum.Store (cubic-feet)		
0.0	00	1,229	0	0		
4.0	00	1,229	4,916	4,916		
Device	Routing Invert		Outlet Device	es		
#1	Discarded 0.00'		0.700 in/hr N	0.700 in/hr Native Infiltration over Surface area		
#2 Primary 3.00'		12.0" Vert. U	Inderdrain C= 0.6	500 Limited to weir flow at low heads

Discarded OutFlow Max=0.02 cfs @ 1.34 hrs HW=0.04' (Free Discharge) 1=Native Infiltration (Exfiltration Controls 0.02 cfs)

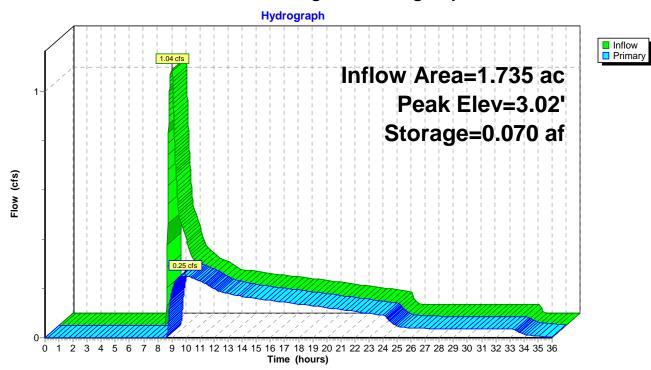
Pond 1P: Underground Storage Pipe

Primary OutFlow Max=0.25 cfs @ 9.95 hrs HW=3.02' (Free Discharge) 1=Orifice/Grate (Orifice Controls 0.25 cfs @ 2.88 fps)

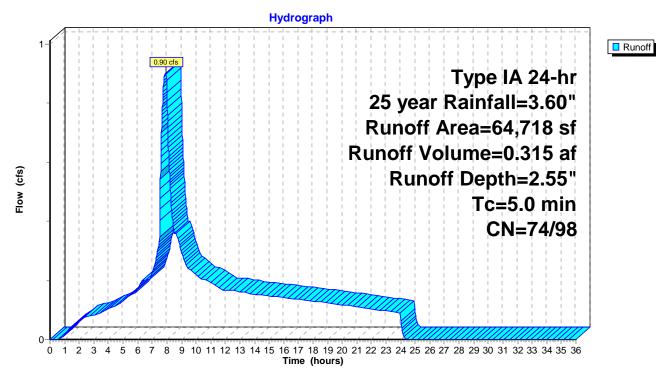
Subcatchment B2: Basin 2

Area (sf)	CN	Description			
	21,385	74	>75% Grass cover, Good, HSG C			
	38,965	98	Paved parking, HSG C			
*	4,368	72	Planter Box			
	64,718	88	Weighted Average			
	25,753	74	39.79% Pervious Area			
	38,965	98	60.21% Impervious Area			
	T-	Ola -	. Valasita	0	Description	
,	Tc Length	Slop	,	Capacity	·	
(n	nin) (feet)	(ft/f	t) (ft/sec)	(cfs)		
	5.0				Direct Entry,

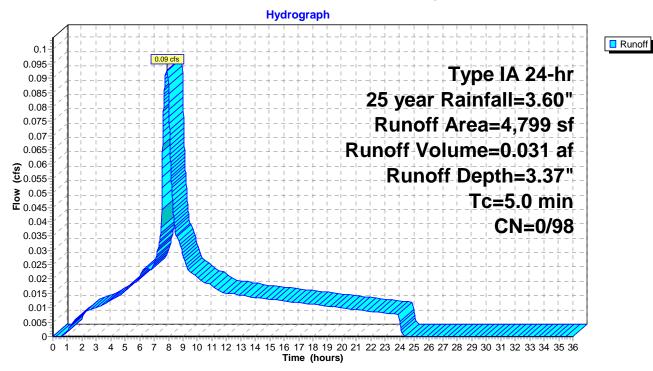
Subcatchment Bld 18: Building 30

_	Α	rea (sf)	CN	Description							
		4,799	98	Roofs, HSG C							
		4,799	98	100.00% Impervious Area							
	Tc	Length	Slope	e Velocity	Capacity	Description					
	(min)	(feet)	(ft/ft) (ft/sec)	(cfs)						
	5.0			-		Direct Entry

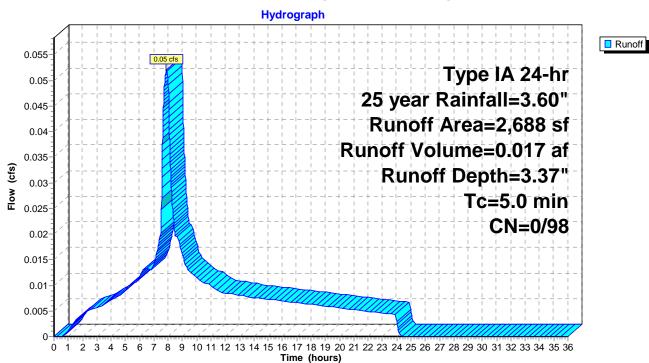
Subcatchment Bldg 0.5AA: Building 28

Α	rea (sf)	CN	Description							
		2,688	98	Roofs, HSG C							
		2,688	98	100.00% Impervious Area							
	Tc	Length	Slope	e Velocity	Capacity	Description					
((min)	(feet)	(ft/ft) (ft/sec)	(cfs)						
	5.0					Direct Entry

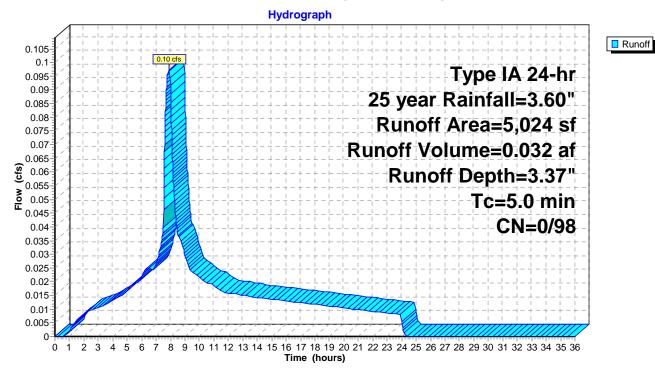
Subcatchment Bldg 13: Building 32

A	rea (sf)	CN I	Description						
	5,024	98 I	Roofs, HSG C						
	5,024	98 ′	100.00% Impervious Area						
Tc (min)	Length (feet)	Slope (ft/ft)	Velocity (ft/sec)	Capacity (cfs)	Description				
5.0					Direct Entry,

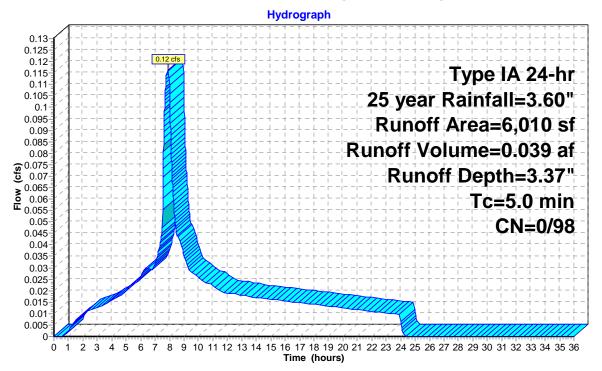
Subcatchment Bldg 16: Building 27

A	rea (sf)	CN [Description						
	6,010	98 F	Roofs, HSG C						
	6,010	98 ′	100.00% Impervious Area						
Tc (min)	Length (feet)	Slope (ft/ft)	Velocity (ft/sec)	Capacity (cfs)	Description				
5.0					Direct Entry,

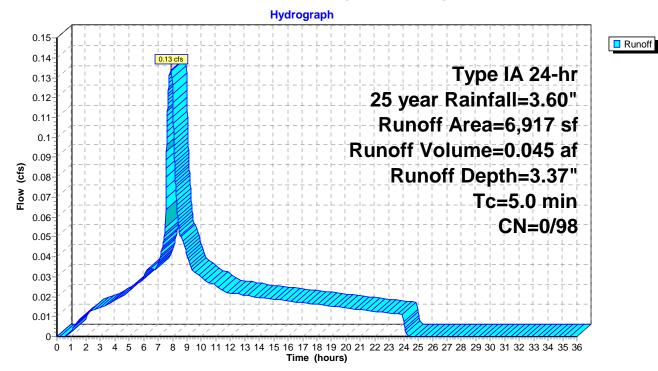
Subcatchment Bldg 19: Building 29

_	Α	rea (sf)	CN	Description							
		6,917	98	Roofs, HSG C							
		6,917	98	100.00% Impervious Area							
	Tc	Length	Slope	 Velocity 	Capacity	Description					
	(min)	(feet)	(ft/ft)	(ft/sec)	(cfs)						
	5.0		·			Direct Entry

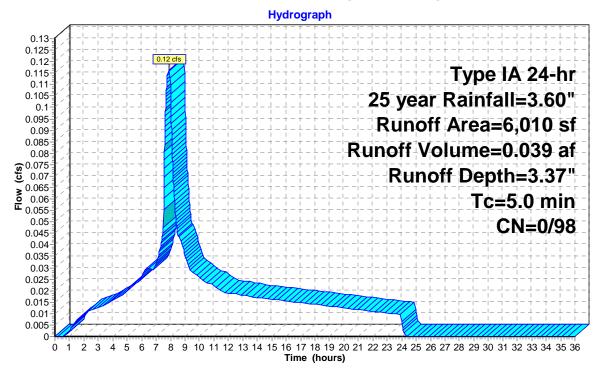
Subcatchment Bldg 2: Building 31

A	rea (sf)	CN [Description						
	6,010	98 F	Roofs, HSG C						
	6,010	98 ′	100.00% Impervious Area						
Tc (min)	Length (feet)	Slope (ft/ft)	Velocity (ft/sec)	Capacity (cfs)	Description				
5.0					Direct Entry,

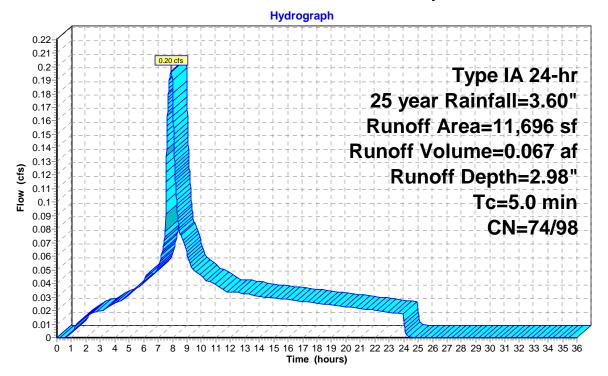
Subcatchment VC2: VC Loop 2

Area (sf)	CN	Description								
	2,181	74	>75% Gras	>75% Grass cover, Good, HSG C							
	9,515	98	Paved park	Paved parking, HSG C							
	11,696	94	Weighted A	Weighted Average							
	2,181	74	18.65% Per	18.65% Pervious Area							
	9,515	98	81.35% lmp	ervious Ar	rea						
	Tc Length (min) (feet)	Slop (ft/	,	Capacity (cfs)	•						
-	5.0	(10									
	i).U		Direct Entry.
