STORMWATER ANALYSIS FOR

The Grove 2 Apartments Salem, Oregon

February 22, 2021

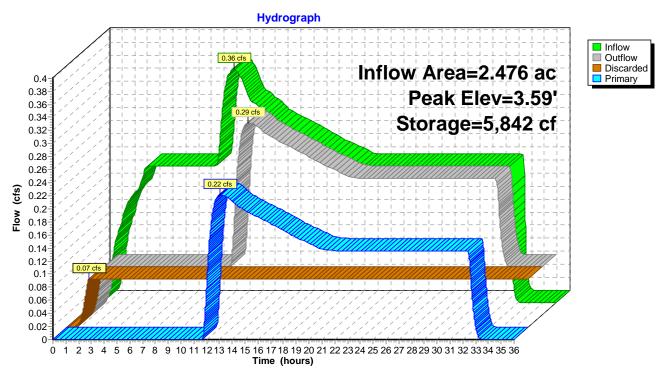
Pond 2 - DR: PB 2 - DR

Volume	Inve	ert Avai	I.Storage	Storage D	Description			
#1	0.0	00'	6,507 cf		ck Storage Overall x 3		atic) Listed below (Recalc) oids	
Elevatio	_	Surf.Area (sq-ft)		c.Store ic-feet)	Cum.Sto			
0.0	00	4,519	0			0		
4.0	00	4,519		18,076	18,0	76		
Device	Routing	In	vert Out	let Devices				
#1	Discarde	ed 0	.00' 0.7 0	700 in/hr Native Infiltration over Surface area				
#2	Primary	3	33' 8.0'	8.0" Vert Underdrain C= 0.600 Limited to weir flow at low heads

Discarded OutFlow Max=0.07 cfs @ 1.68 hrs HW=0.04' (Free Discharge) 1=Native Infiltration (Exfiltration Controls 0.07 cfs)

Primary OutFlow Max=0.22 cfs @ 13.06 hrs HW=3.59' (Free Discharge) **2=Underdrain** (Orifice Controls 0.22 cfs @ 1.74 fps)

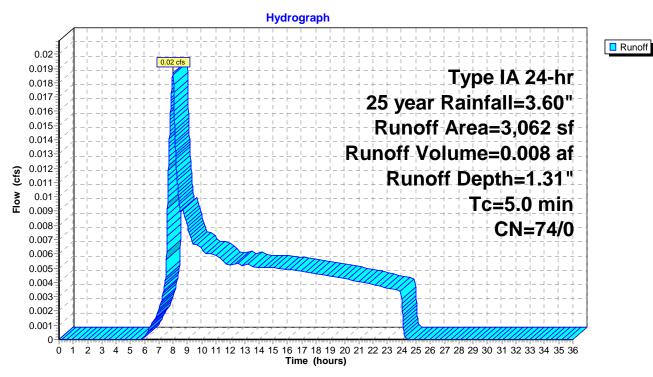
Subcatchment Undet: Undetained

A	rea (sf)	CN	Description							
	3,062	74	>75% Grass cover, Good, HSG C							
	3,062	74	100.00% Pervious Area							
Tc (min)	Length (feet)	Slope (ft/ft)	•	Capacity (cfs)	/ Description					
5.0					Direct Entry,

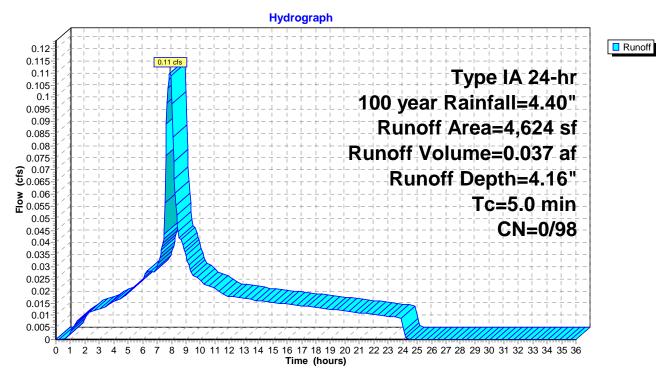
Subcatchment MU Path: Multi Use Path

A	rea (sf)	CN I	Description							
	4,624	98 I	Unconnected pavement, HSG C							
	4,624	98	100.00% Impervious Area							
Tc (min)	Length (feet)	Slope (ft/ft)	Velocity (ft/sec)	Capacity (cfs)	Description					
5.0					Direct Entry,

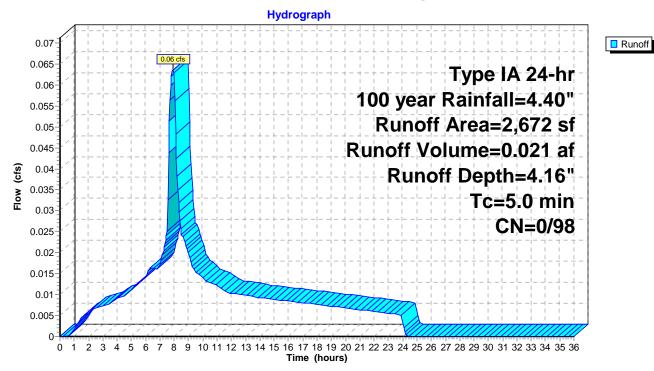
Subcatchment 0.5: Building 25

A	rea (sf)	CN [Description						
	2,672	98 F	Roofs, HSG C						
•	2,672	98 1	100.00% Impervious Area						
Tc (min)	Length (feet)	Slope (ft/ft)	Velocity (ft/sec)	Capacity (cfs)	Description				
5.0	, ,	, ,	, ,	, ,	Direct Entry,

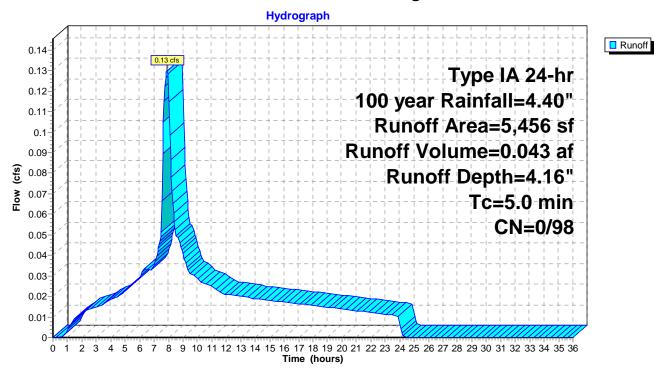
Subcatchment 9: Building 24

A	rea (sf)	CN [Description						
	5,456	98 F	Roofs, HSG C						
	5,456	98 1	100.00% Impervious Area						
Tc (min)	Length (feet)	Slope (ft/ft)	Velocity (ft/sec)	Capacity (cfs)	Description				
5.0					Direct Entry,

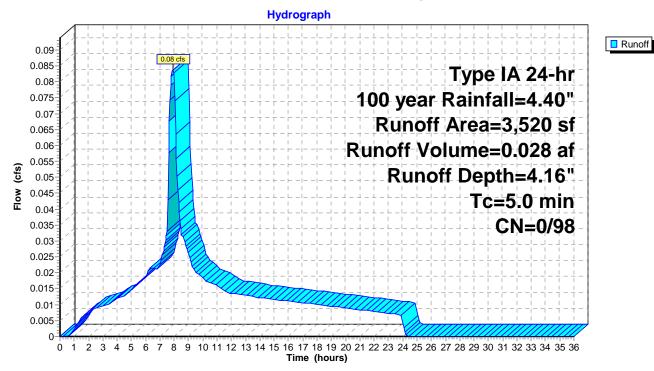
Subcatchment 17: Building 26

A	rea (sf)	CN [Description						
	3,520	98 F	Roofs, HSG C						
	3,520	98 ′	100.00% Impervious Area						
Tc (min)	Length (feet)	Slope (ft/ft)	Velocity (ft/sec)	Capacity (cfs)	Description				
5.0					Direct Entry,

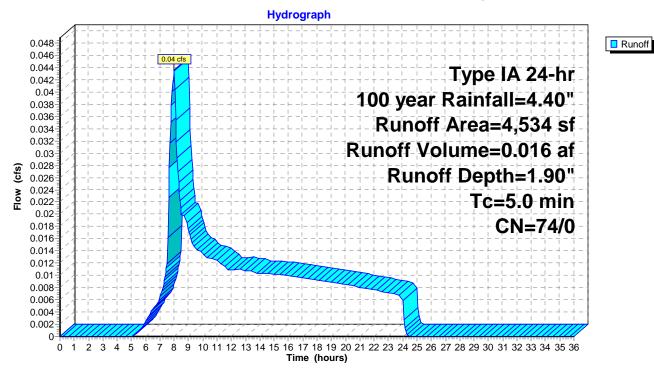
Subcatchment Landscape: Landscaping

Area (sf)	CN	Description								
	4,534	74	>75% Gras	75% Grass cover, Good, HSG C							
	4,534	74	100.00% Pe	00.00% Pervious Area							
Tc (min)	Length (feet)	Slope (ft/ft)	,	Capacity (cfs)	v Description						
5.0					Direct Entry,

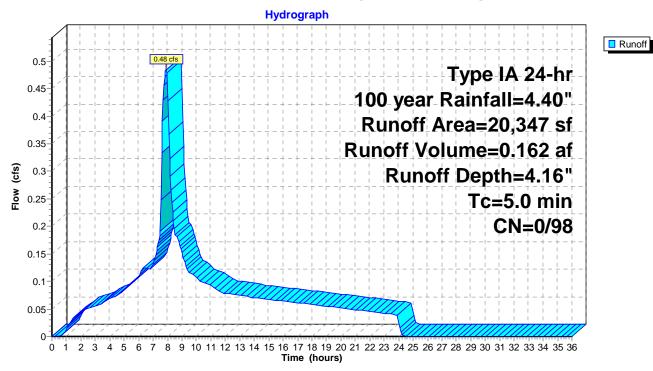
Subcatchment S Parking: South Parking

Α	rea (sf)	CN	Description								
	20,347	98	Paved park	Paved parking, HSG C							
	20,347	98	100.00% Impervious Area								
.	1	01	- Mala a'i	0 11	Description						
	Length	Siop	•	Capacity	Description						
(min)	(feet)	(ft/f	t) (ft/sec)	(cfs)							
5.0					Direct Entry

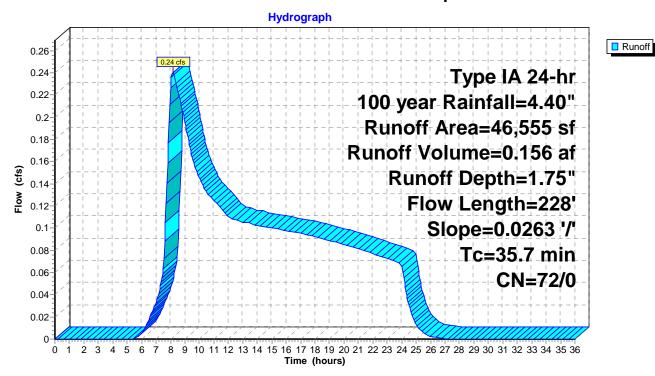
Subcatchment Undev SW: Undeveloped SW

_	Α	rea (sf)	CN	Description							
*		46,555	72	City of Salem Predeveloped, HSG C							
		46,555	72	72 100.00% Pervious Area							
	Tc (min)	Length (feet)	Slope (ft/ft)	,	Capacity (cfs)	Description					
_	35.7	228	0.0263		(013)	Sheet Flow,					
				• • • • • • • • • • • • • • • • • • • •		n= 0.300 P2= 2.20"

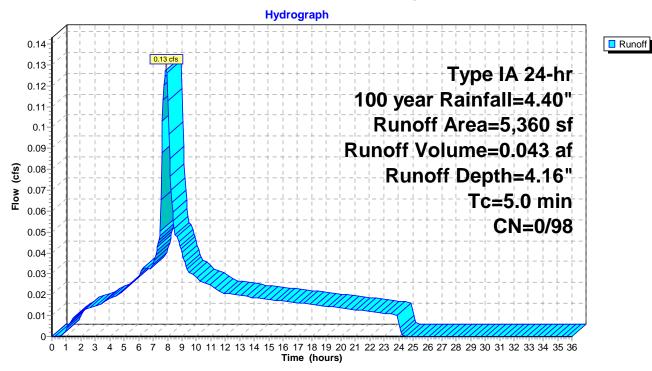
Subcatchment 3: Building 23

A	rea (sf)	CN [Description						
	5,360	98 F	Roofs, HSG C						
	5,360	98 1	100.00% Impervious Area						
Tc (min)	Length (feet)	Slope (ft/ft)	Velocity (ft/sec)	Capacity (cfs)	Description				
5.0					Direct Entry,

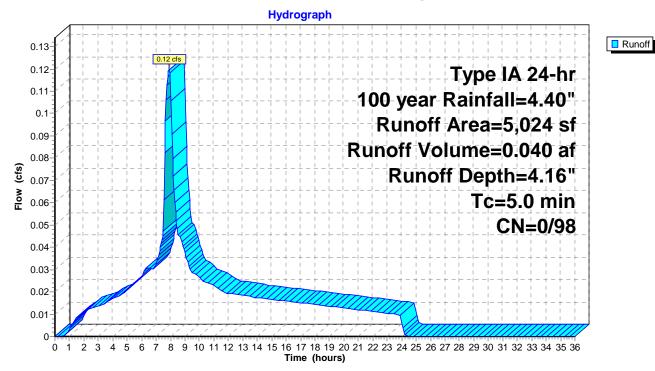
Subcatchment 13: Building 22

A	rea (sf)	CN I	Description						
	5,024	98 I	Roofs, HSG C						
	5,024	98 ′	100.00% Impervious Area						
Tc (min)	Length (feet)	Slope (ft/ft)	Velocity (ft/sec)	Capacity (cfs)	Description				
5.0					Direct Entry,

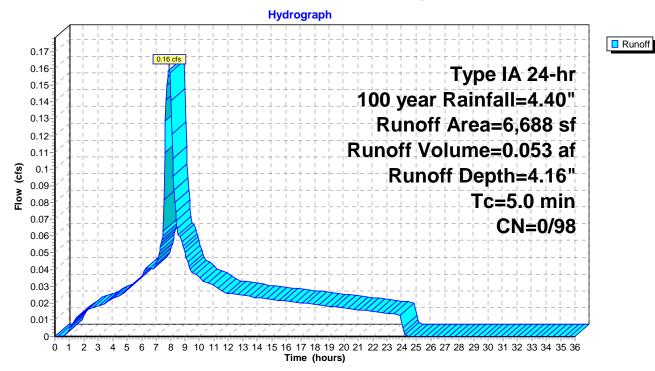
Subcatchment 14: Building 21

A	rea (sf)	CN [Description						
	6,688	98 F	Roofs, HSG C						
	6,688	98 1	100.00% Impervious Area						
Tc (min)	Length (feet)	Slope (ft/ft)	Velocity (ft/sec)	Capacity (cfs)	Description				
5.0					Direct Entry,

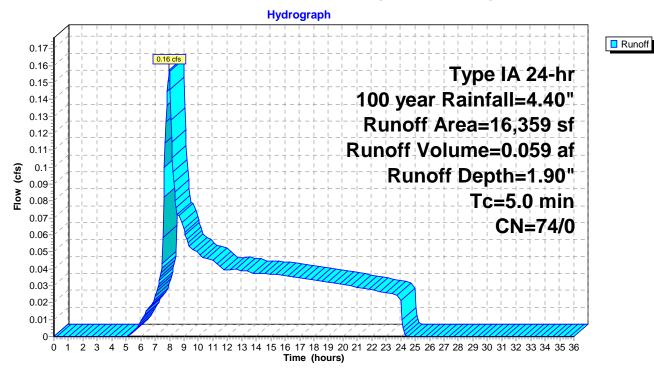
Subcatchment Landscaping: Landscaping

Are	ea (sf)	CN I	Description		
1	6,359	74 >75% Grass cover, Good, HSG C			
16,359		74 ′	100.00% Pervious Area		
Tc (min)	Length (feet)	Slope (ft/ft)	Velocity (ft/sec)	Capacity (cfs)	Description
5.0					Direct Entry,

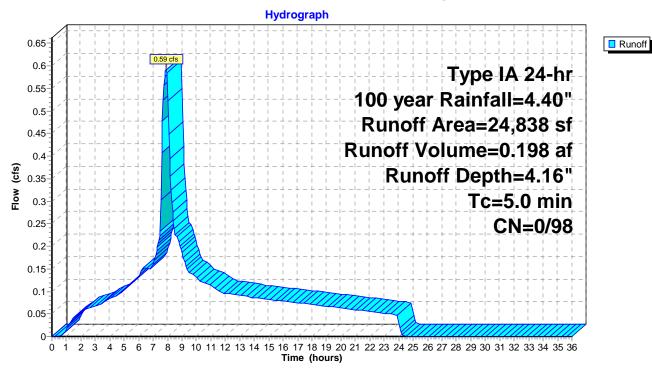
Subcatchment N Park2: N Parking B2

Area (sf)	CN	Description	Description				
24,838	98	98 Unconnected pavement, HSG C					
24,838	24,838 98 100.00% Impervious Ar			Area			
Tc Length (min) (feet		•	Capacity (cfs)	Description			
5.0				Direct Entry,

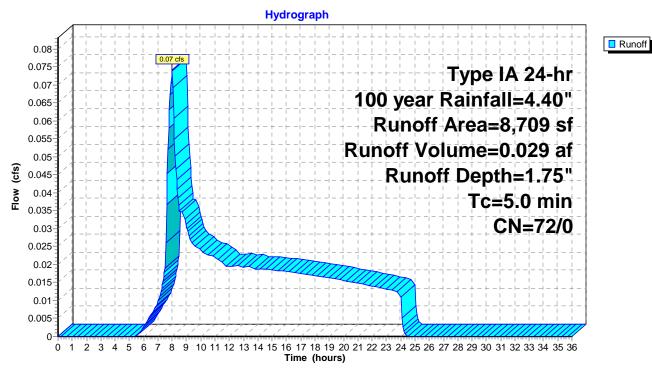
Subcatchment Undev W: Undeveloped W

_	Α	rea (sf)	CN	Description					
*		8,709	72	City of Salem Undeveloped, HSG C					
		8,709	72	72 100.00% Pervious Area					
	To	Longth	Slope	Volocity	Capacity	Description			
	(min)	Length (feet)	(ft/ft)	(ft/sec)	(cfs)	Description			
_	5.0			, ,	, ,	Direct Entry

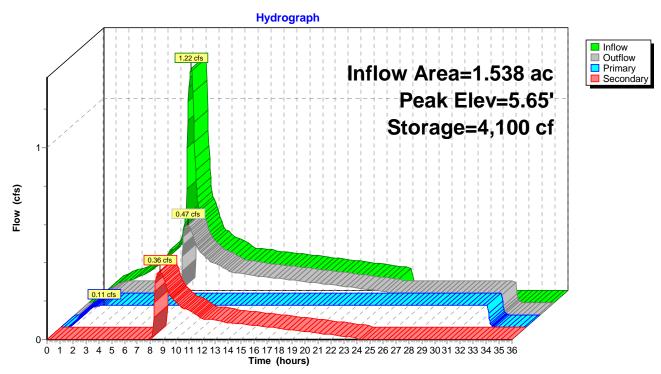
Pond 2 - GM: PB 2 - GM

Secondary OutFlow Max=0.36 cfs @ 8.72 hrs HW=5.65' (Free Discharge) 2=Rock Box (Weir Controls 0.36 cfs @ 1.27 fps)

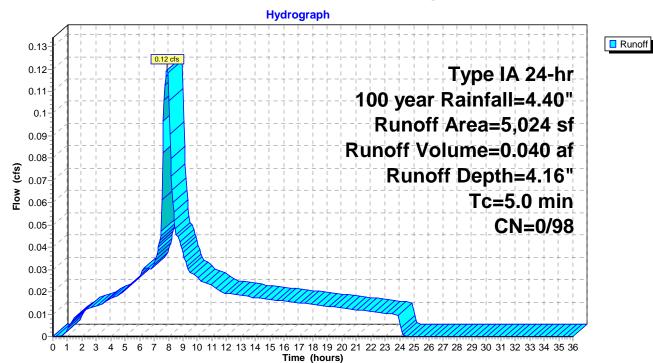
Subcatchment Bld13: Building 20

A	rea (sf)	CN I	Description				
	5,024	98 I	98 Roofs, HSG C				
	5,024	98 ′	98 100.00% Impervious Area				
Tc (min)	Length (feet)	Slope (ft/ft)	Velocity (ft/sec)	Capacity (cfs)	Description		
5.0					Direct Entry,

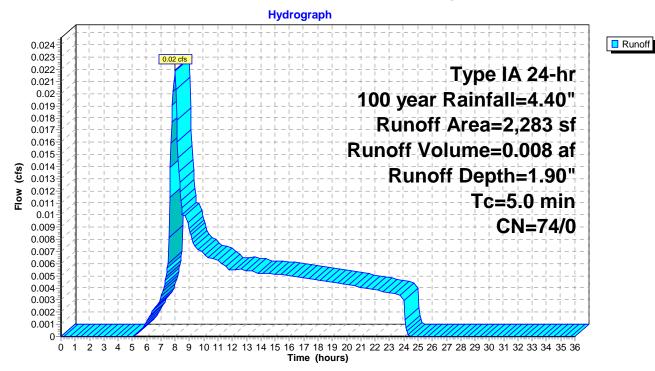
Subcatchment LS: Landscaping

A	rea (sf)	CN [Description					
	2,283	74 >	75% Grass cover, Good, HSG C					
	2,283	74 ′	74 100.00% Pervious Area					
Tc (min)	Length (feet)	Slope (ft/ft)	Velocity (ft/sec)	Capacity (cfs)	Description			
5.0					Direct Entry,

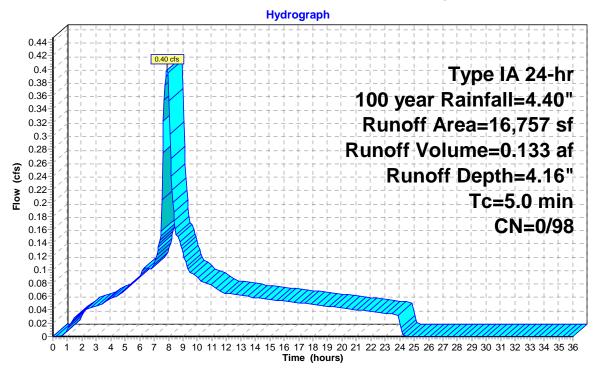
Subcatchment N Park3: N Parking B3

A	rea (sf)	CN [N Description				
	16,757	98 F	98 Paved parking, HSG C				
•	16,757	98 ′	100.00% lm	pervious A	Area		
Tc (min)	Length (feet)	Slope (ft/ft)	Velocity (ft/sec)	Capacity (cfs)	Description		
5.0					Direct Entry,

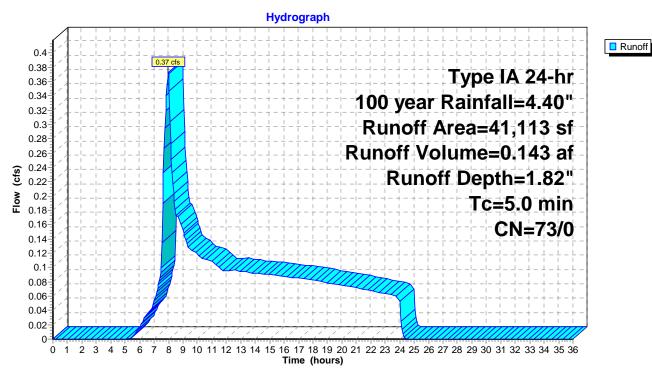
Subcatchment Undet: Undetained

Area (sf) CN	Description						
	3,6	80 74	>75% Grass cover, Good, HSG C						
	3,2	96 74	>75% Grass cover, Good, HSG C						
	7,6	04 74	>75% Grass cover, Good, HSG C						
	1,3	17 74	>75% Grass cover, Good, HSG C						
*	25,2	16 72	City of Salem Predeveloped, HSG C						
	41,1	13 73	Weighted Average						
	41,1	13 73	100.00% Pervious Area						
(Tc Len	0	ope Velocity Capacity Description ft/ft) (ft/sec) (cfs)						
	5.0		Direct Entry,

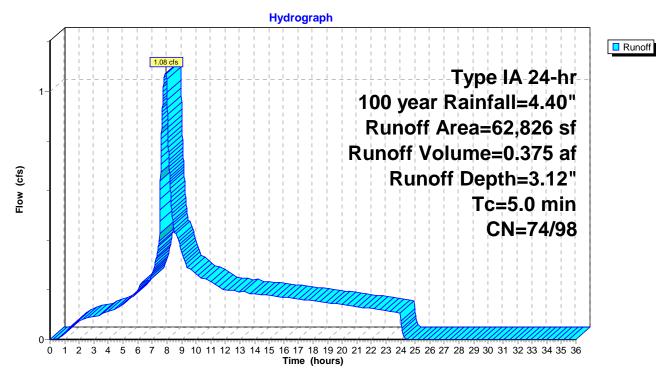
Subcatchment B1: Basin 1

Area (sf)	CN	Description						
	33,861	98	Paved park	ing, HSG C	C				
	27,754	74	>75% Gras	s cover, Go	Good, HSG C				
*	1,211	72	Planter Box						
	62,826	87	Weighted A	Weighted Average					
	28,965	74	46.10% Per	46.10% Pervious Area					
	33,861	98	53.90% Imp	ervious Ar	rea				
Te	3	Slop	,	Capacity	• • • • • • • • • • • • • • • • • • •				
(min) (feet)	(ft/f	t) (ft/sec)	(cfs)					
5.0)				Direct Entry,

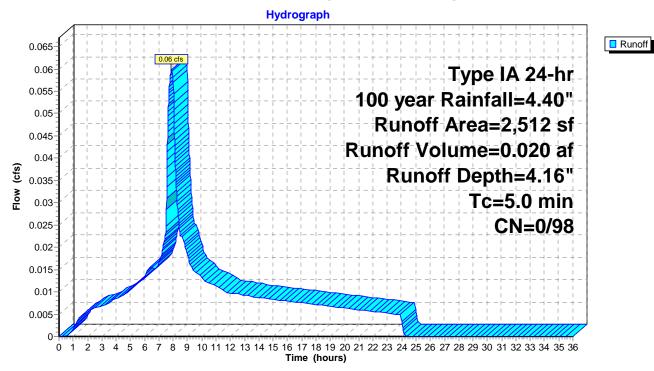
Subcatchment Bldg 0.5CD: Building 33

rea (sf)	CN [Description					
	2,512	98 F	Roofs, HSG C					
	2,512	98 ′	3 100.00% Impervious Area					
Tc (min)	Length (feet)	Slope (ft/ft)	Velocity (ft/sec)	Capacity (cfs)	Description			
5.0					Direct Entry,

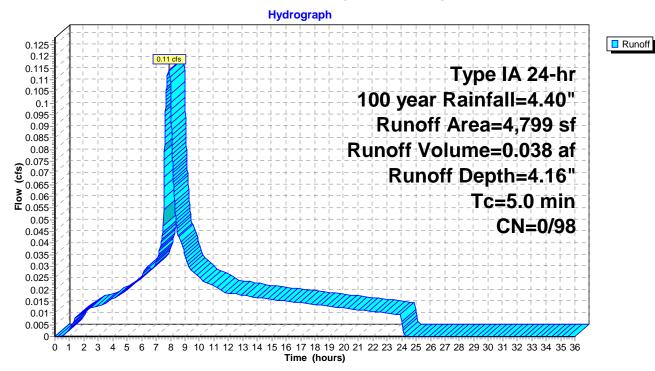
Subcatchment Bldg 18: Building 34

A	rea (sf)	CN [Description					
	4,799	98 F	Roofs, HSG C					
•	4,799	98 ′	100.00% Impervious Area					
Tc (min)	Length (feet)	Slope (ft/ft)	Velocity (ft/sec)	Capacity (cfs)	Description			
5.0					Direct Entry,

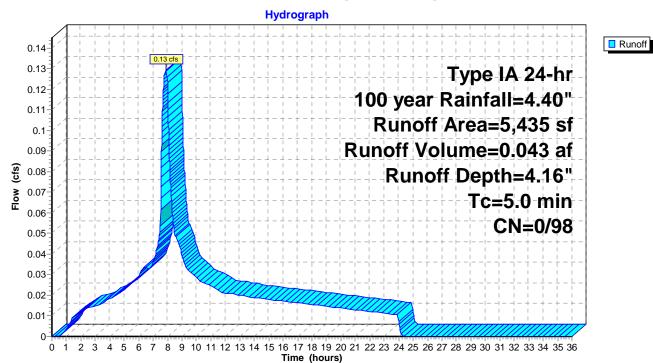
Subcatchment Bldg 3: Building 35

_	Α	rea (sf)	CN	Description						
		5,435	98	Roofs, HSG C						
		5,435	98	100.00% Impervious Area						
	Tc	Length	Slope	Velocity	Capacity	Description				
	(min)	(feet)	(ft/ft)	(ft/sec)	(cfs)					
_	5.0					Direct Entry

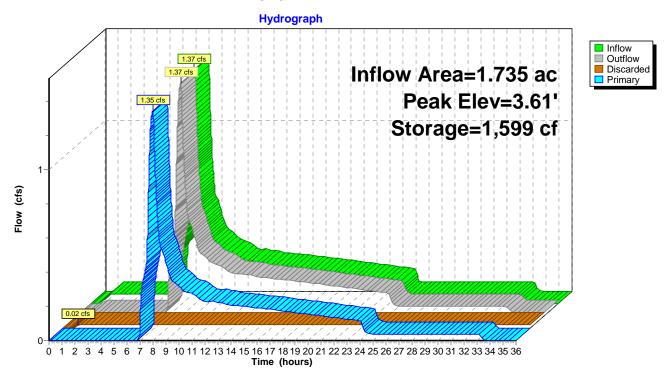
Pond 1 - DR: PB 1 - DR

Volume	Inver	t Avail.Sto	rage Storage	e Description	
#1	0.00)' 1,7		Rock Storage of Overall x 36	(Prismatic) Listed below (Recalc) 5.0% Voids
Elevation (fee		Surf.Area (sq-ft)	Inc.Store (cubic-feet)	Cum.Sto (cubic-fee	
0.0	00	1,229	0		0
4.0	00	1,229	4,916	4,9	16
Device	Routing	Invert	Outlet Devic	es	
#1	Discarded	0.00'	0.700 in/hr N	Native Infiltrat	ion over Surface area
#2	Primary	3.00'	12.0" Vert. l	Inderdrain (C= 0.600 Limited to weir flow at low heads

Discarded OutFlow Max=0.02 cfs @ 1.17 hrs HW=0.04' (Free Discharge) 1=Native Infiltration (Exfiltration Controls 0.02 cfs)

Primary OutFlow Max=1.35 cfs @ 7.98 hrs HW=3.61' (Free Discharge)
—2=Underdrain (Orifice Controls 1.35 cfs @ 2.67 fps)

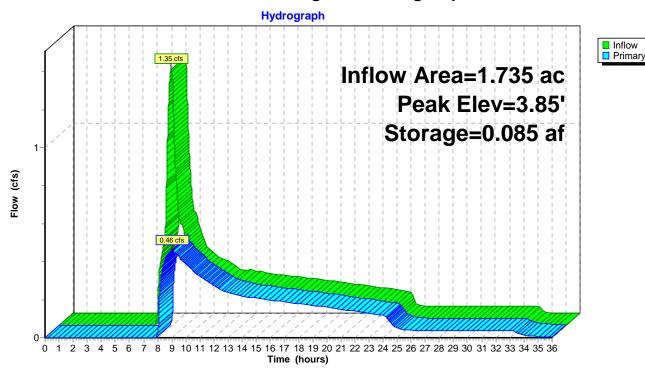
Pond 1P: Underground Storage Pipe

Primary OutFlow Max=0.46 cfs @ 9.01 hrs HW=3.85' (Free Discharge)
1=Orifice/Grate (Orifice Controls 0.46 cfs @ 5.23 fps)

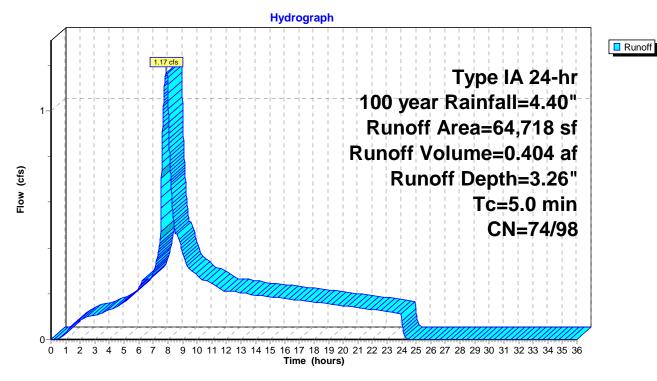
Subcatchment B2: Basin 2

Area (sf)	CN	Description						
	21,385	74	>75% Gras	s cover, Go	lood, HSG C				
	38,965	98	Paved park	ing, HSG C	C				
*	4,368	72	Planter Box						
	64,718	88	Weighted A	verage					
	25,753	74	39.79% Per	39.79% Pervious Area					
	38,965	98	60.21% lmp	60.21% Impervious Area					
	Tc Length	Slop	,	Capacity	•				
(n	nin) (feet)	(ft/f	ft) (ft/sec)	(cfs)					
	5.0				Direct Entry,

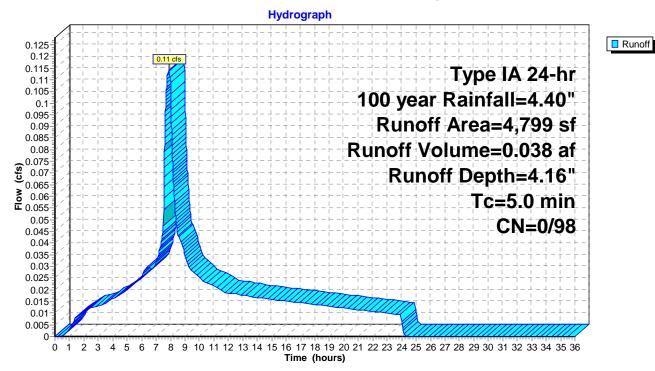
Subcatchment Bld 18: Building 30

A	rea (sf)	CN [Description					
	4,799	98 F	Roofs, HSG C					
•	4,799	98 ′	100.00% Impervious Area					
Tc (min)	Length (feet)	Slope (ft/ft)	Velocity (ft/sec)	Capacity (cfs)	Description			
5.0					Direct Entry,

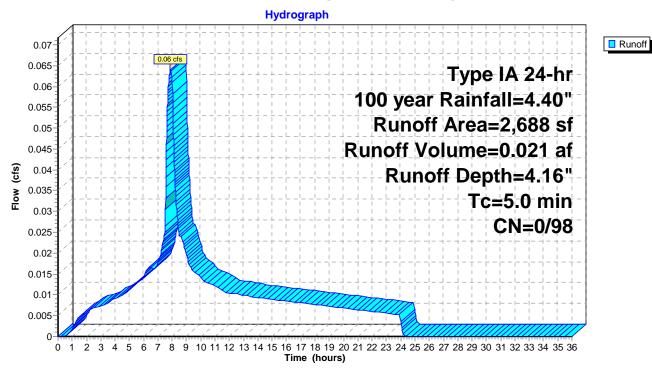
Subcatchment Bldg 0.5AA: Building 28

A	rea (sf)	CN I	Description						
	2,688	98 I	8 Roofs, HSG C						
	2,688	98	8 100.00% Impervious Area						
Tc (min)	Length (feet)	Slope (ft/ft)	Velocity (ft/sec)	Capacity (cfs)	Description				
5.0					Direct Entry,

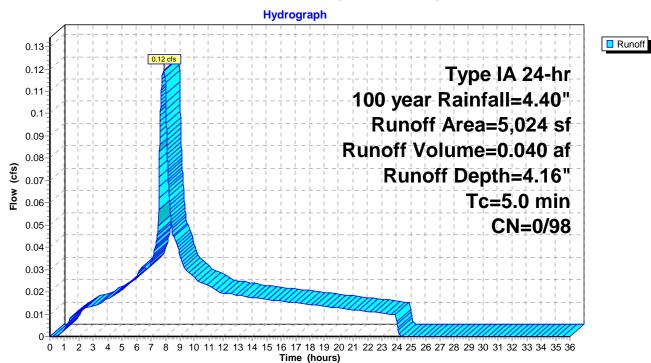
Subcatchment Bldg 13: Building 32

A	rea (sf)	CN I	Description					
	5,024	98 I	Roofs, HSG C					
	5,024	98 ′	100.00% lm	pervious A	Area			
Tc (min)	Length (feet)	Slope (ft/ft)	Velocity (ft/sec)	Capacity (cfs)	Description			
5.0					Direct Entry,

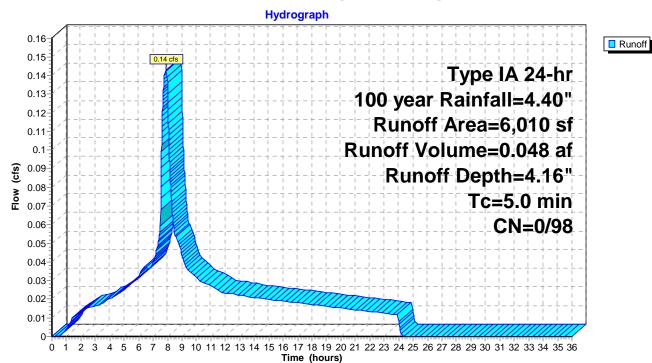
Subcatchment Bldg 16: Building 27

A	rea (sf)	CN [Description						
	6,010	98 F	Roofs, HSG C						
	6,010	98 ′	100.00% Im	pervious A	Area				
Tc (min)	Length (feet)	Slope (ft/ft)	Velocity (ft/sec)	Capacity (cfs)	Description				
5.0					Direct Entry,

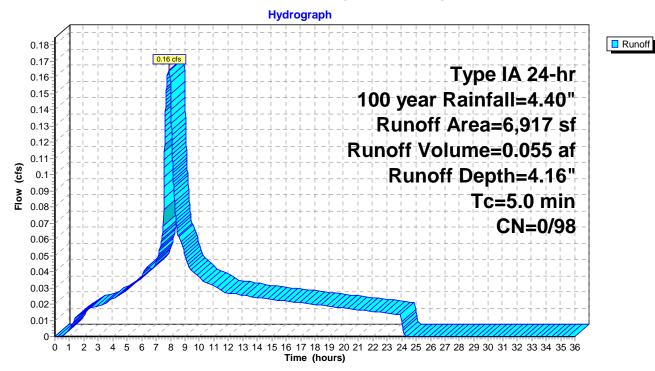
Subcatchment Bldg 19: Building 29

A	rea (sf)	CN [Description						
	6,917	98 F	Roofs, HSG C						
	6,917	98 ′	100.00% Im	pervious A	Area				
To	Length	Slope	Velocity	Canacity	Description				
(min)	(feet)	(ft/ft)	(ft/sec)	(cfs)	Description				
5.0		•			Direct Entry,

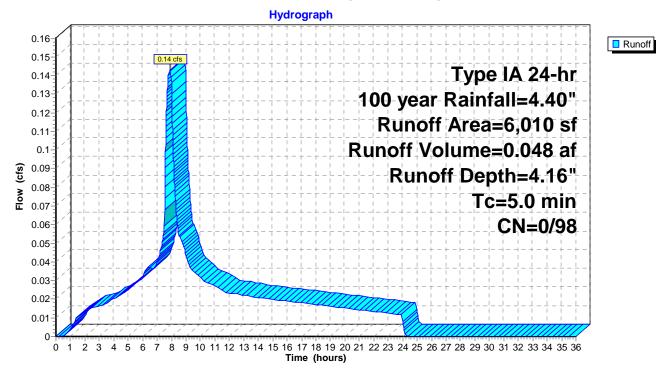
Subcatchment Bldg 2: Building 31

A	rea (sf)	CN [Description						
	6,010	98 F	Roofs, HSG C						
	6,010	98 ′	100.00% Im	pervious A	Area				
Tc (min)	Length (feet)	Slope (ft/ft)	Velocity (ft/sec)	Capacity (cfs)	Description				
5.0					Direct Entry,

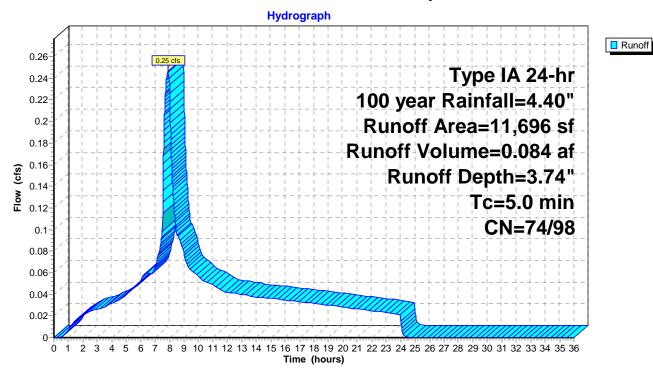
Subcatchment VC2: VC Loop 2

Area	(sf) CN	Description					
2,	181 74	>75% Gras	s cover, Go	Good, HSG C			
9,5	515 98	Paved park	ing, HSG C	C			
11,6	696 94	Weighted A	verage				
2,1	181 74	74 18.65% Pervious Area					
9,5	515 98	81.35% lmp	ervious Ar	rea			
	ngth Slop	•	Capacity	·			
(min) (1	eet) (ft/	ft) (ft/sec)	(cfs)				
5.0				Direct Entry.

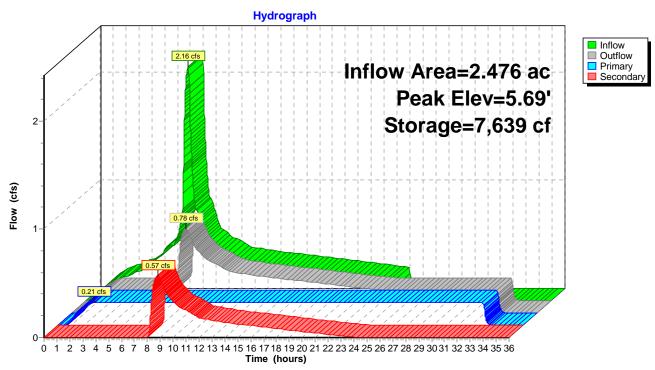
WEST (VC) Site Prelim Hydrographs

Grove 2 Apartments - WEST Property Type IA 24-hr 100 year Rainfall=4.40" Printed 2/18/2021

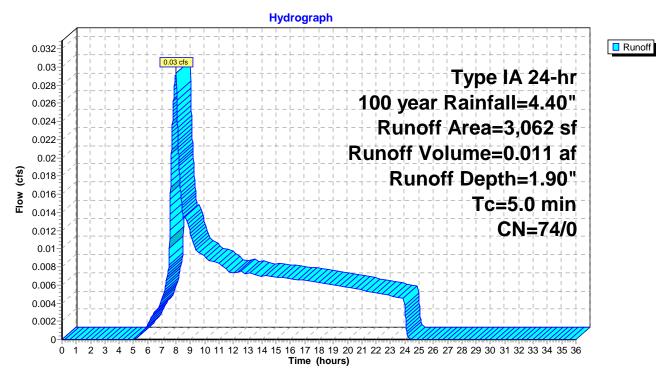
Subcatchment Undet: Undetained

A	rea (sf)	CN	Description					
	3,062	74	74 >75% Grass cover, Good, HSG C					
	3,062	74	100.00% Pe	ervious Are	rea			
Tc (min)	Length (feet)	Slope (ft/ft)	•	Capacity (cfs)	/ Description			
5.0					Direct Entry,
