**Geotechnical Investigation**  
**and**  
**Geologic Hazard Assessment Services**  
**Proposed Loan Oak Residential Subdivision Site**  
**Tax Lot No's. 1900, 2000, 2100 and 2200**  
**5730 Loan Oak Road SE**  
**Salem (Marion County), Oregon**

**Project No. 1001.074.G**  
**July 16, 2021**

**GEOTECHNICAL INVESTIGATION AND GEOLOGIC HAZARD ASSESSMENT  
PROPOSED LOAN OAK RESIDENTIAL DEVELOPMENT SITE  
TAX LOT NO'S. 1900, 2000, 2100 AND 2200  
5730 LOAN OAK ROAD SE  
SALEM (MARION COUNTY) OREGON**

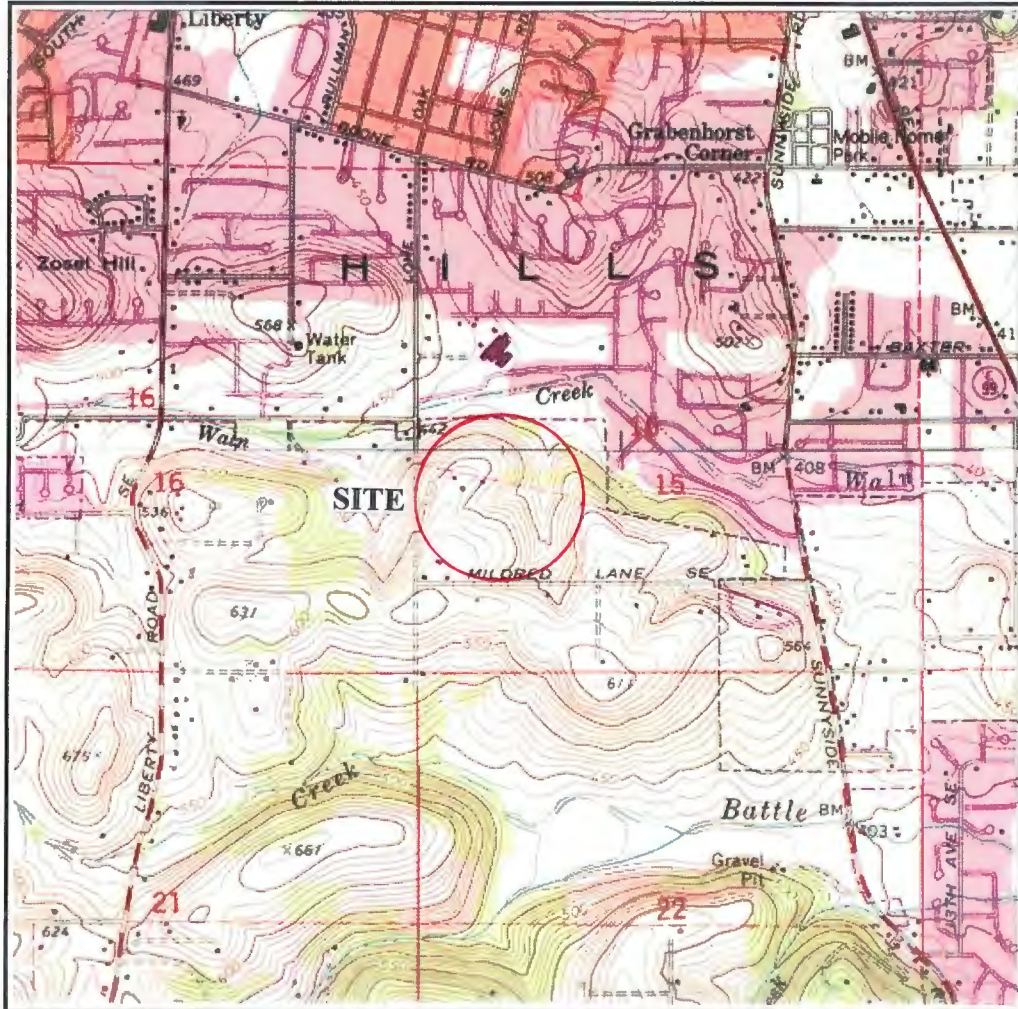
Figure No. 1

**SITE VICINITY AND GEOLOGIC MAP**

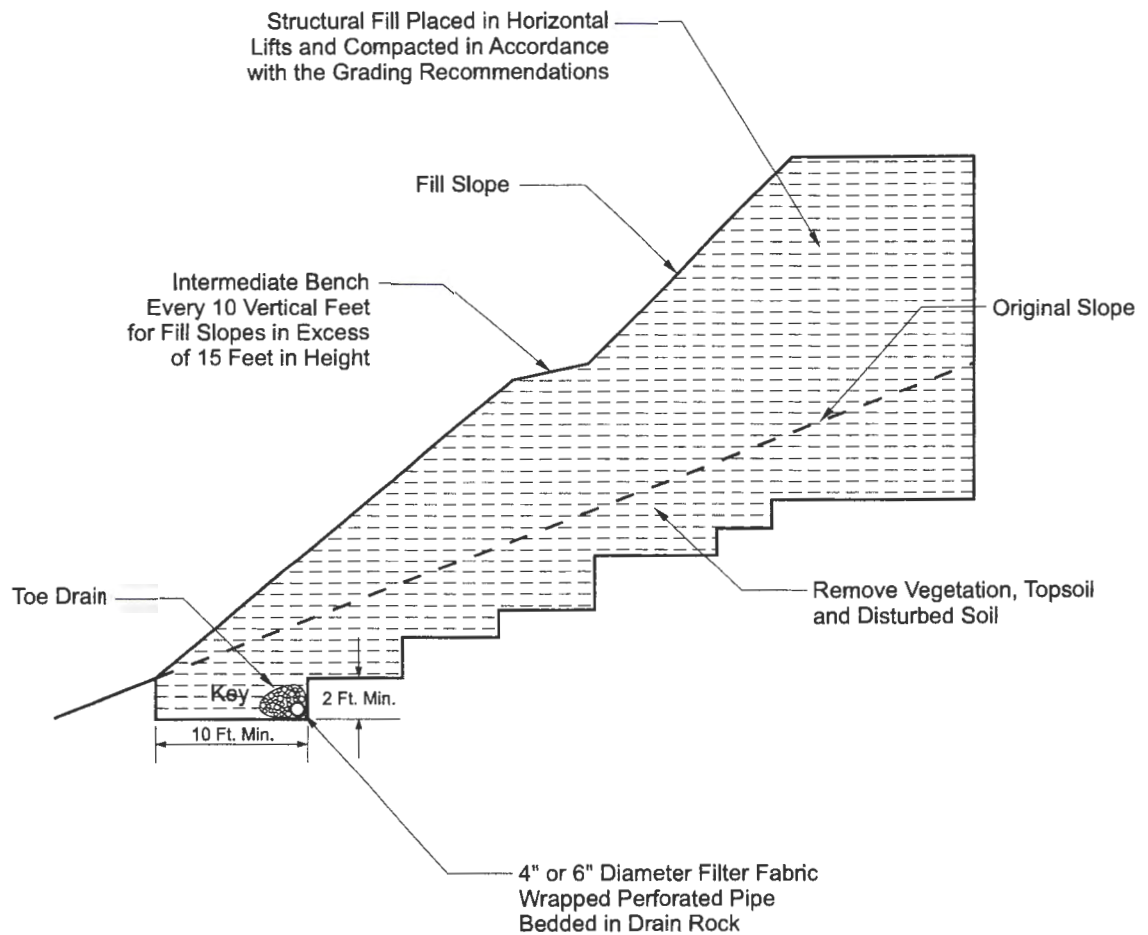
### TYPICAL KEY AND BENCH FILL SLOPE DETAIL

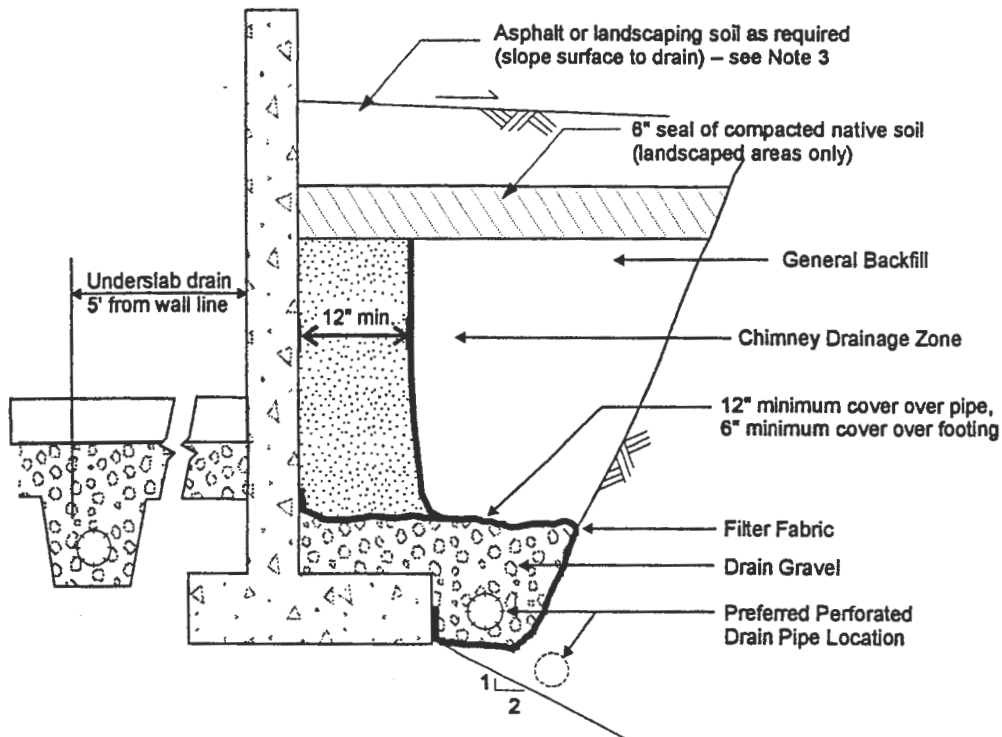
Figure No. 4

**SCHEMATIC - NOT TO SCALE**

As such, based on our current understand of the possible site grading required to bring the subject site and/or residential lots to finish design grade(s), we are of the opinion that an underslab drainage system is not required for the proposed single-family residential structures. However, a perimeter foundation drain is recommended for any perimeter footings and/or below grade retaining walls. A typical recommended perimeter footing/retaining wall drain detail is shown on Figure No. 4. Further, due to our understanding that various surface infiltration ditches and/or swales may be utilized for the project as well as the relatively low infiltration rates of the near surface sandy, clayey silt and/or residual soils anticipated within and/or near to the foundation bearing level of the proposed residential structures, we are generally of the opinion that storm water detention and/or disposal systems should not be utilized within the residential lots and/or around the proposed residential structures unless approved by the Geotechnical Engineer.

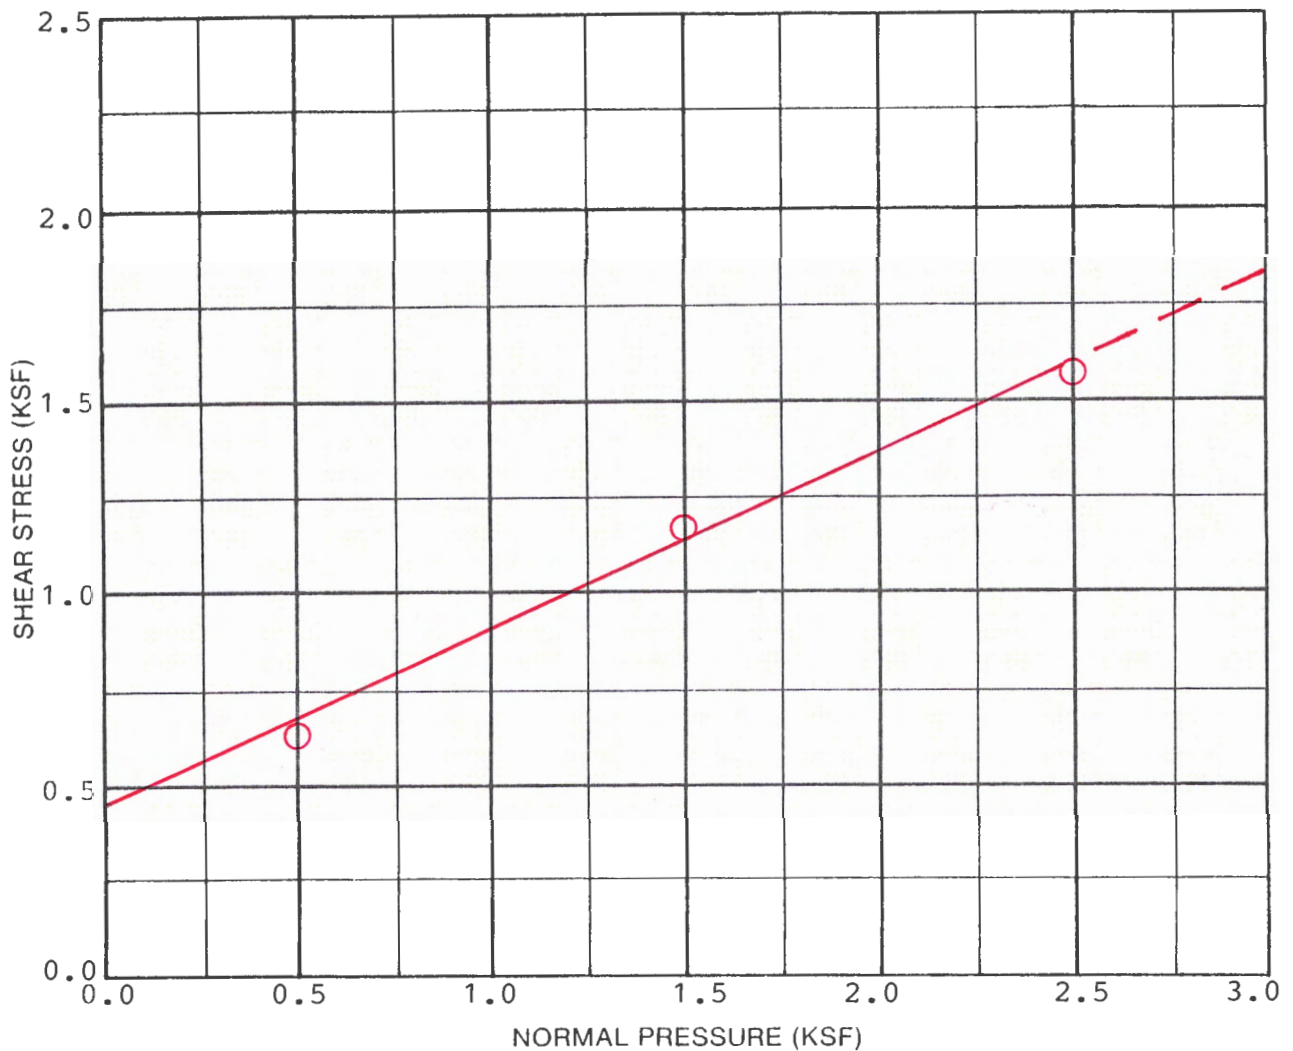
FIGURE A-10

| SAMPLE DATA | |
|---|---|
| DESCRIPTION: Medium to reddish-brown, sandy, clayey SILT (ML) (Remolded) | |

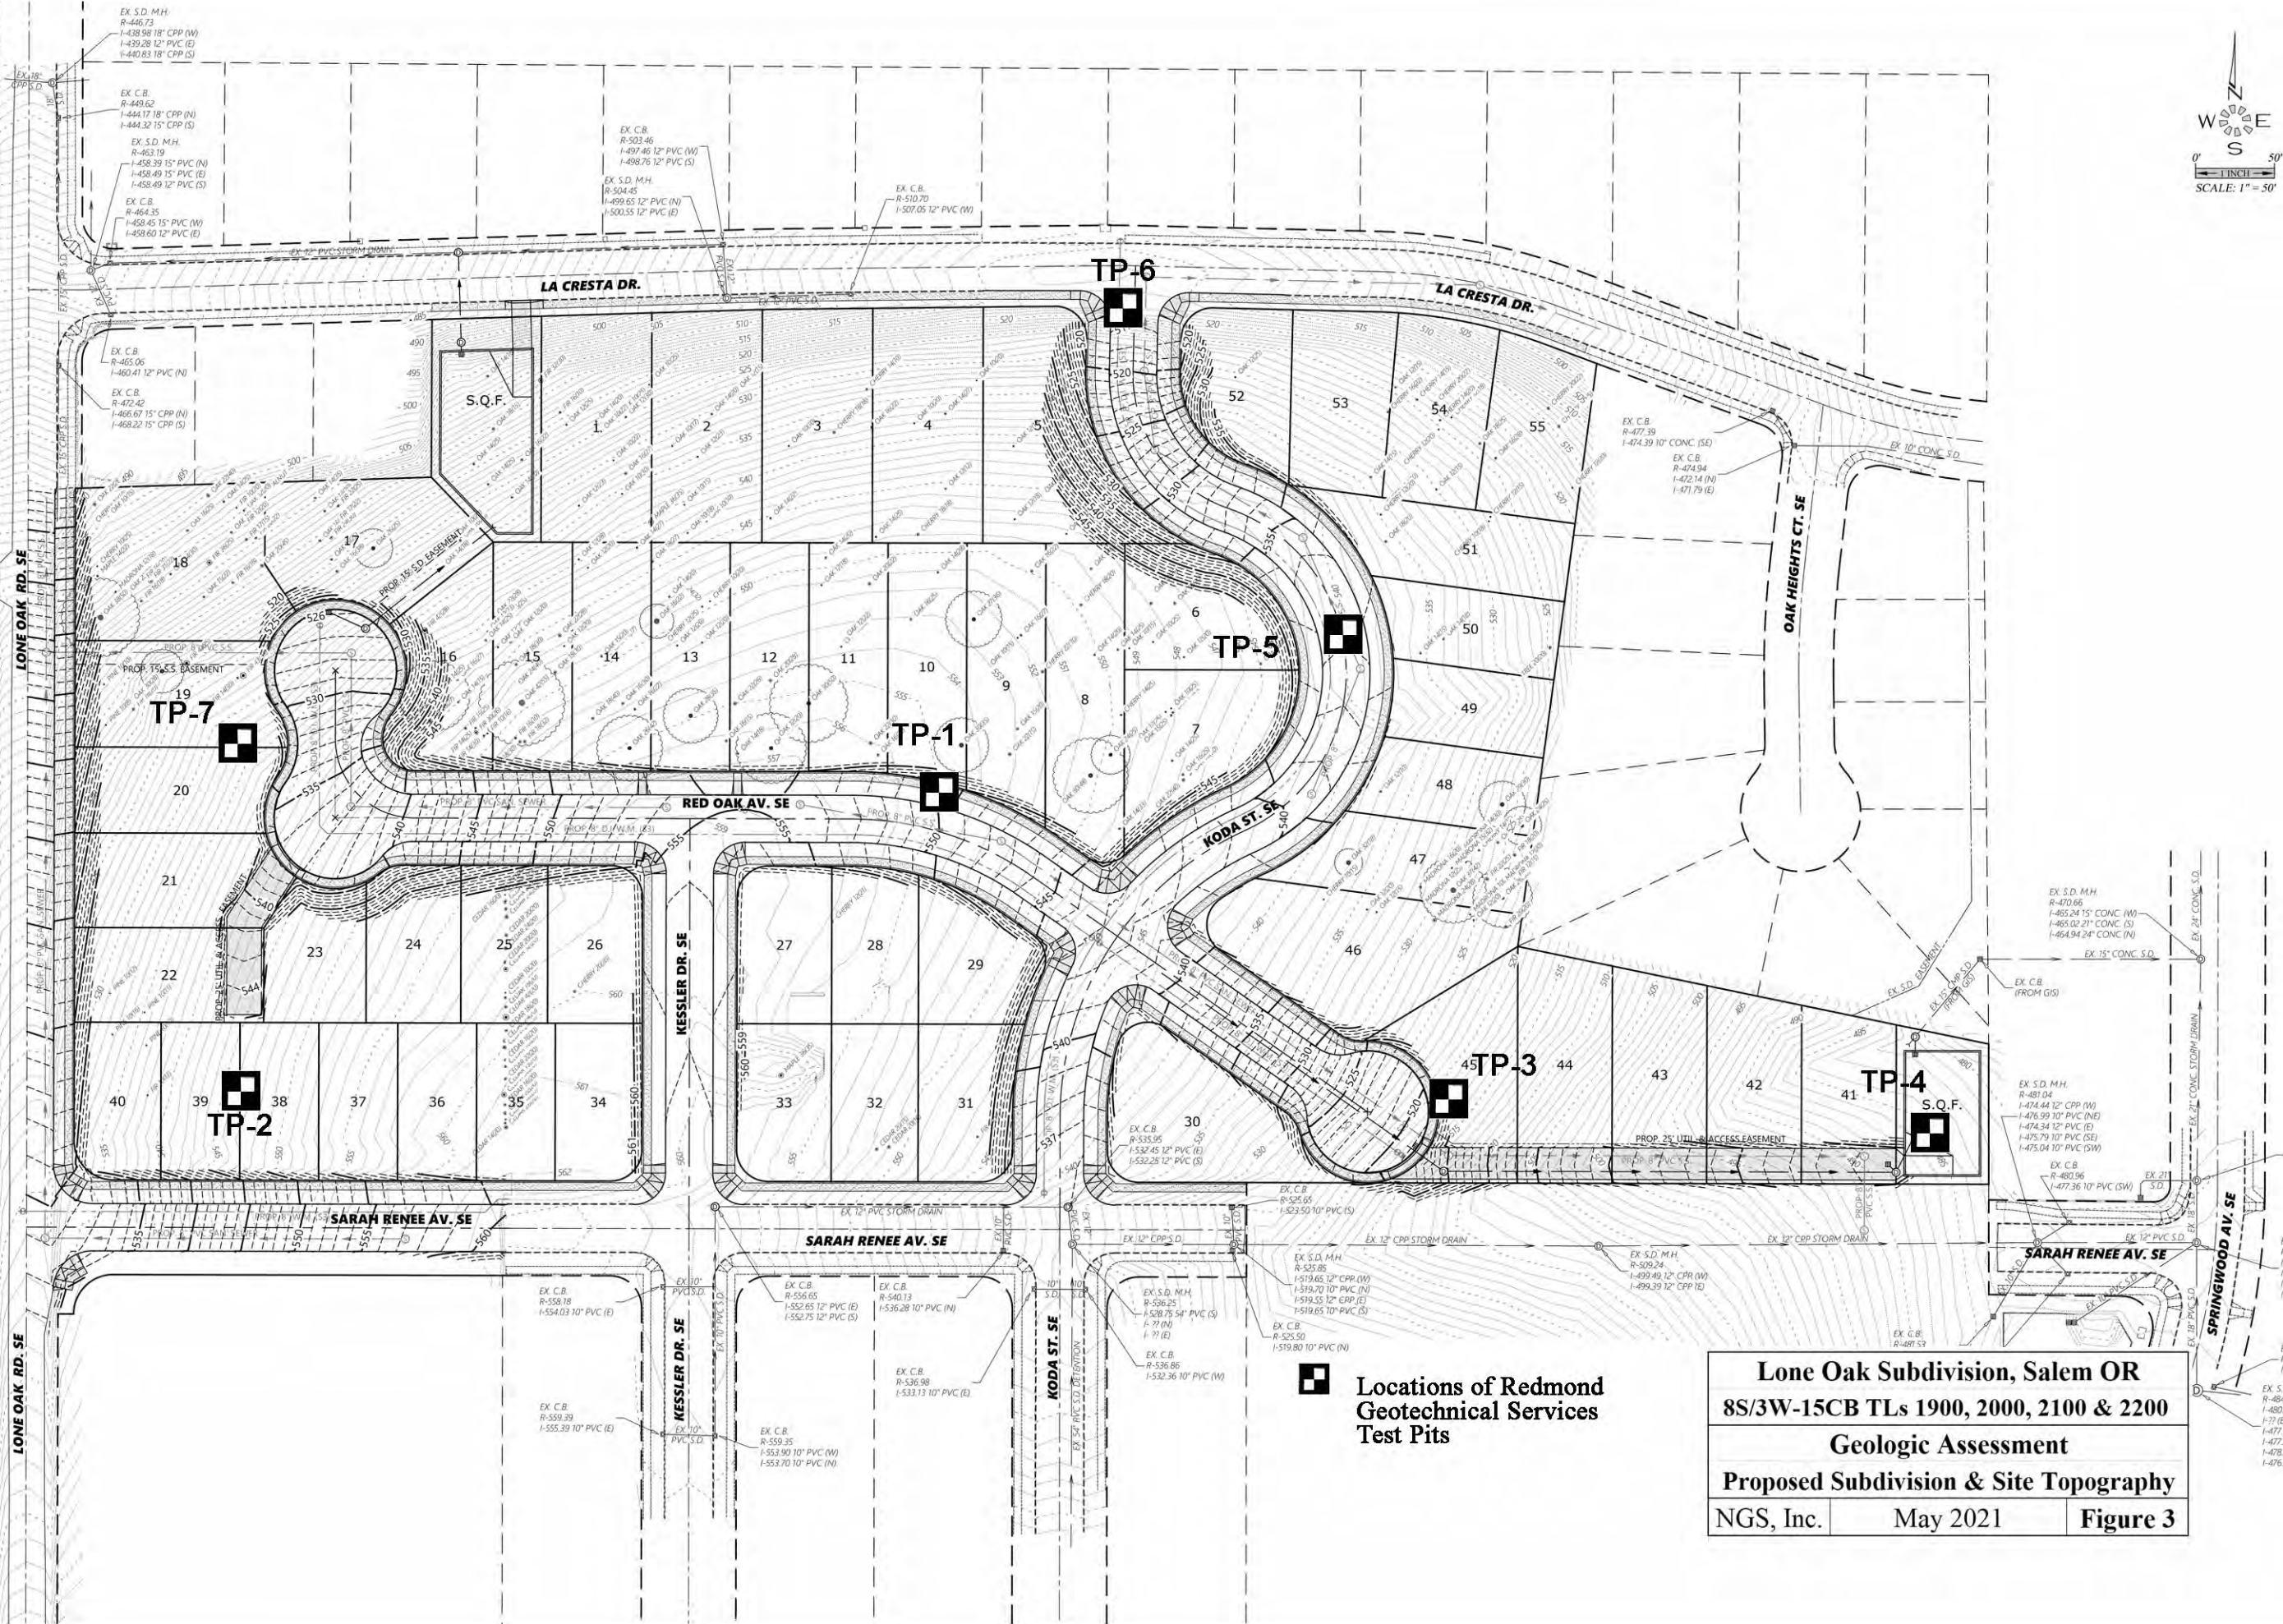
**Locations of Redmond Geotechnical Services Test Pits**

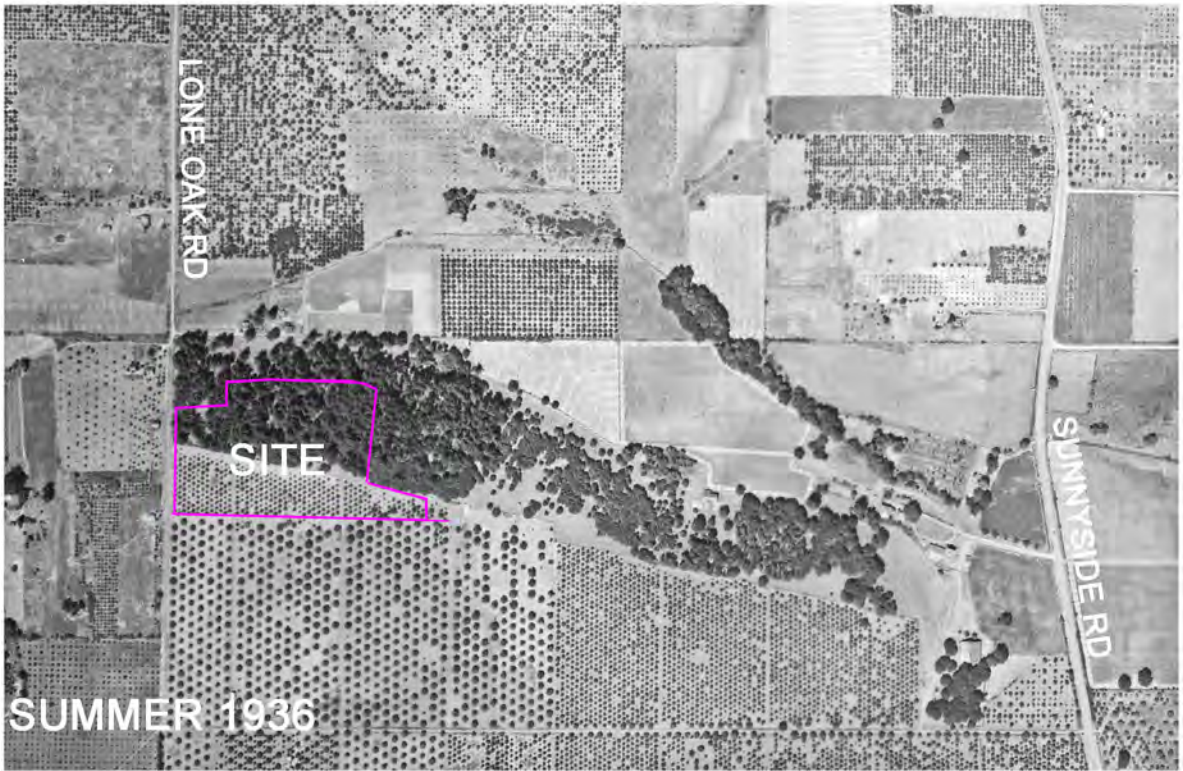
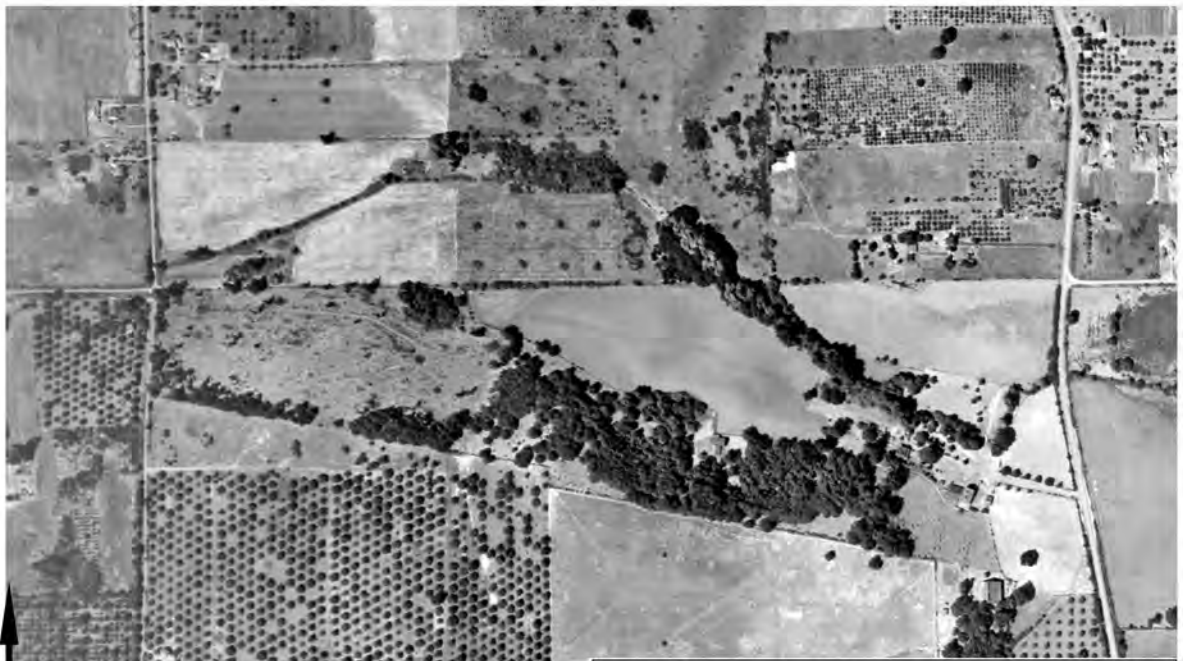
**Figure 4**

11 AUG 1954

Figure 4 shows 1936 and 1954 aerial photos of the site and adjacent area. They show the site has been used for agricultural purposes since before 1936. In 1936, TL1900 was forested and TLs 2100 and 2200 were an orchard. By 1954, all lots were mostly cleared with a few trees remaining in TL 2200 and along the south boundary of TL 1900 (Figure 4, lower). However, by 1967, TL2100 was replanted as orchard. TL 1900 had gone to scrub and the areas cleared previously were crisscrossed by trails. TL2200 was developed with a farm house, barn and sheds.

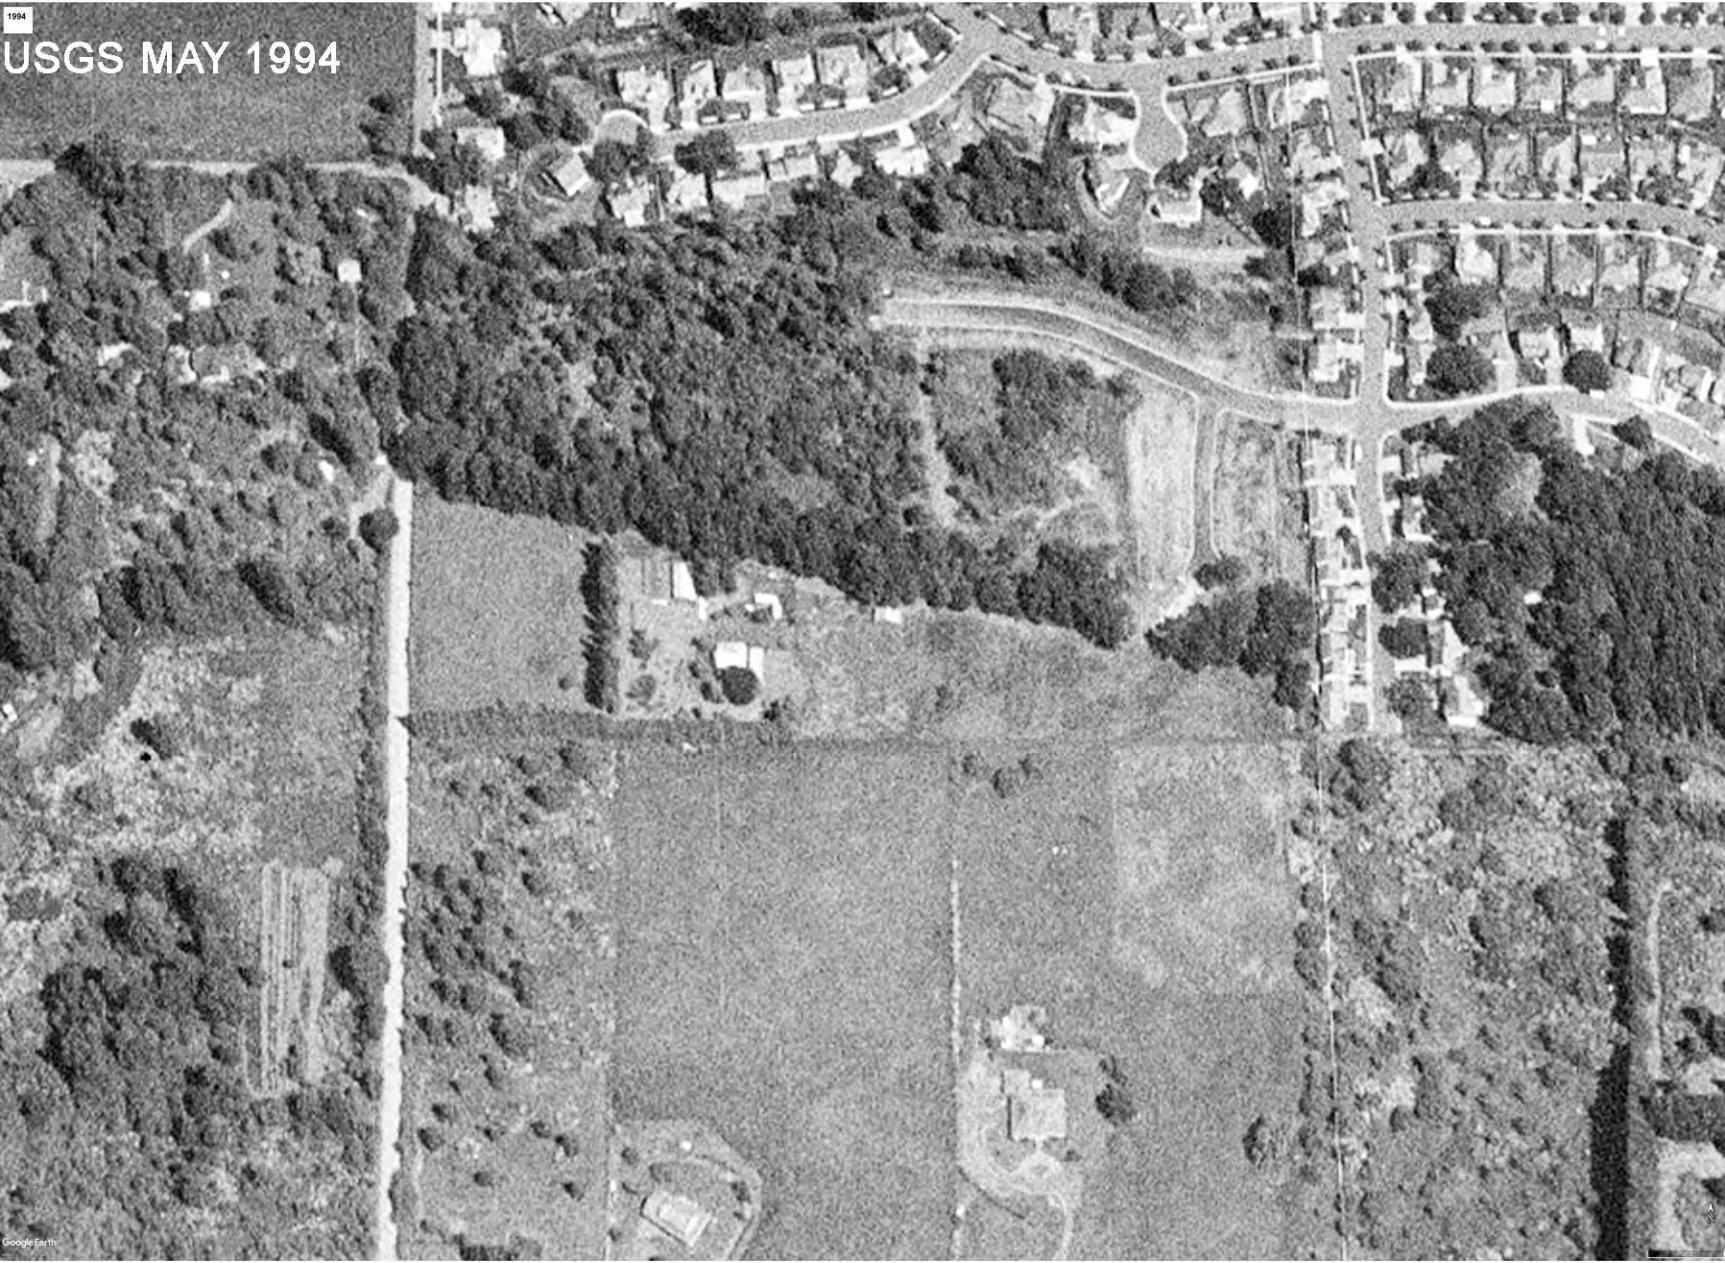
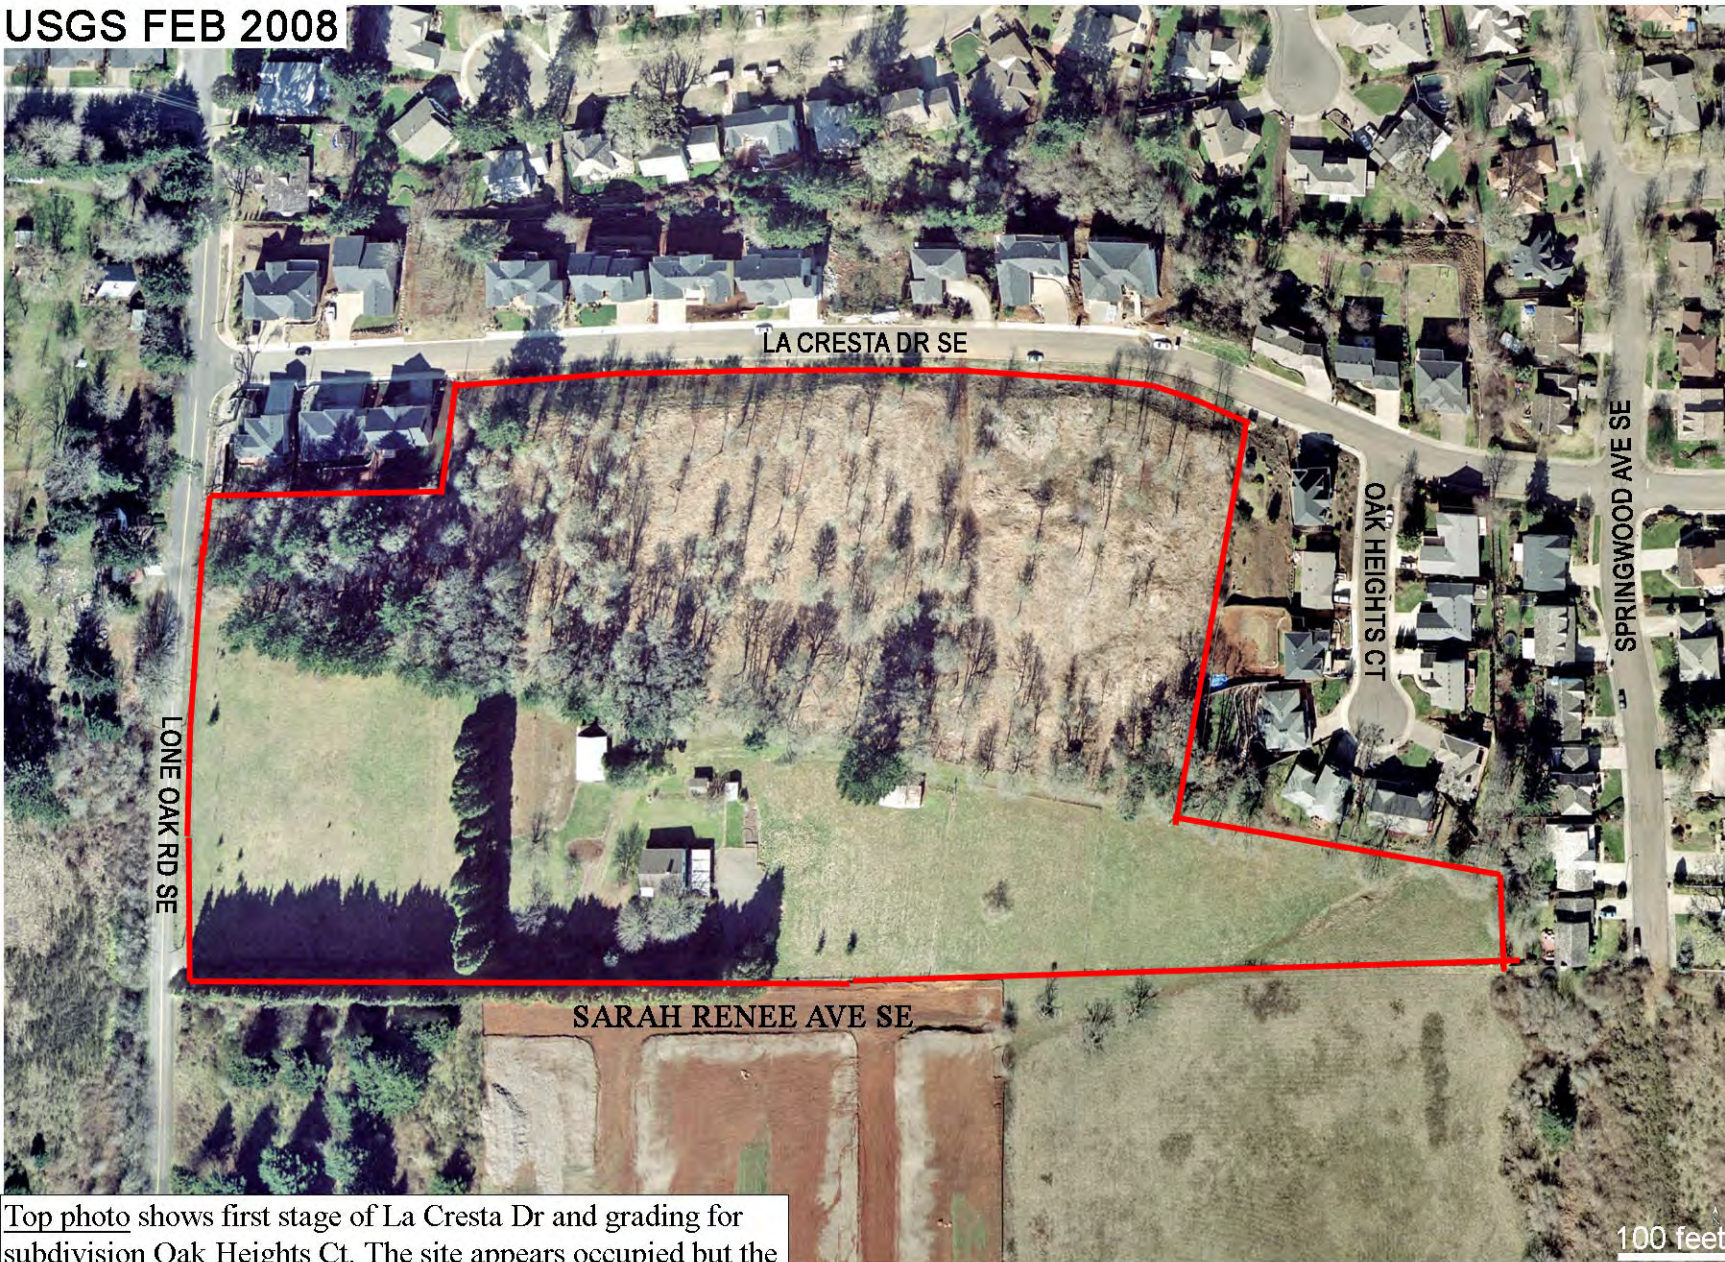
| NGS, Inc. | May 2021 | Figure 5 |

Top photo shows first stage of La Cresta Dr and grading for subdivision Oak Heights Ct. The site appears occupied but the fields are fallow.  
Lower photo shows La Cresta completed to Lone Oak and the subdivision along Oak Heights Ct built out. Grading for subdivision south of site mostly completed. Woodlot in north part of site mostly cleared & three houses completed NW of site.

By 1984, TL2100 was again cleared and TL1900 was again covered by trees. TL2200 appears to still be an active farm. The site appears largely unchanged on March 1990 photos and 1994 USGS images (Figure 5, top). Subsequent images suggest the site was last actively farmed and/or maintained in 2008 (Figure 5, bottom).
