## **ARBORIST REPORT**

Located at: 1457 Goldcrest Ave NW, Salem

## Hazardous Tree Removal pursuant to SRC 808.030(d)(1).

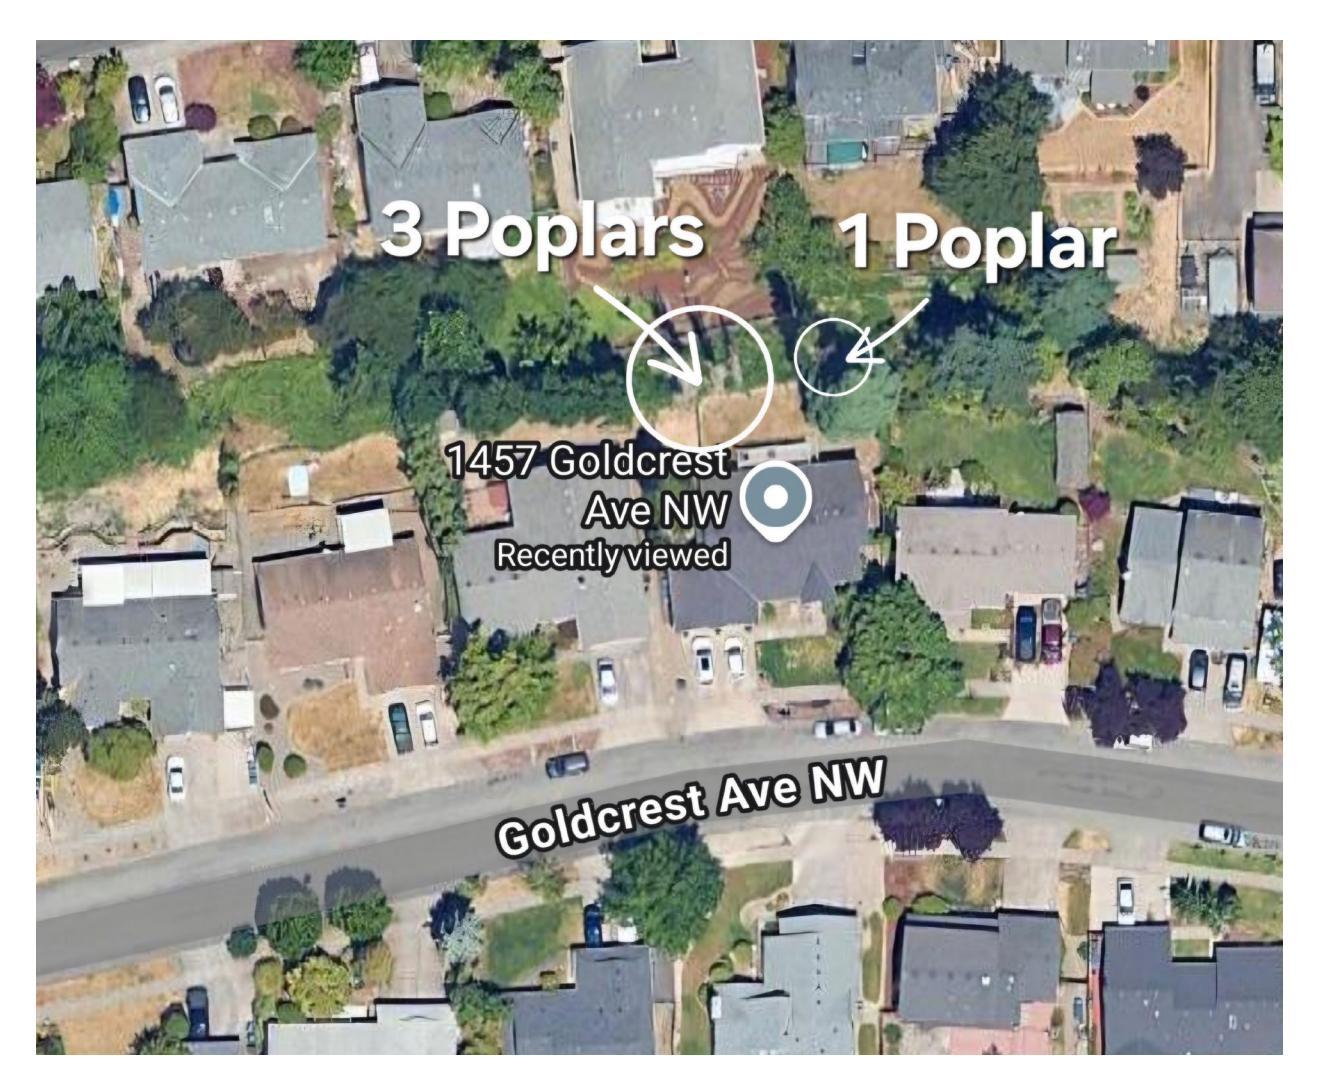
**LOCATION** - Overview

Our company was contacted by Christopher Easton, property owner of 1457 Goldcrest Ave NW in Salem, regarding the hazardous condition of four poplar trees located within the riparian zone. The four poplar trees are located in the backyard of the home. (*Tree locations are circled in white on following page*)

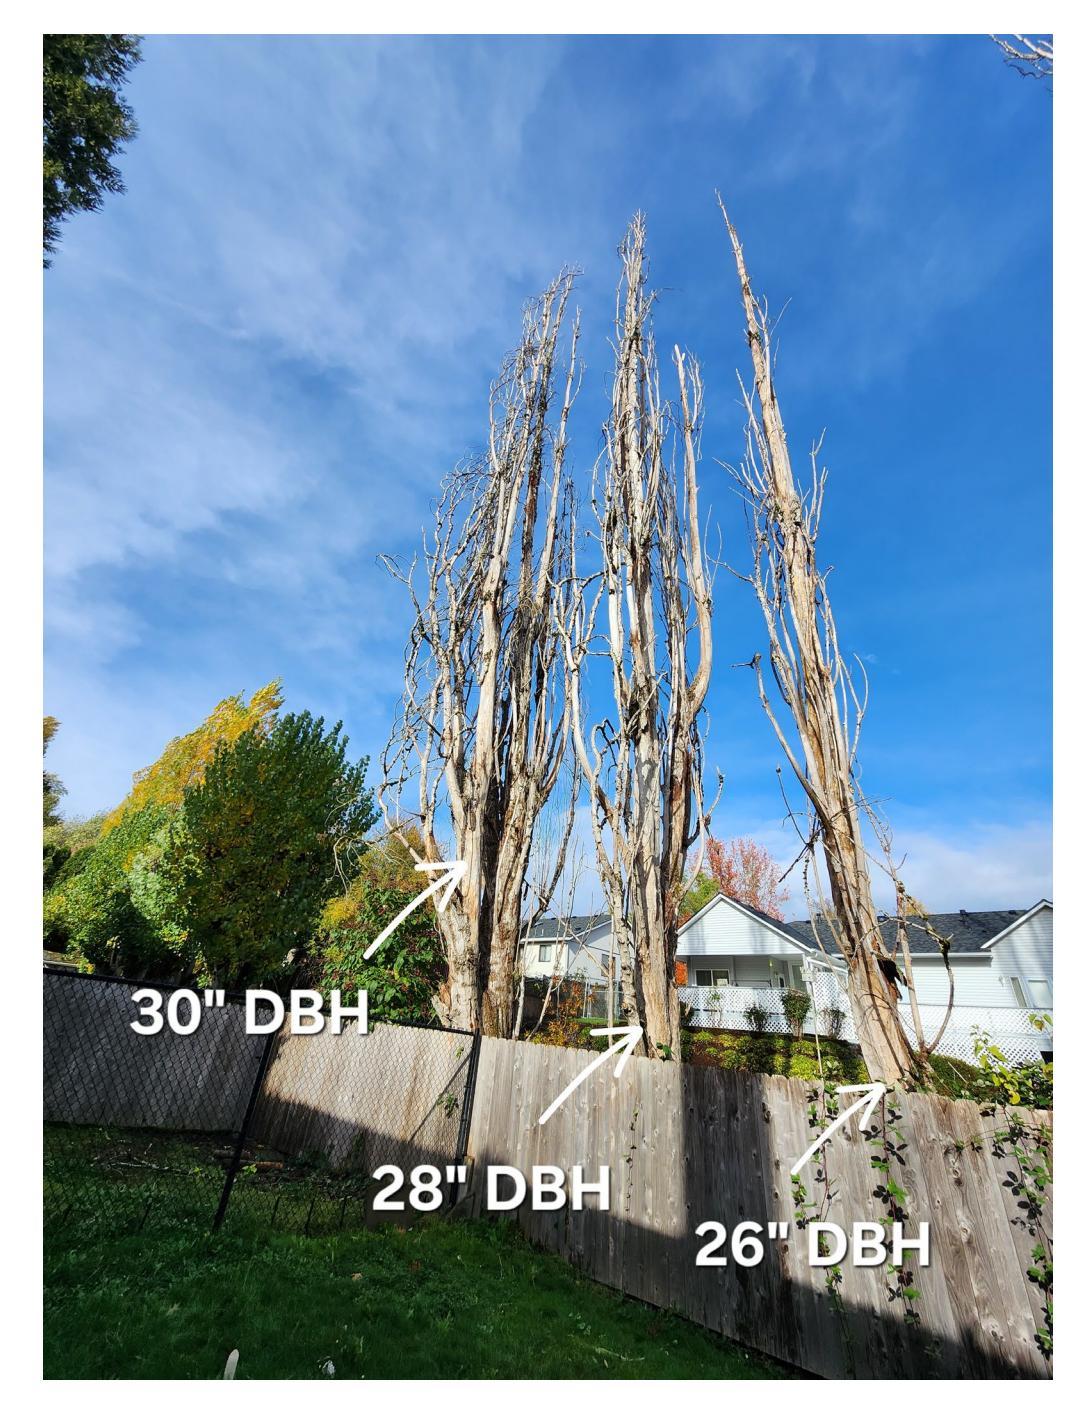
**PICTURE 1** Taken 11/05/2024

All four trees are dead.

In my opinion, the removal is necessary for safety of the nearby homes, property and people and these hazards cannot be alleviated by treatment or pruning.
